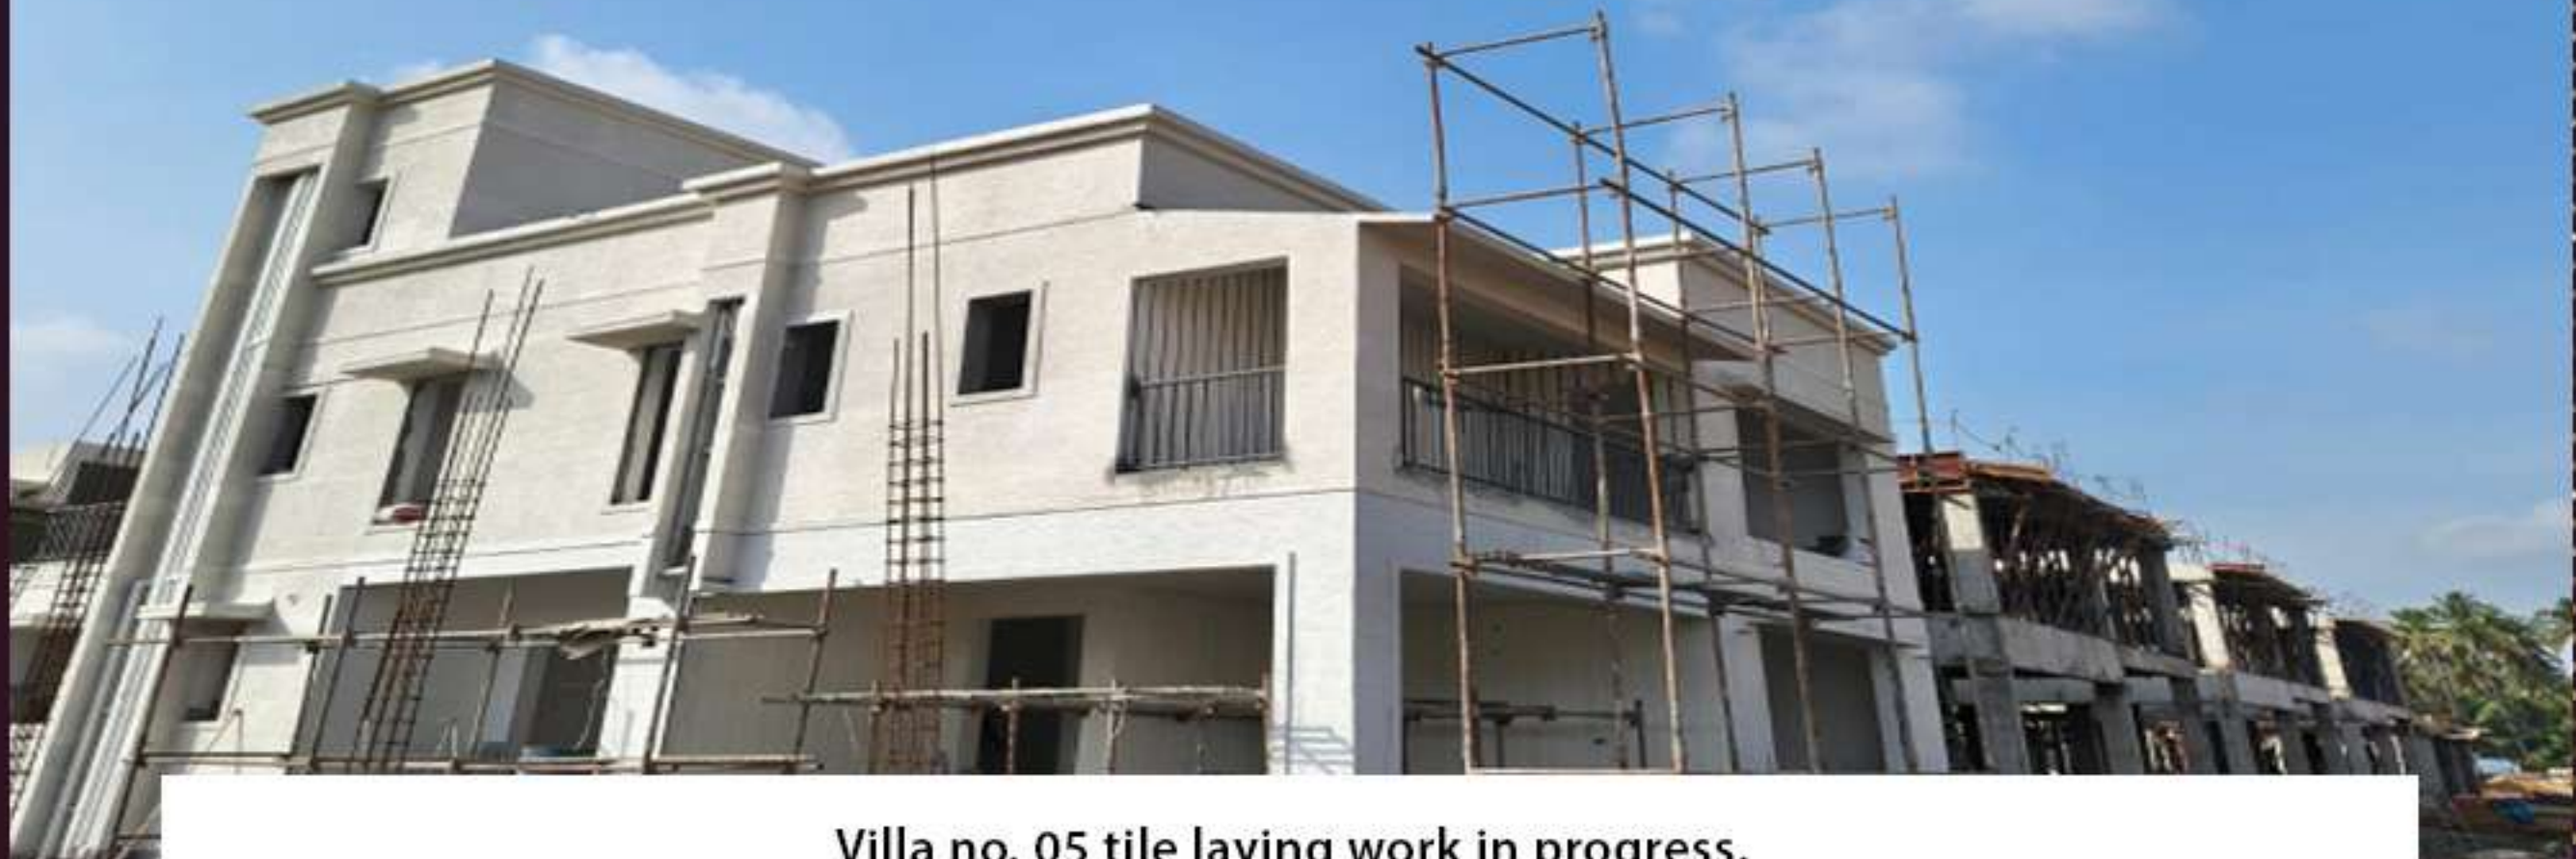
Villa no. 05 tile laying work in progress.

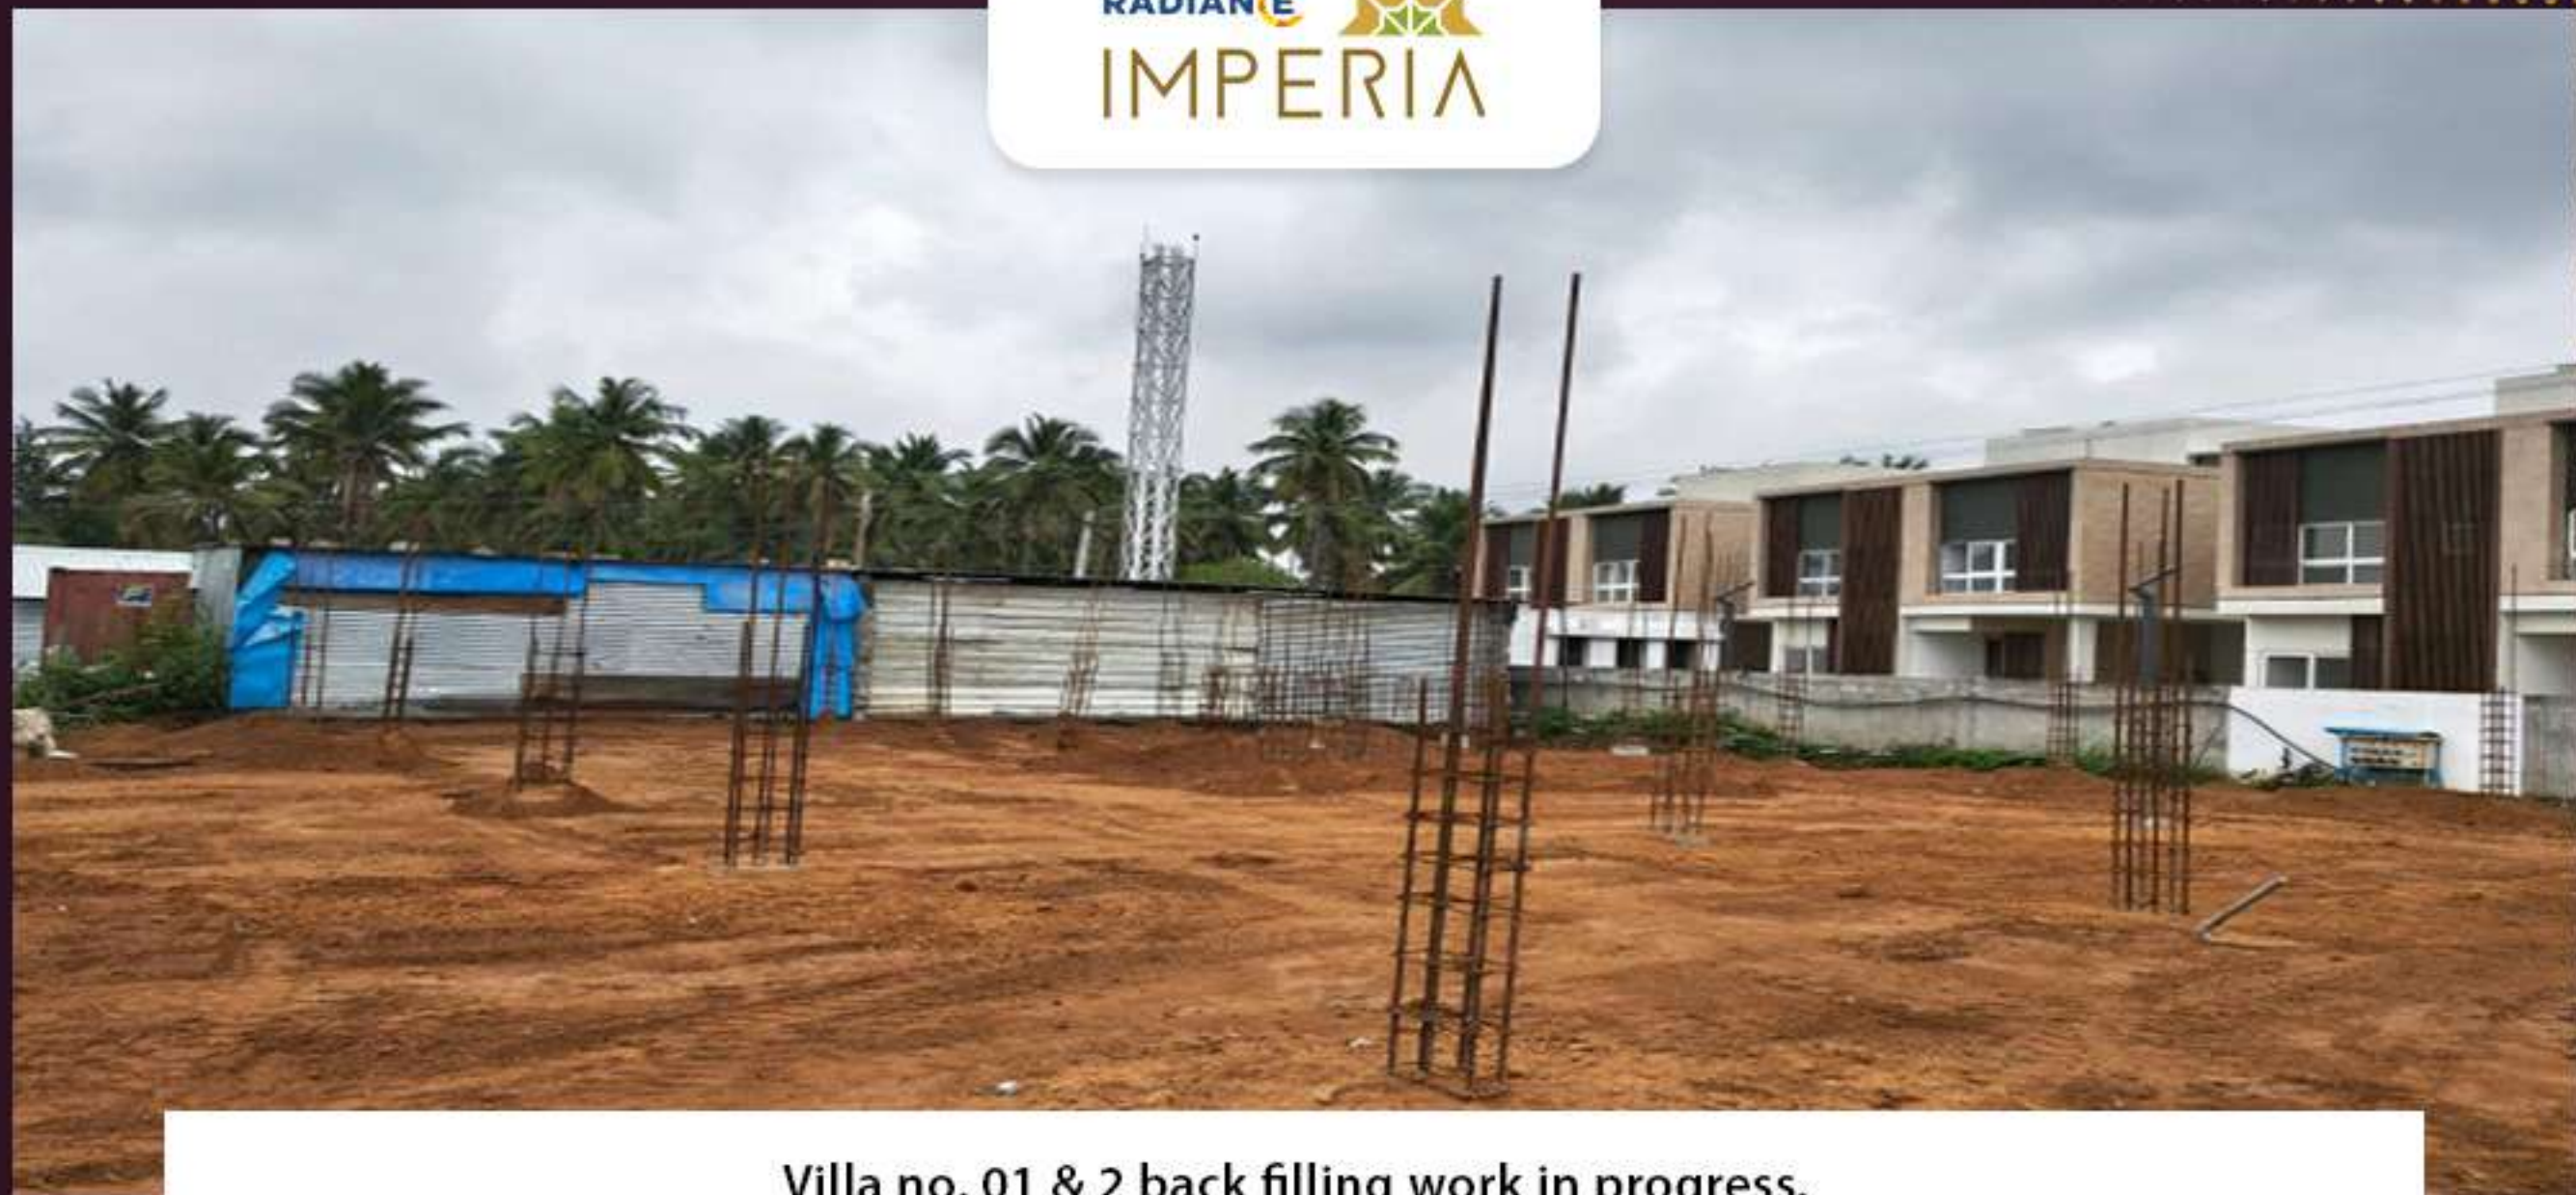
Villa no. 01 & 2 back filling work in progress.

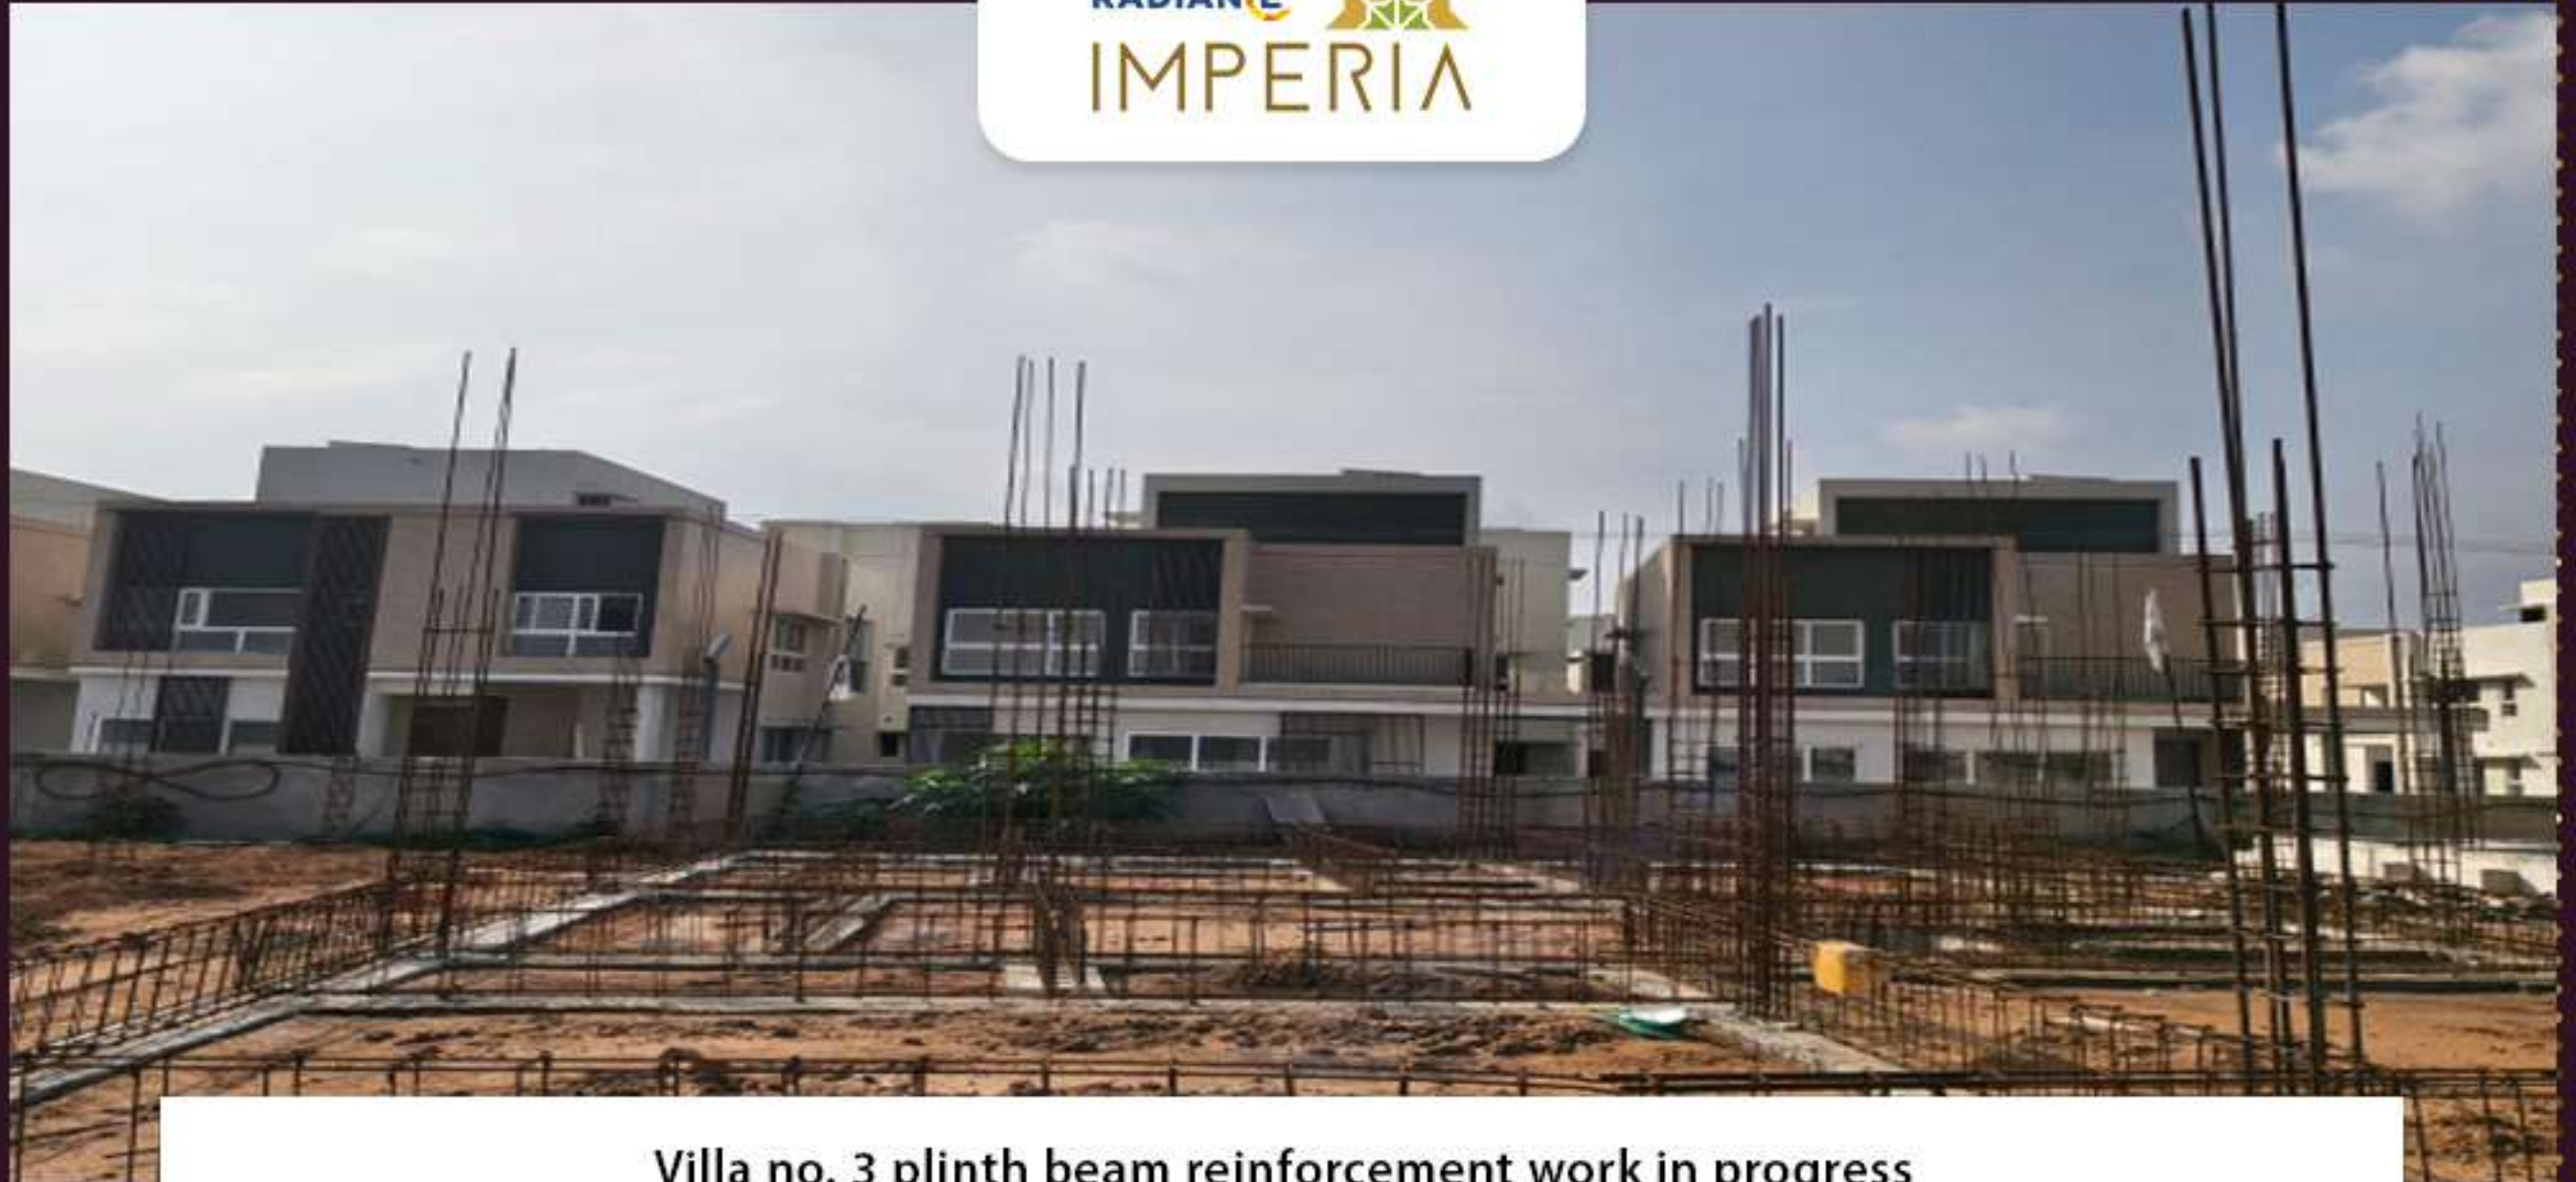
Villa no. 3 plinth beam reinforcement work in progress

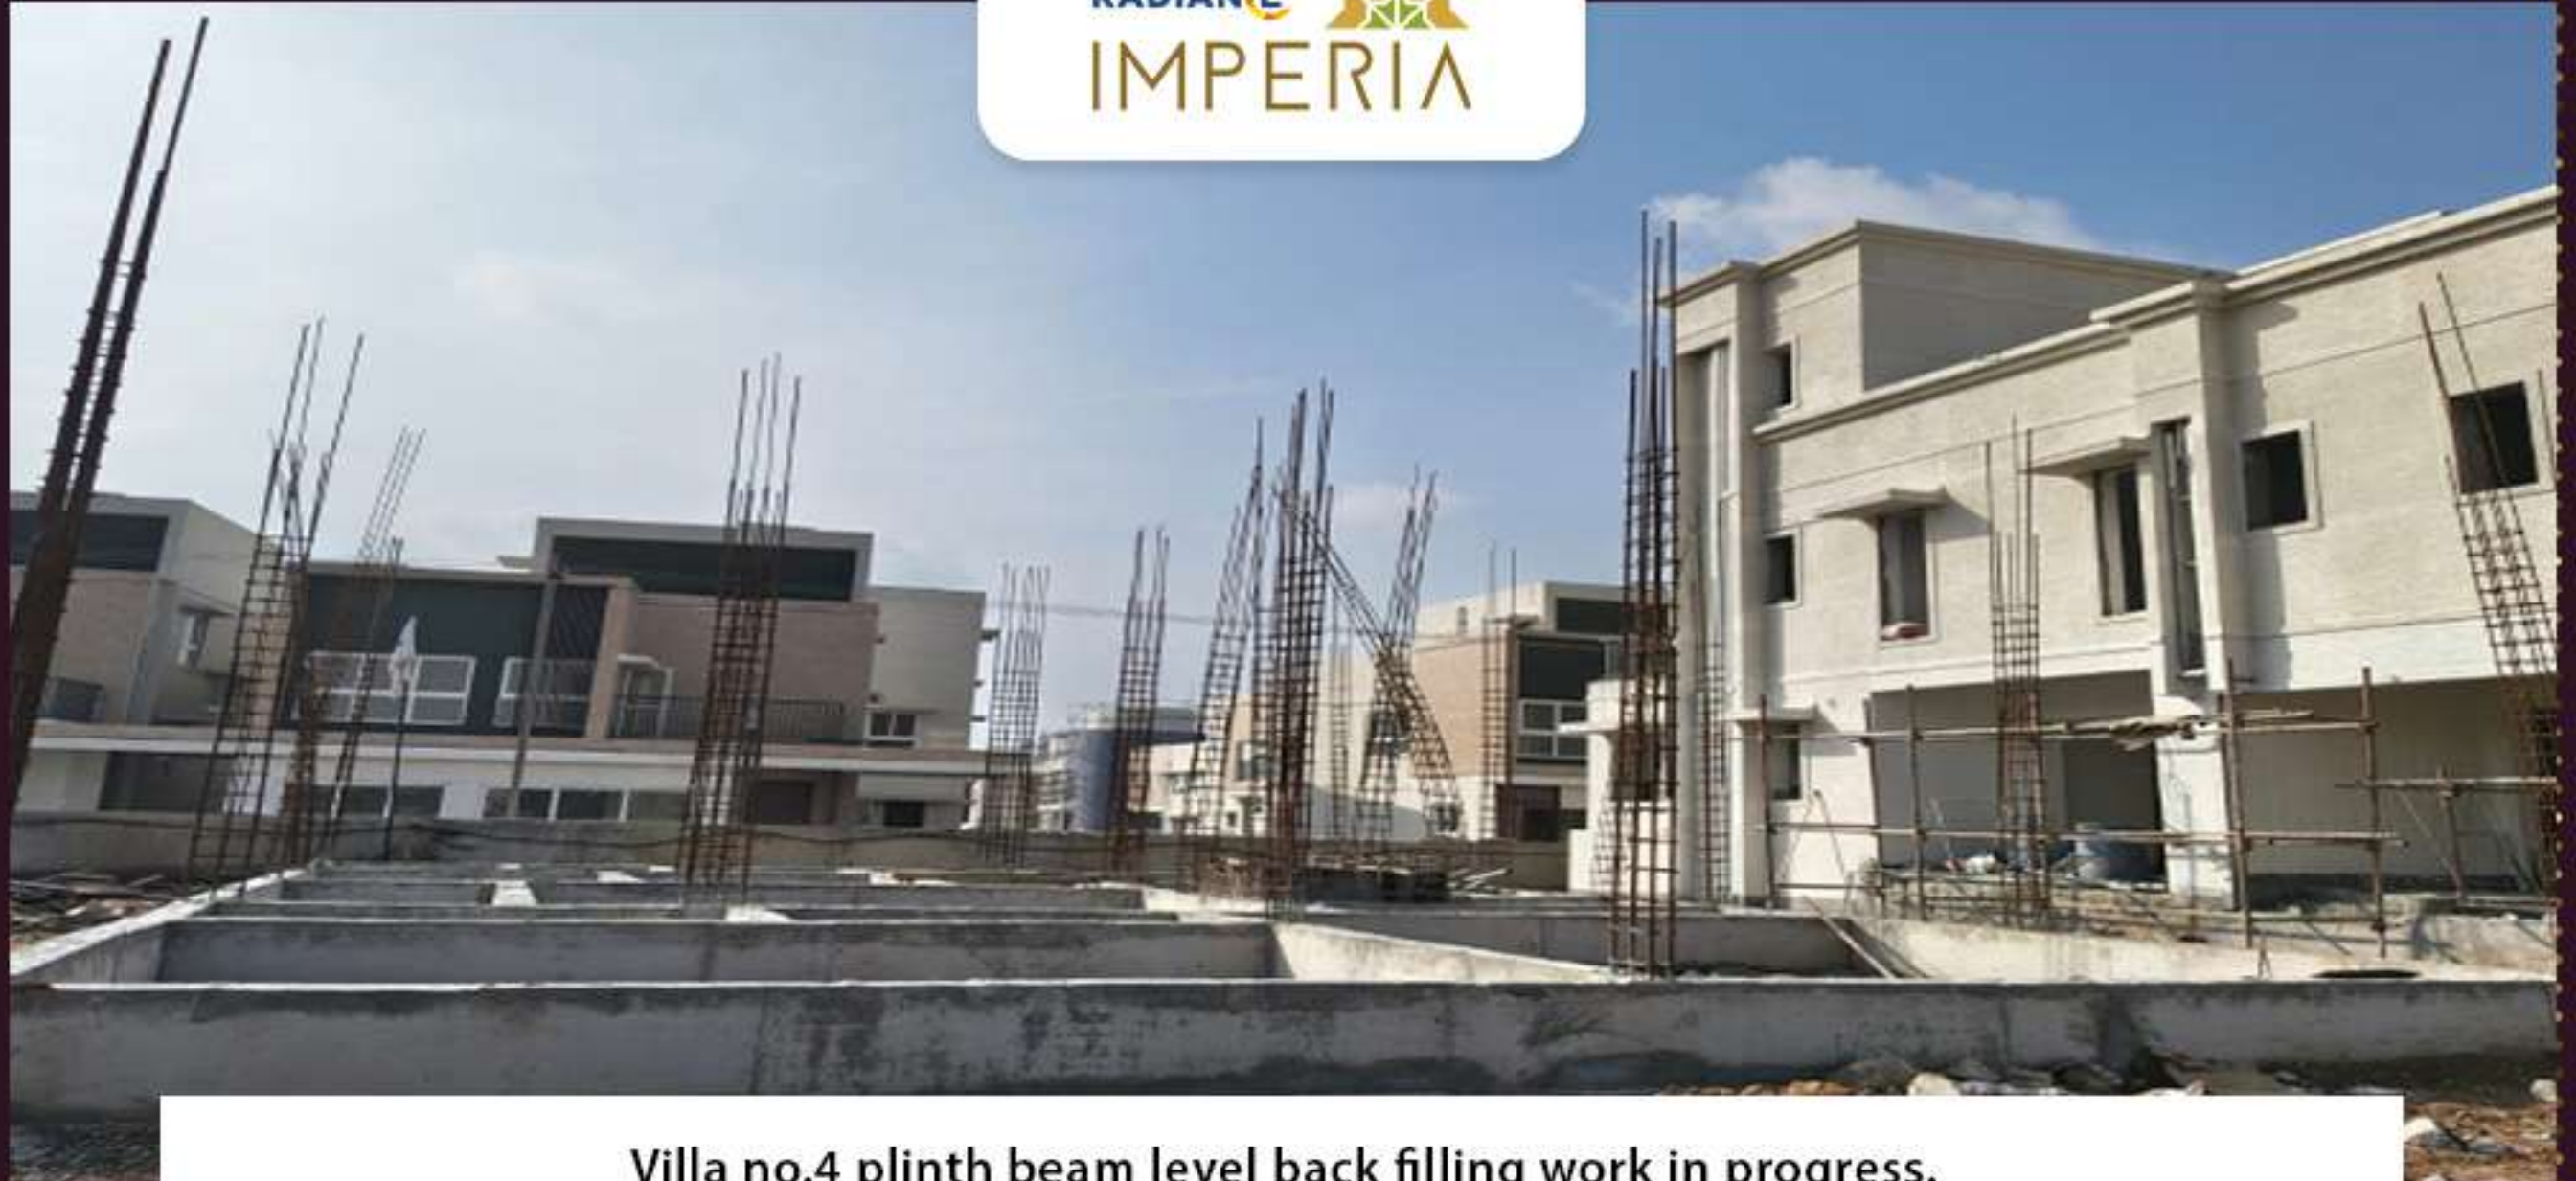
Villa no.4 plinth beam level back filling work in progress.

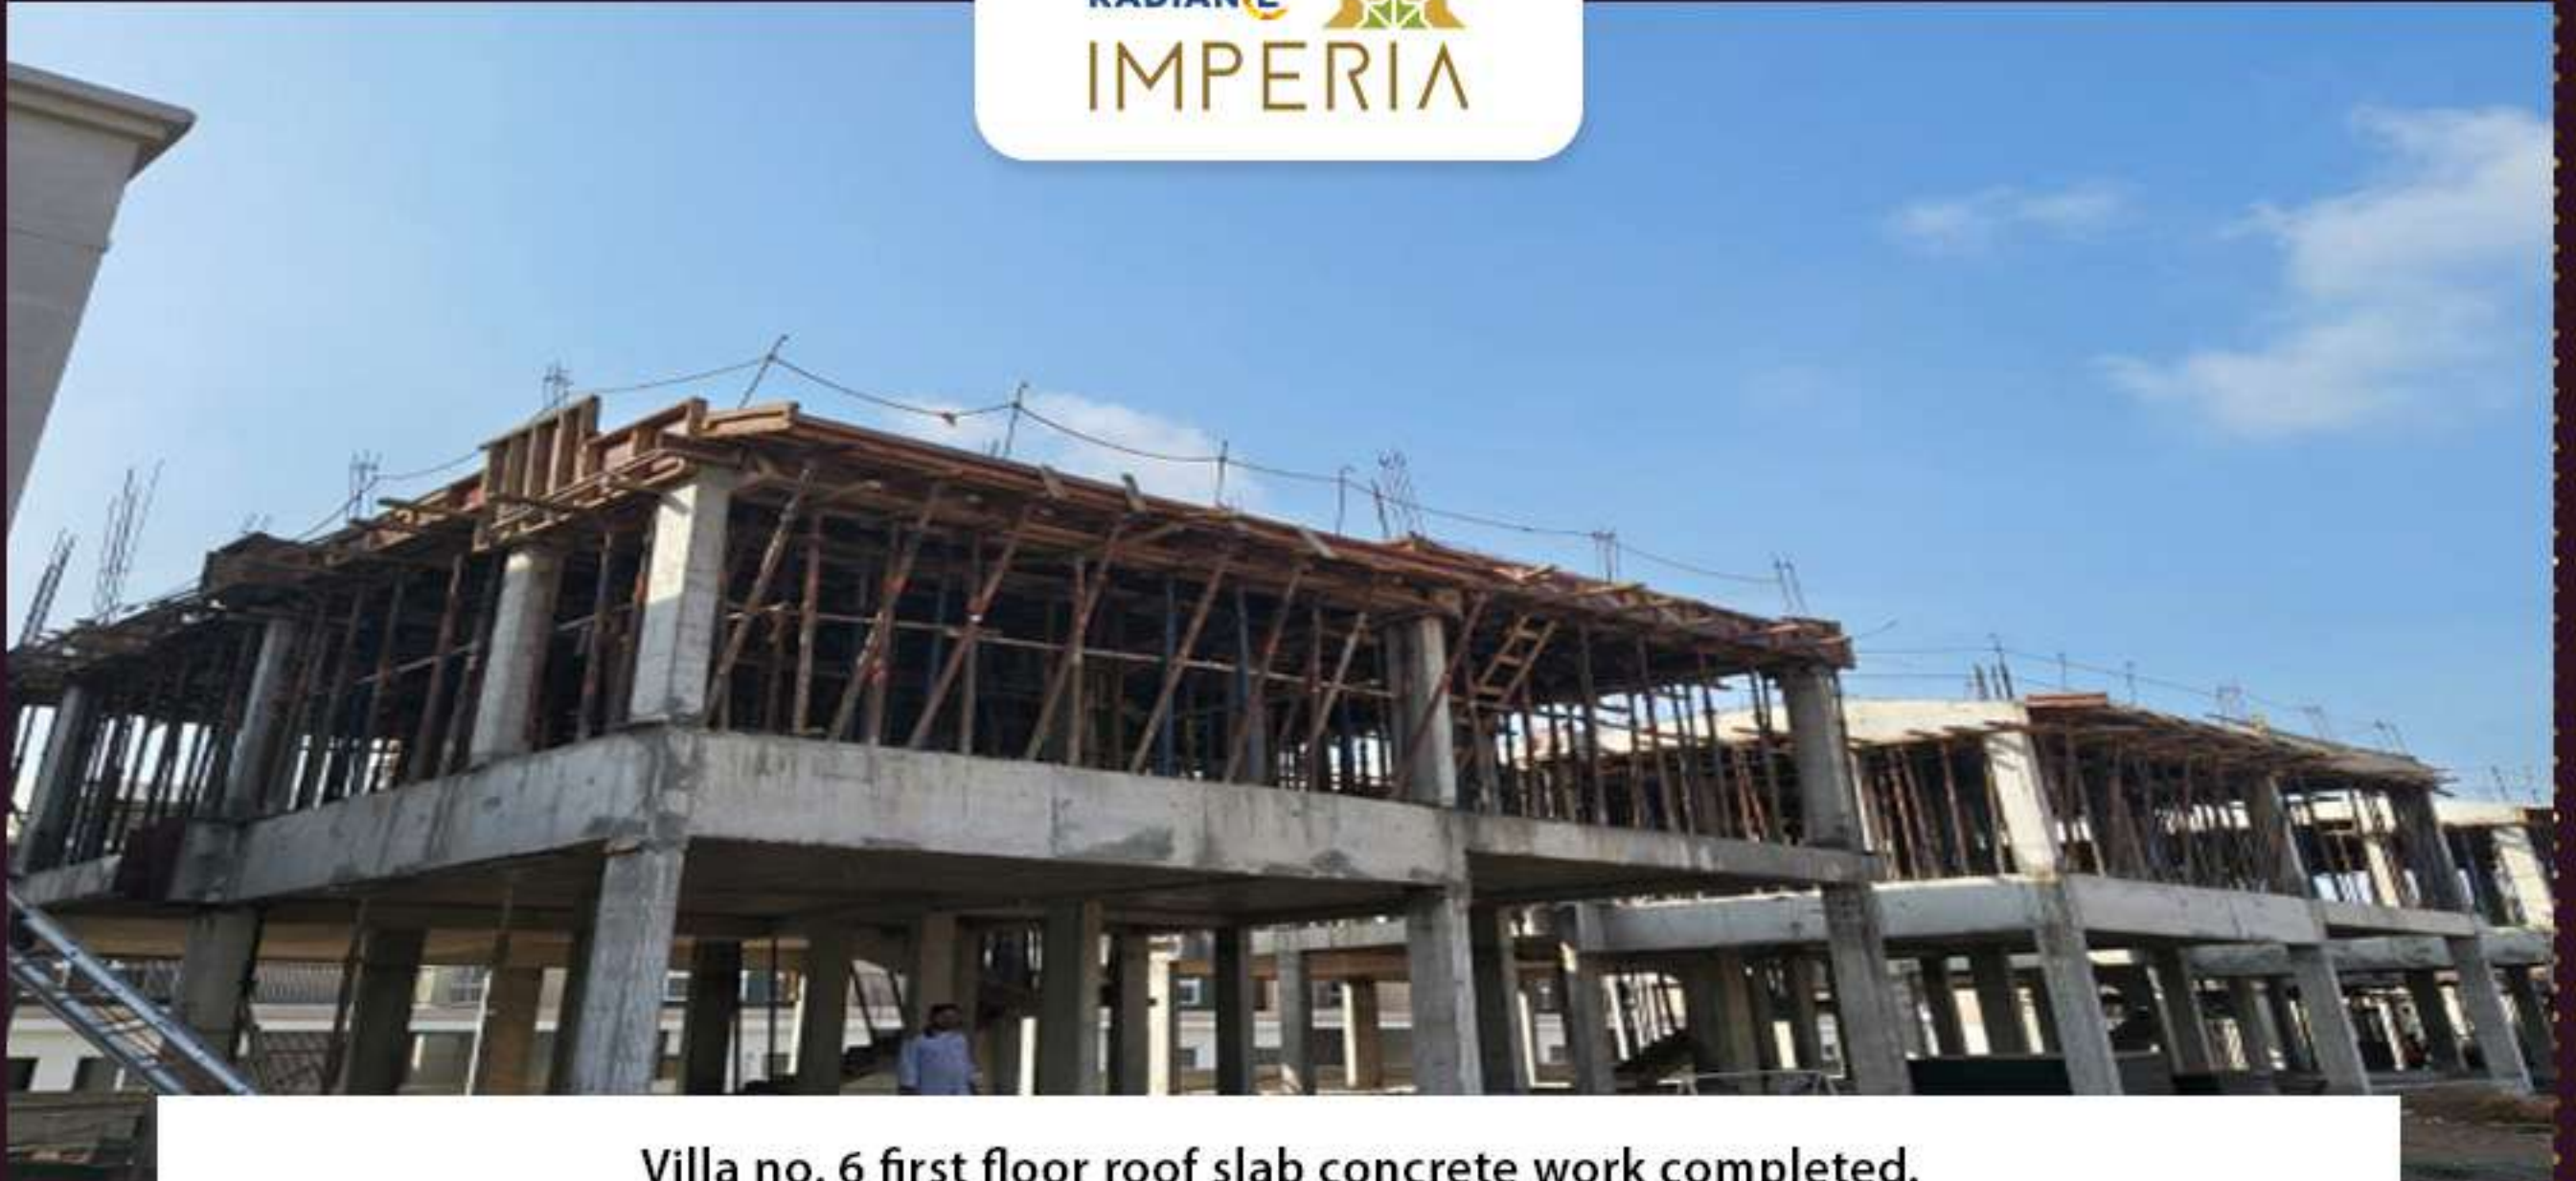
Villa no. 6 first floor roof slab concrete work completed.

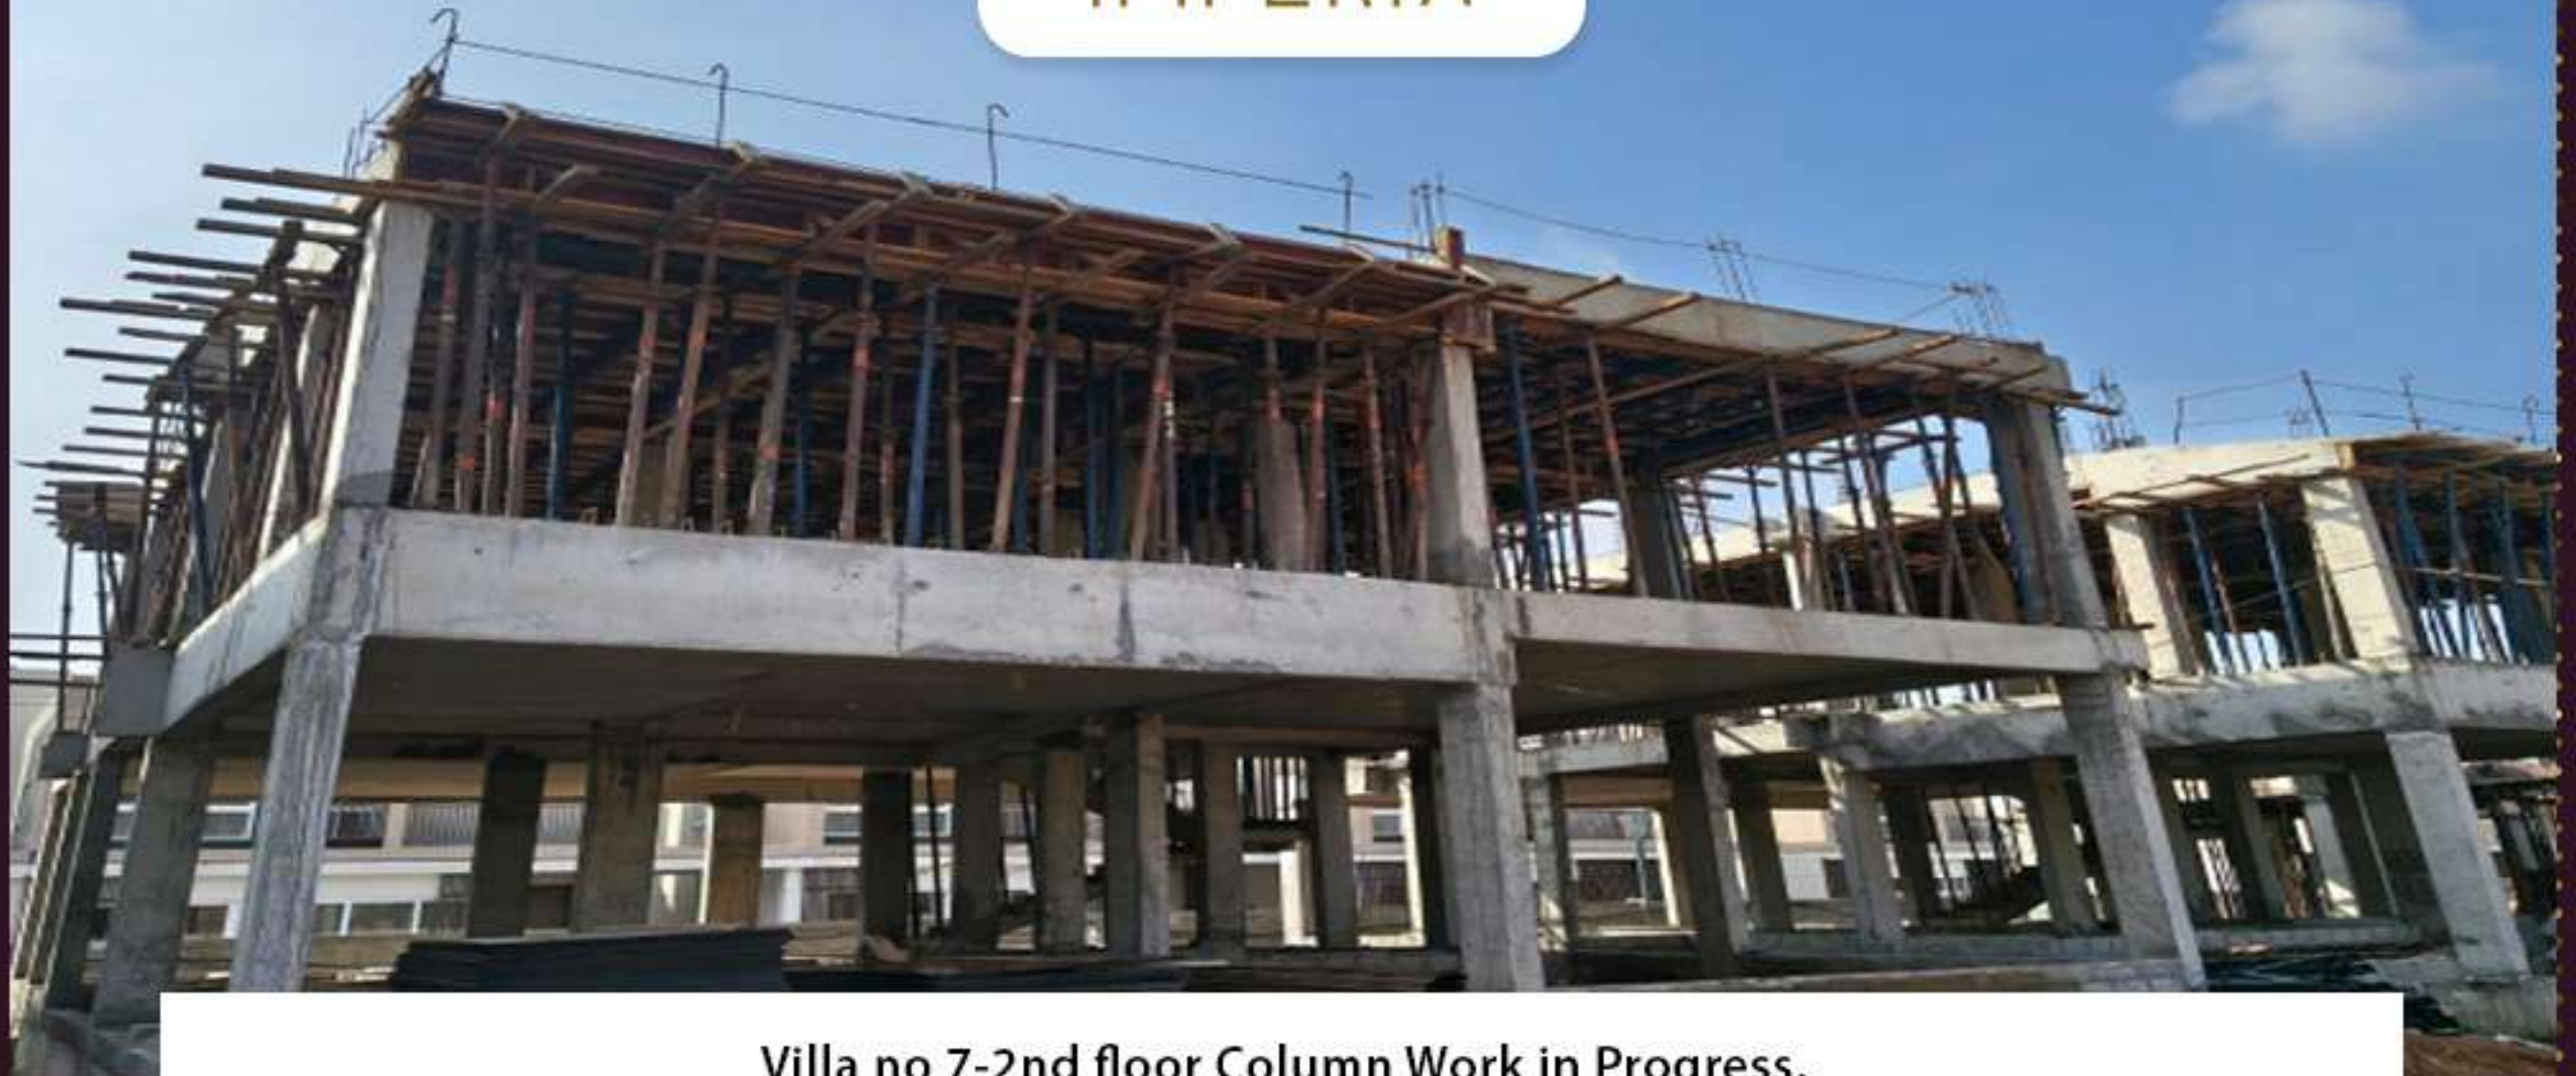
Villa no 7-2nd floor Column Work in Progress.

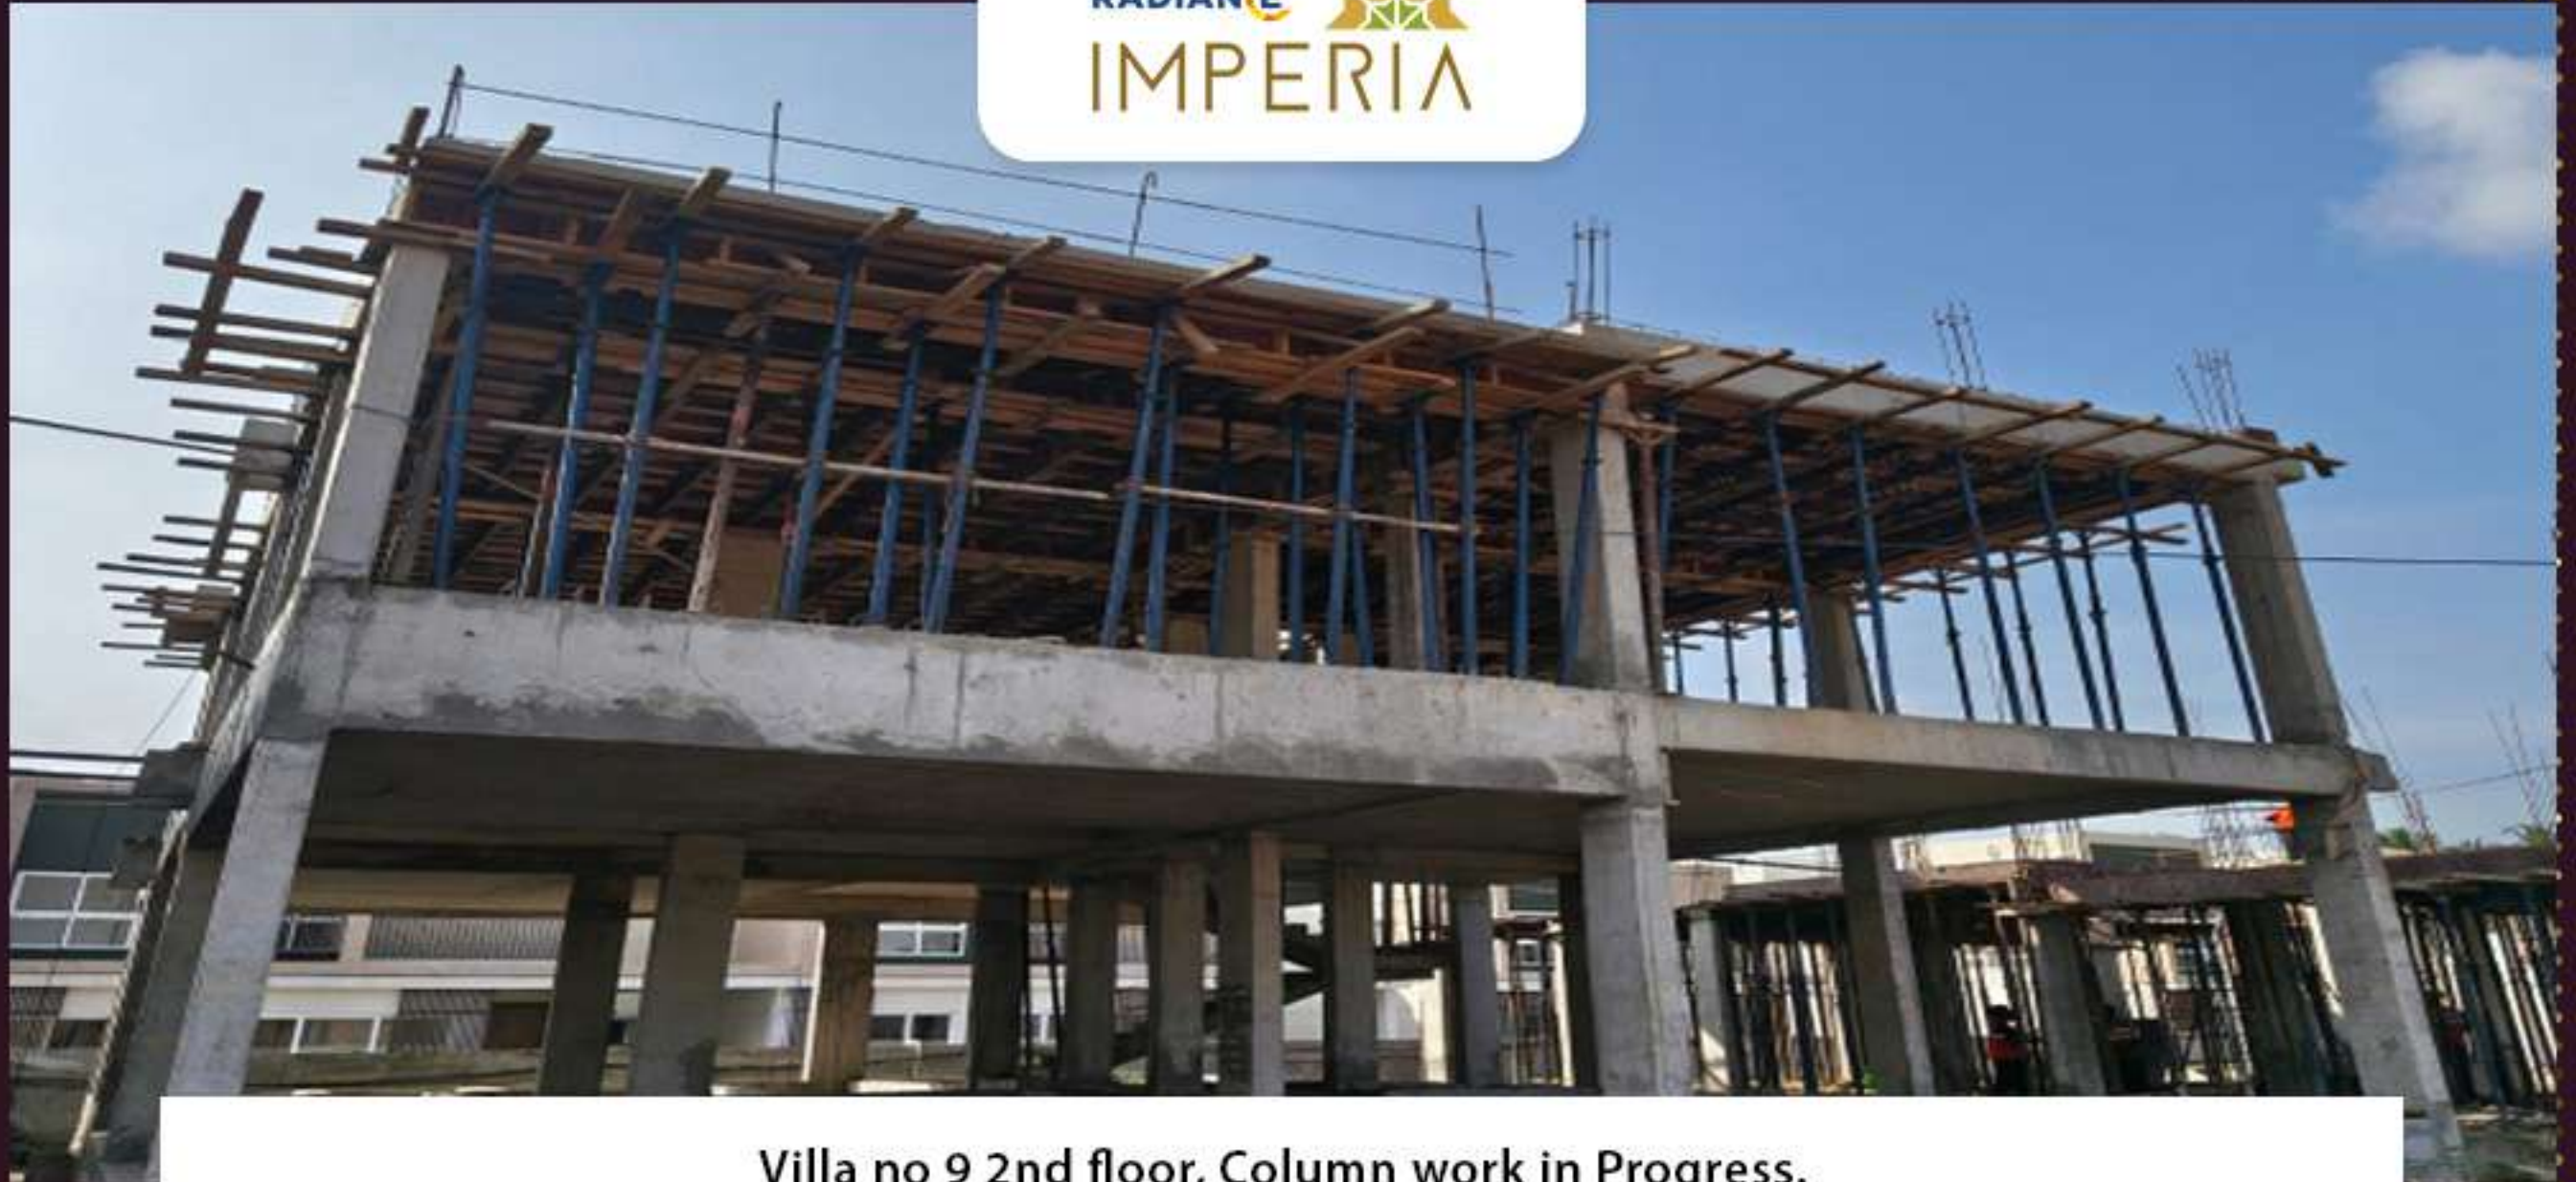
Villa no 9 2nd floor, Column work in Progress.

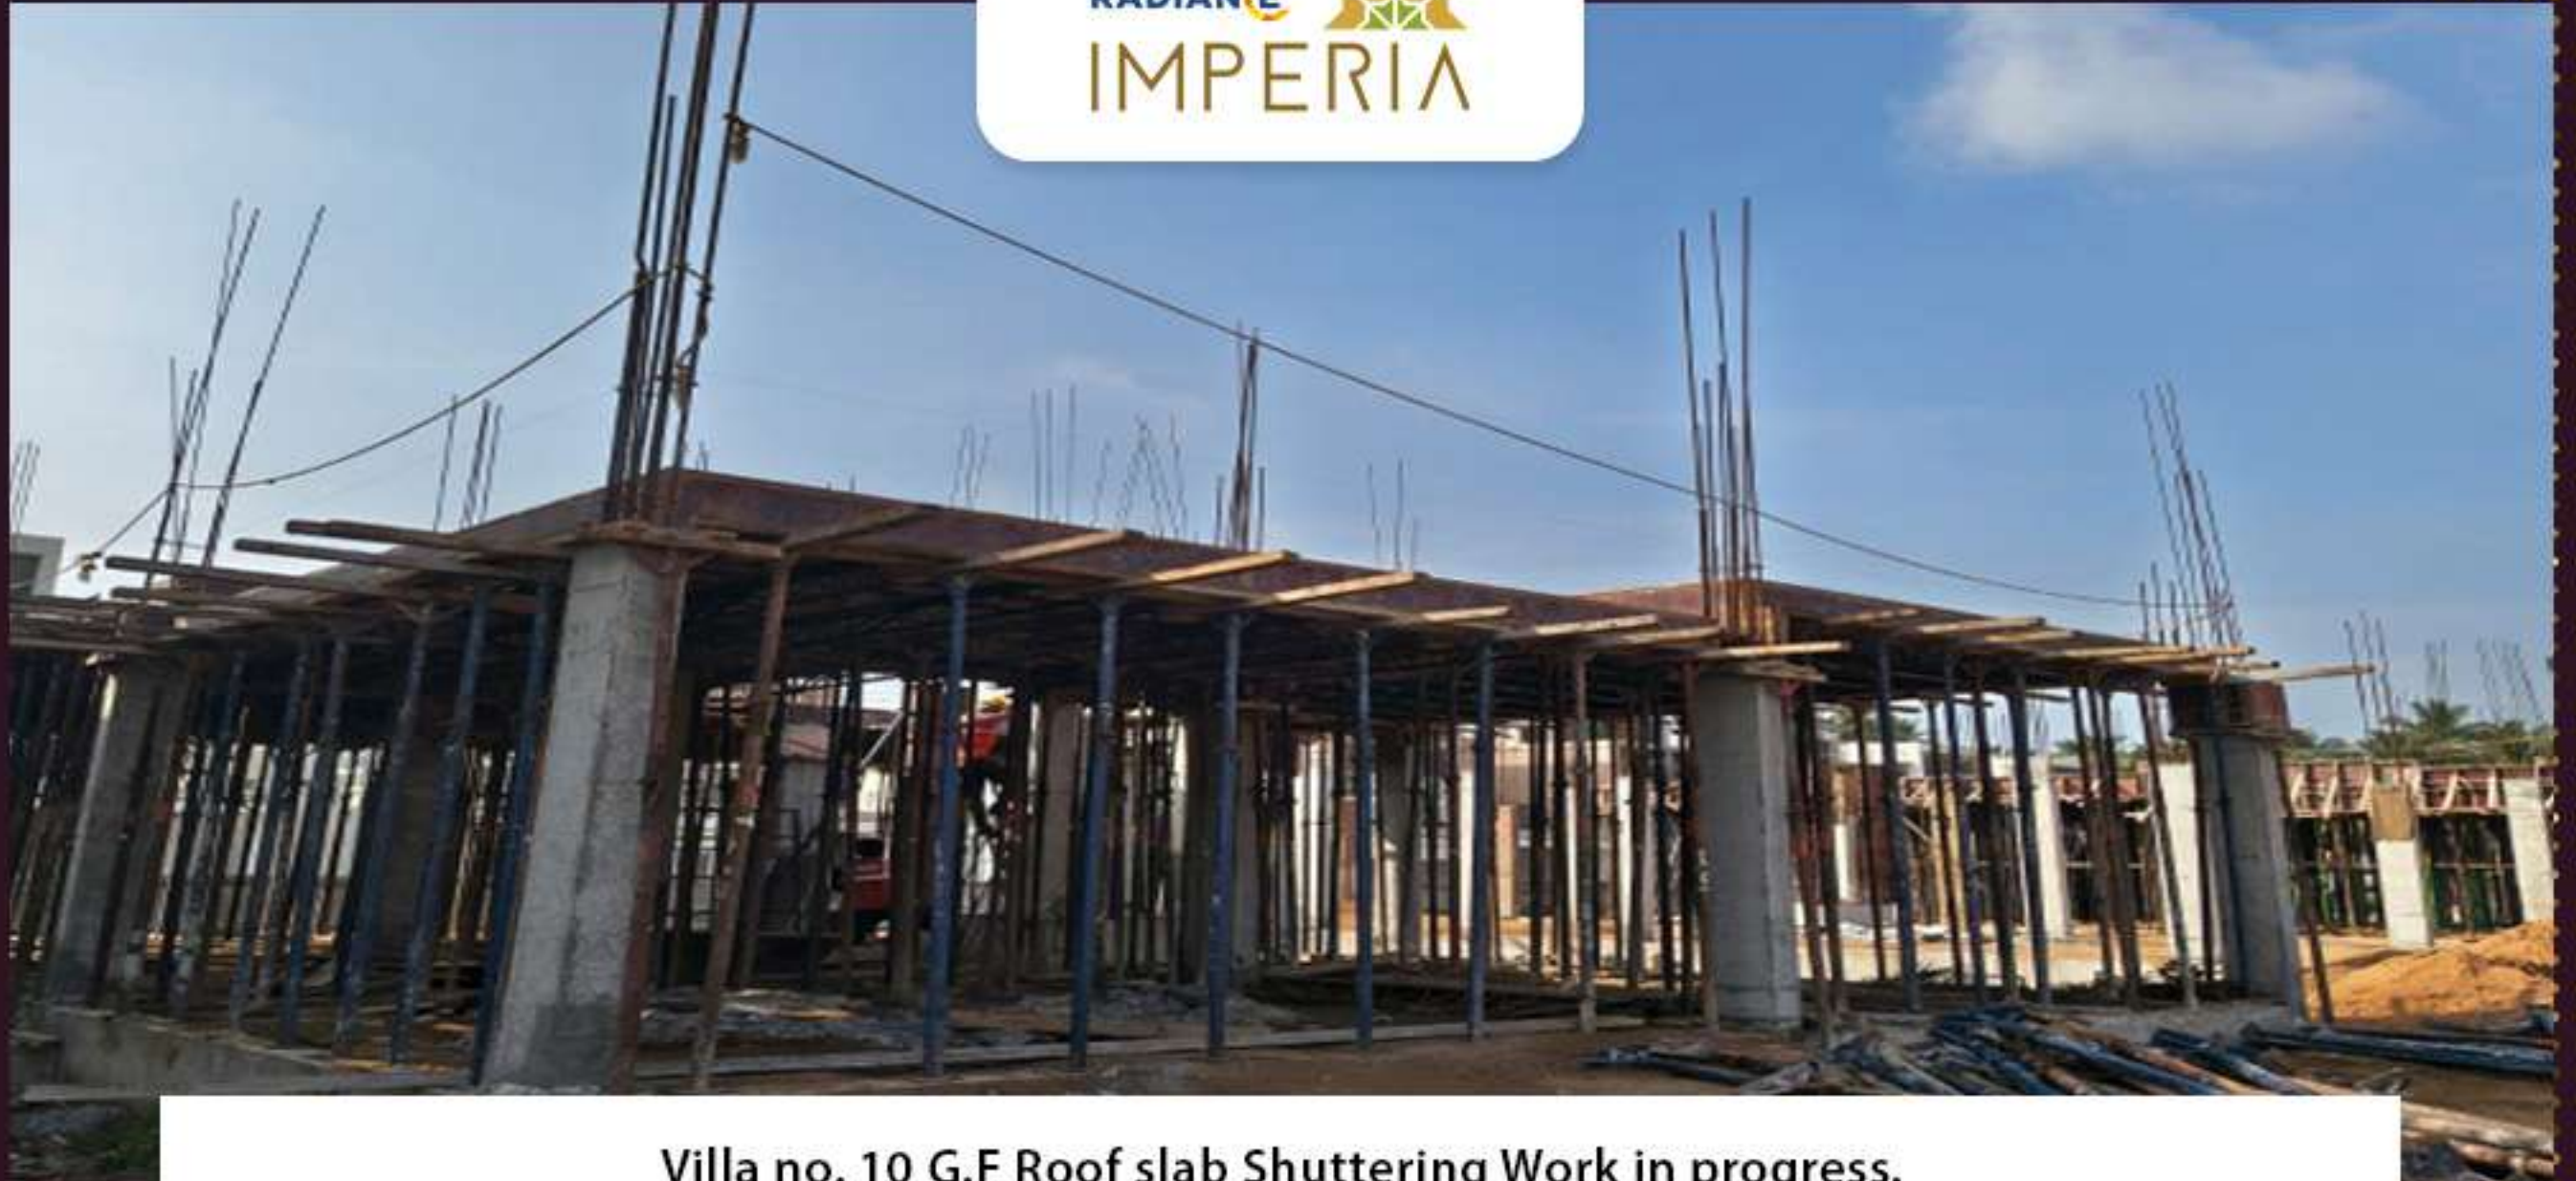
Villa no. 10 G.F Roof slab Shuttering Work in progress.
