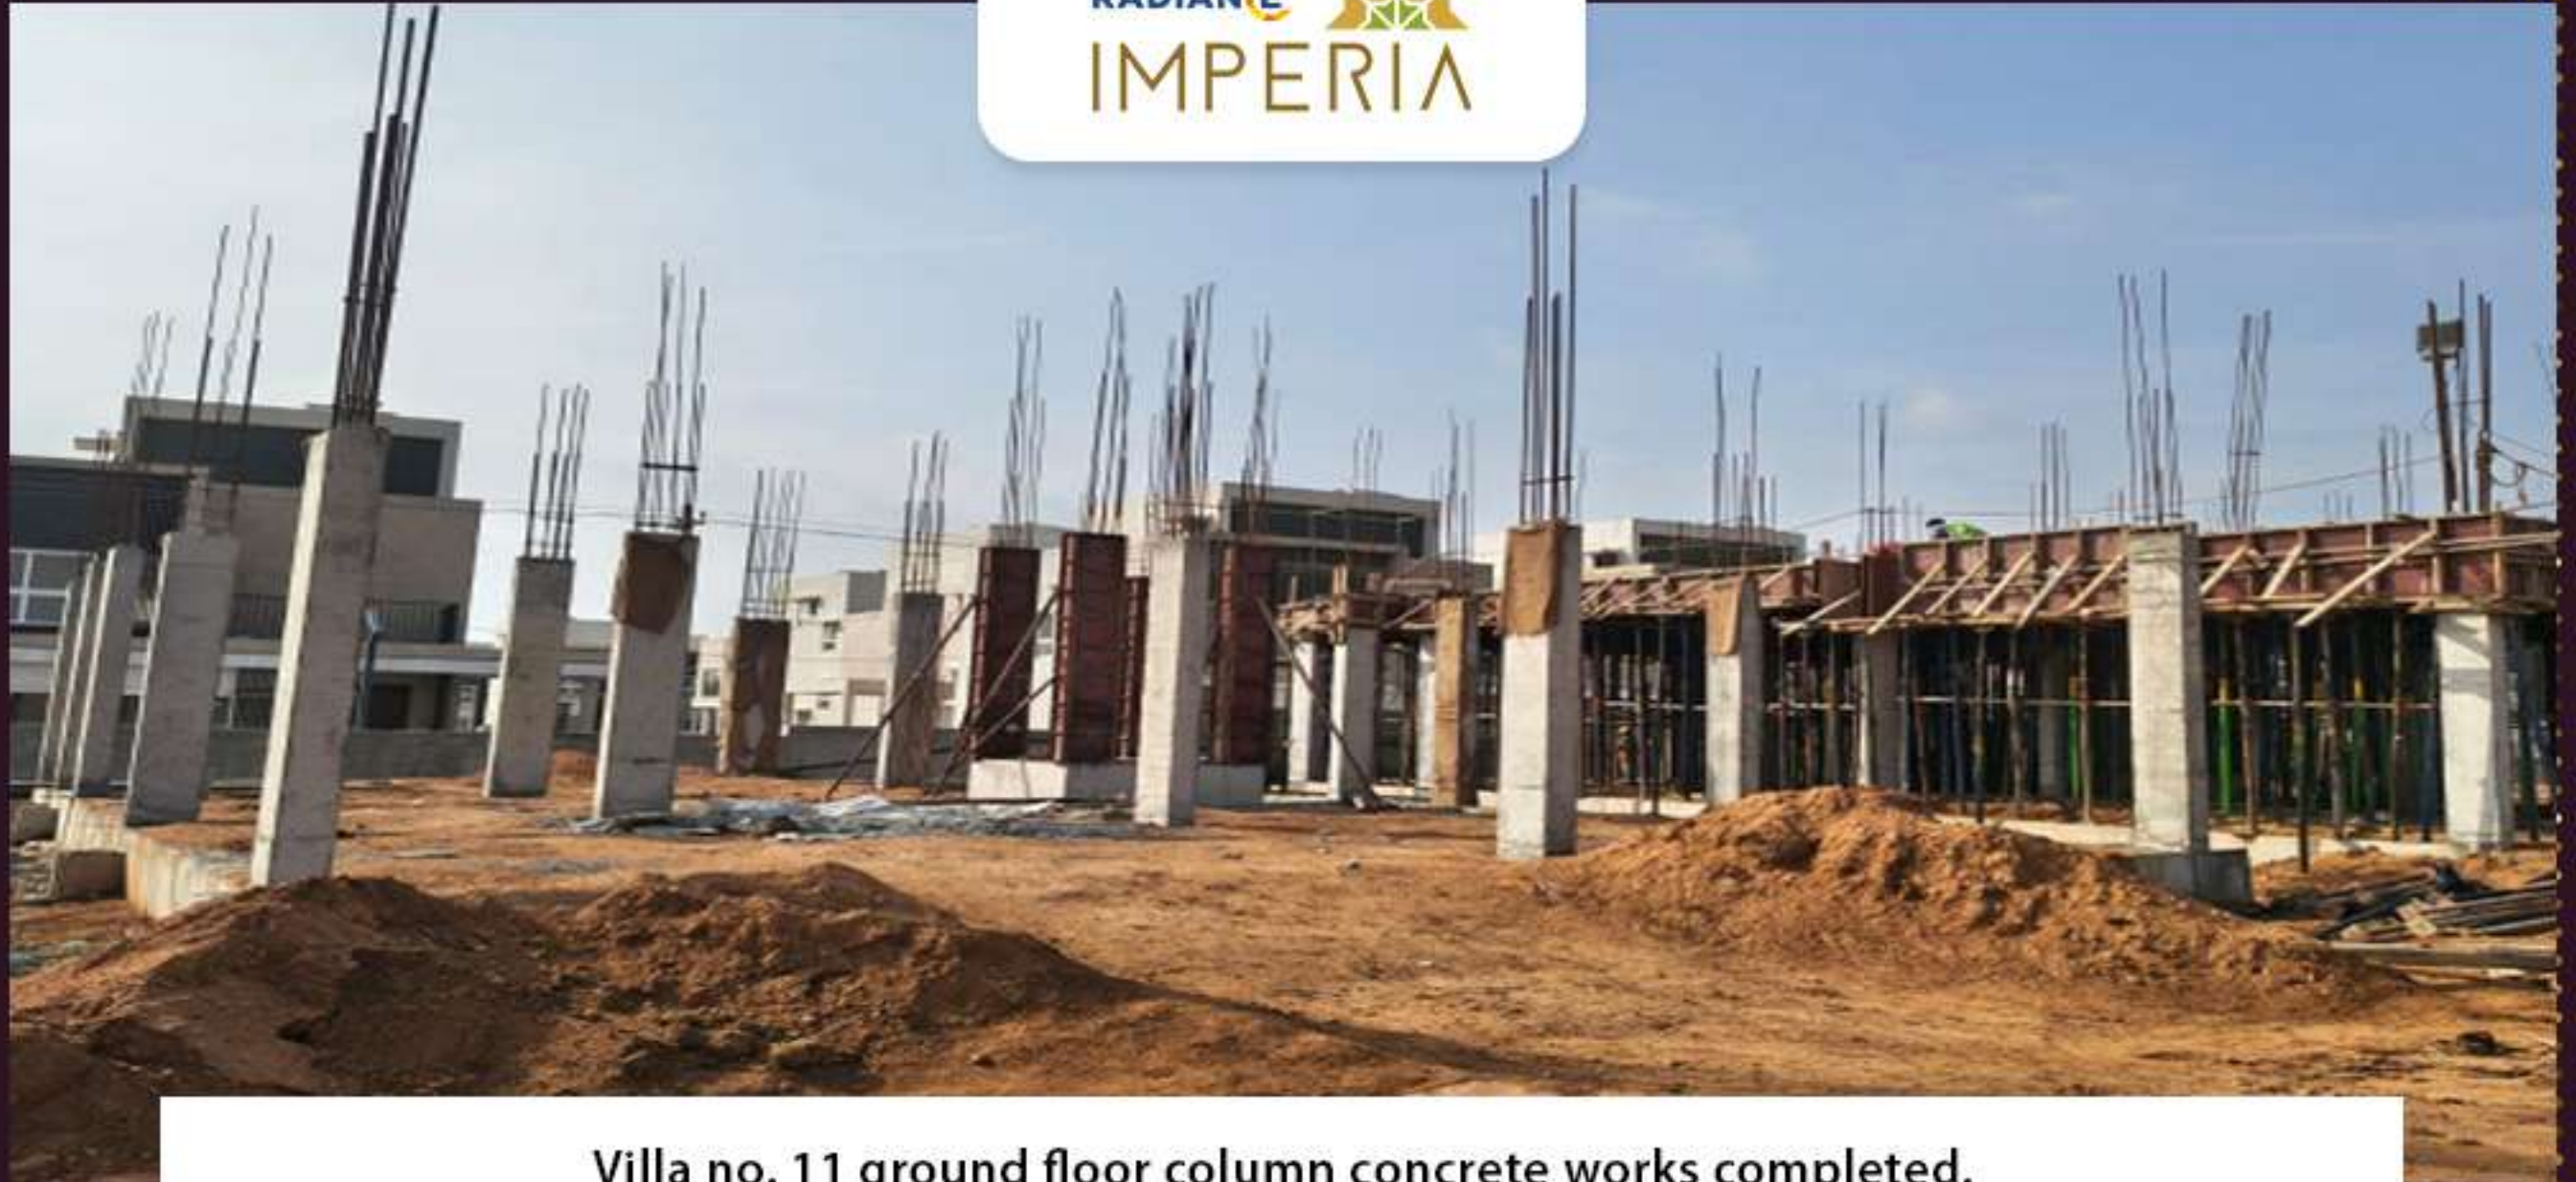
Villa no. 11 ground floor column concrete works completed.

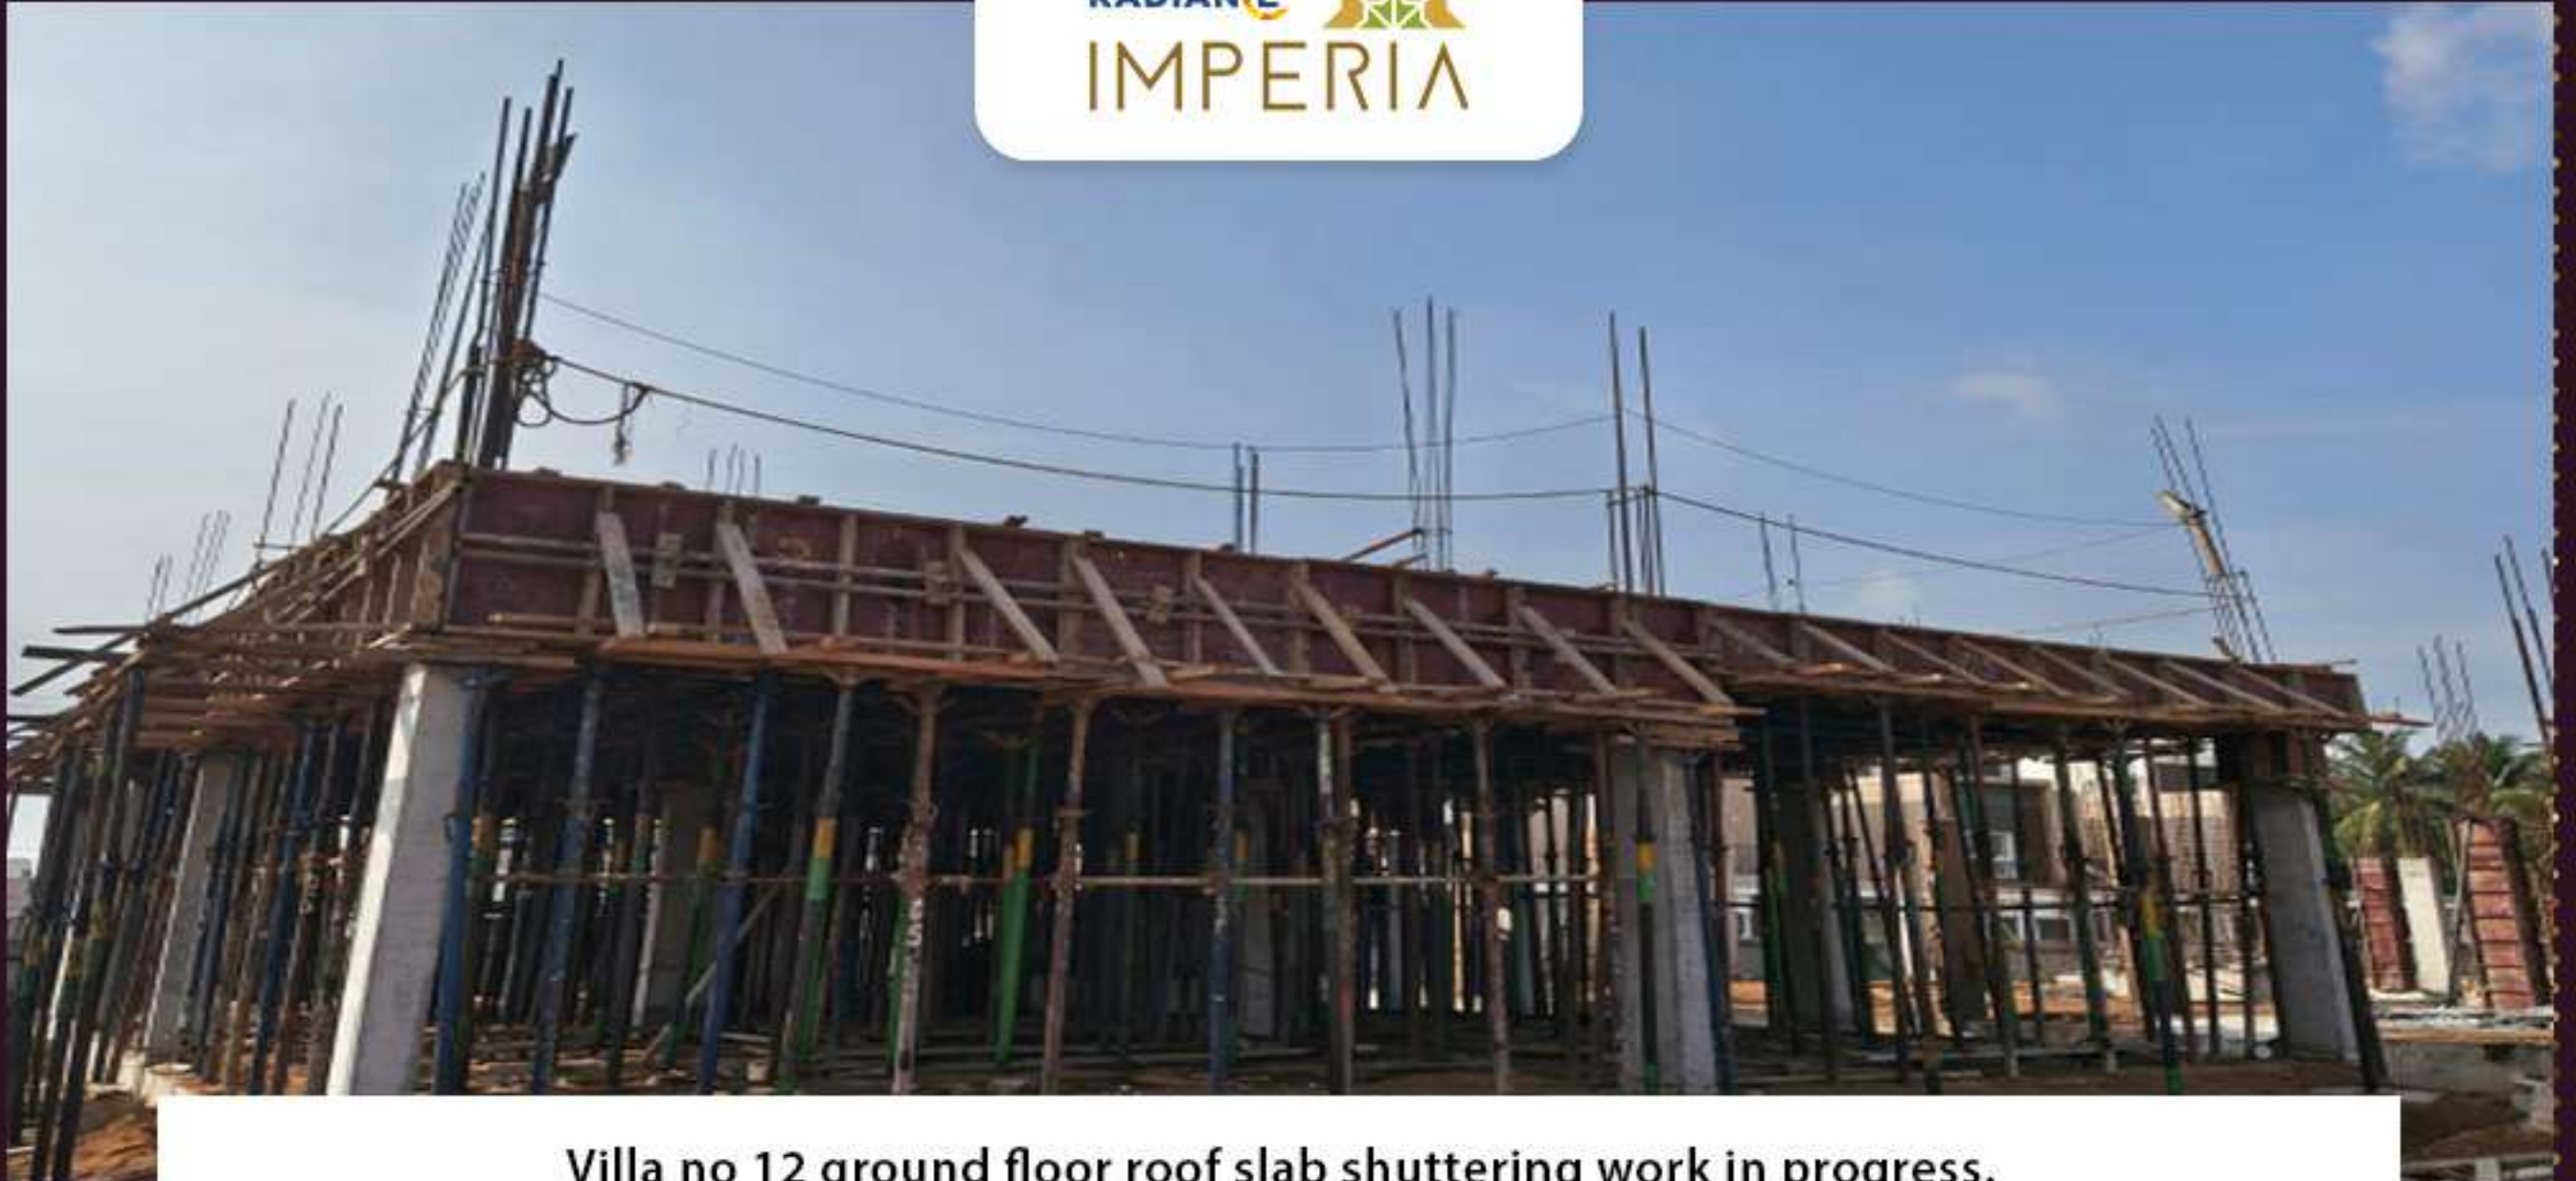
Villa no 12 ground floor roof slab shuttering work in progress.

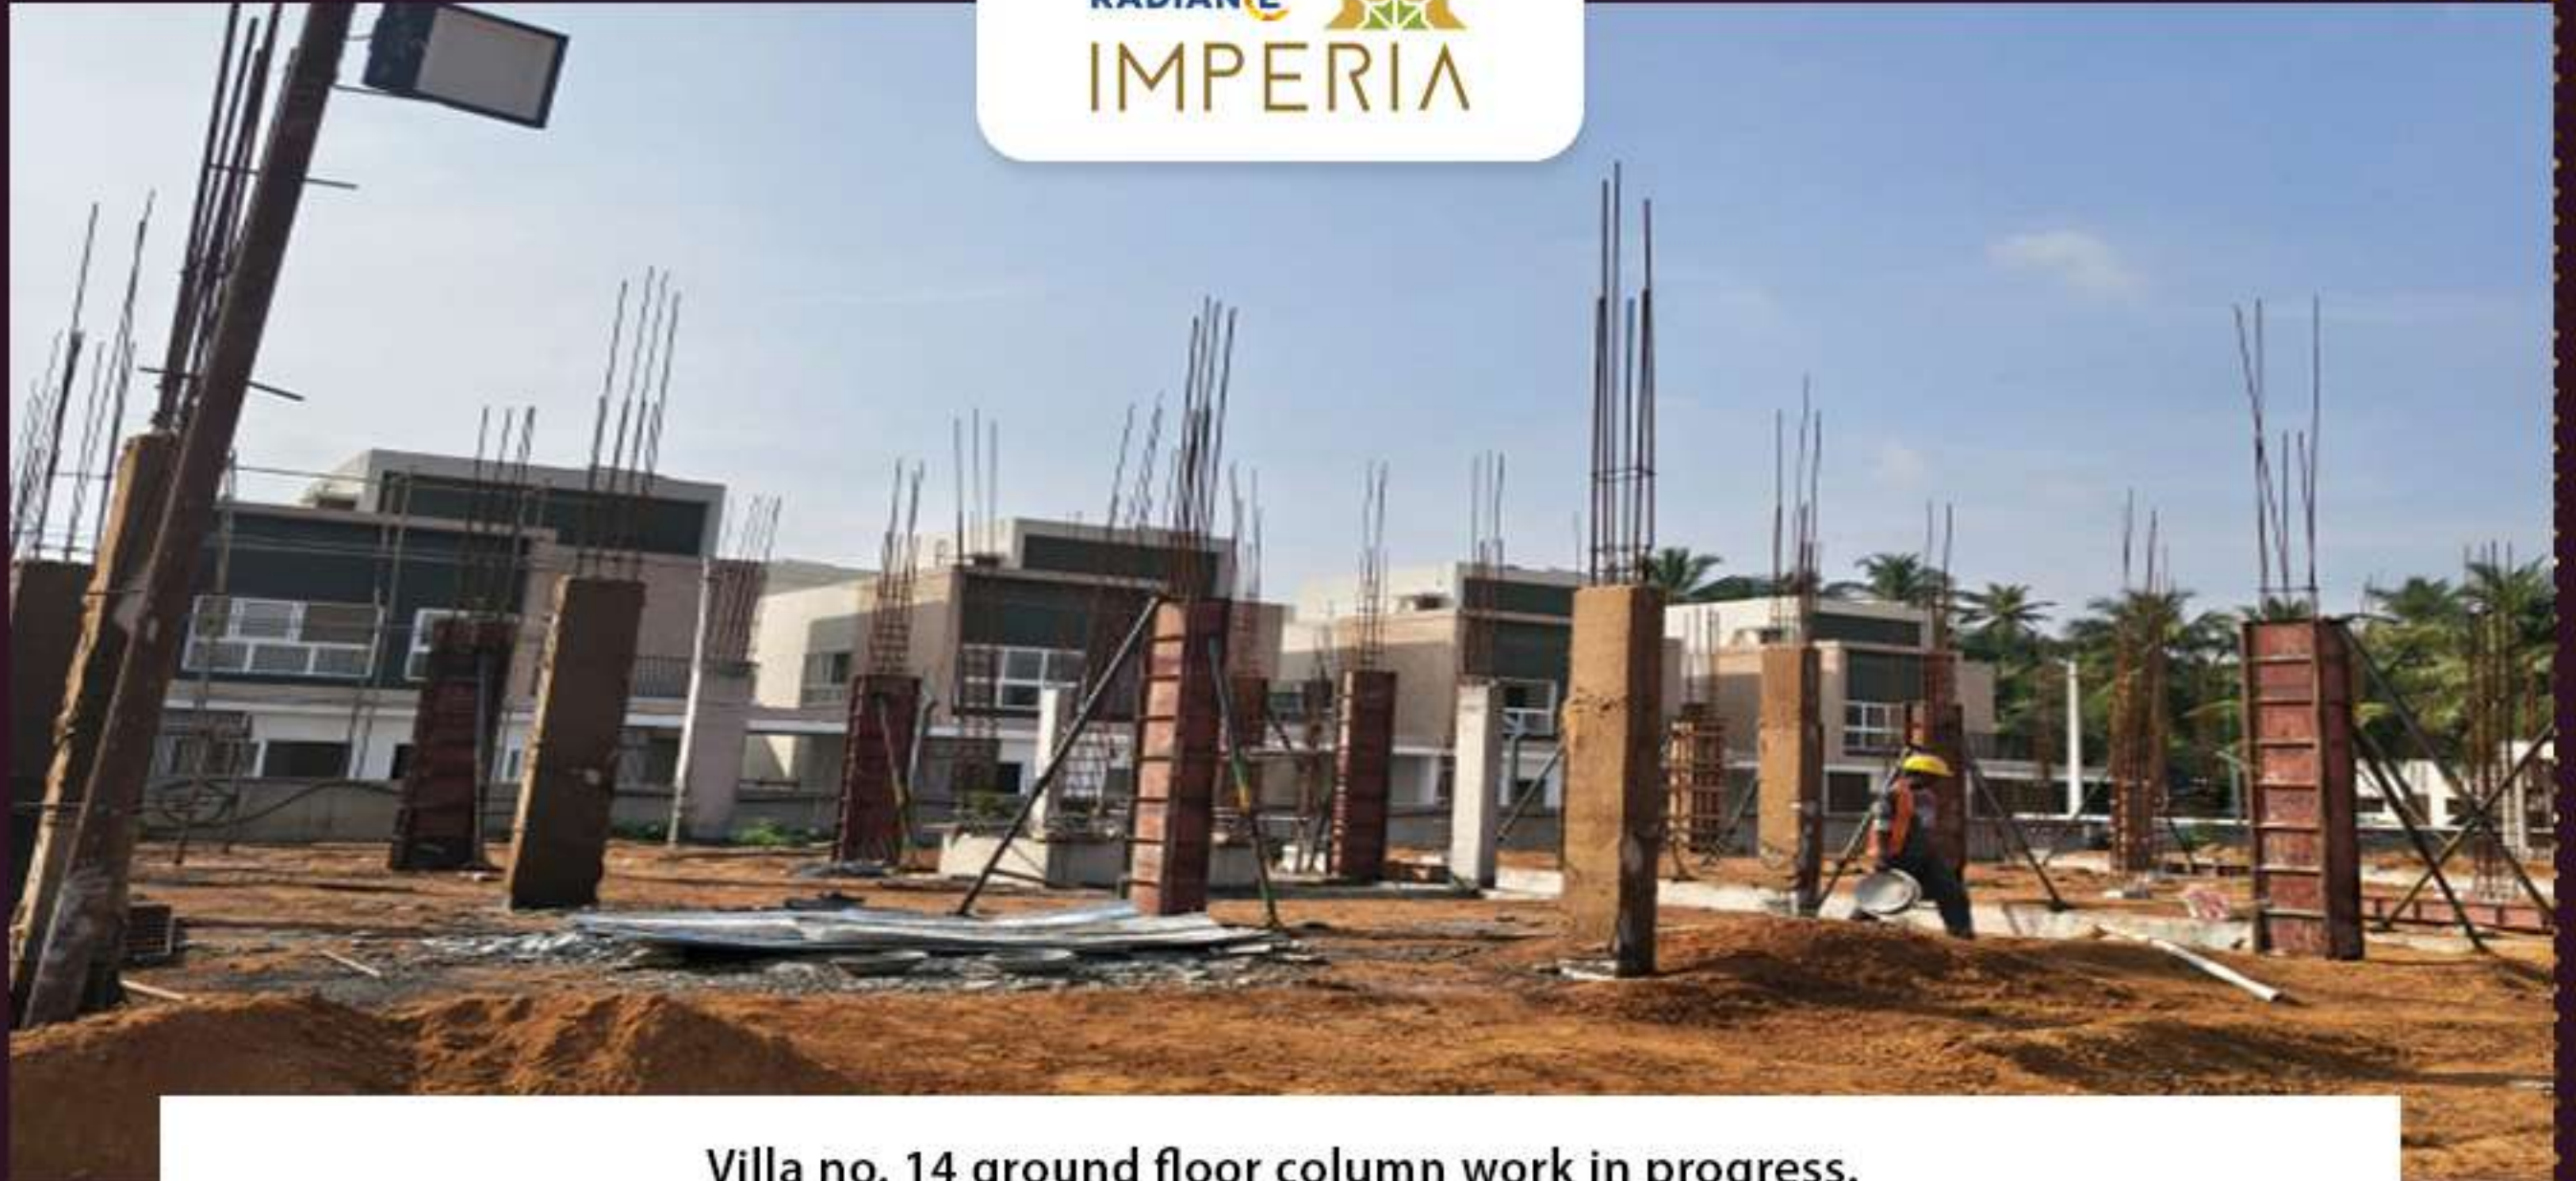
Villa no. 14 ground floor column work in progress.

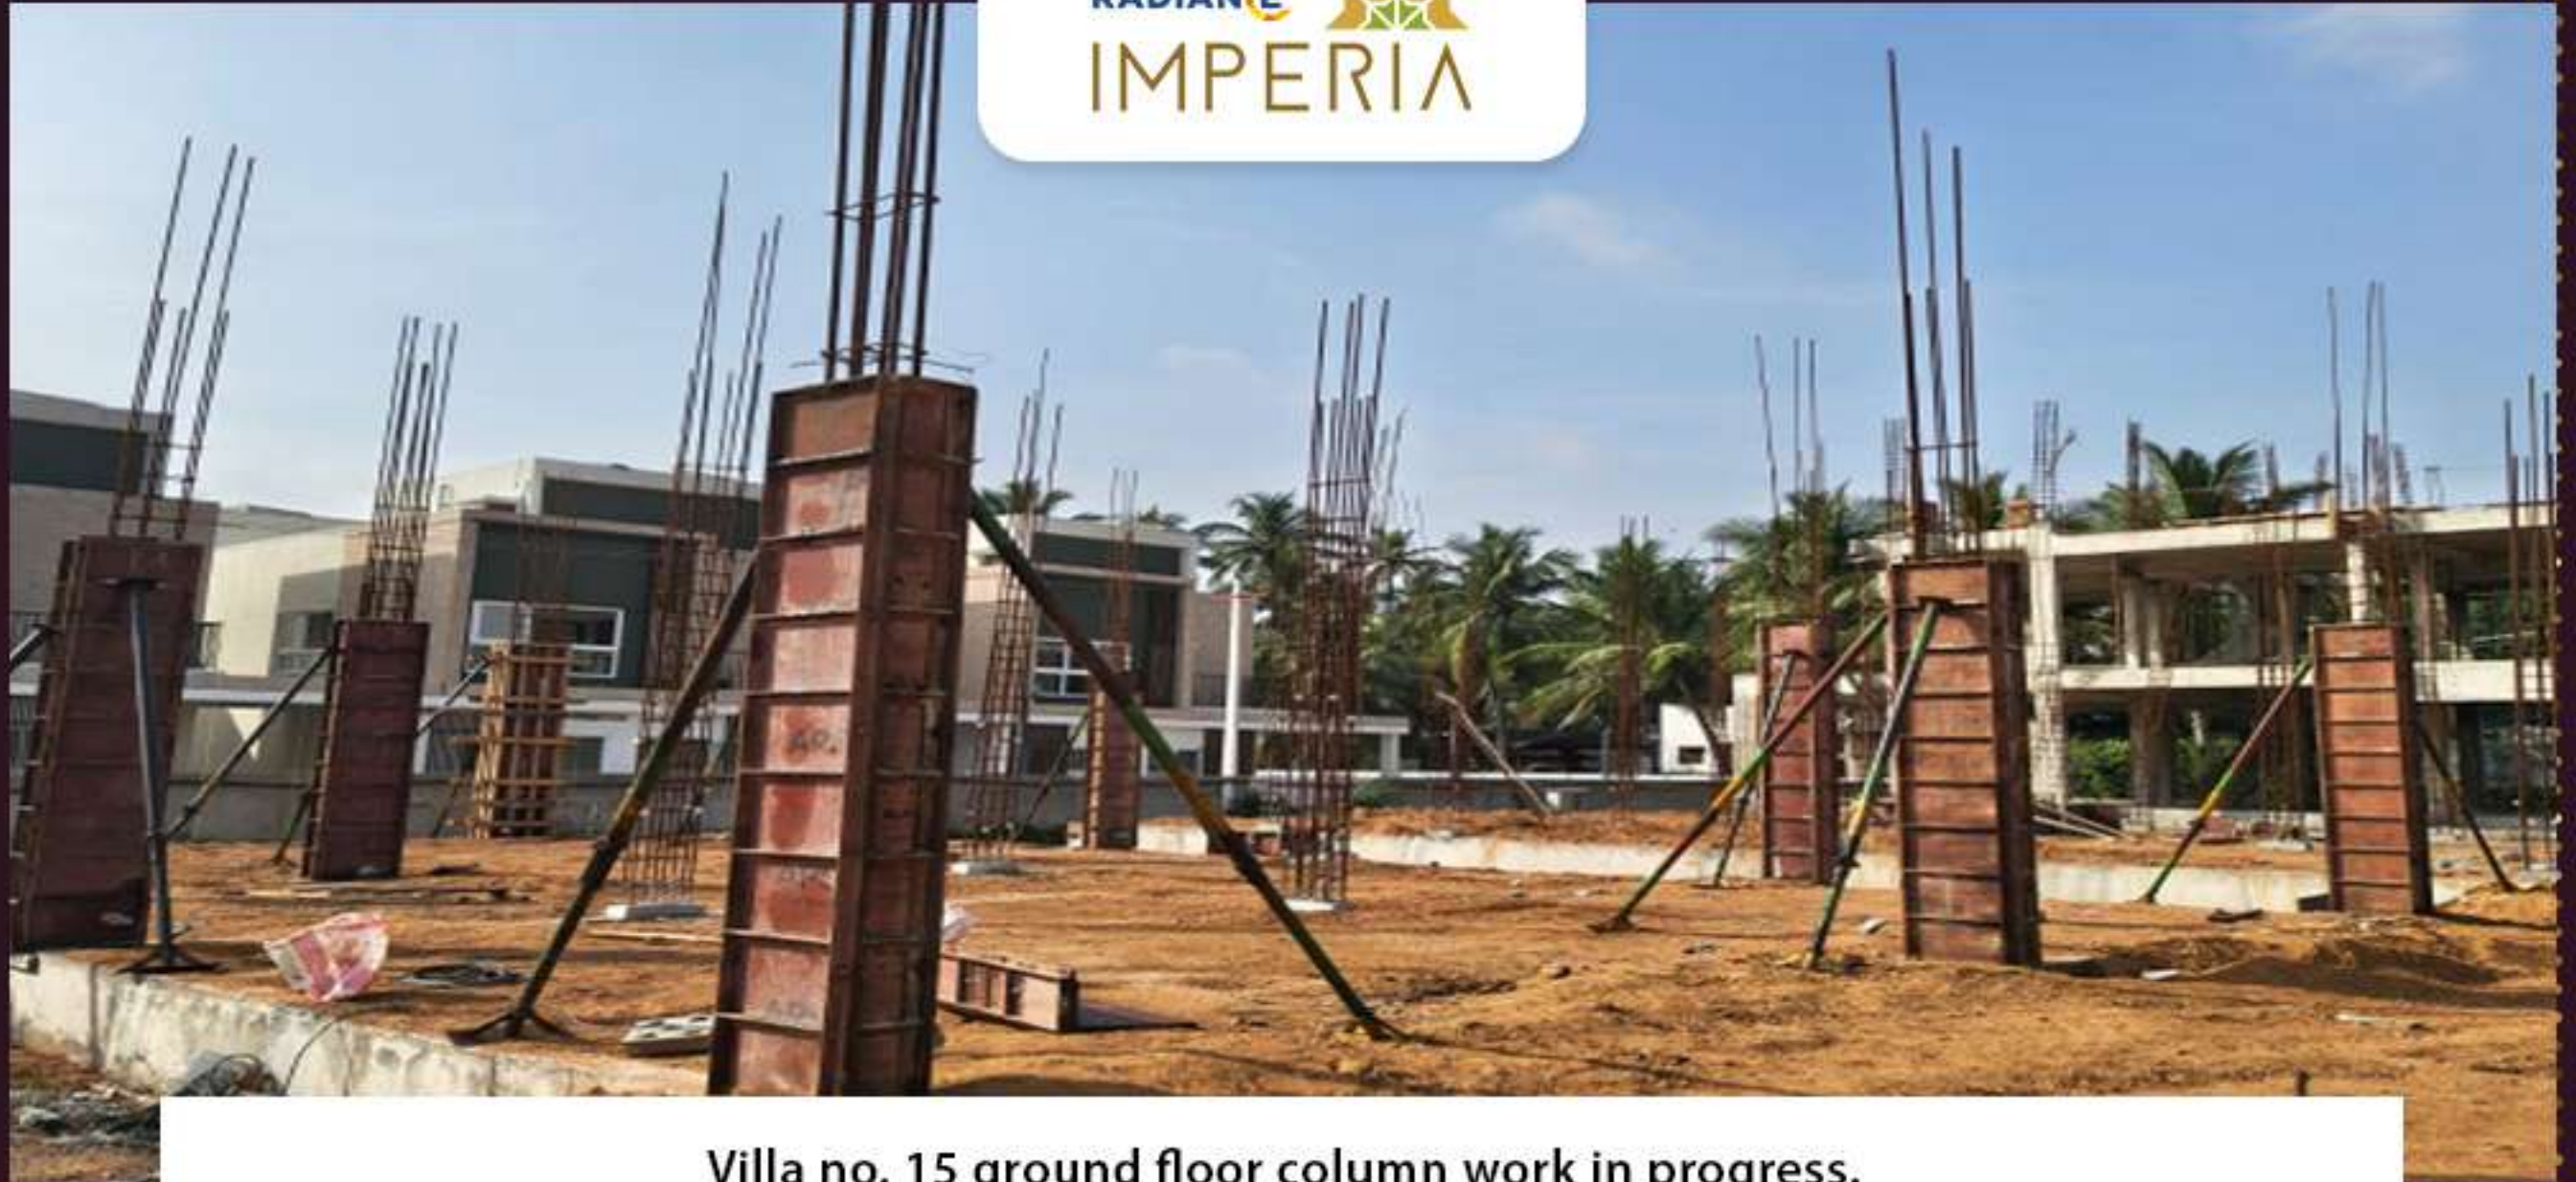
Villa no. 15 ground floor column work in progress.

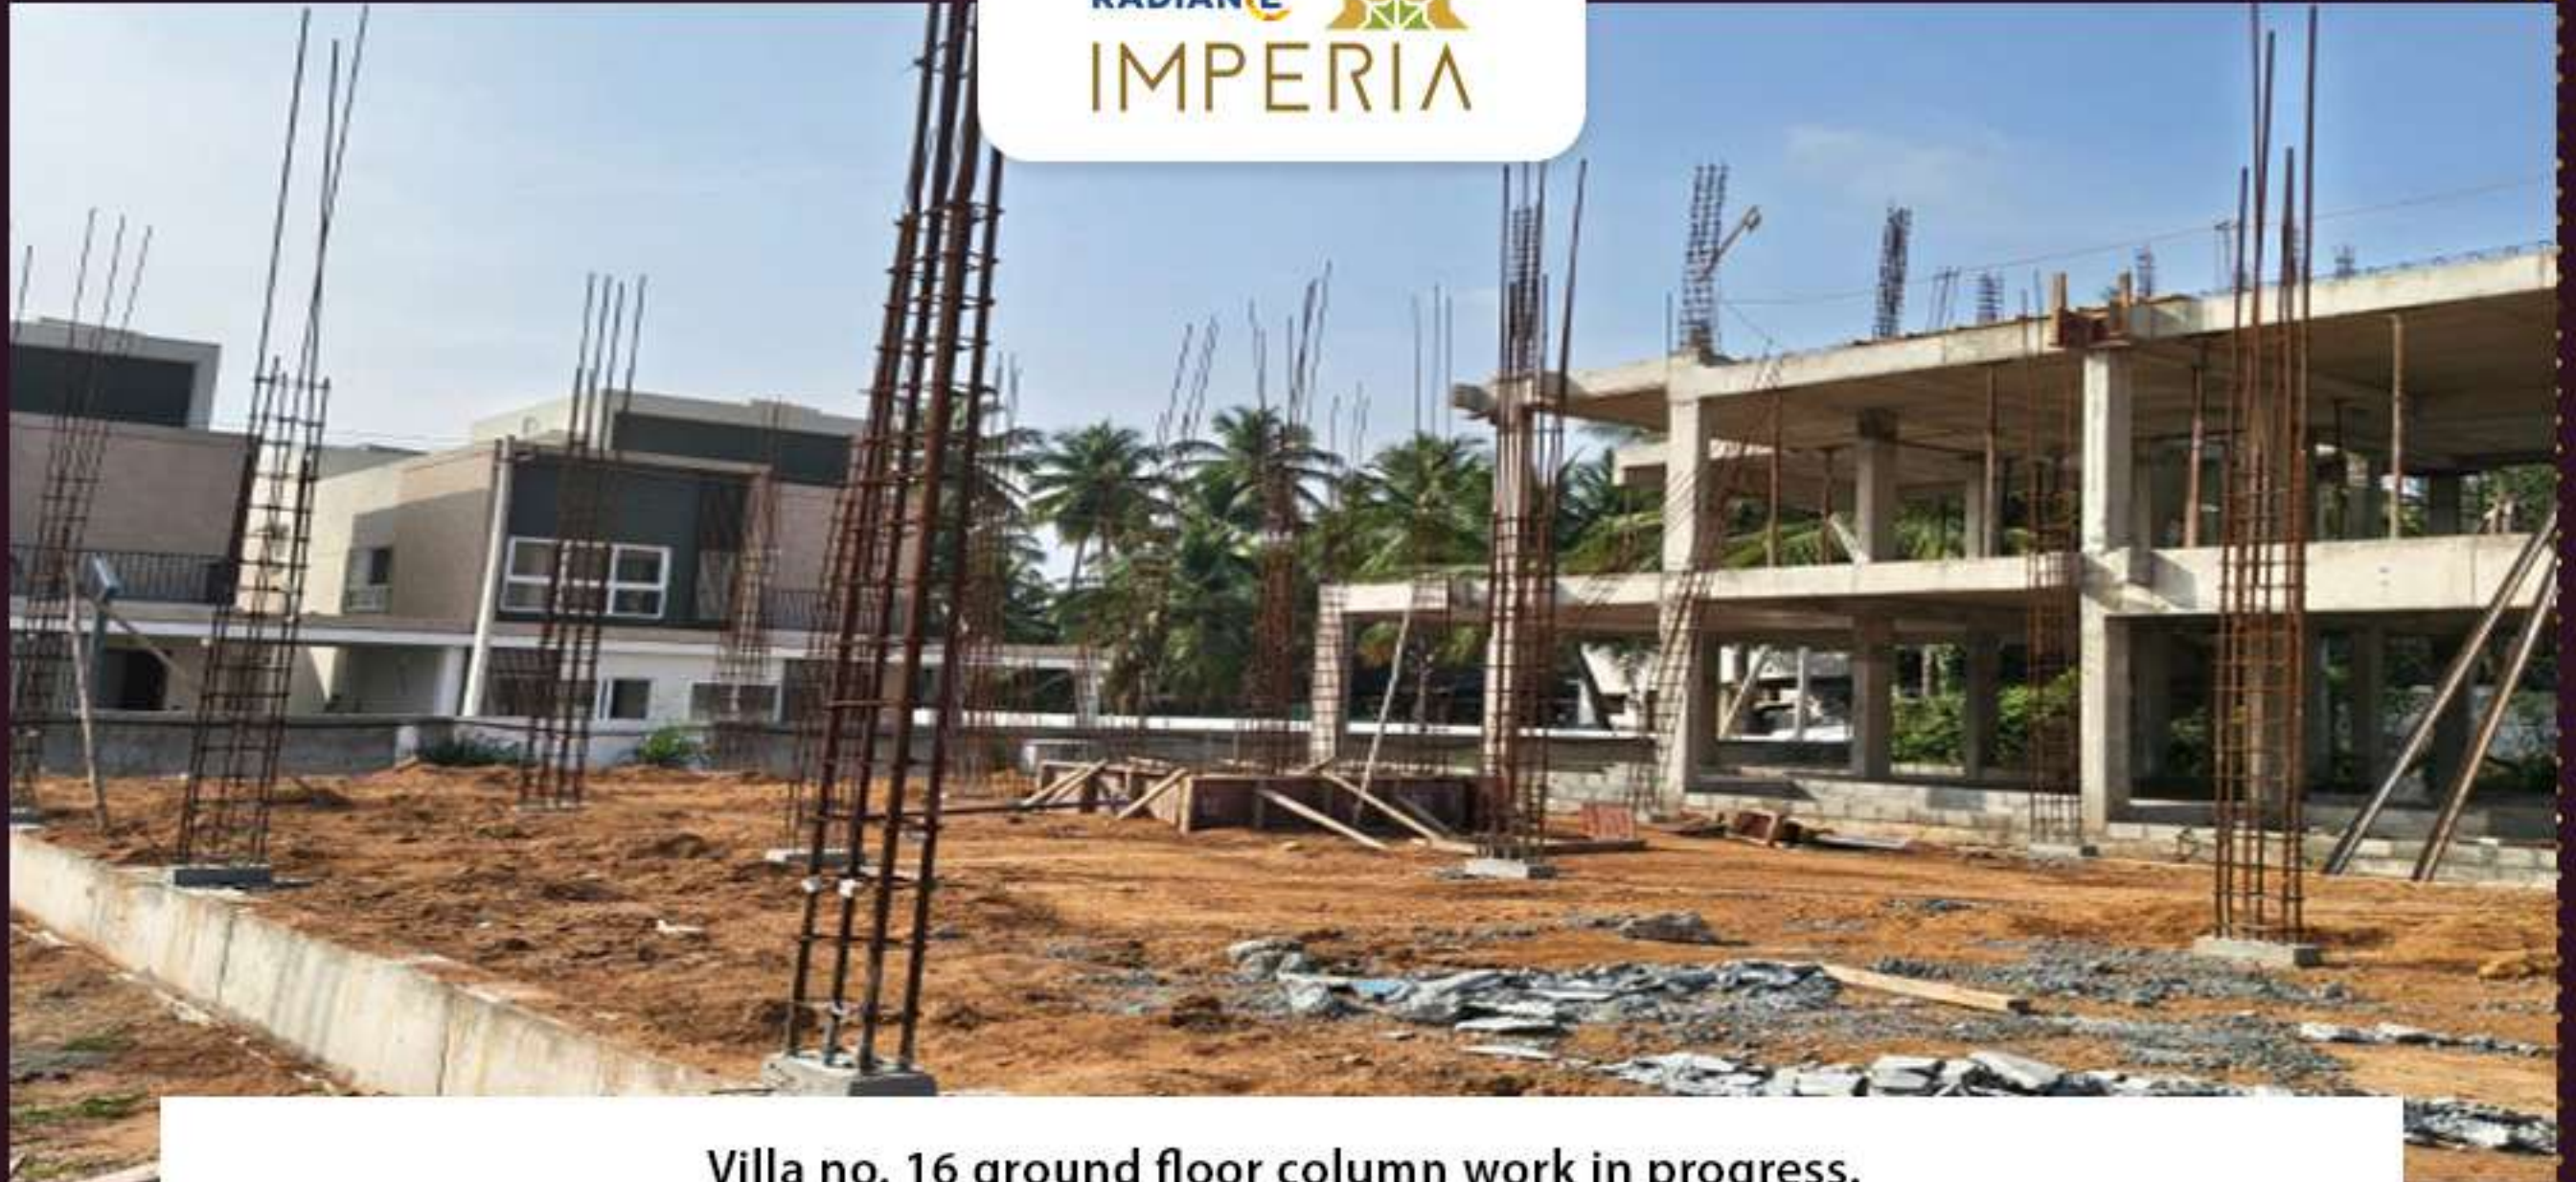
Villa no. 16 ground floor column work in progress.

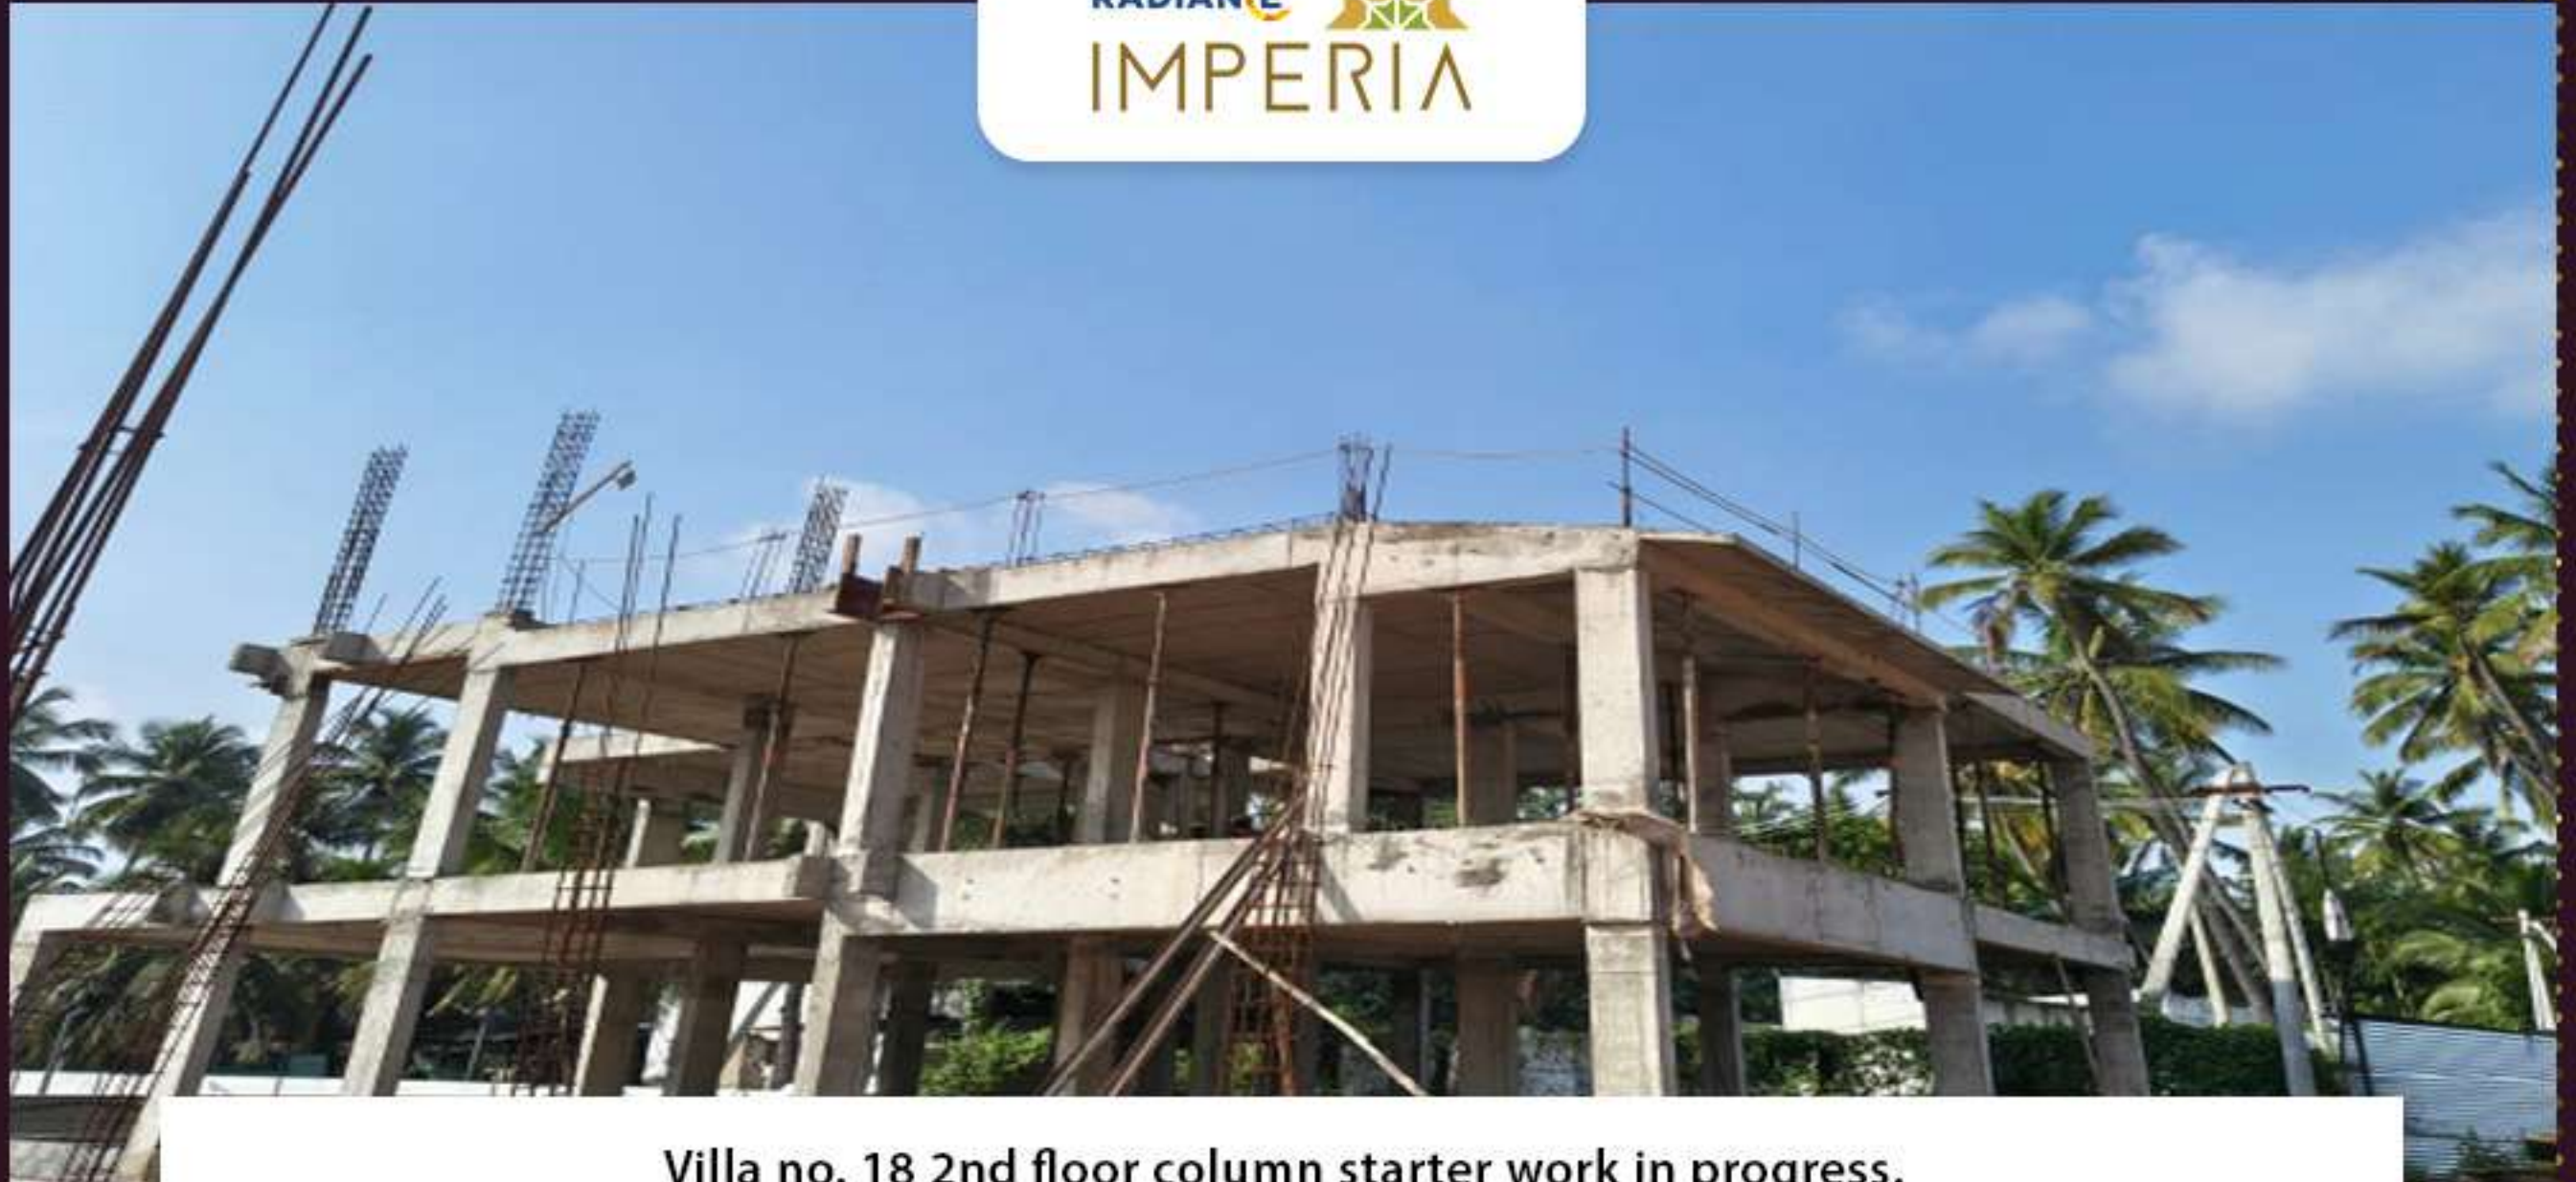
Villa no. 18 2nd floor column starter work in progress.

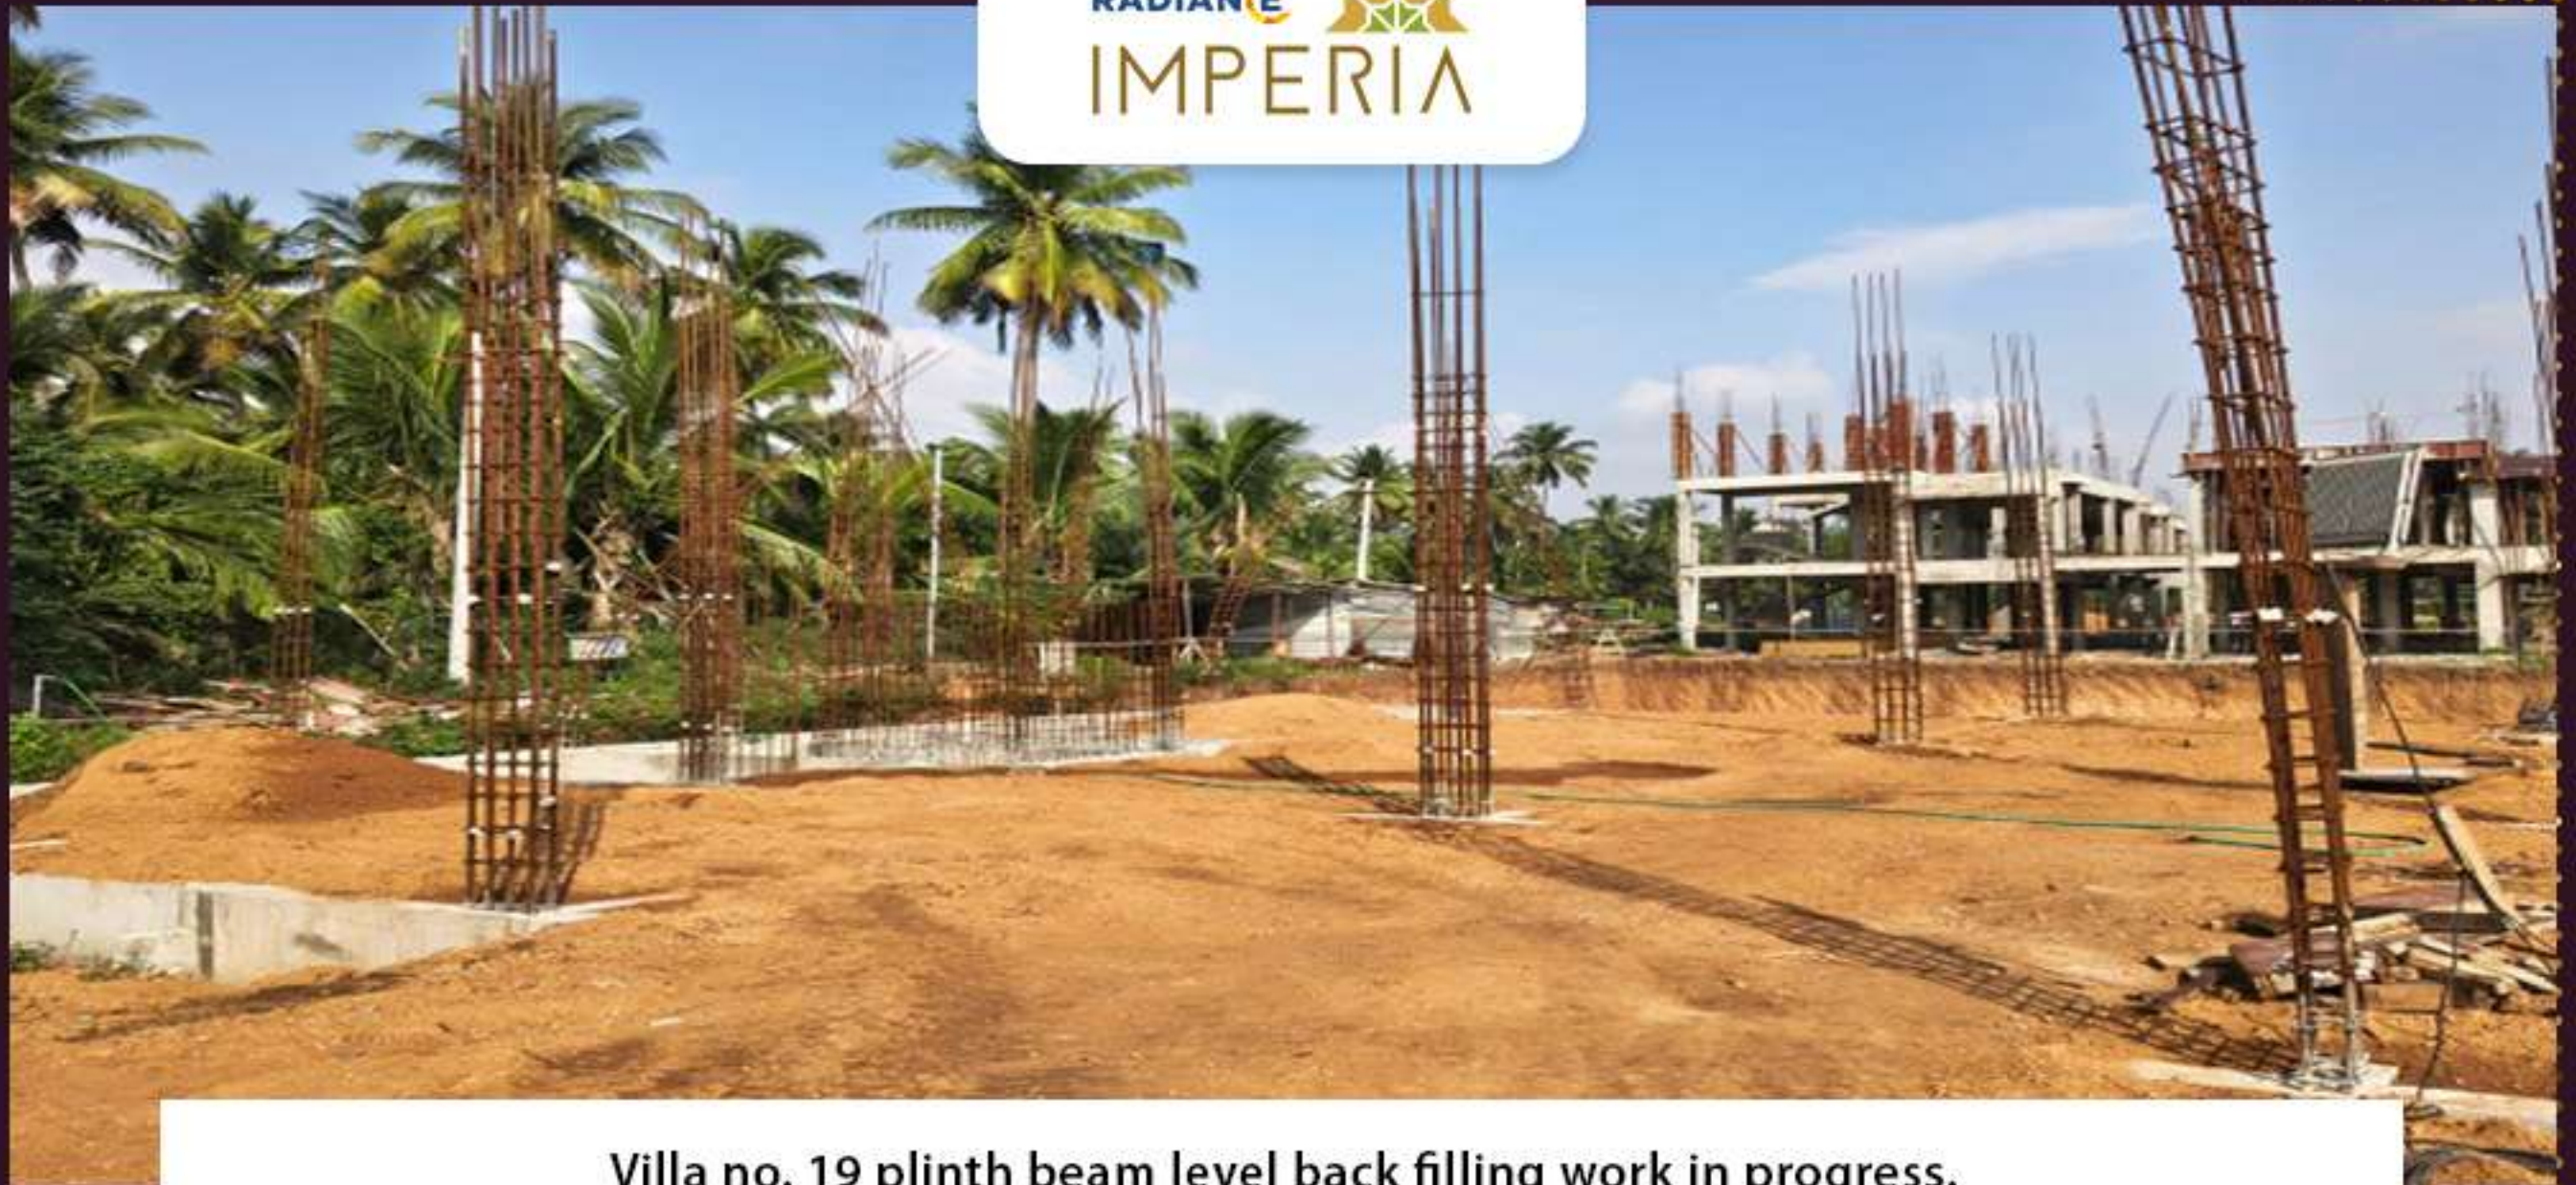
Villa no. 19 plinth beam level back filling work in progress.

Villa no. 20 plinth beam concrete completed.
