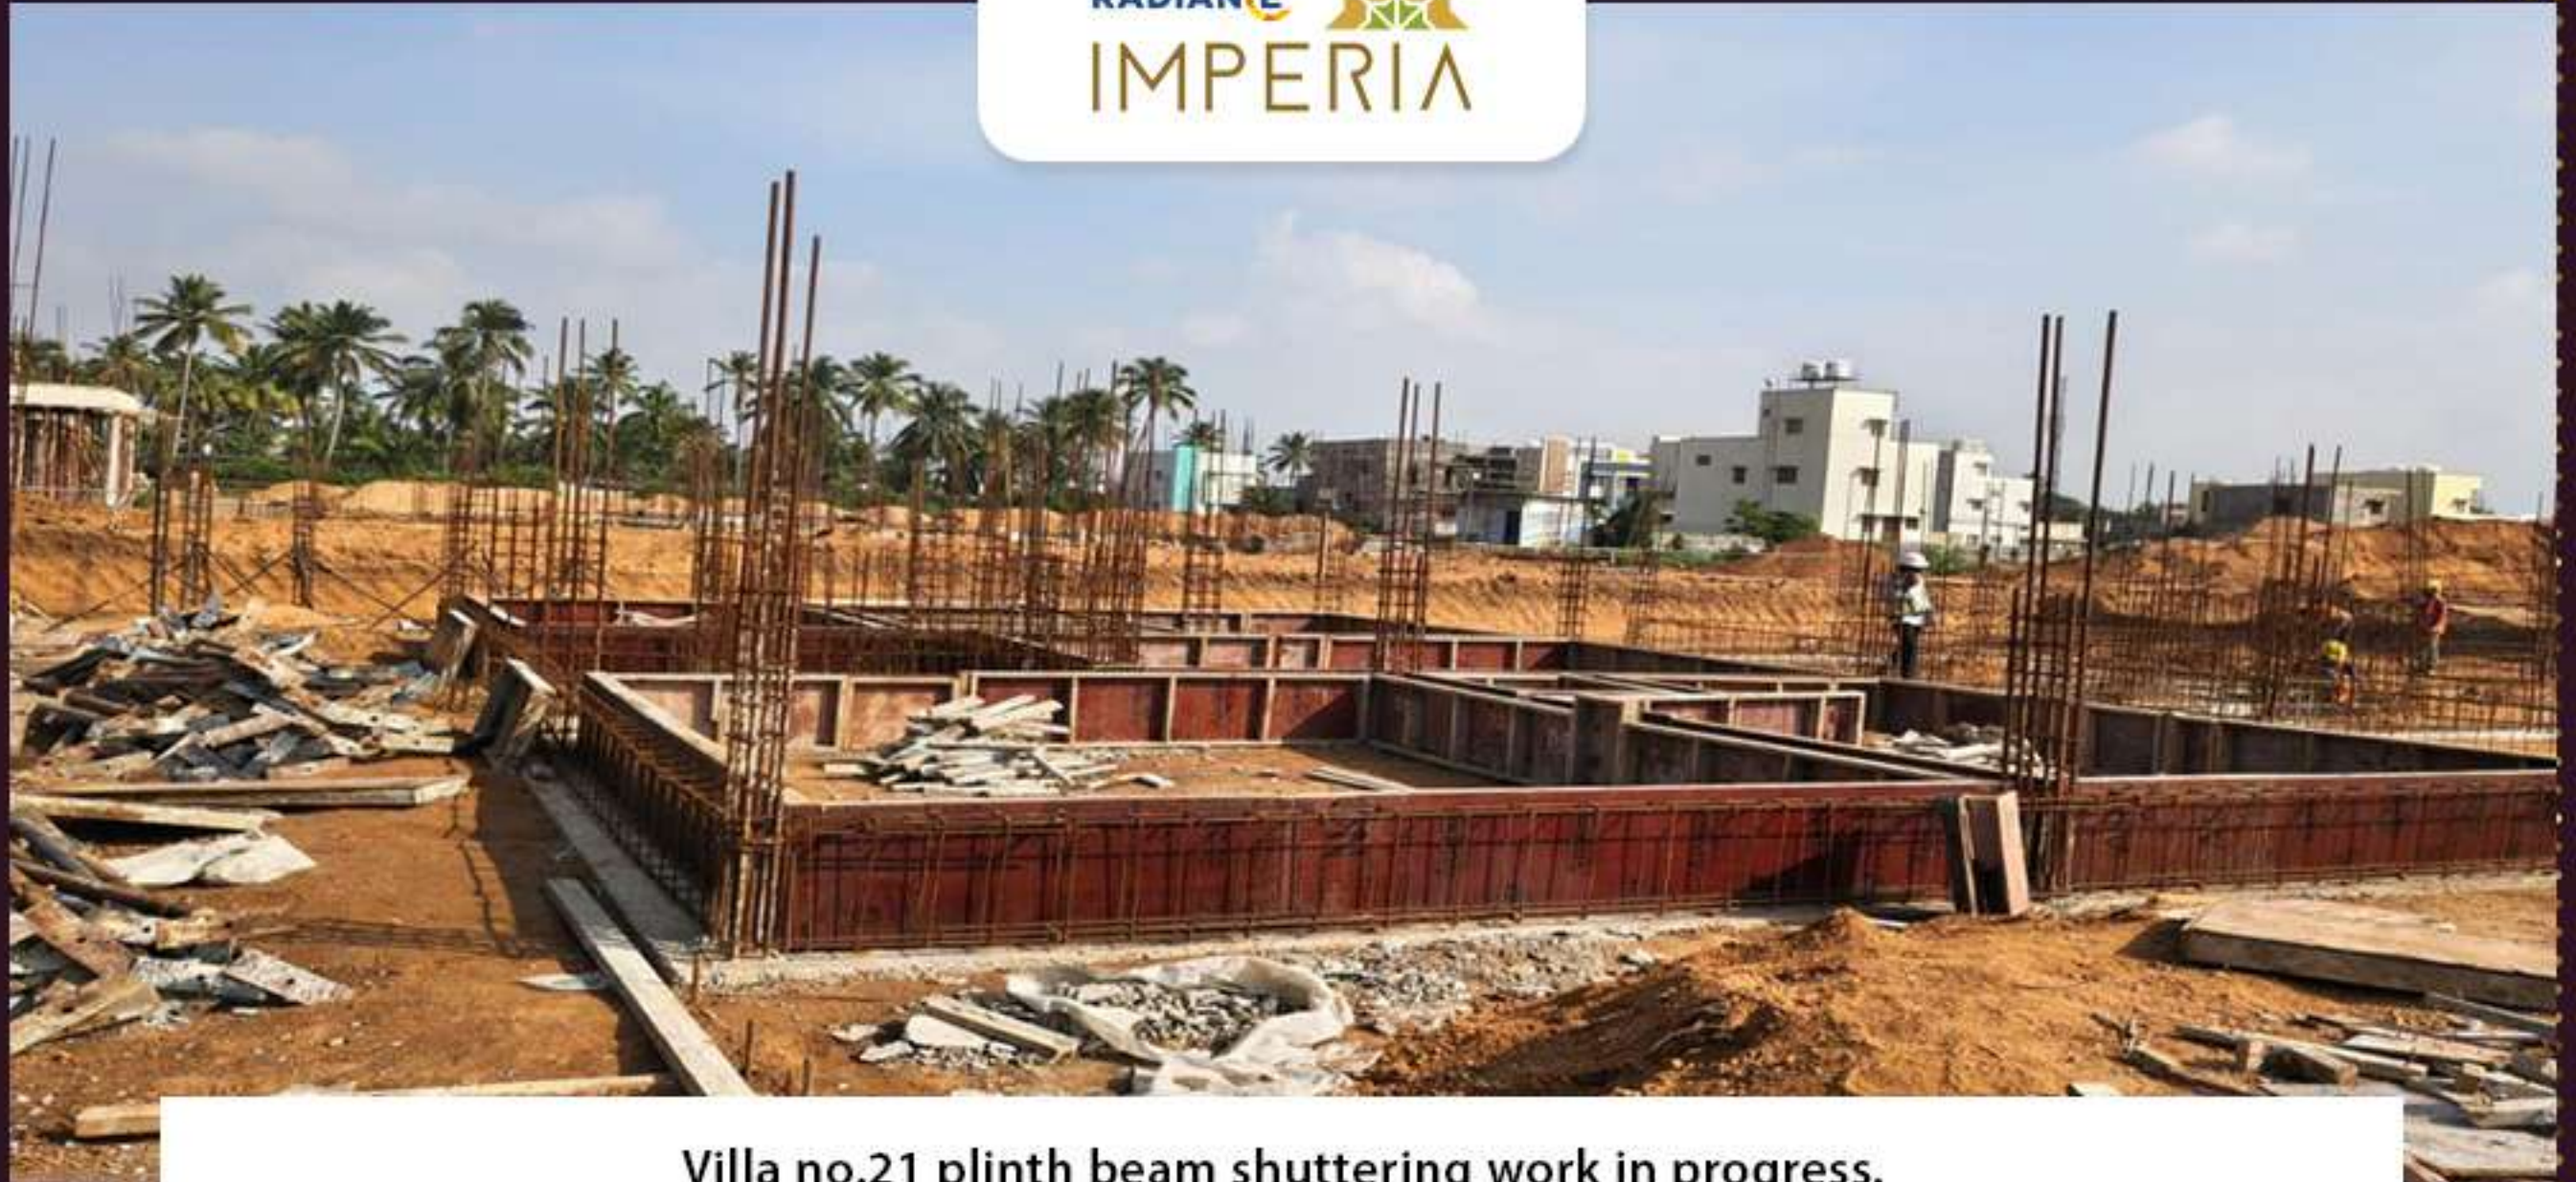
Villa no.21 plinth beam shuttering work in progress.

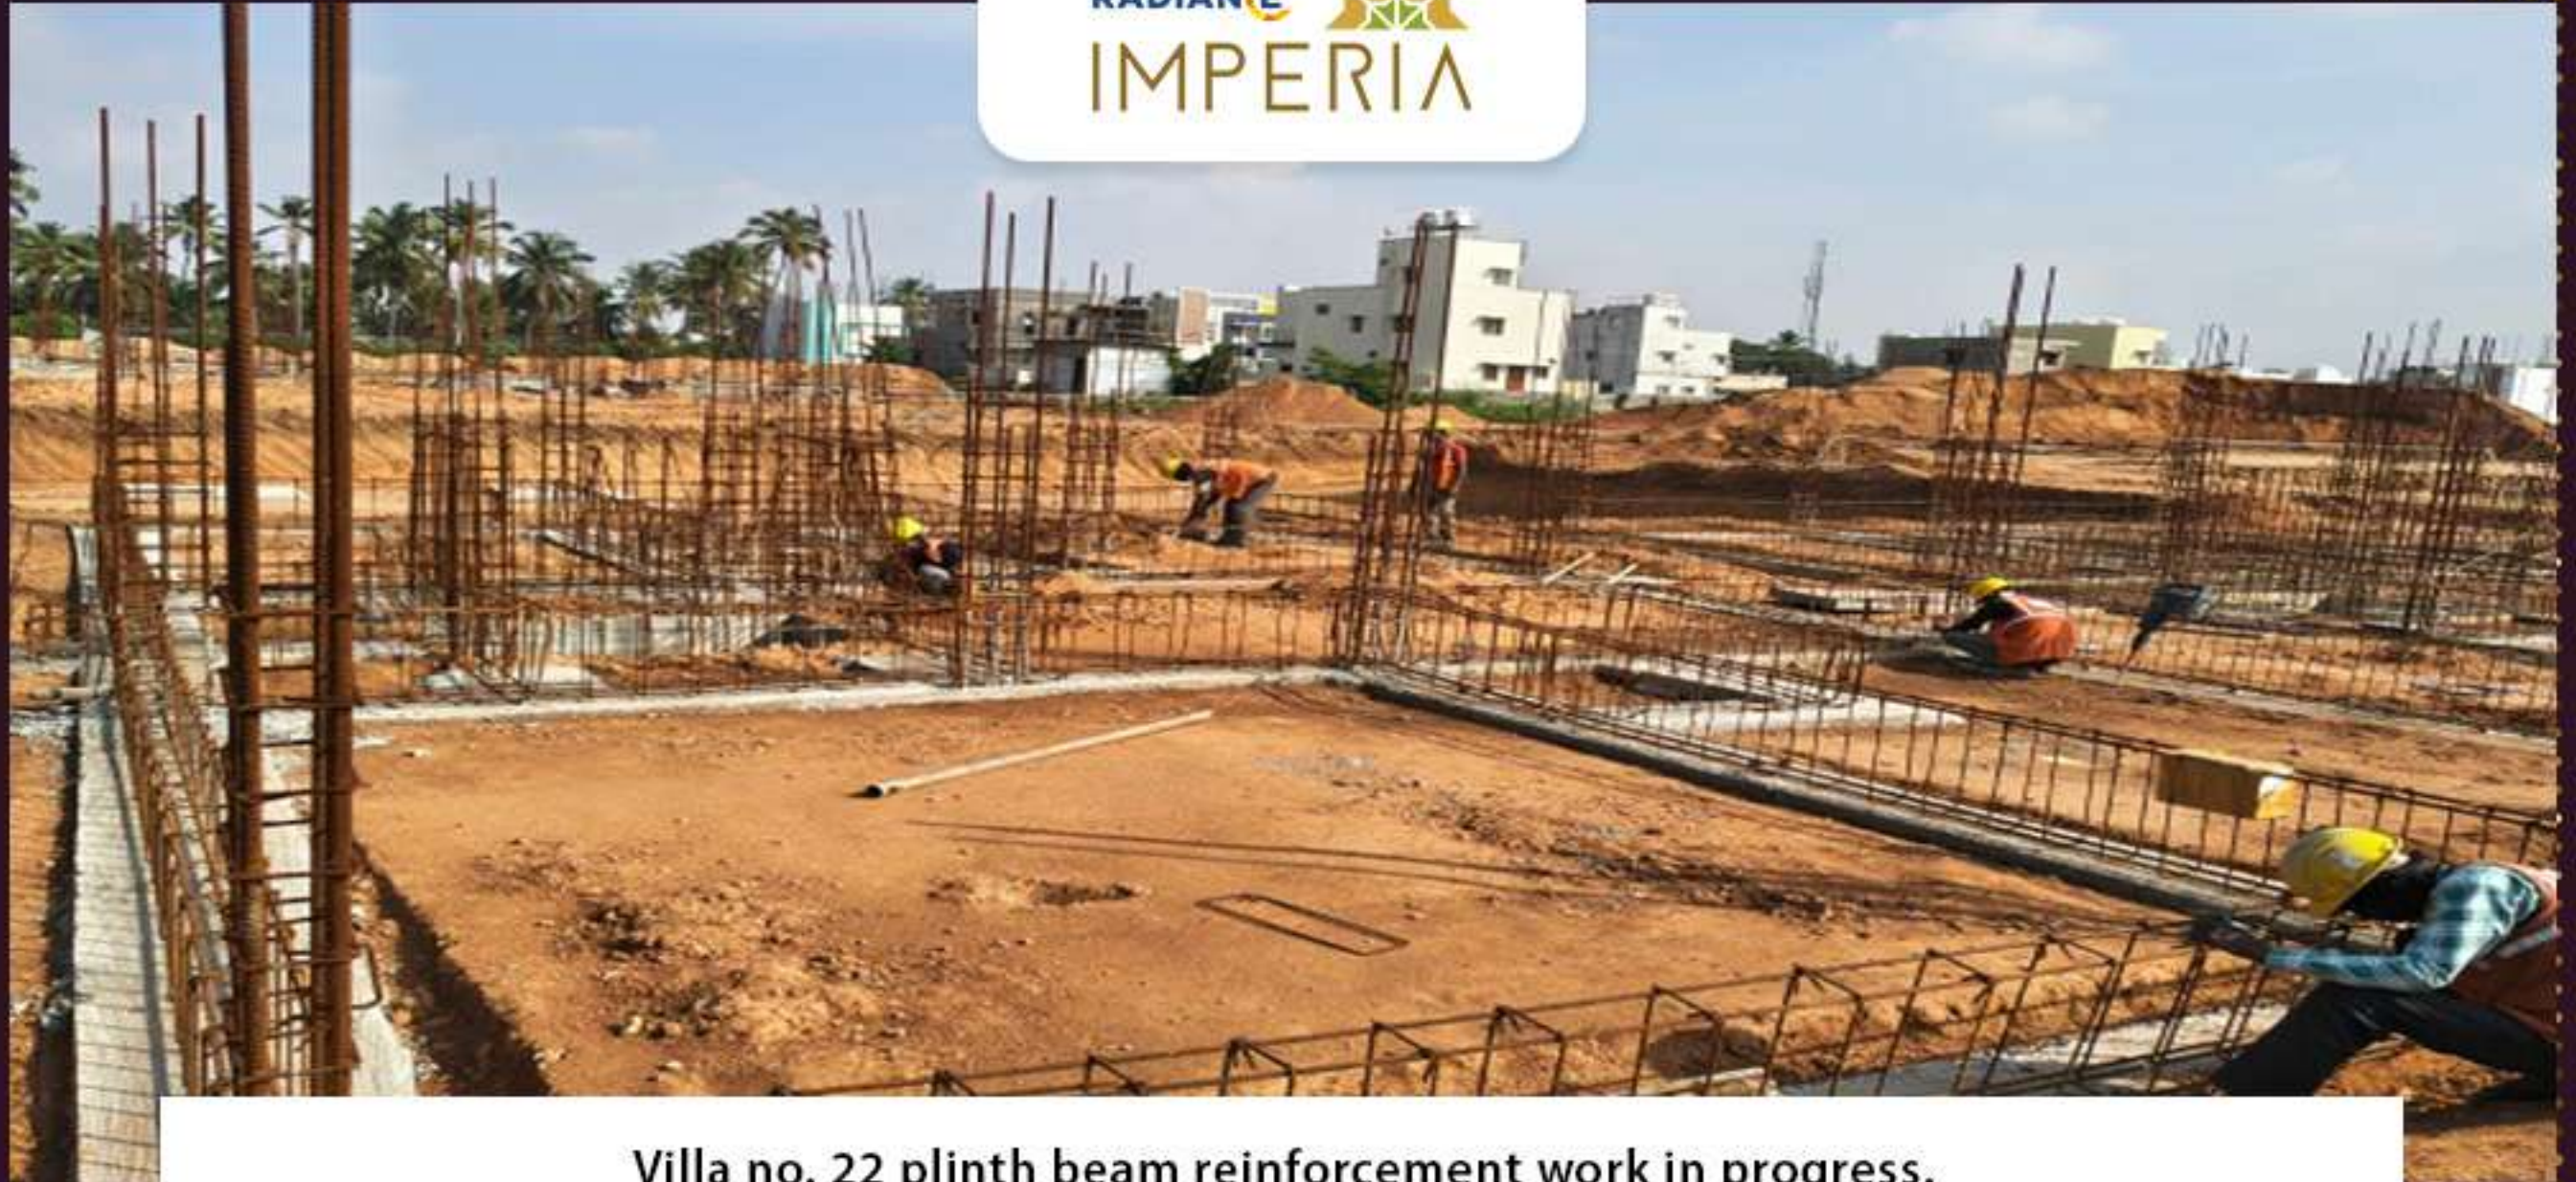
Villa no. 22 plinth beam reinforcement work in progress.

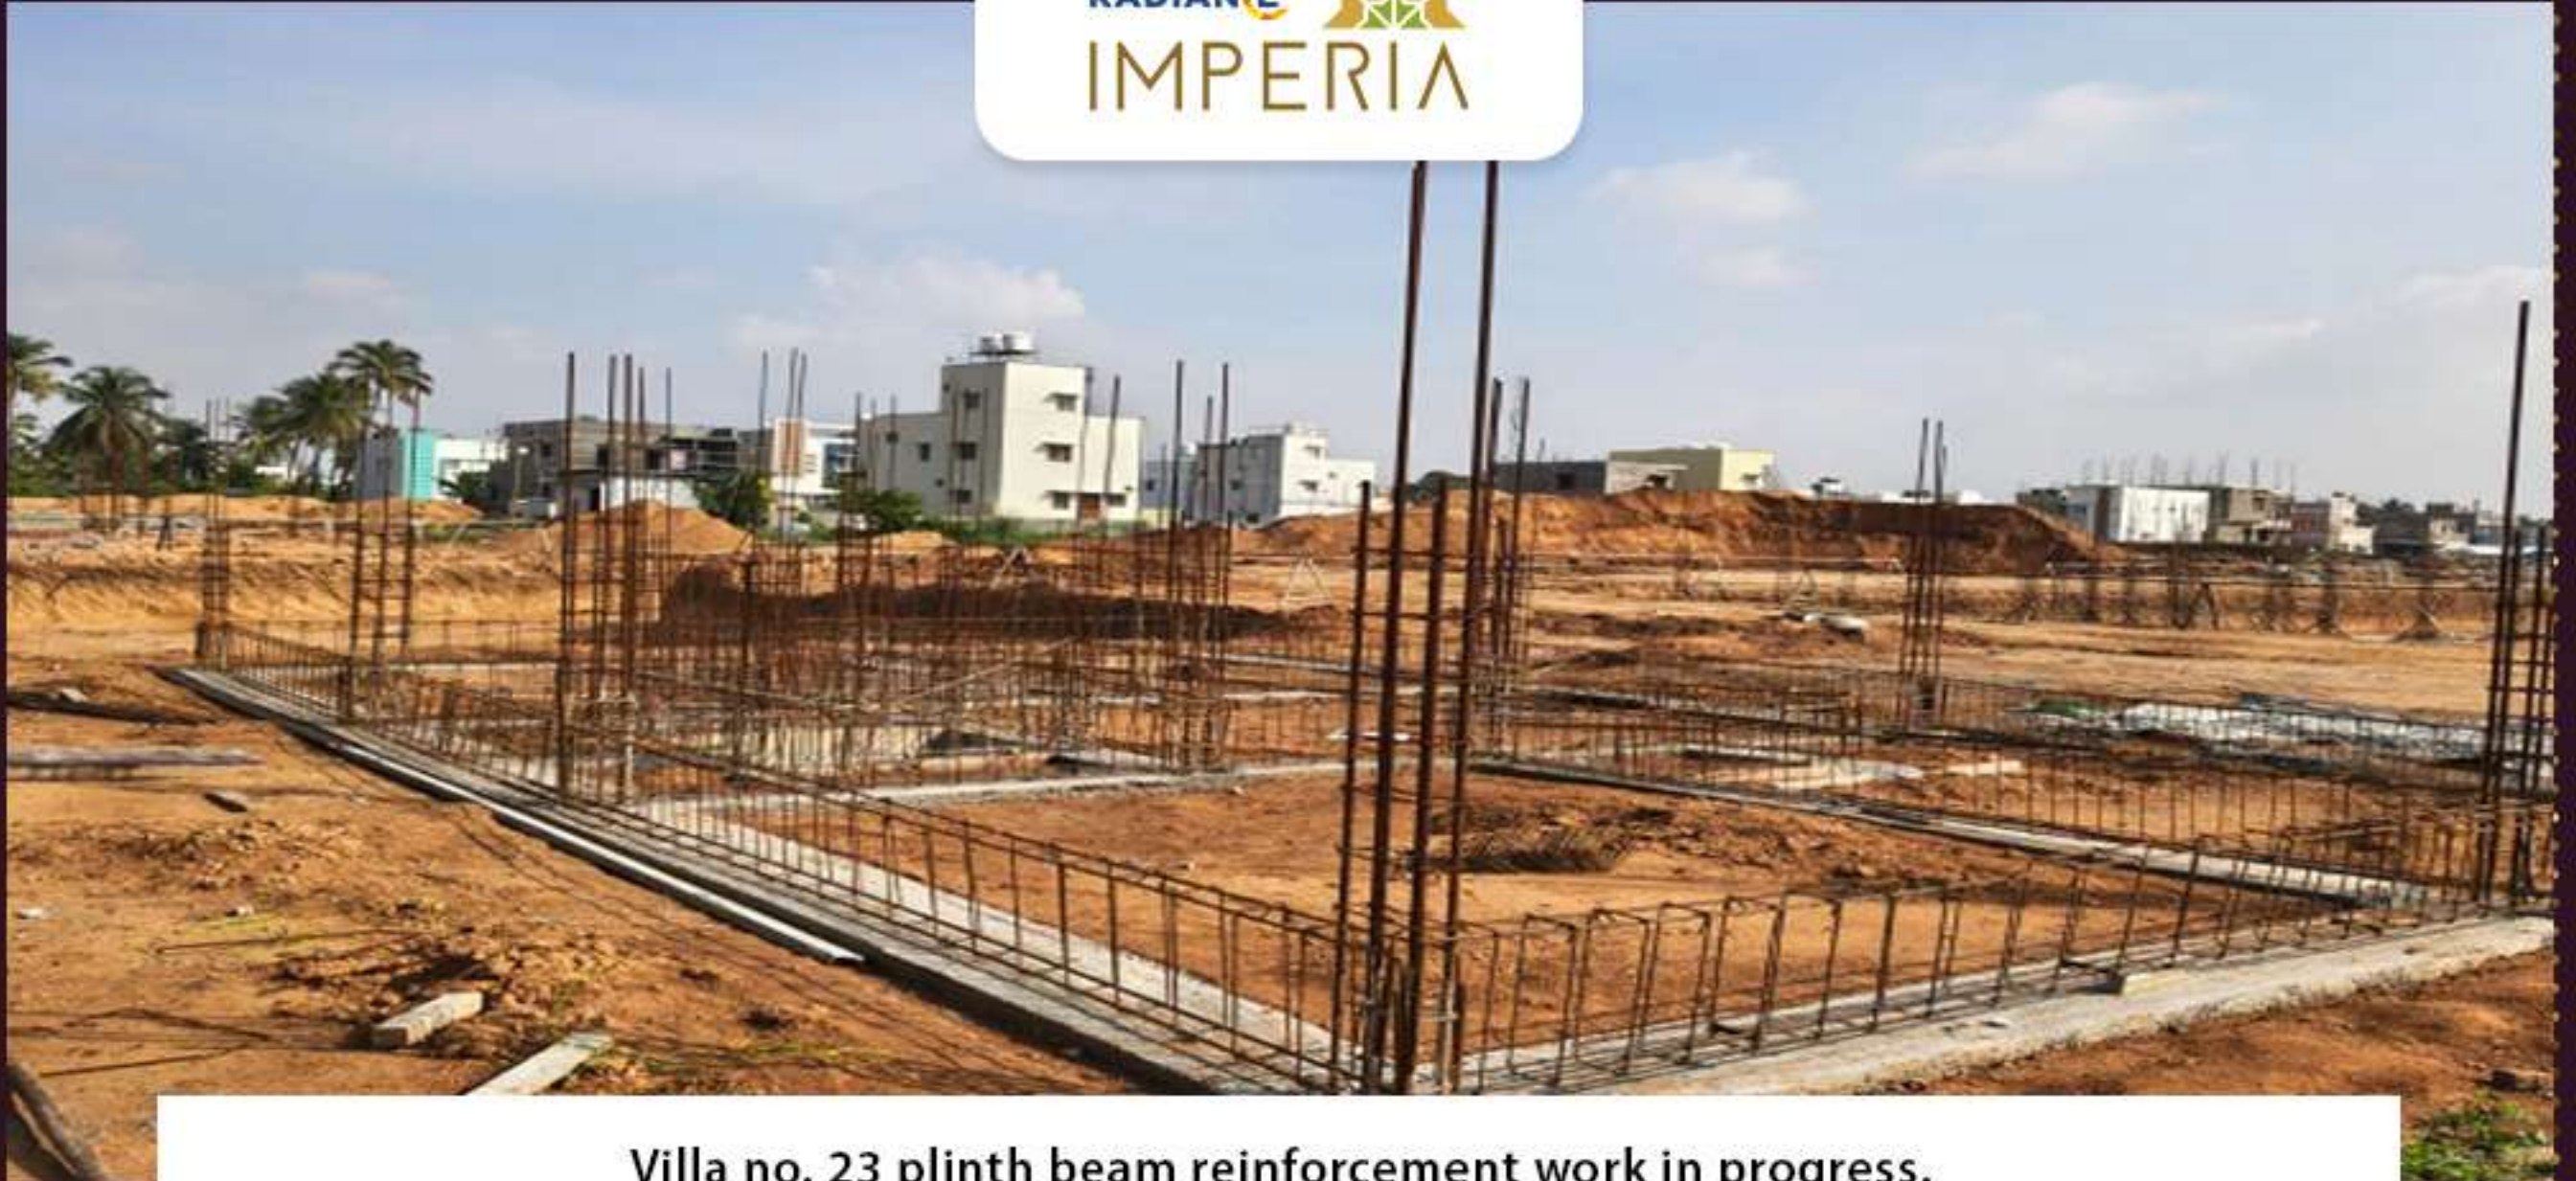
Villa no. 23 plinth beam reinforcement work in progress.

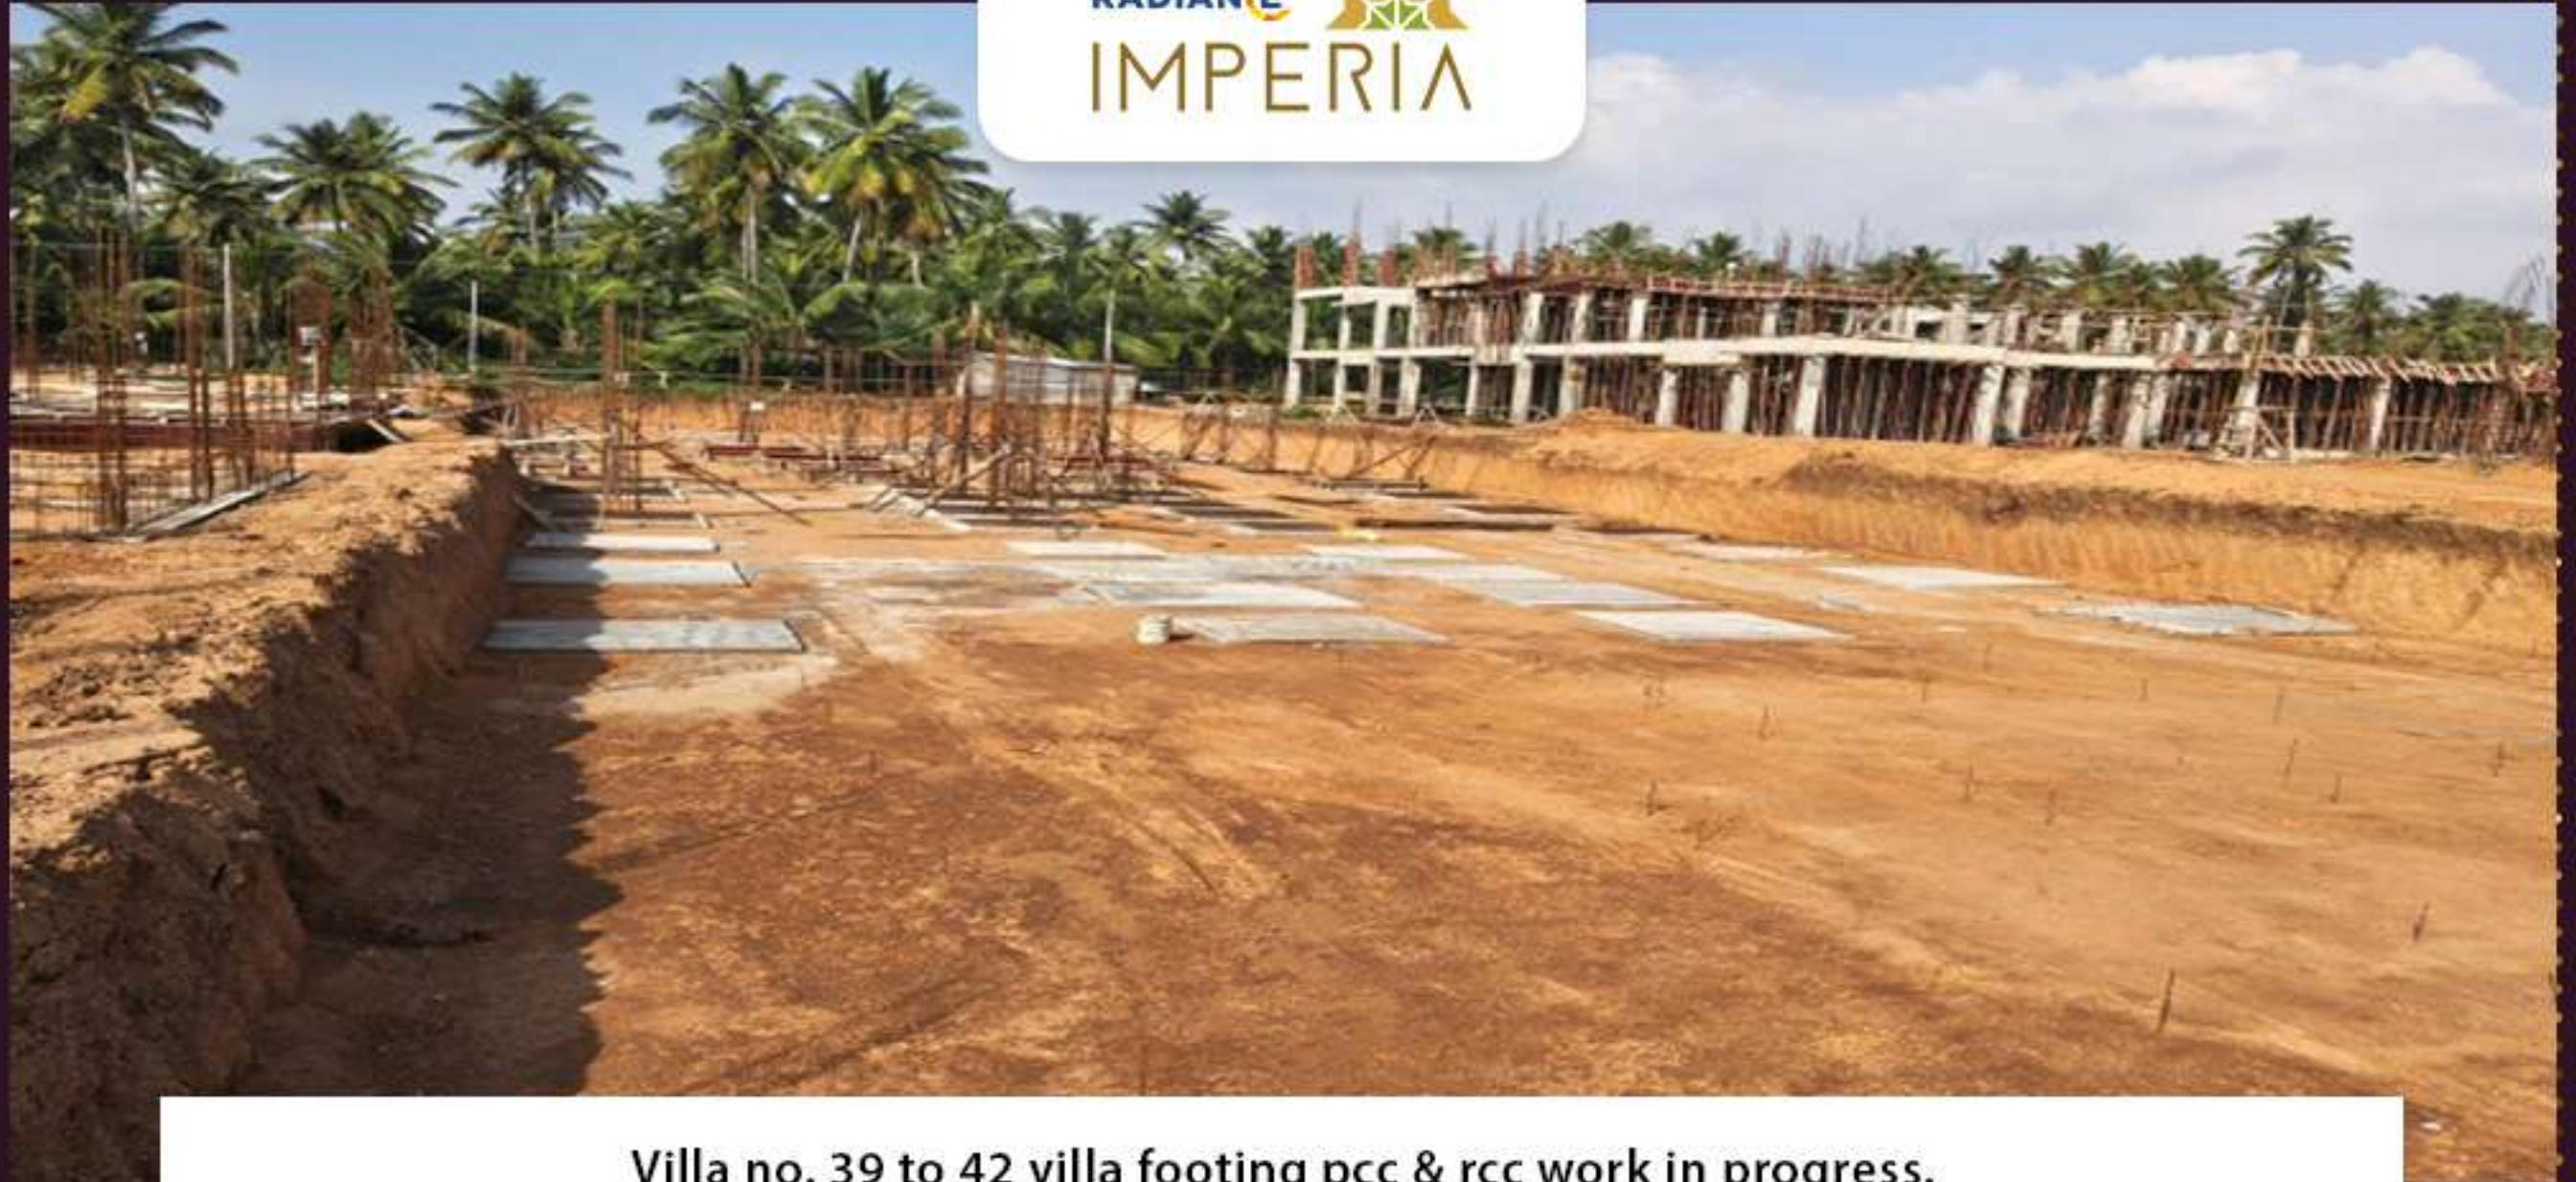
Villa no. 39 to 42 villa footing pcc & rcc work in progress.

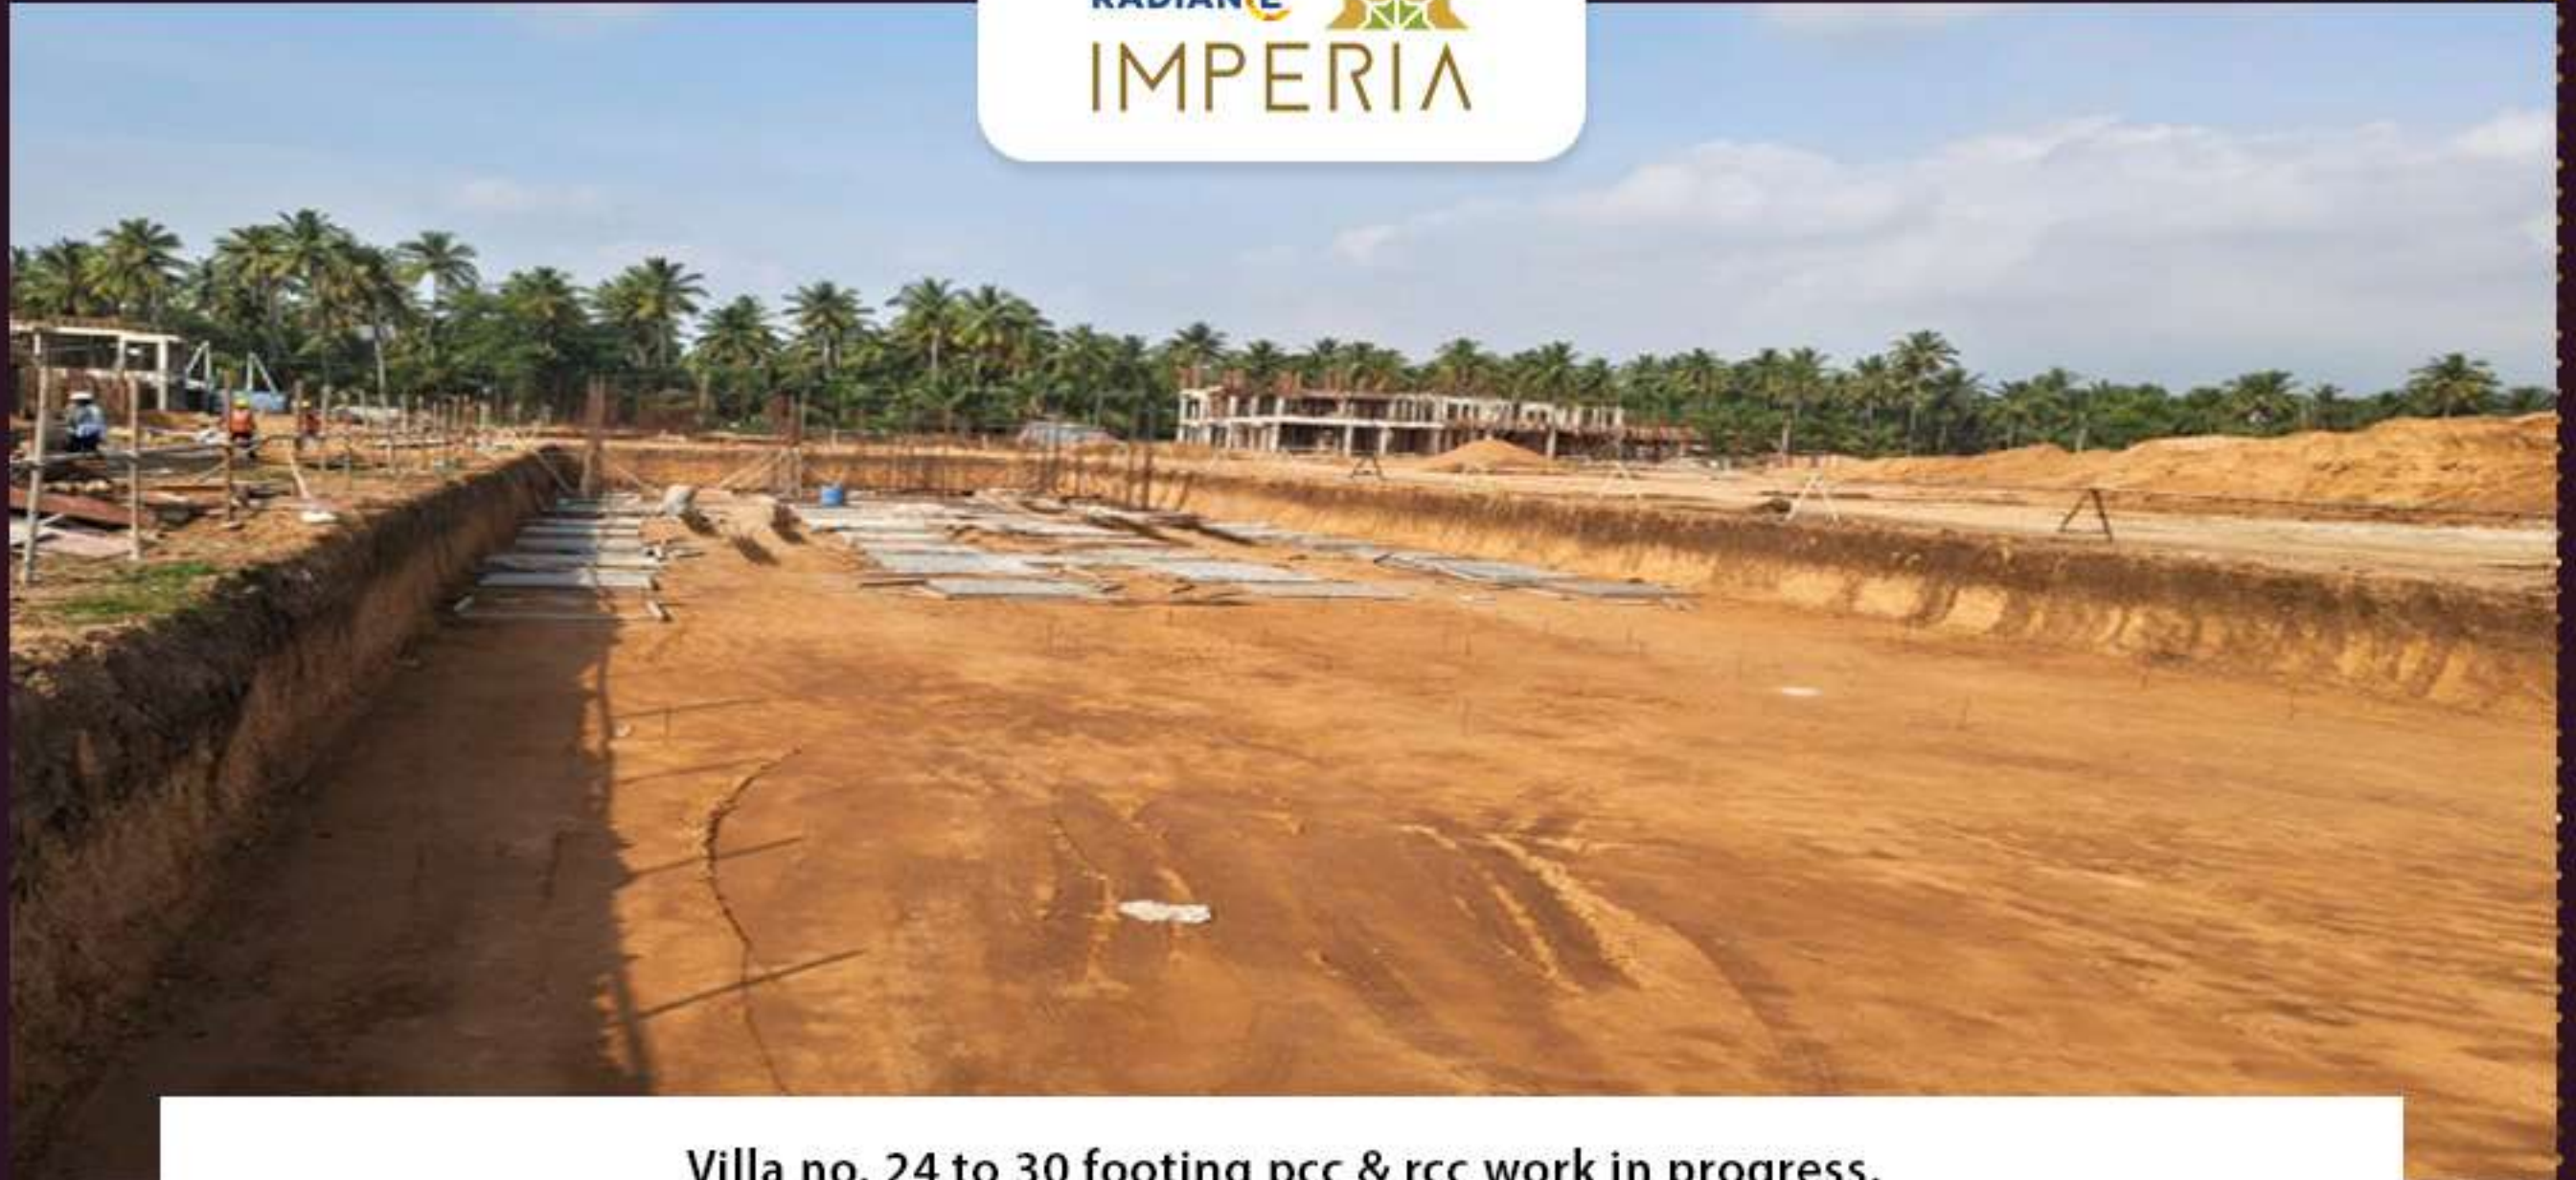
Villa no. 24 to 30 footing pcc & rcc work in progress.

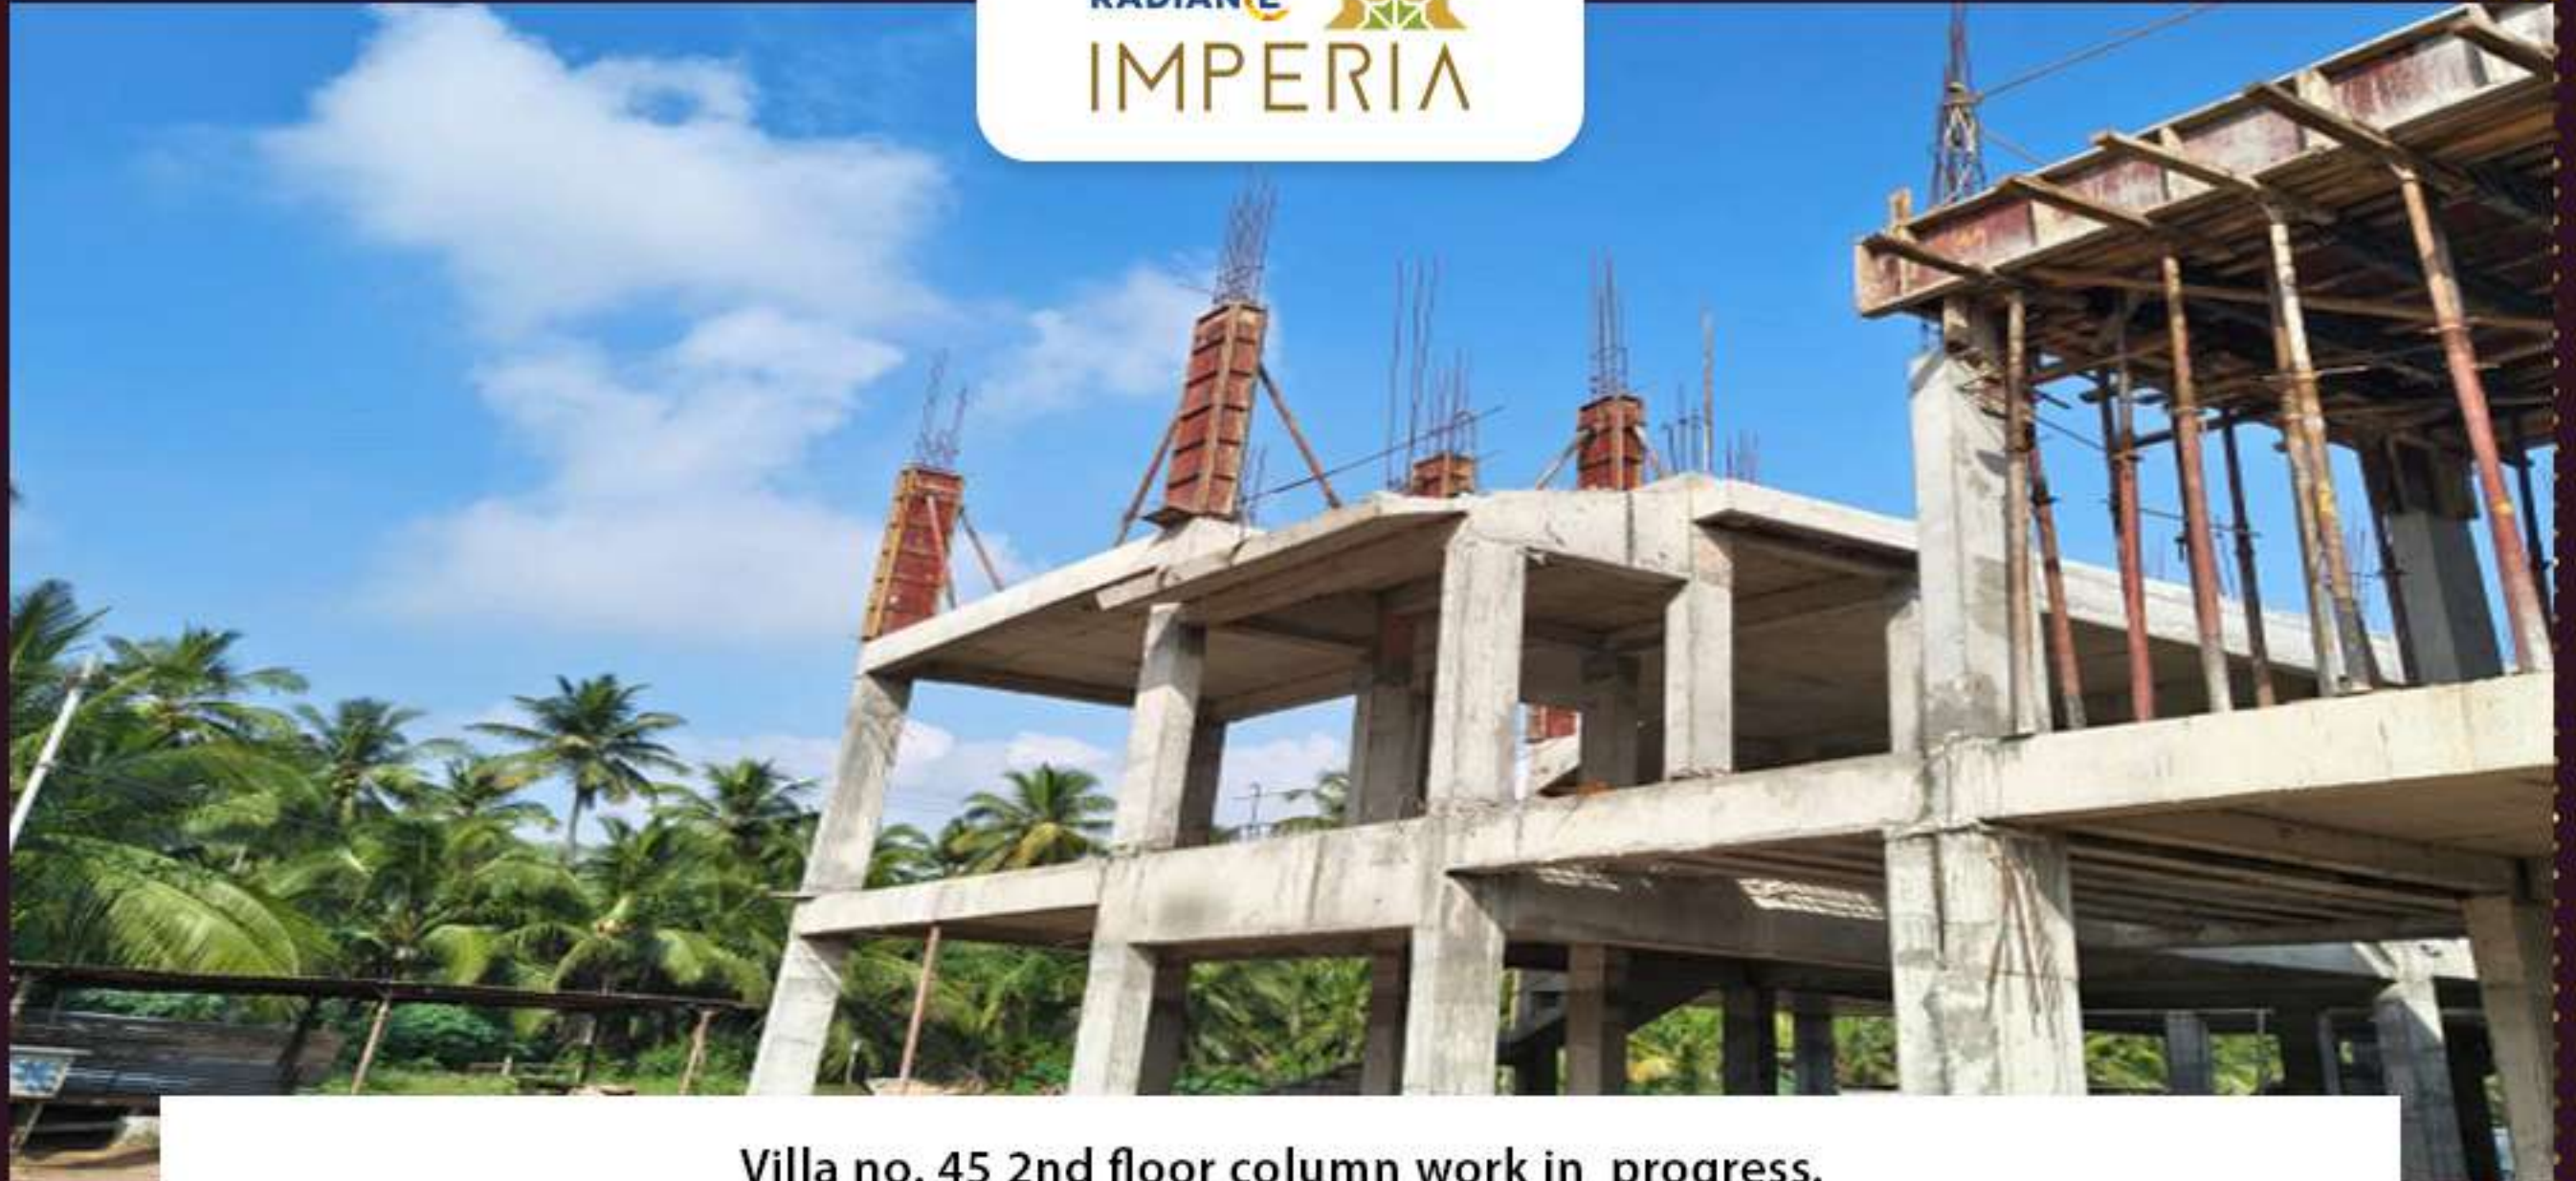
Villa no. 45 2nd floor column work in progress.

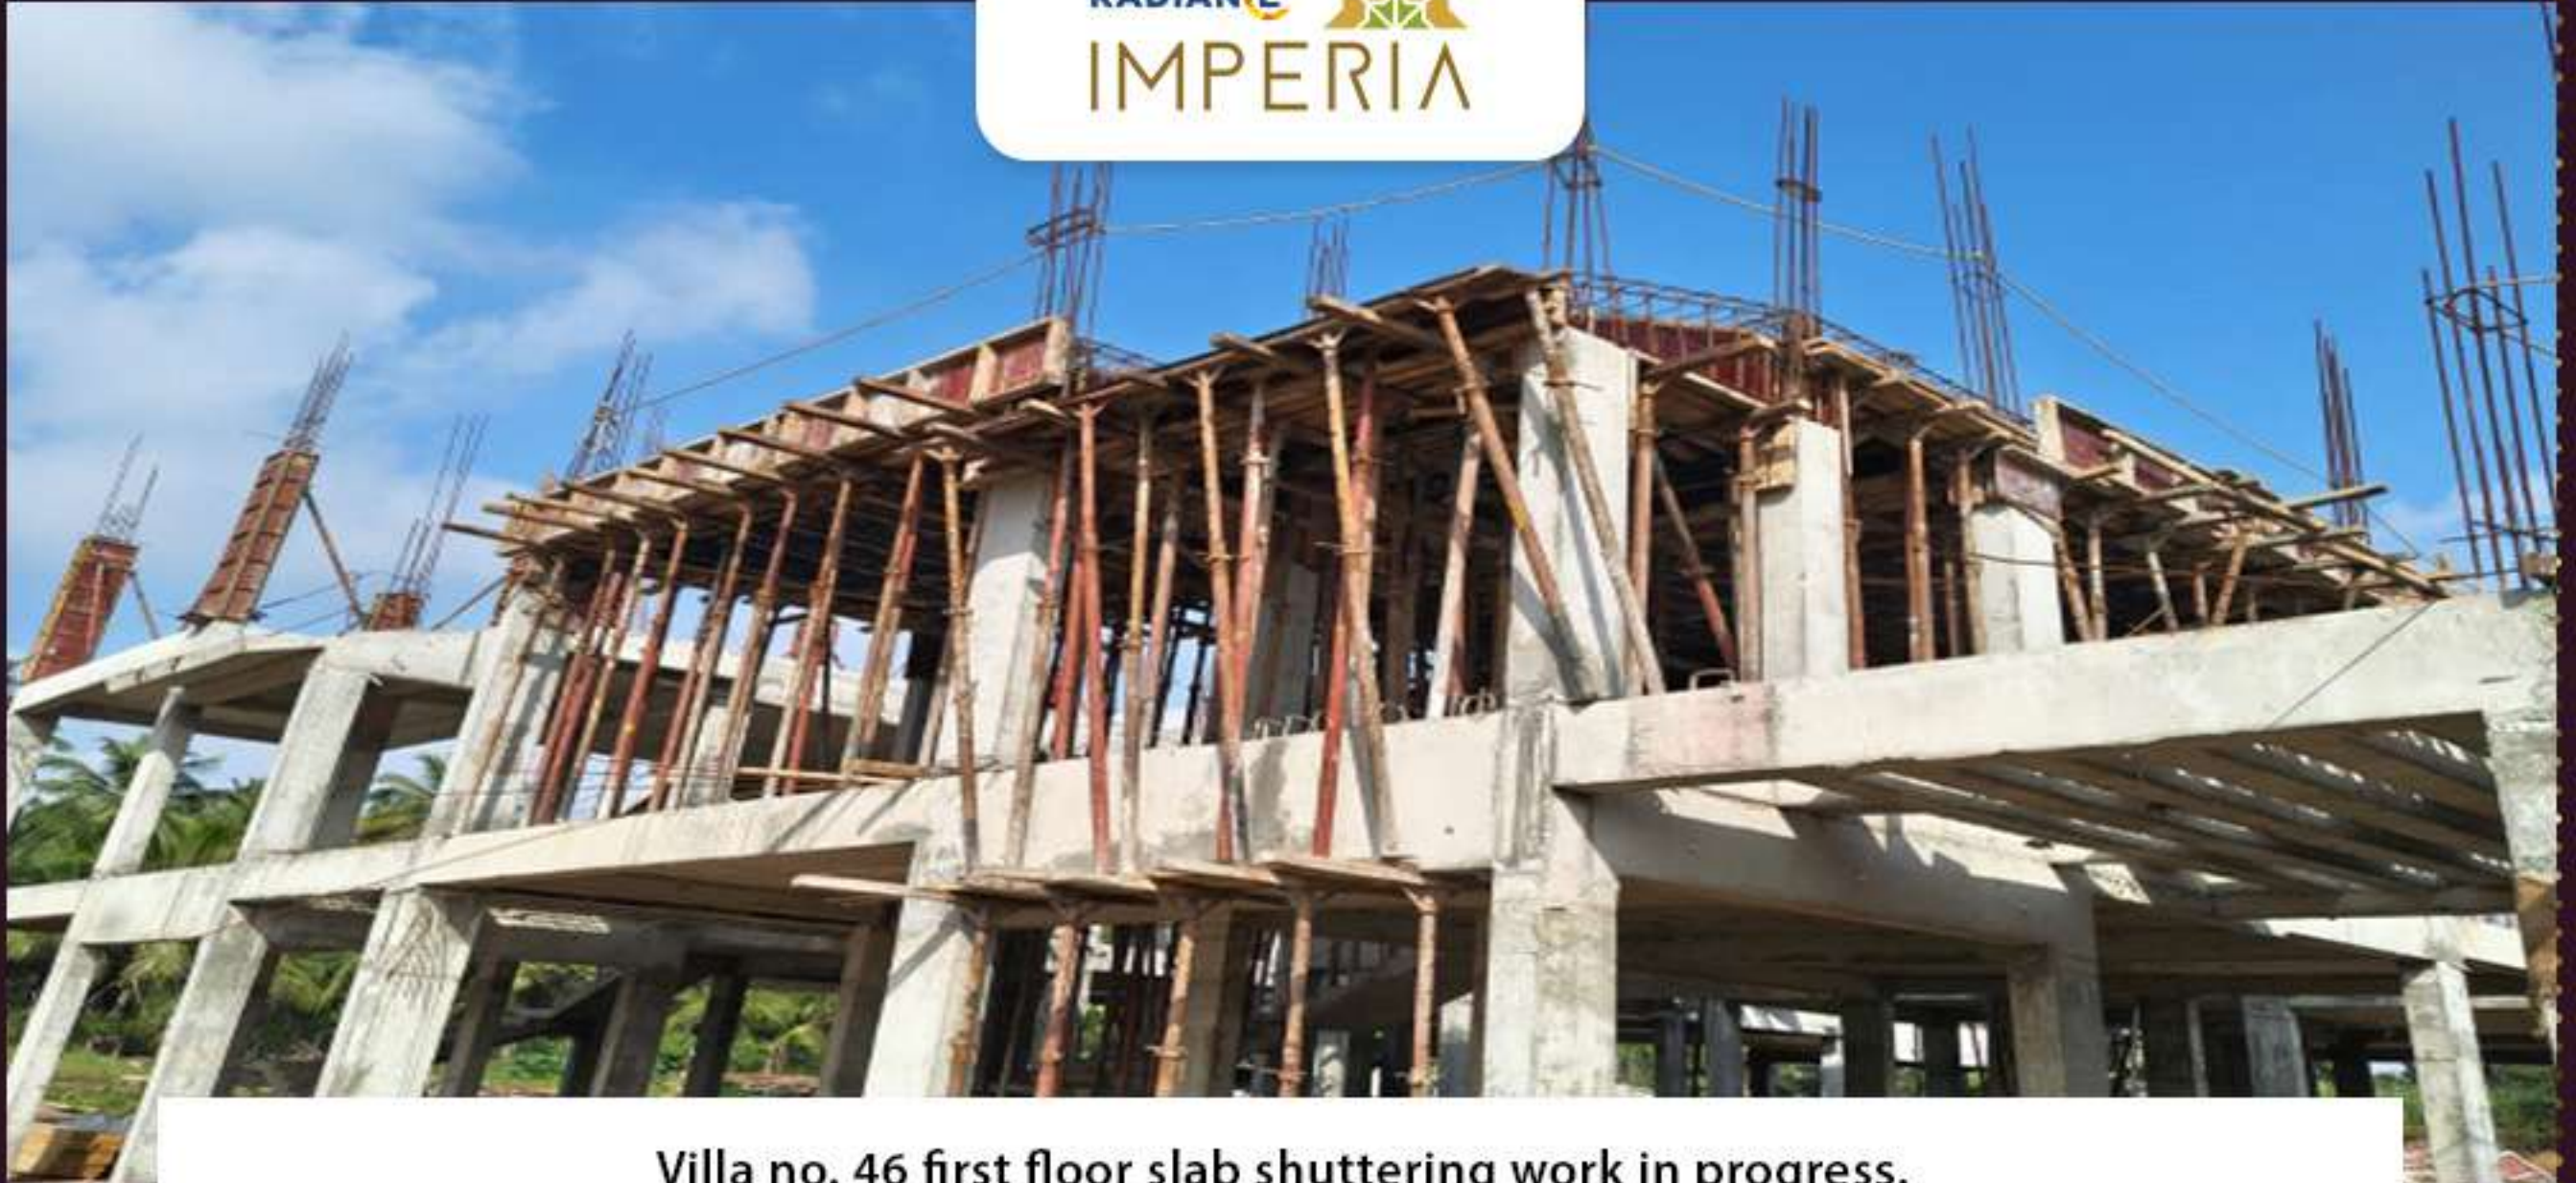
Villa no. 46 first floor slab shuttering work in progress.
