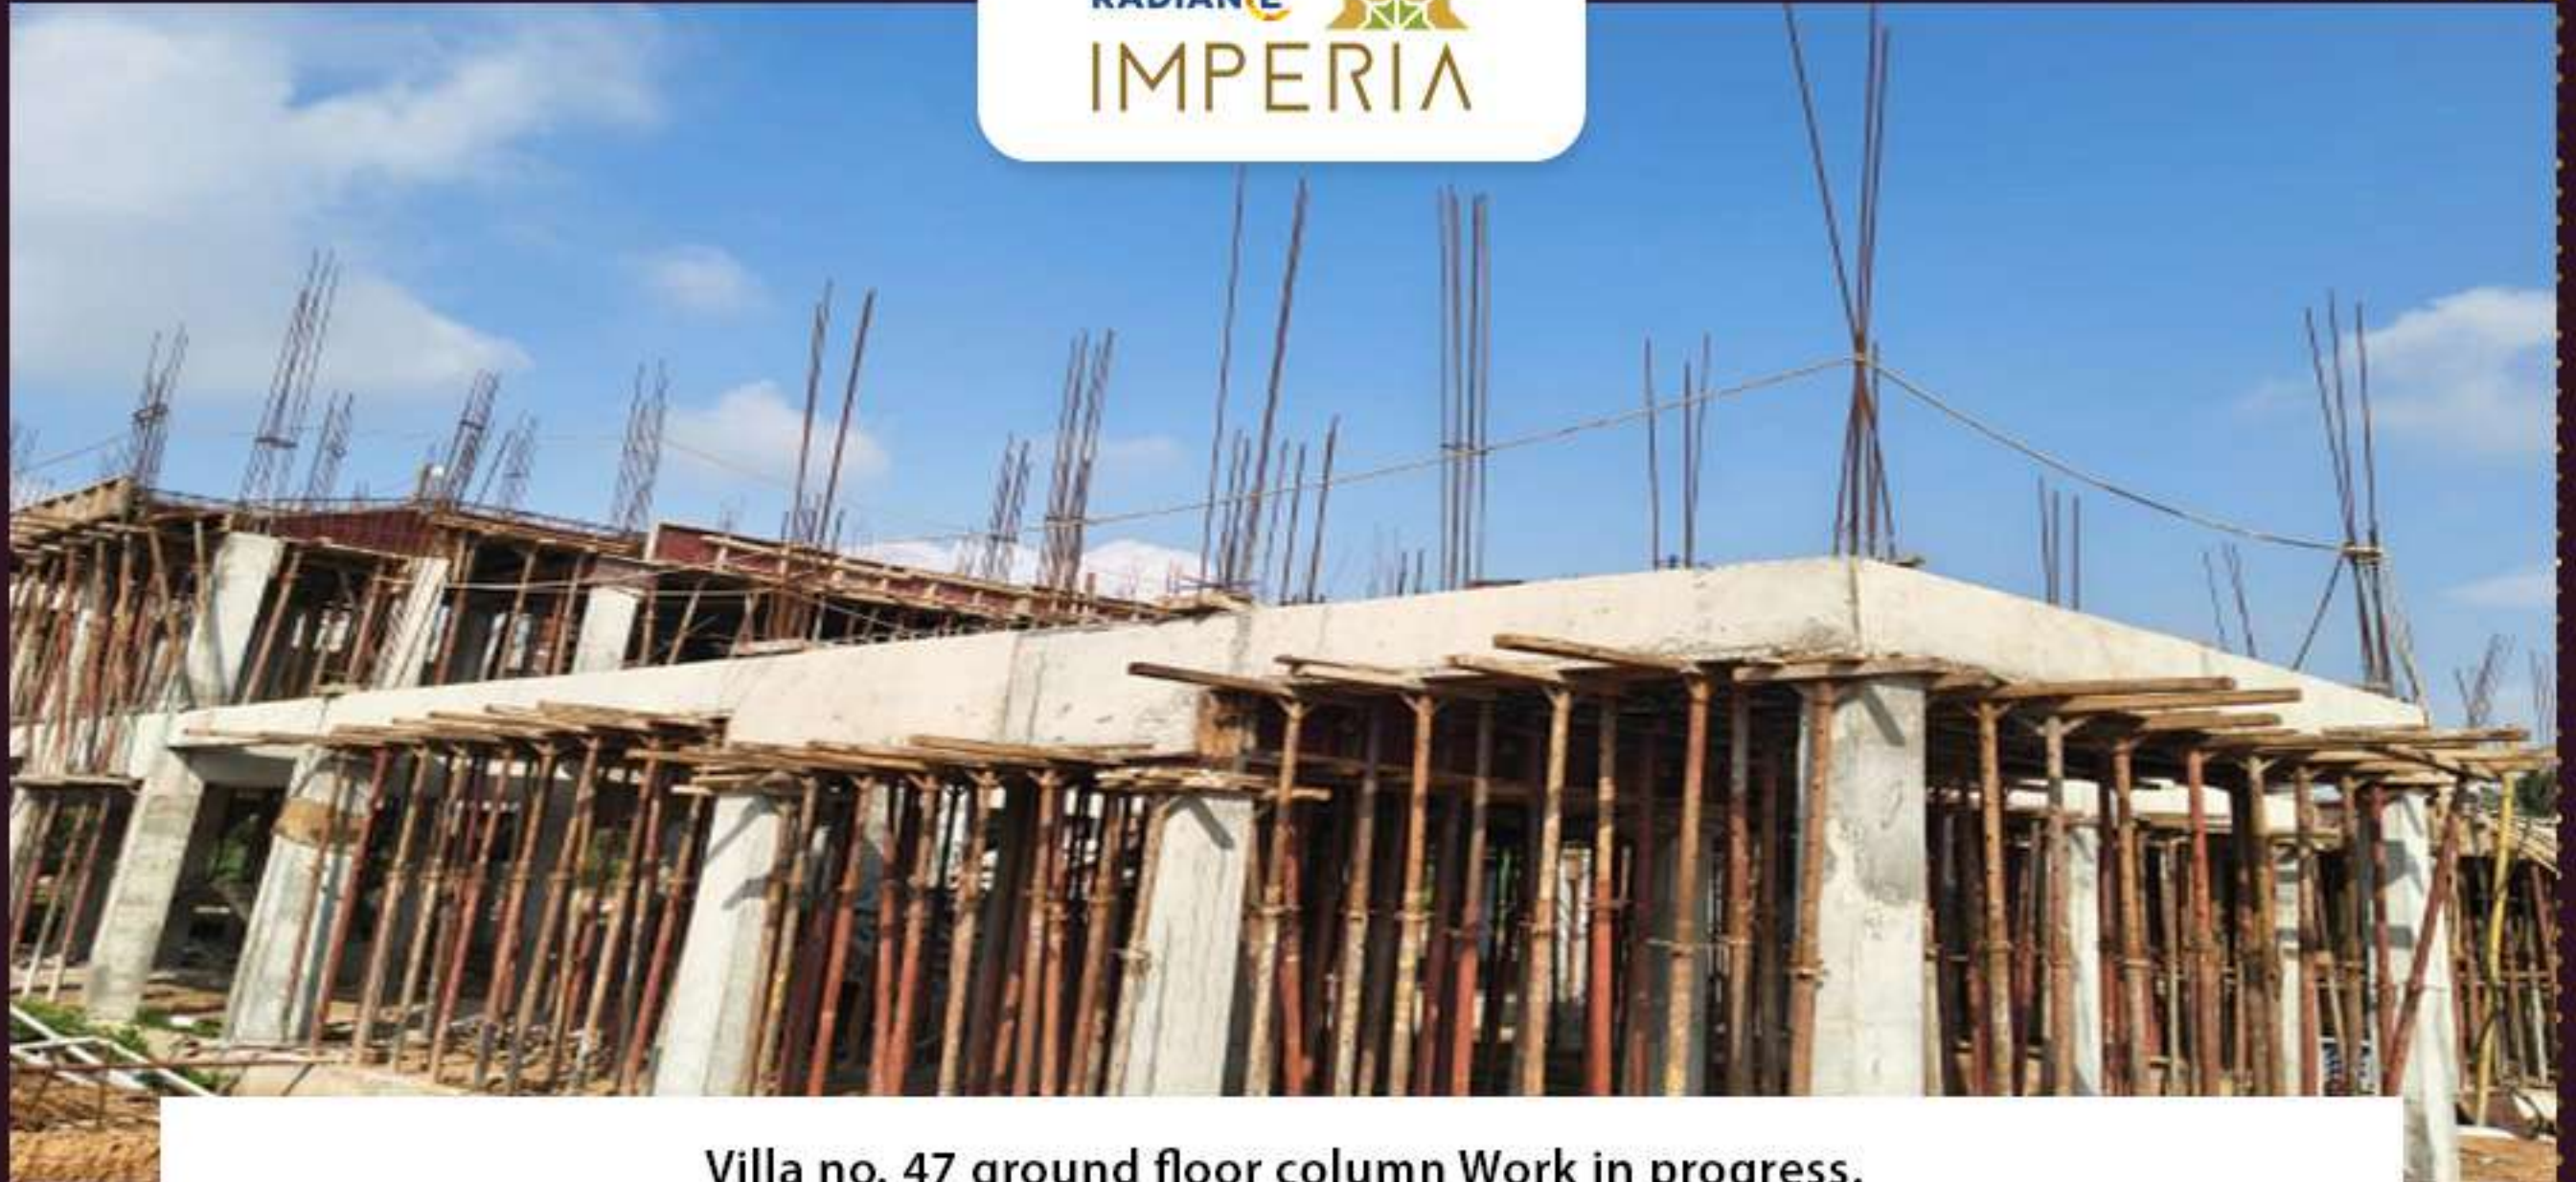
Villa no. 47 ground floor column Work in progress.

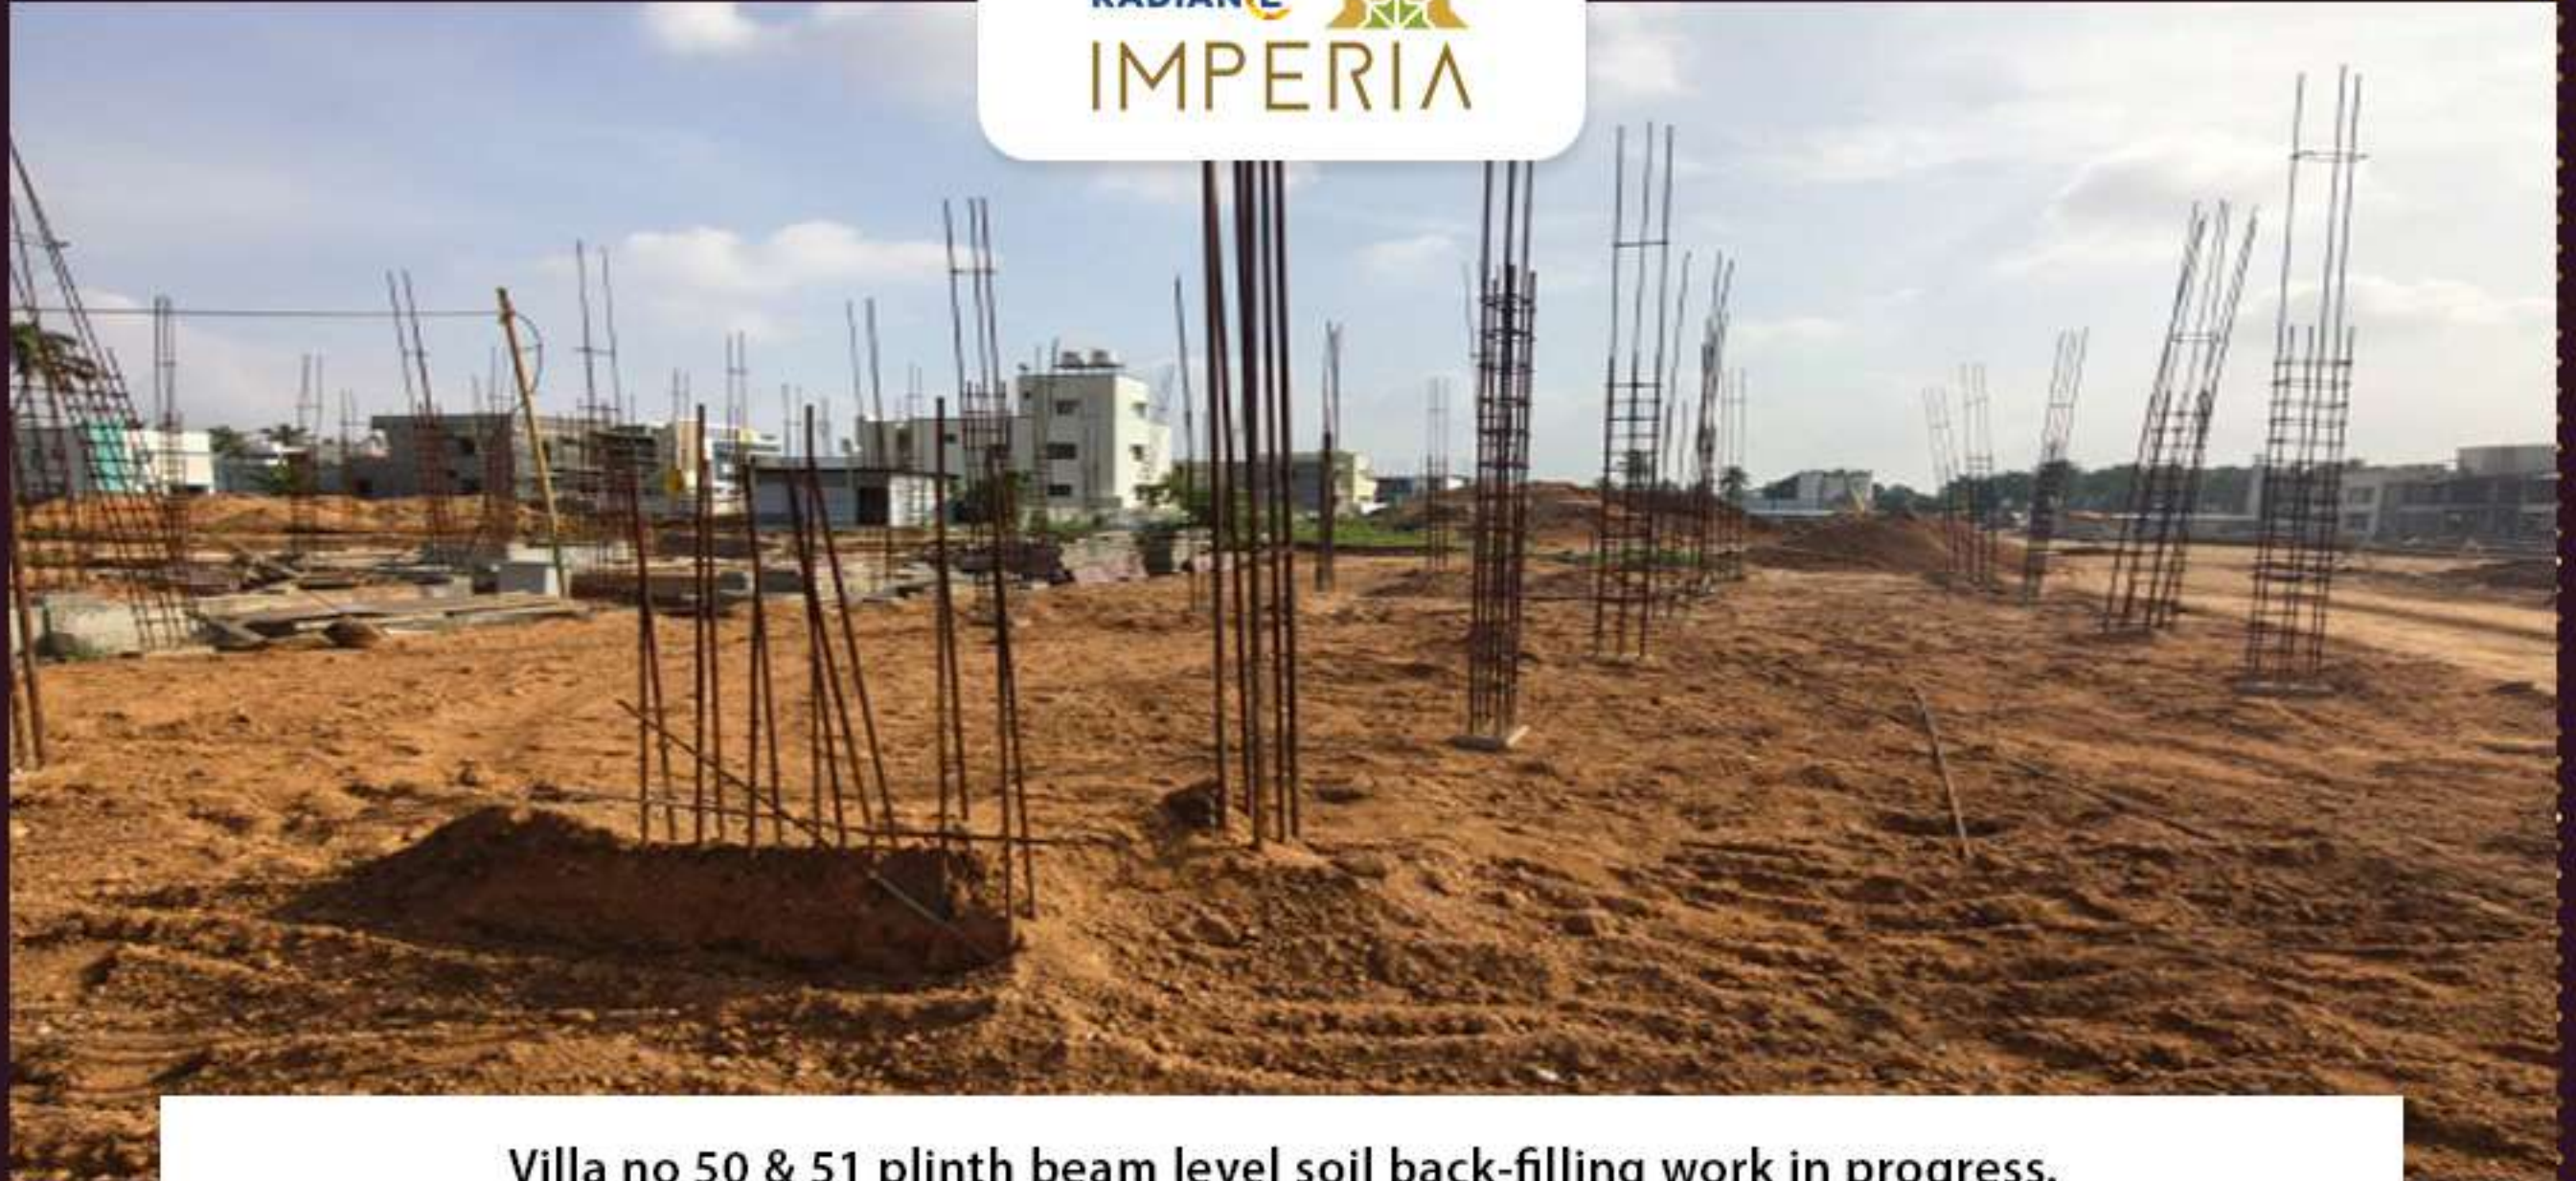
Villa no 50 & 51 plinth beam level soil back-filling work in progress.

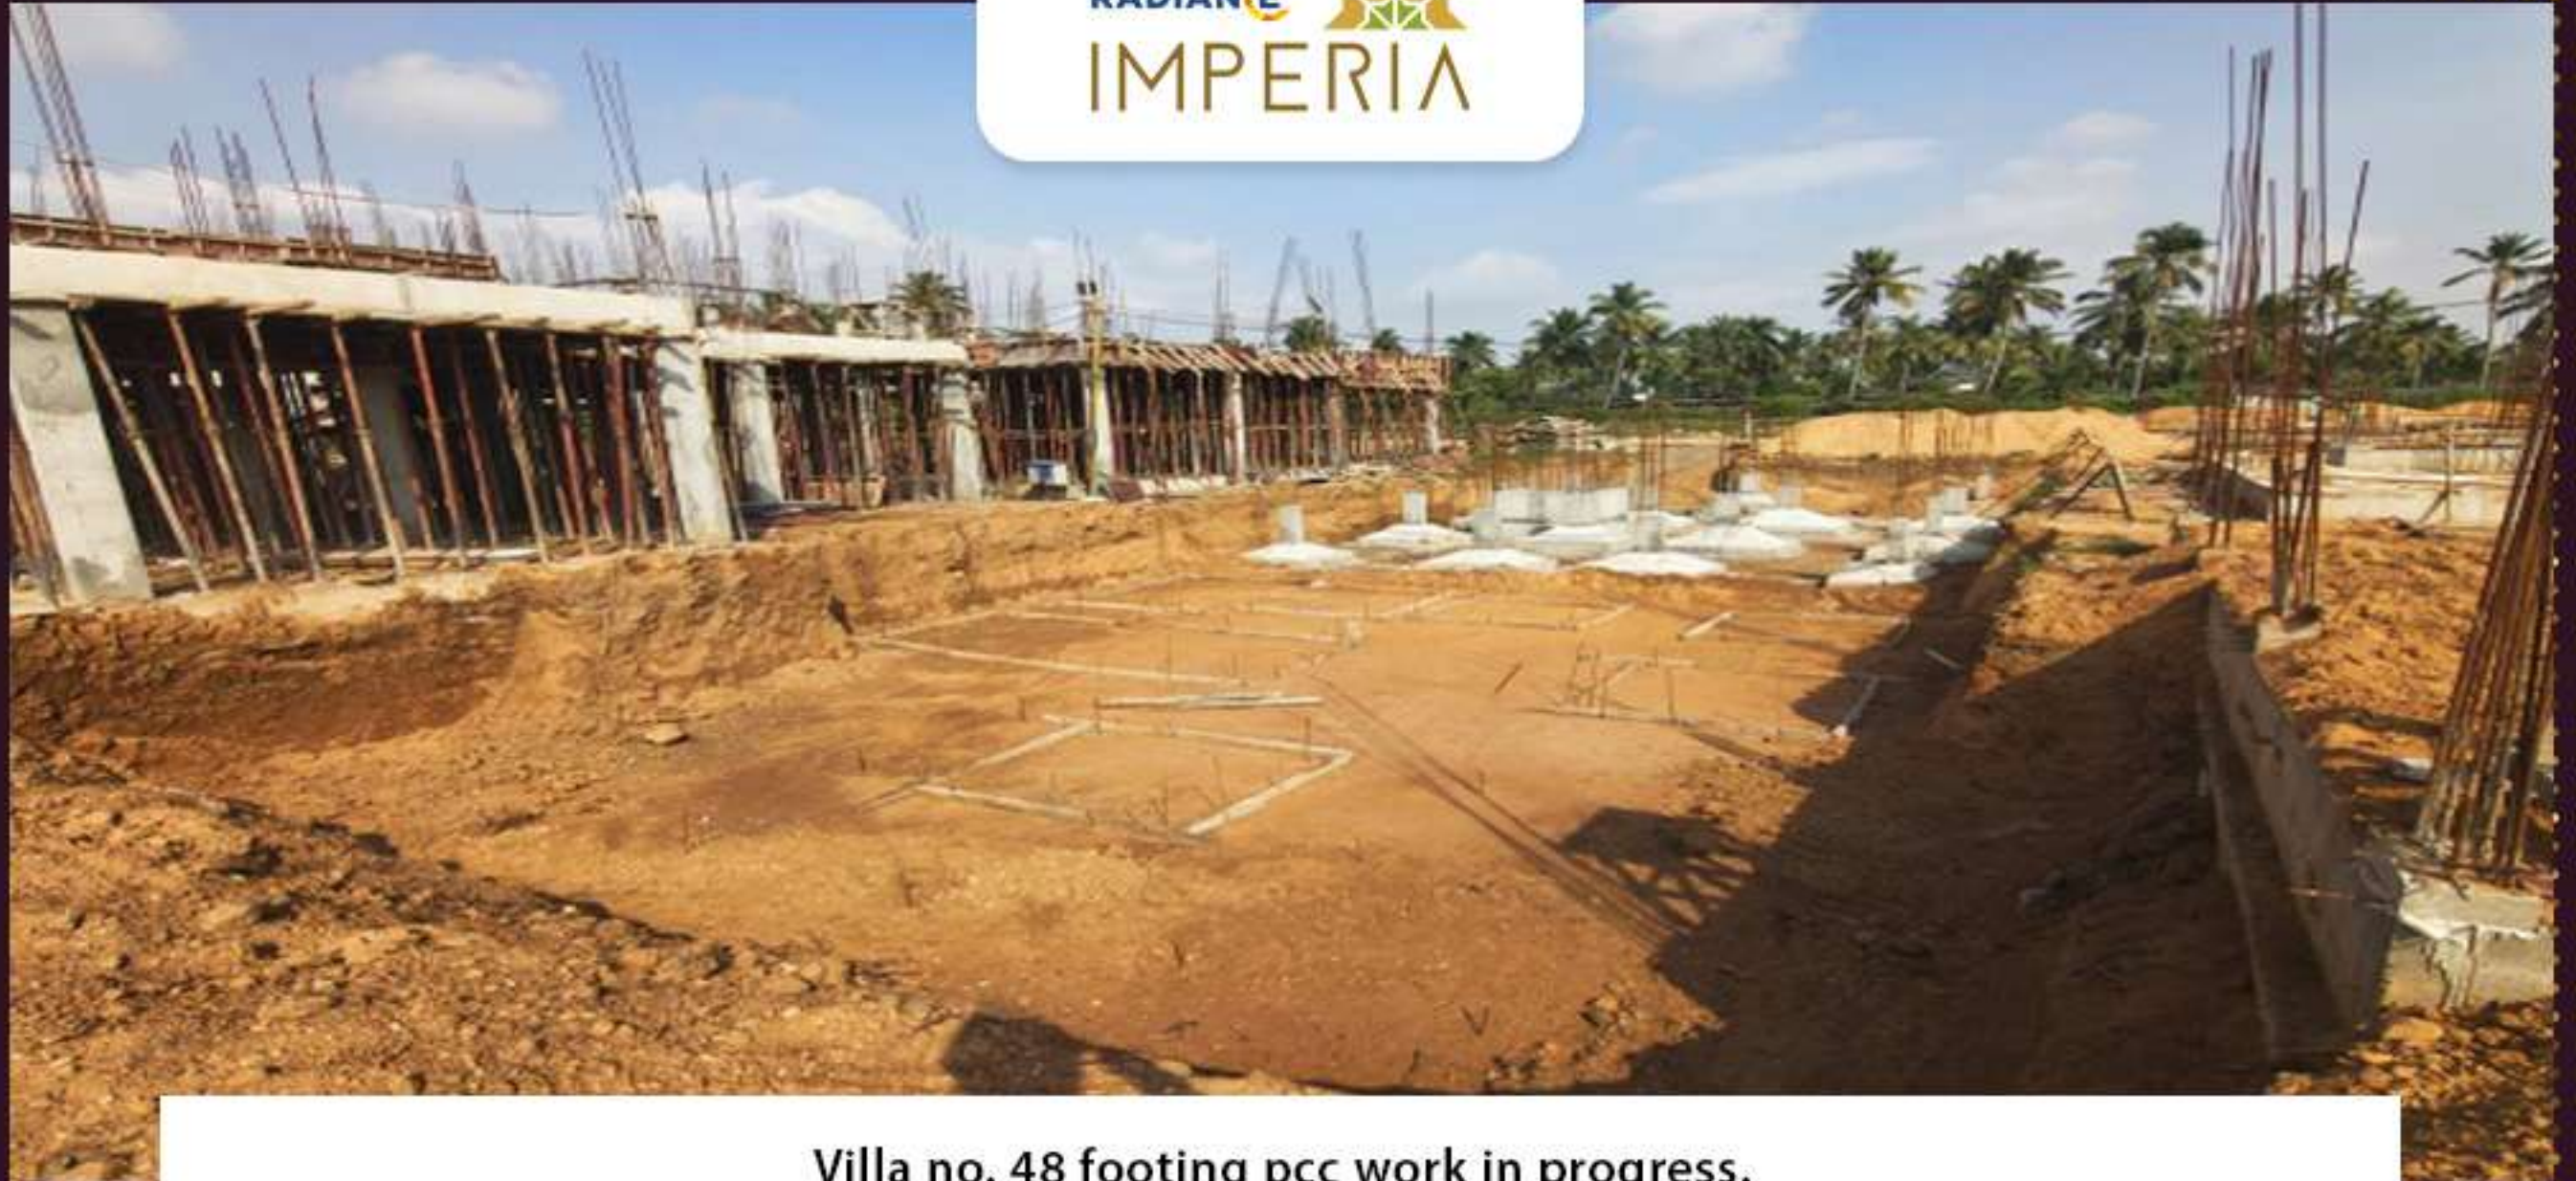
Villa no. 48 footing pcc work in progress.

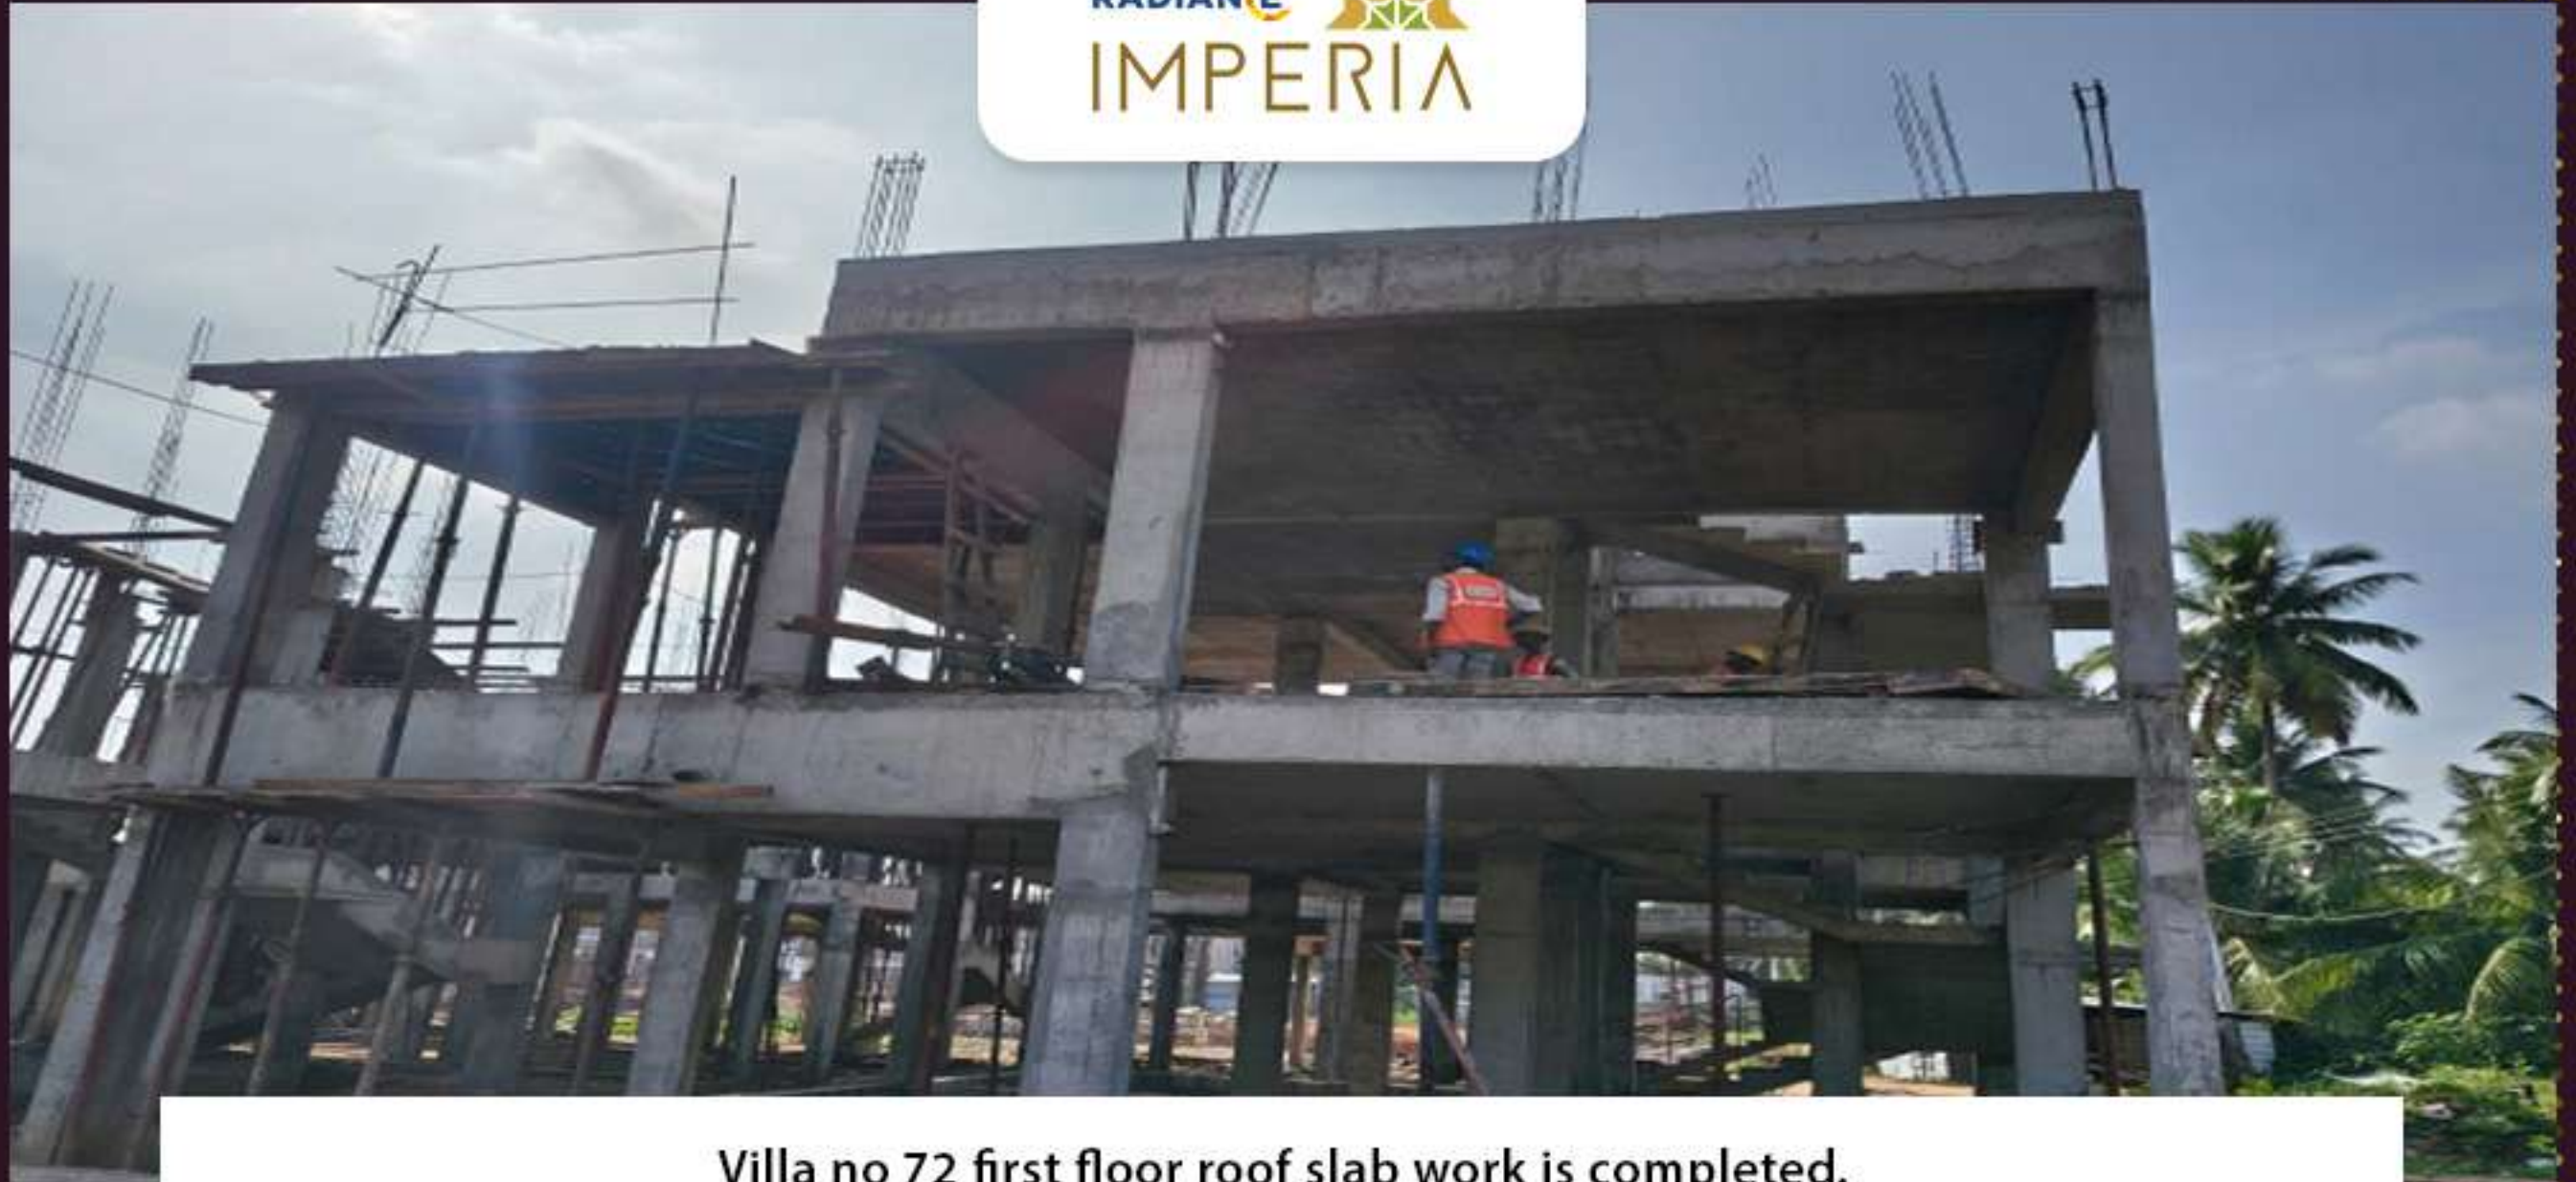
Villa no 72 first floor roof slab work is completed.

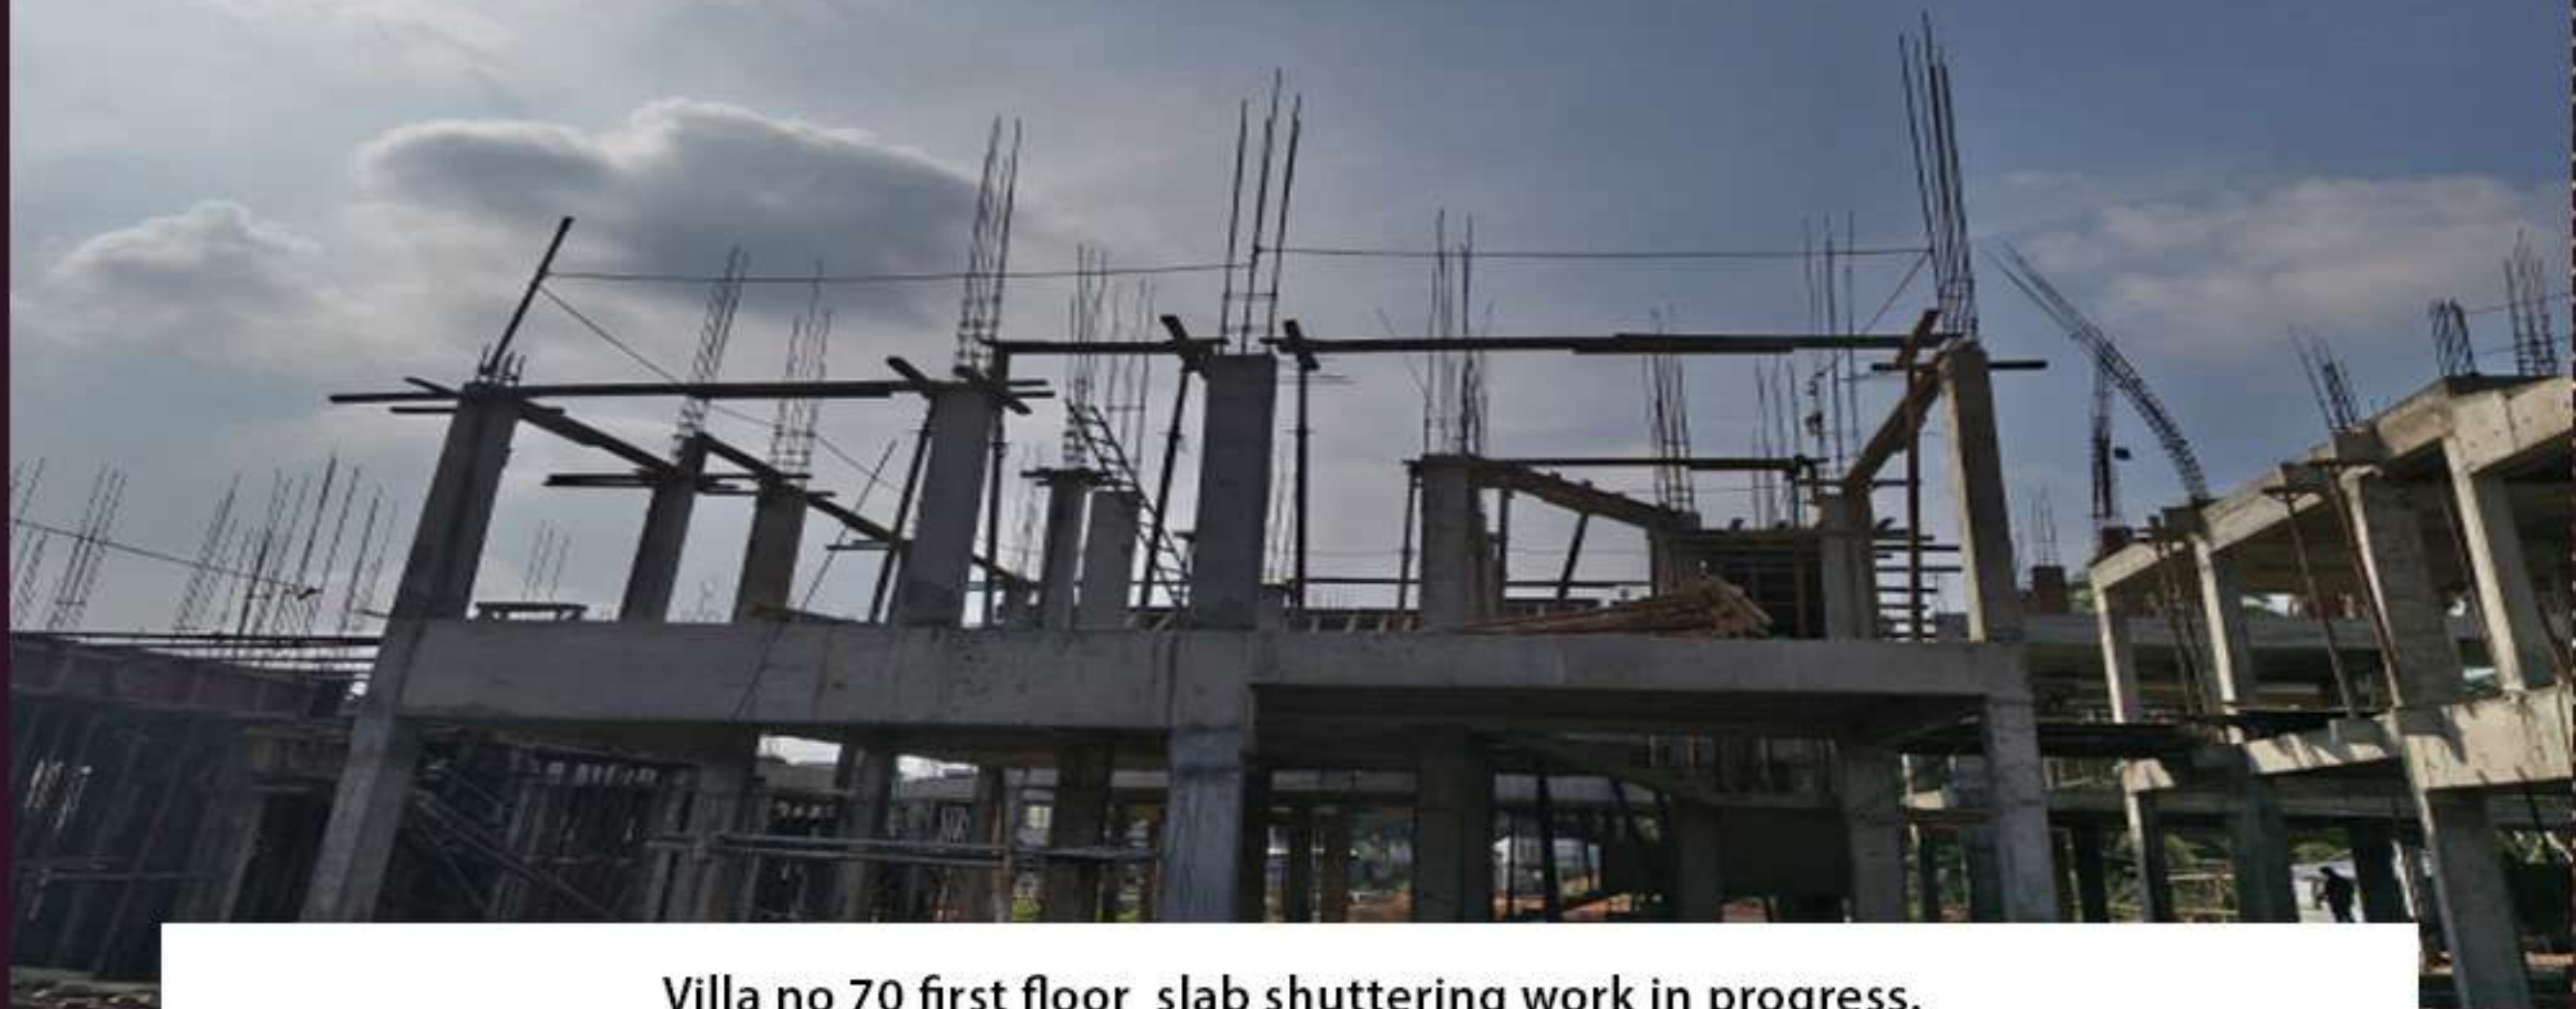
Villa no 70 first floor slab shuttering work in progress.

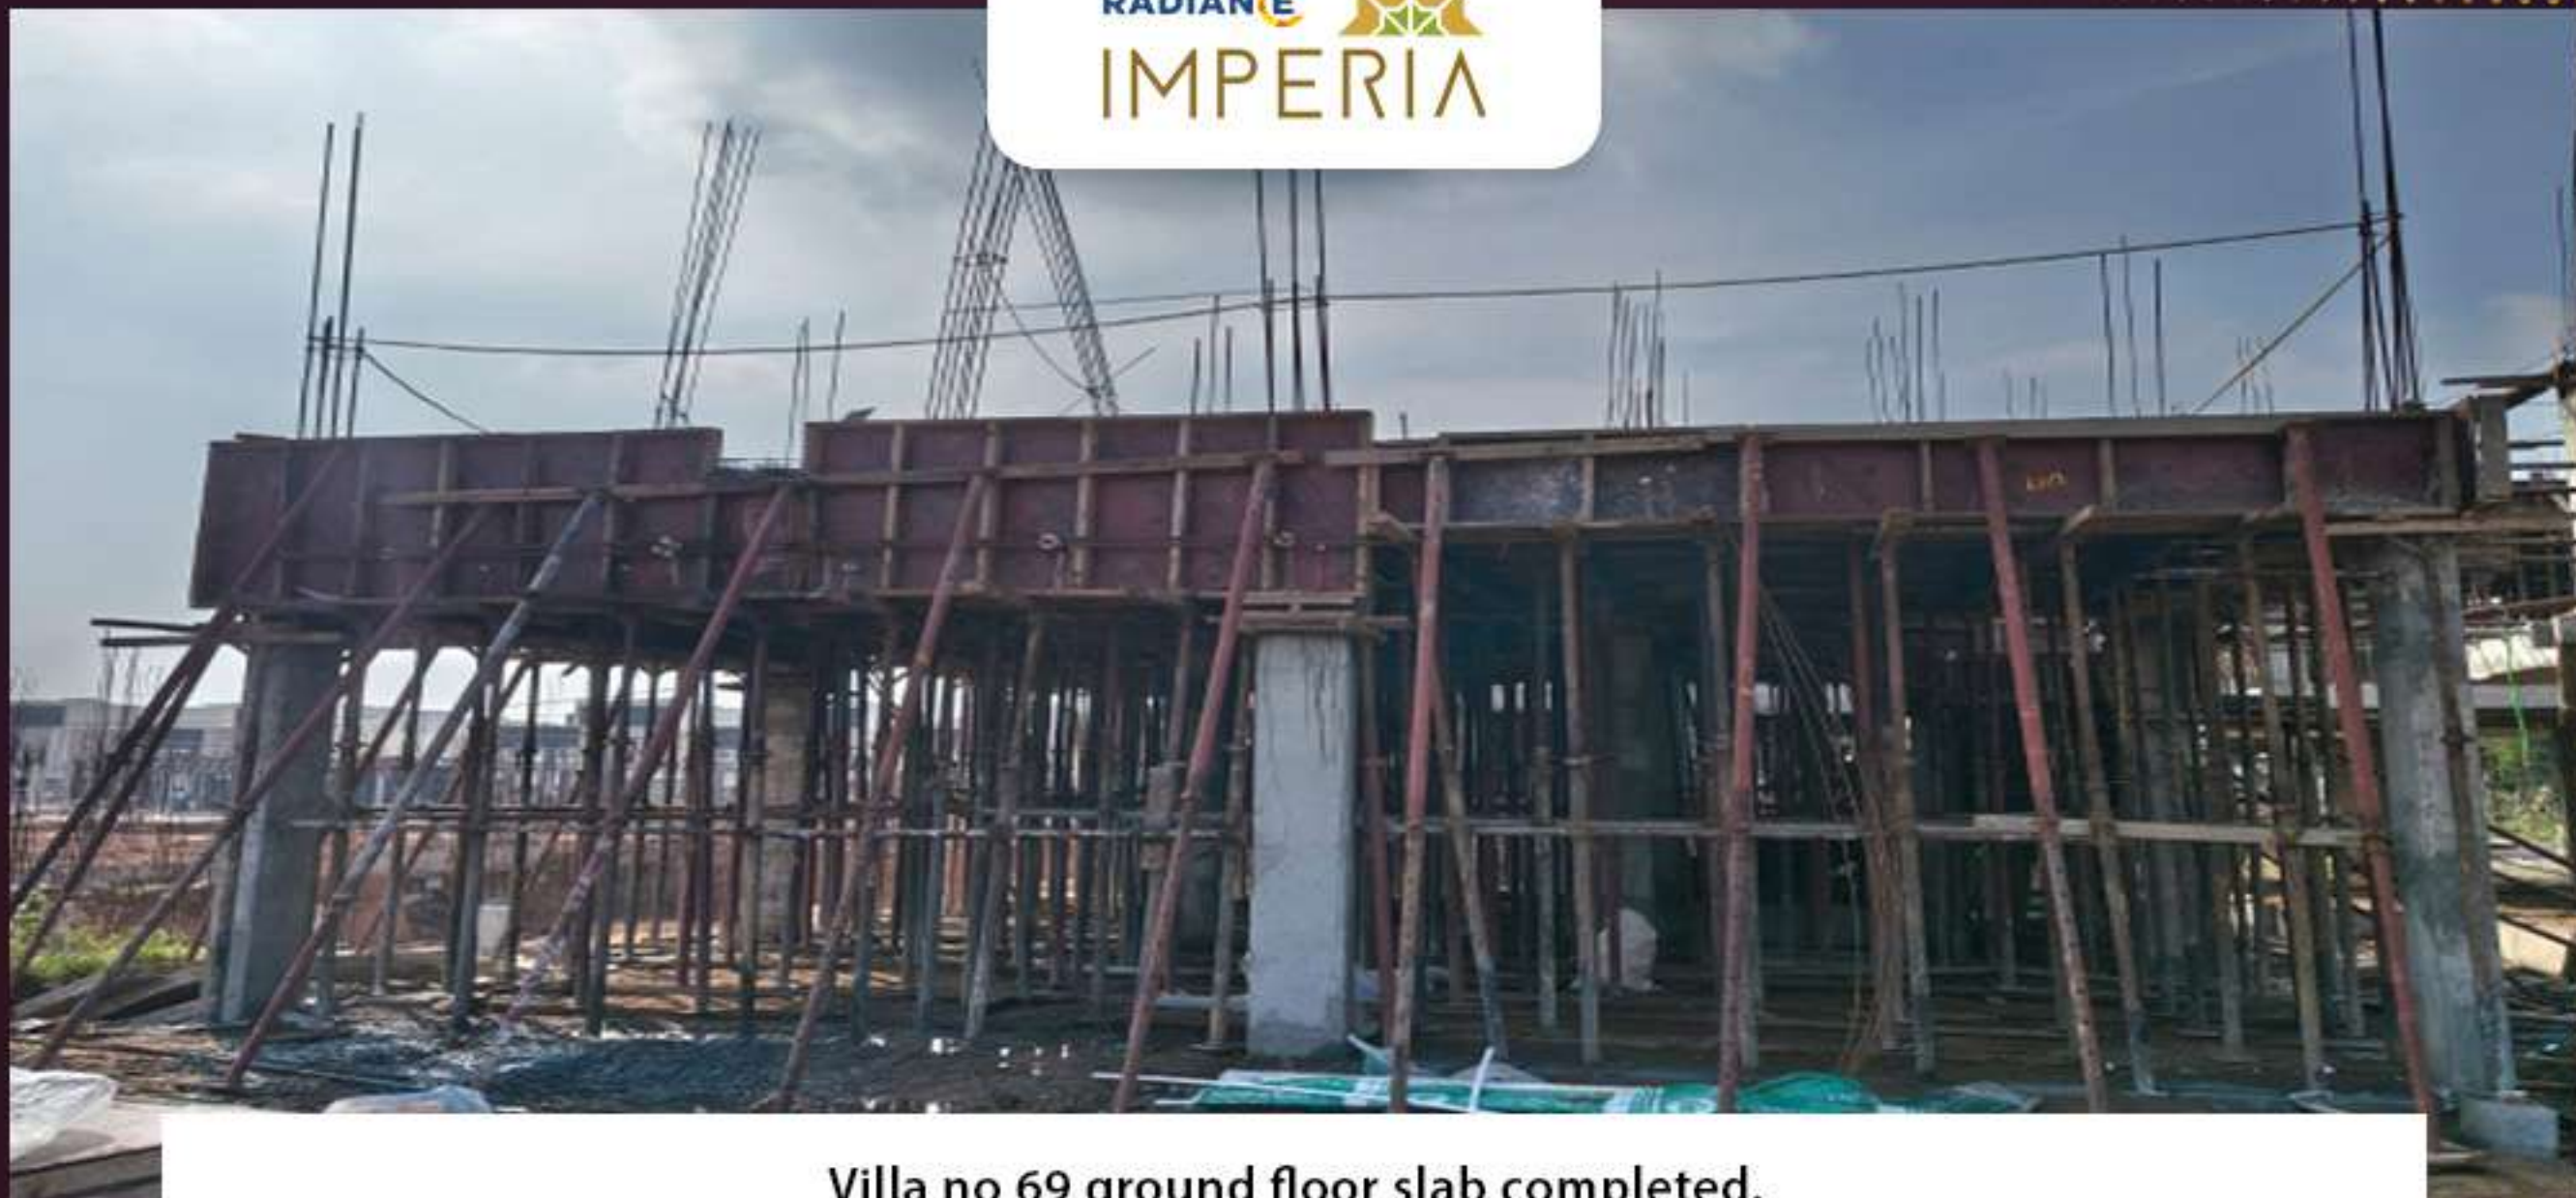
Villa no 69 ground floor slab completed.

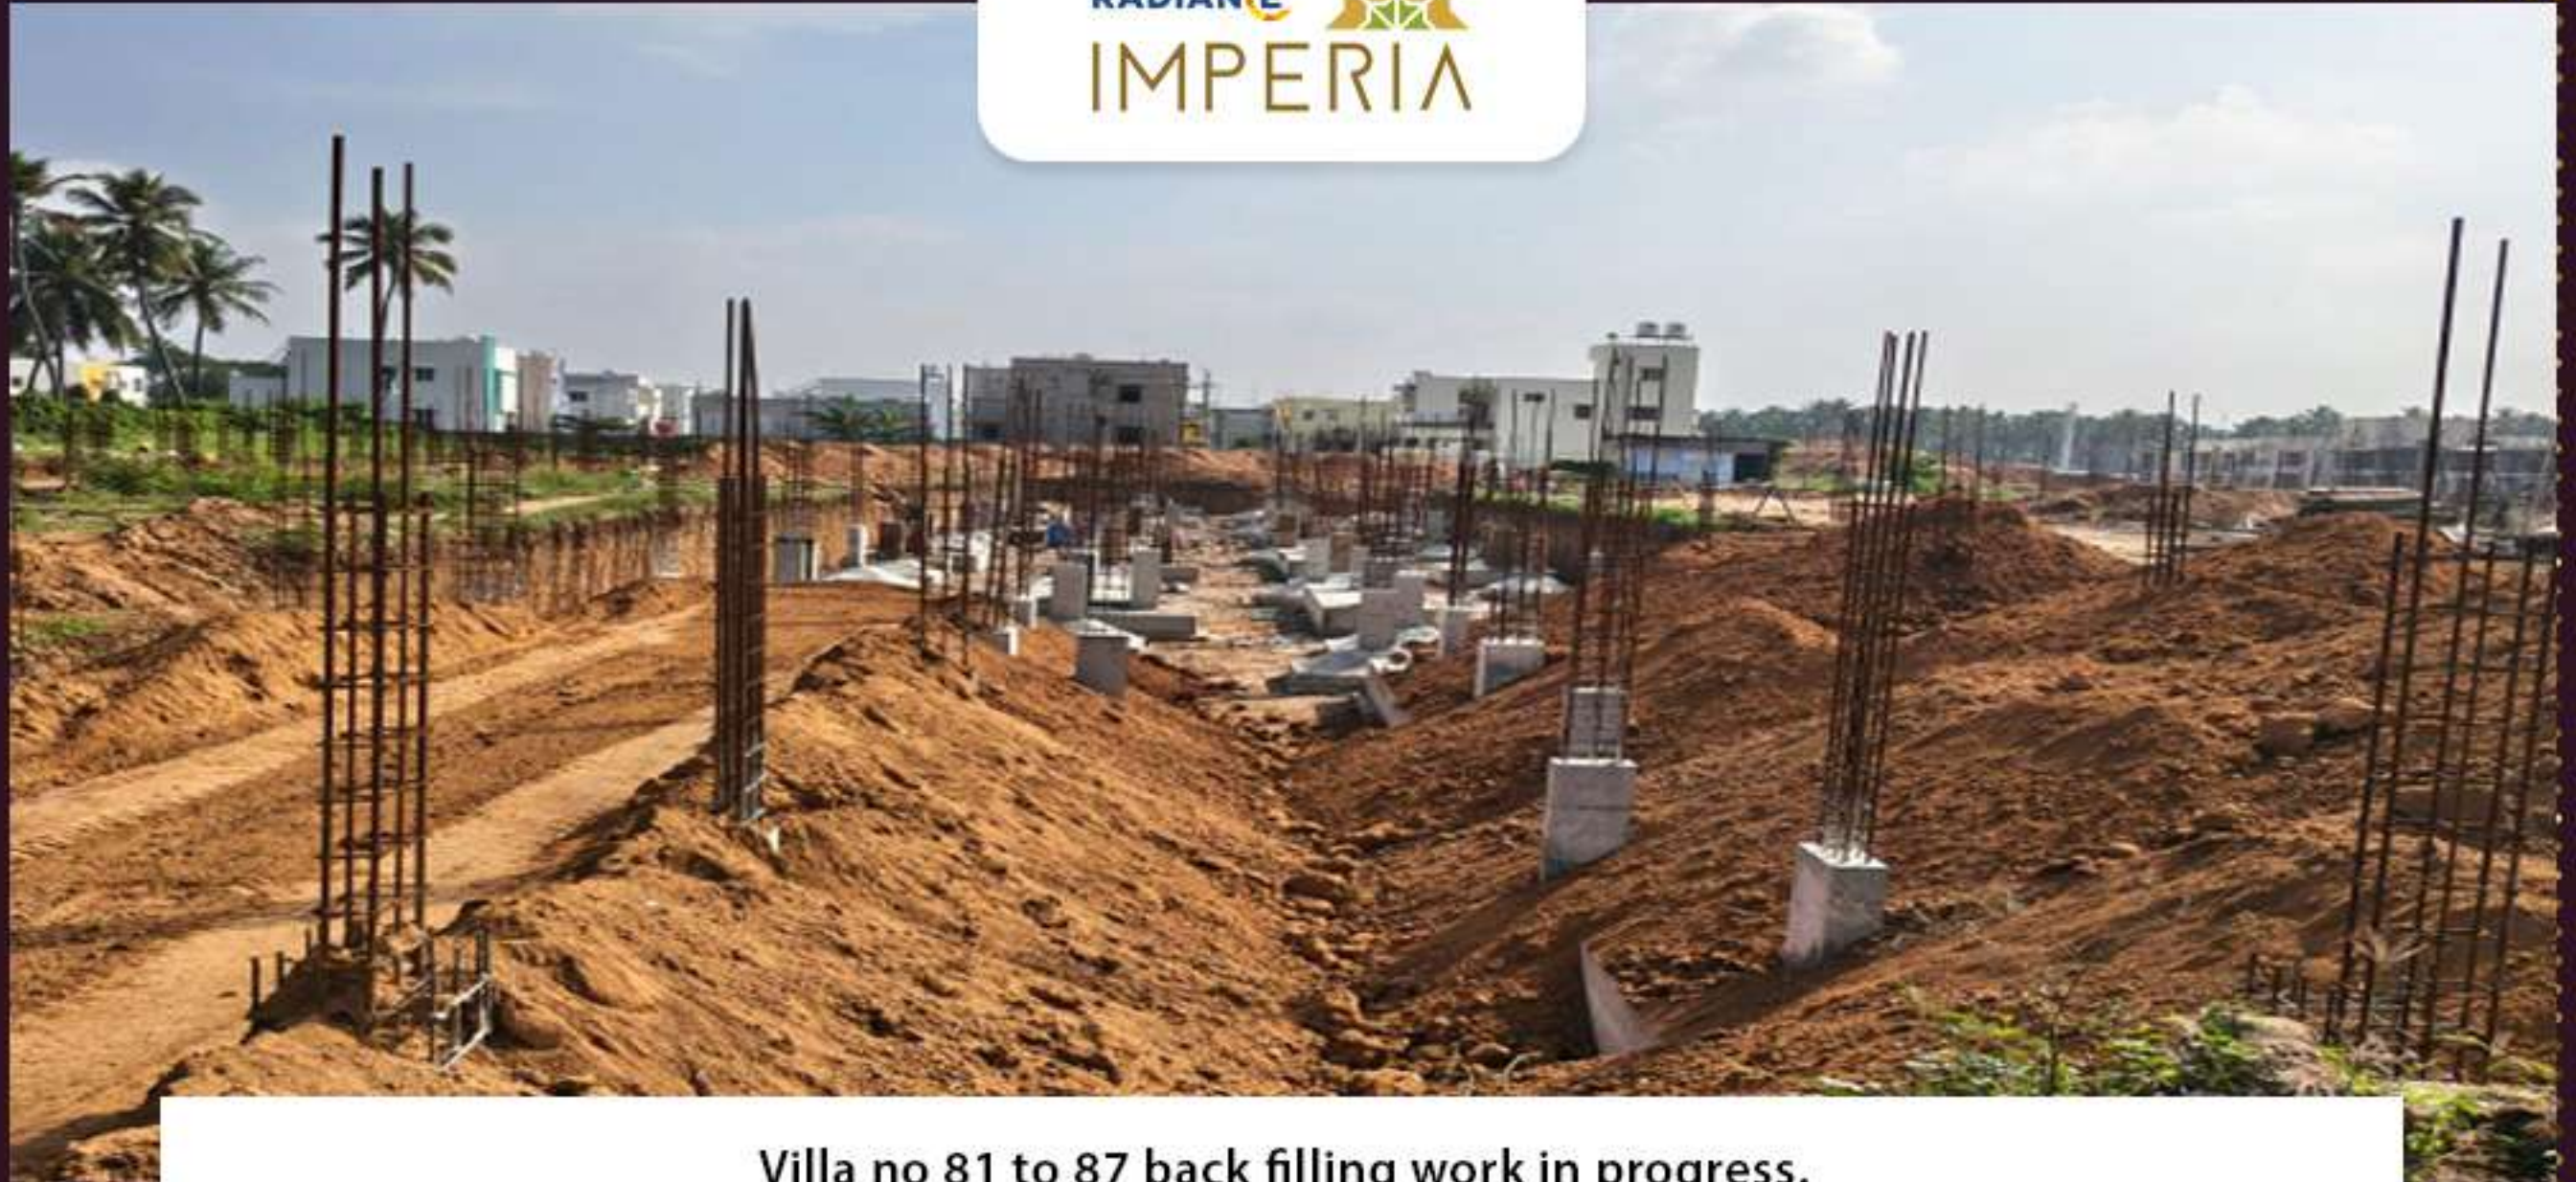
Villa no 81 to 87 back filling work in progress.
