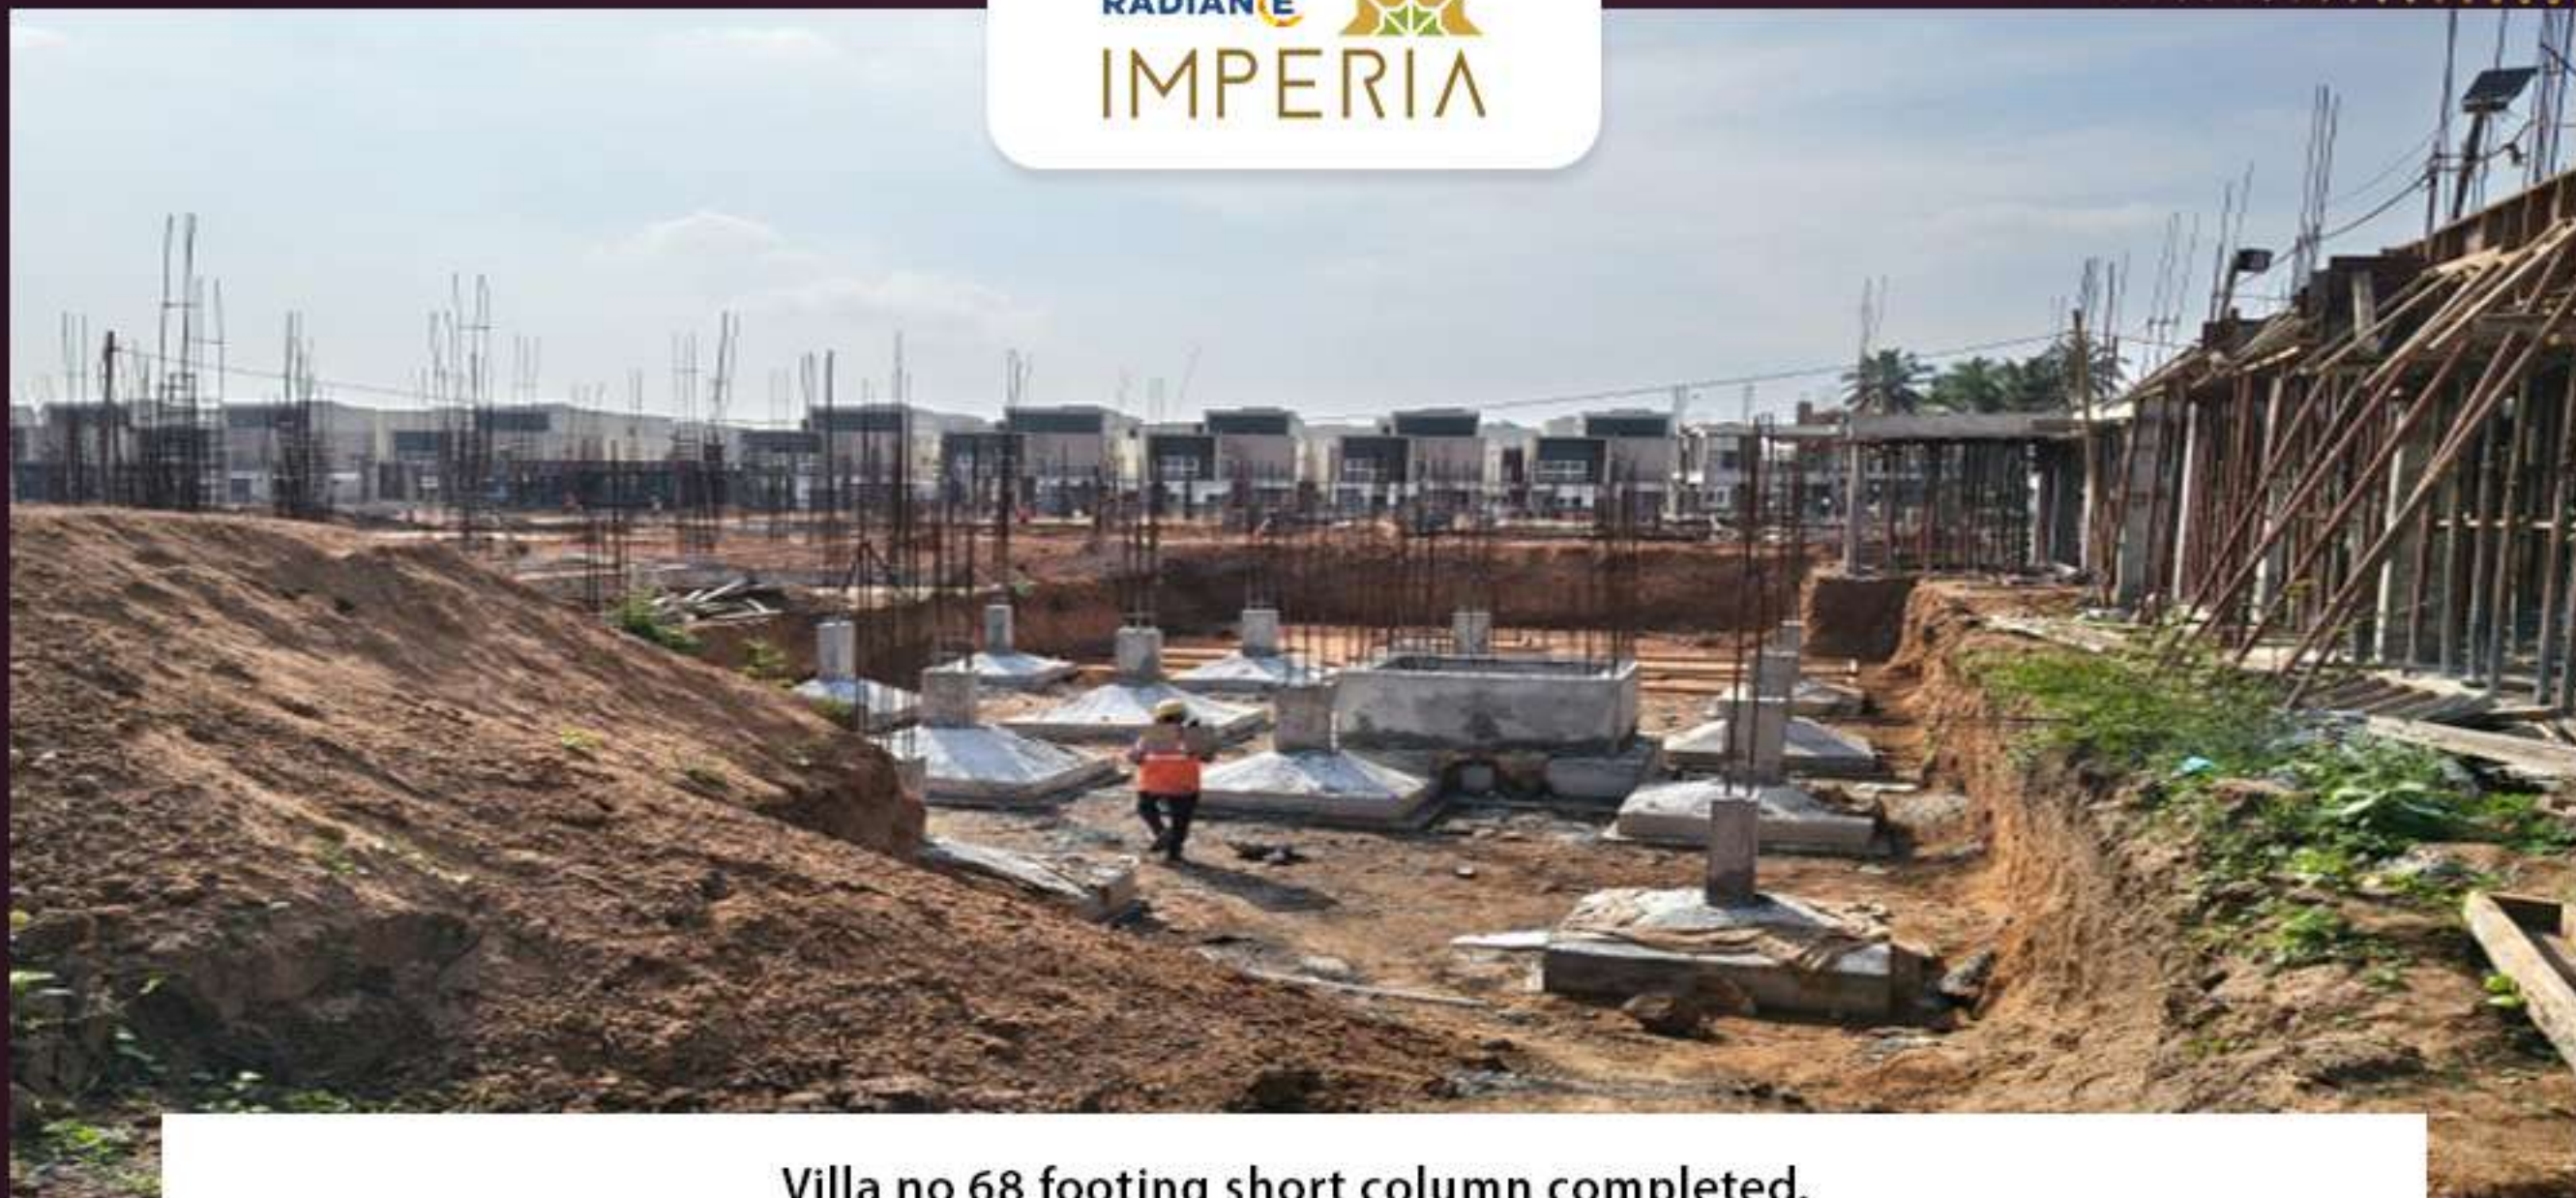
Villa no 68 footing short column completed.

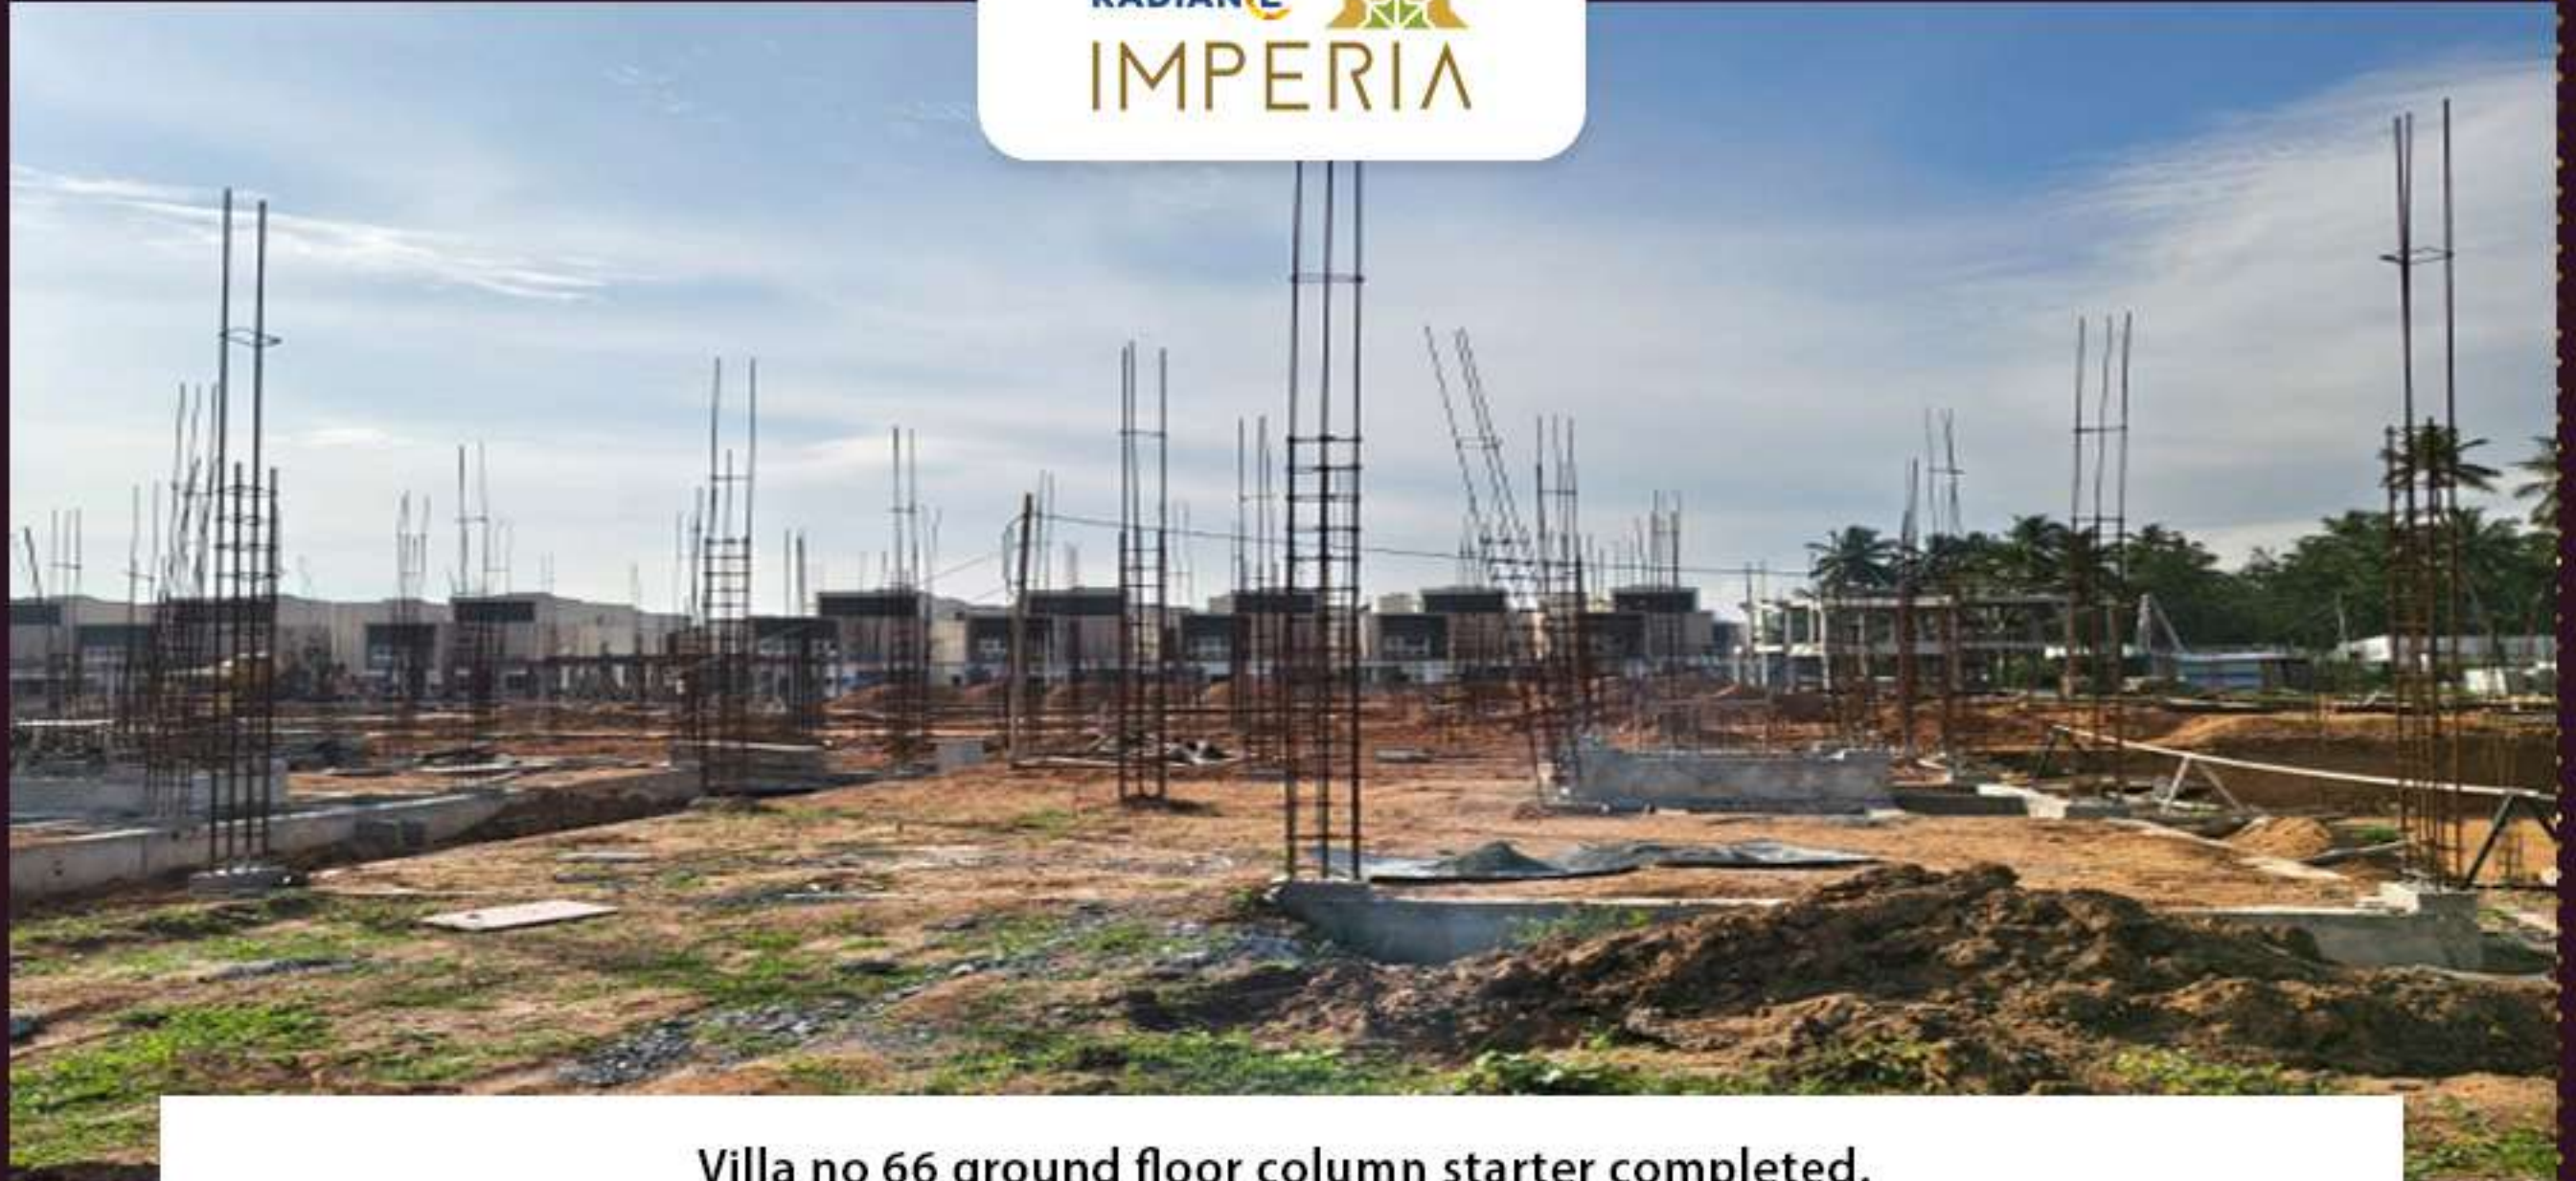
Villa no 66 ground floor column starter completed.

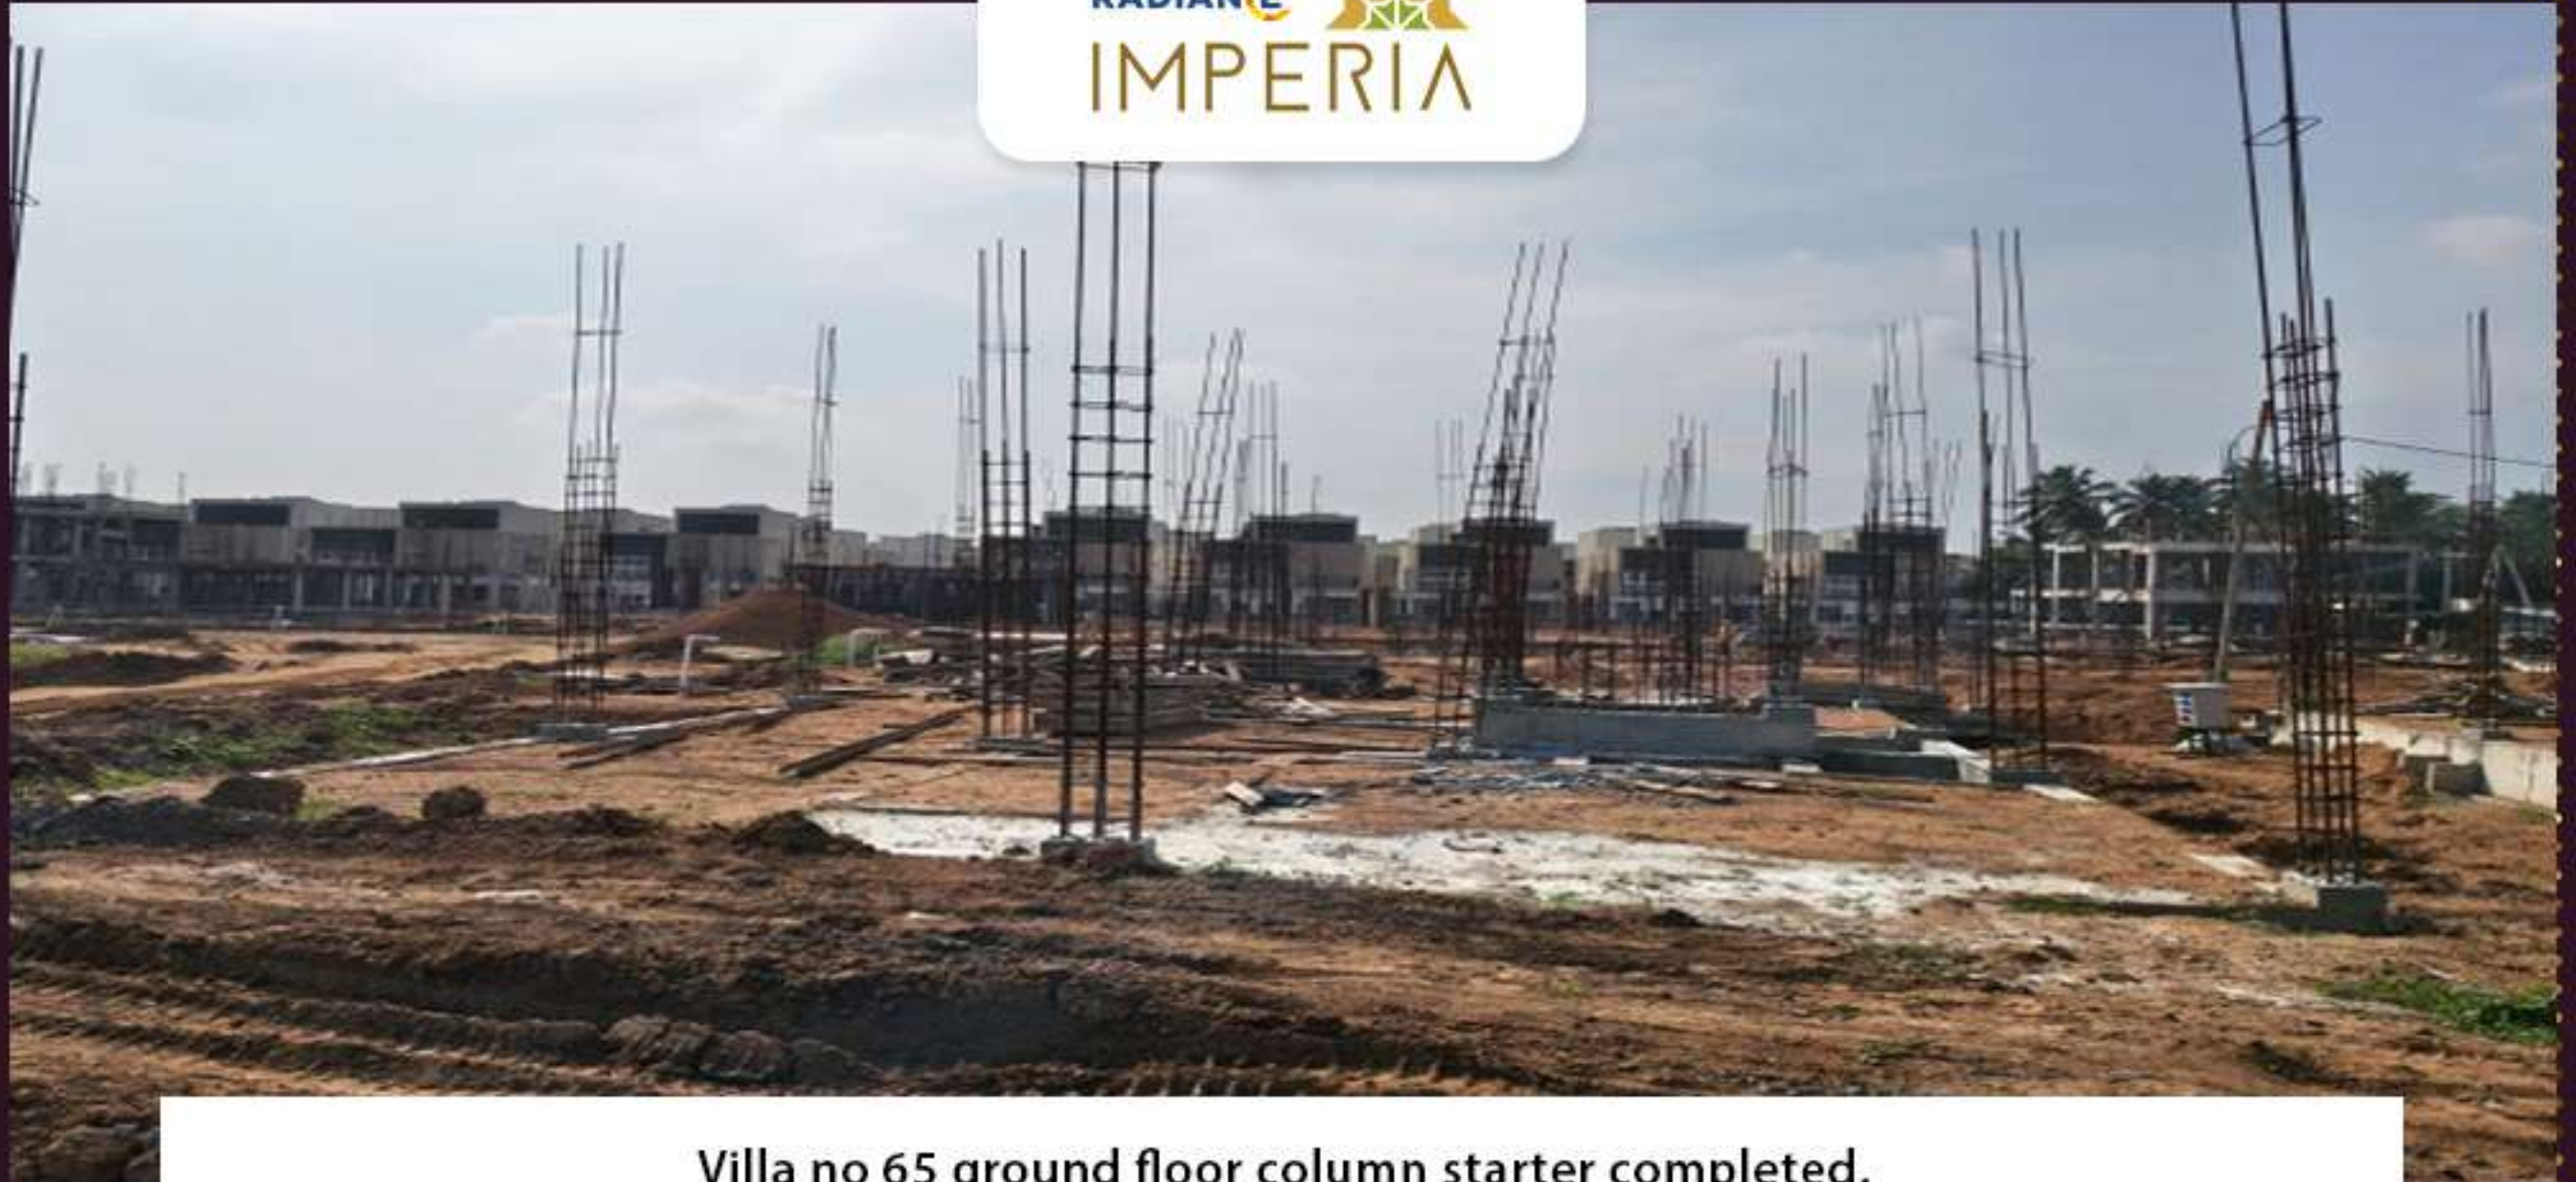
Villa no 65 ground floor column starter completed.

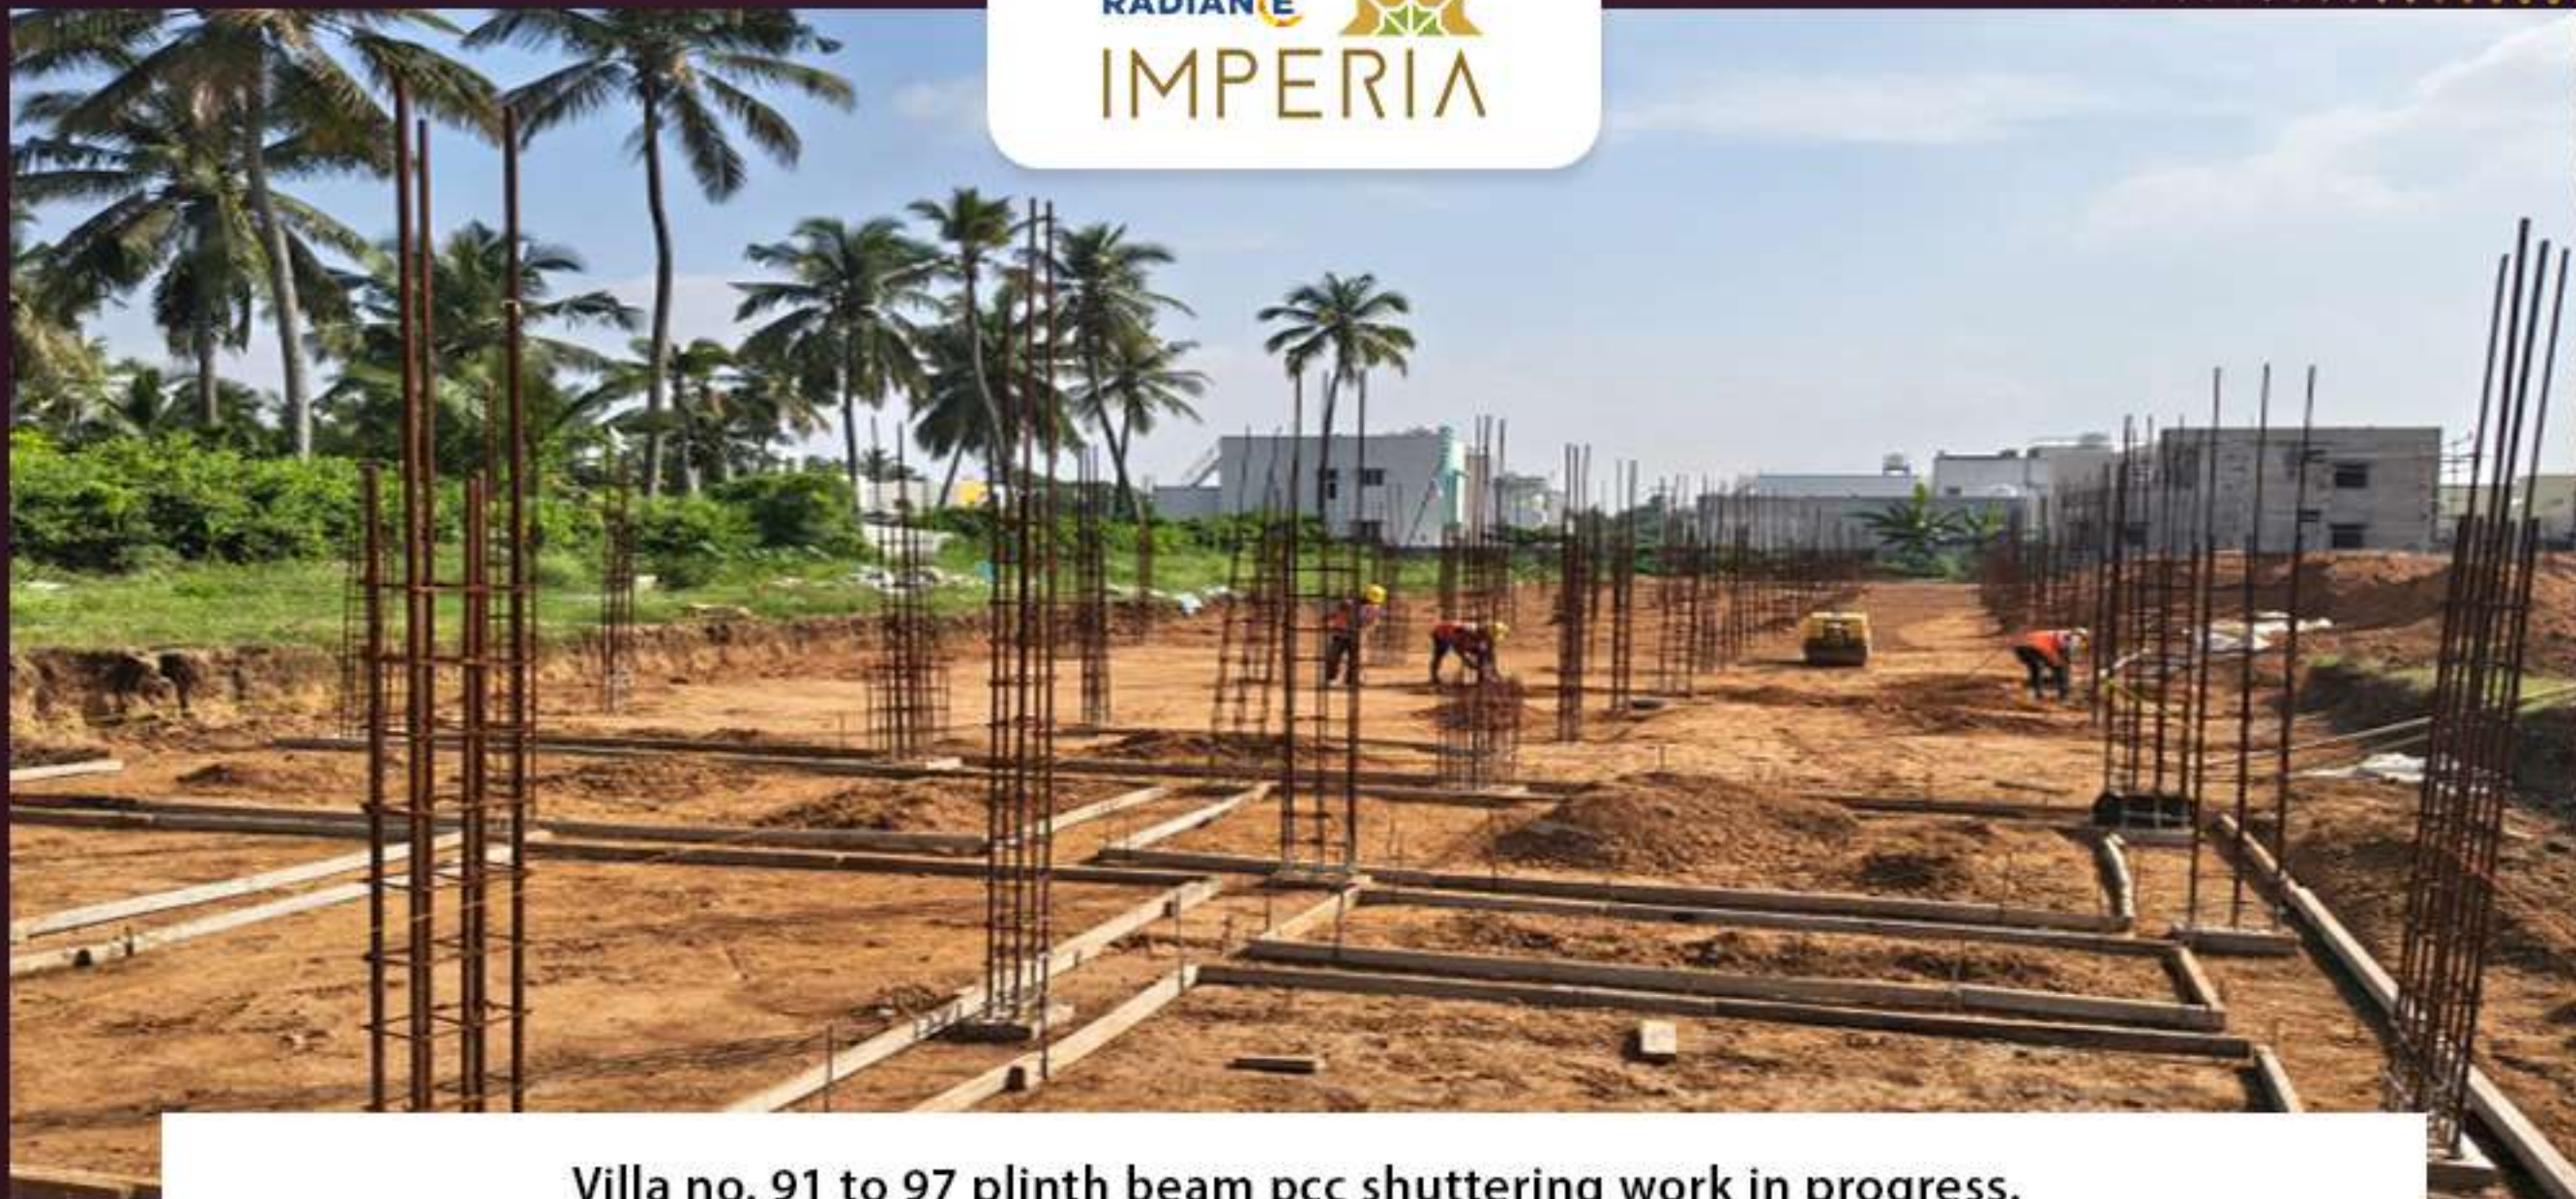
Villa no. 91 to 97 plinth beam pcc shuttering work in progress.

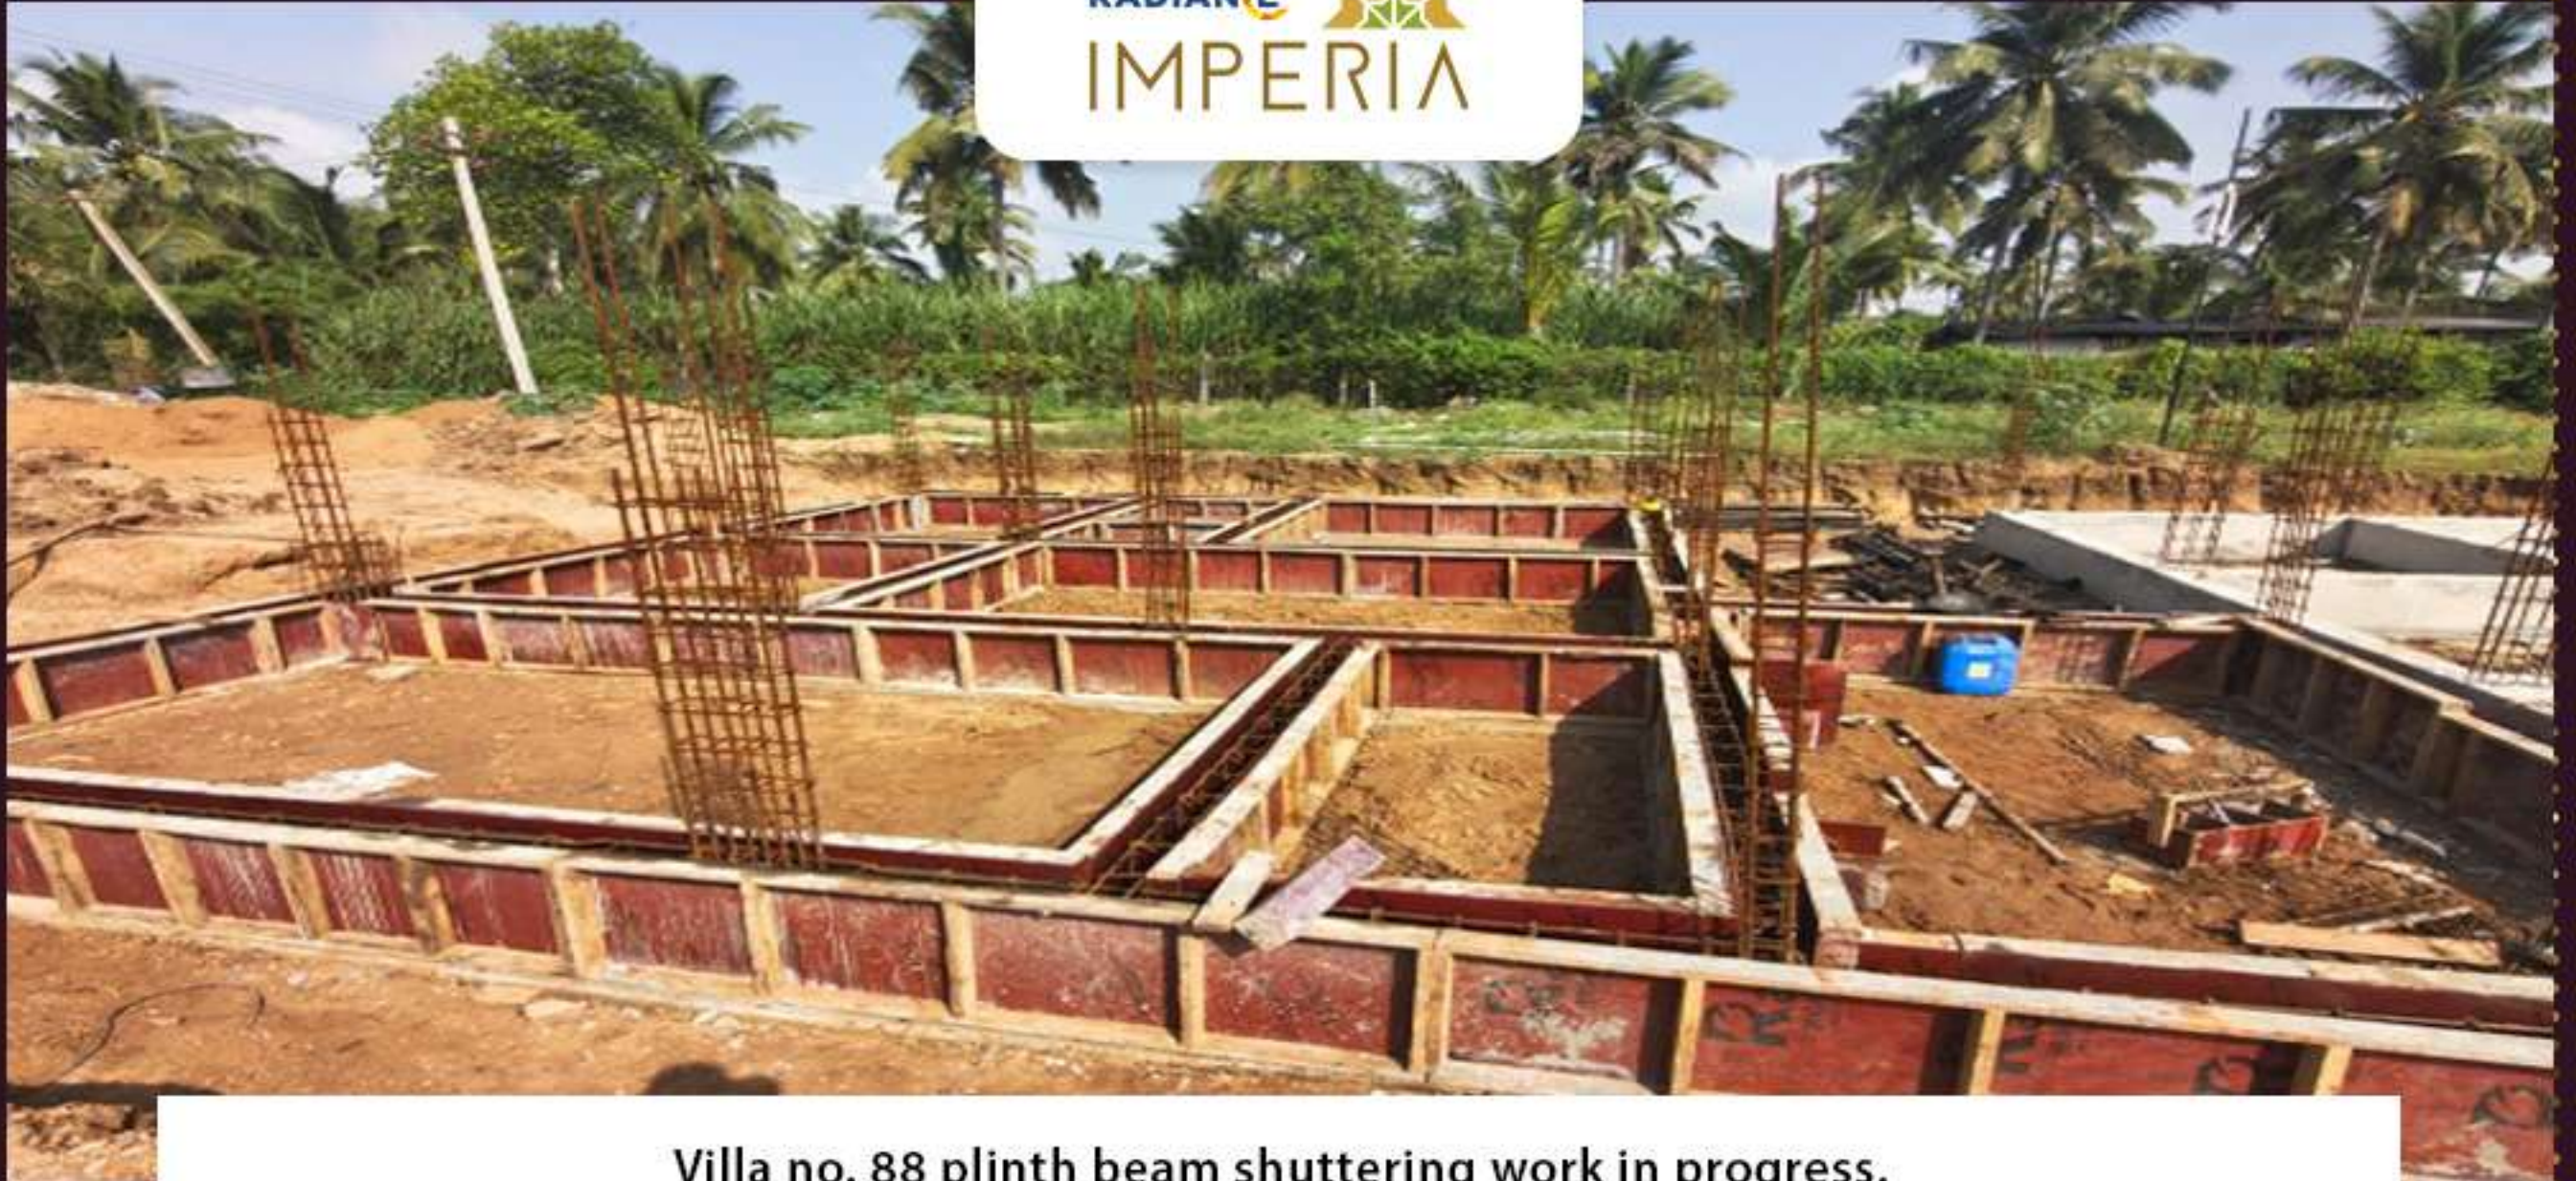
Villa no. 88 plinth beam shuttering work in progress.

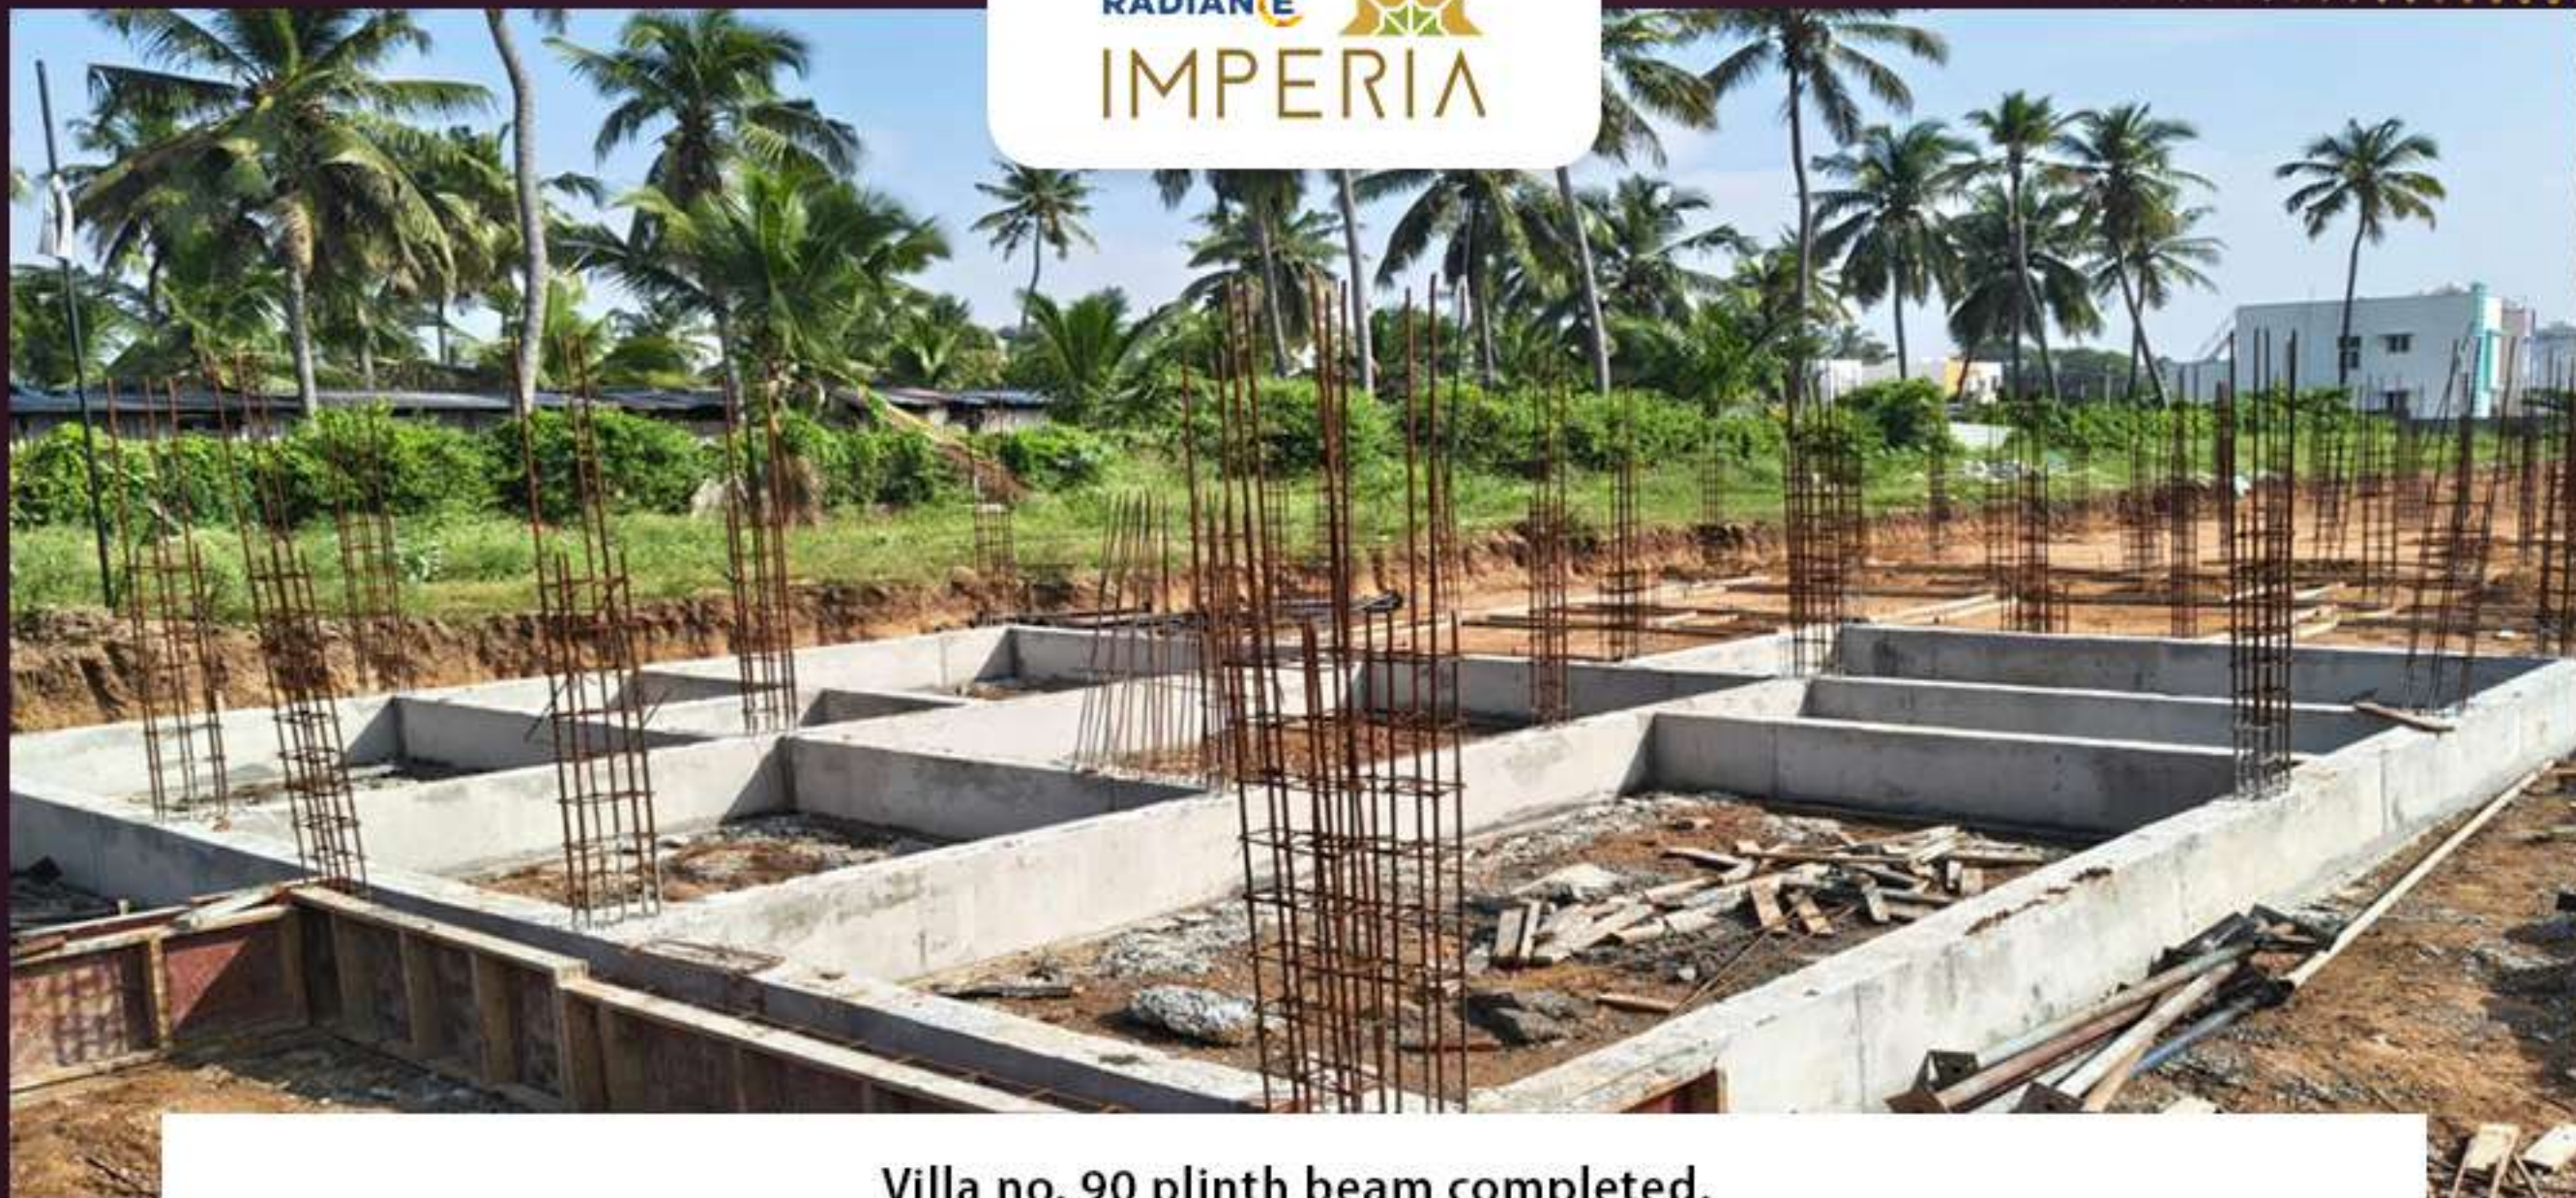
Villa no. 90 plinth beam completed.
