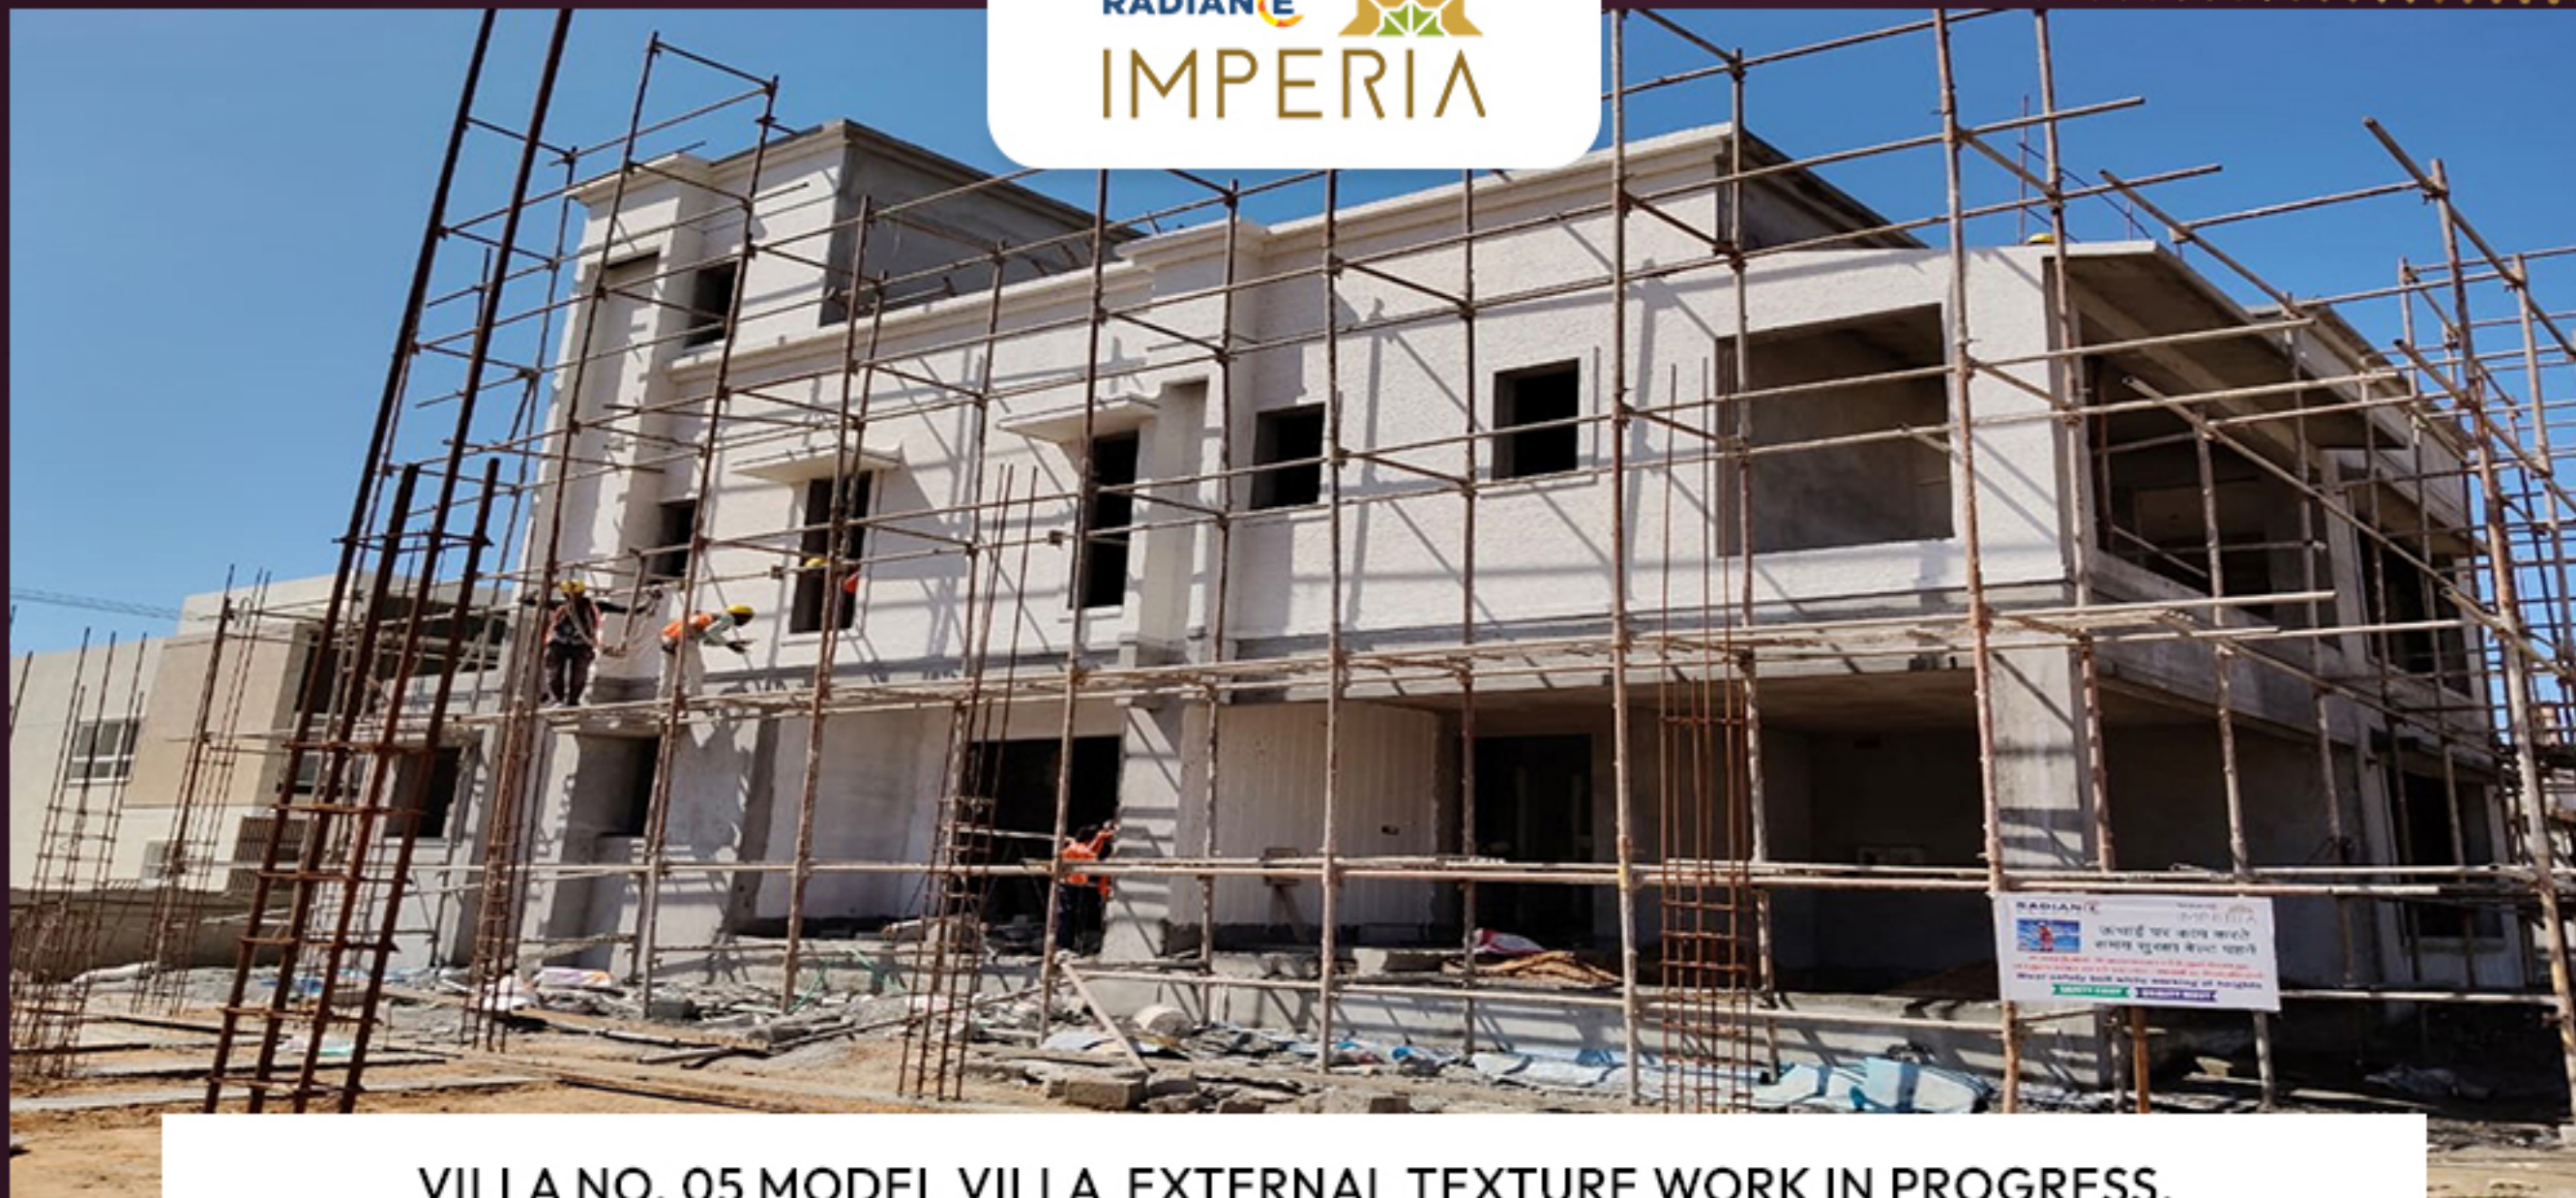
VILLA NO. 05 MODEL VILLA EXTERNAL TEXTURE WORK IN PROGRESS.

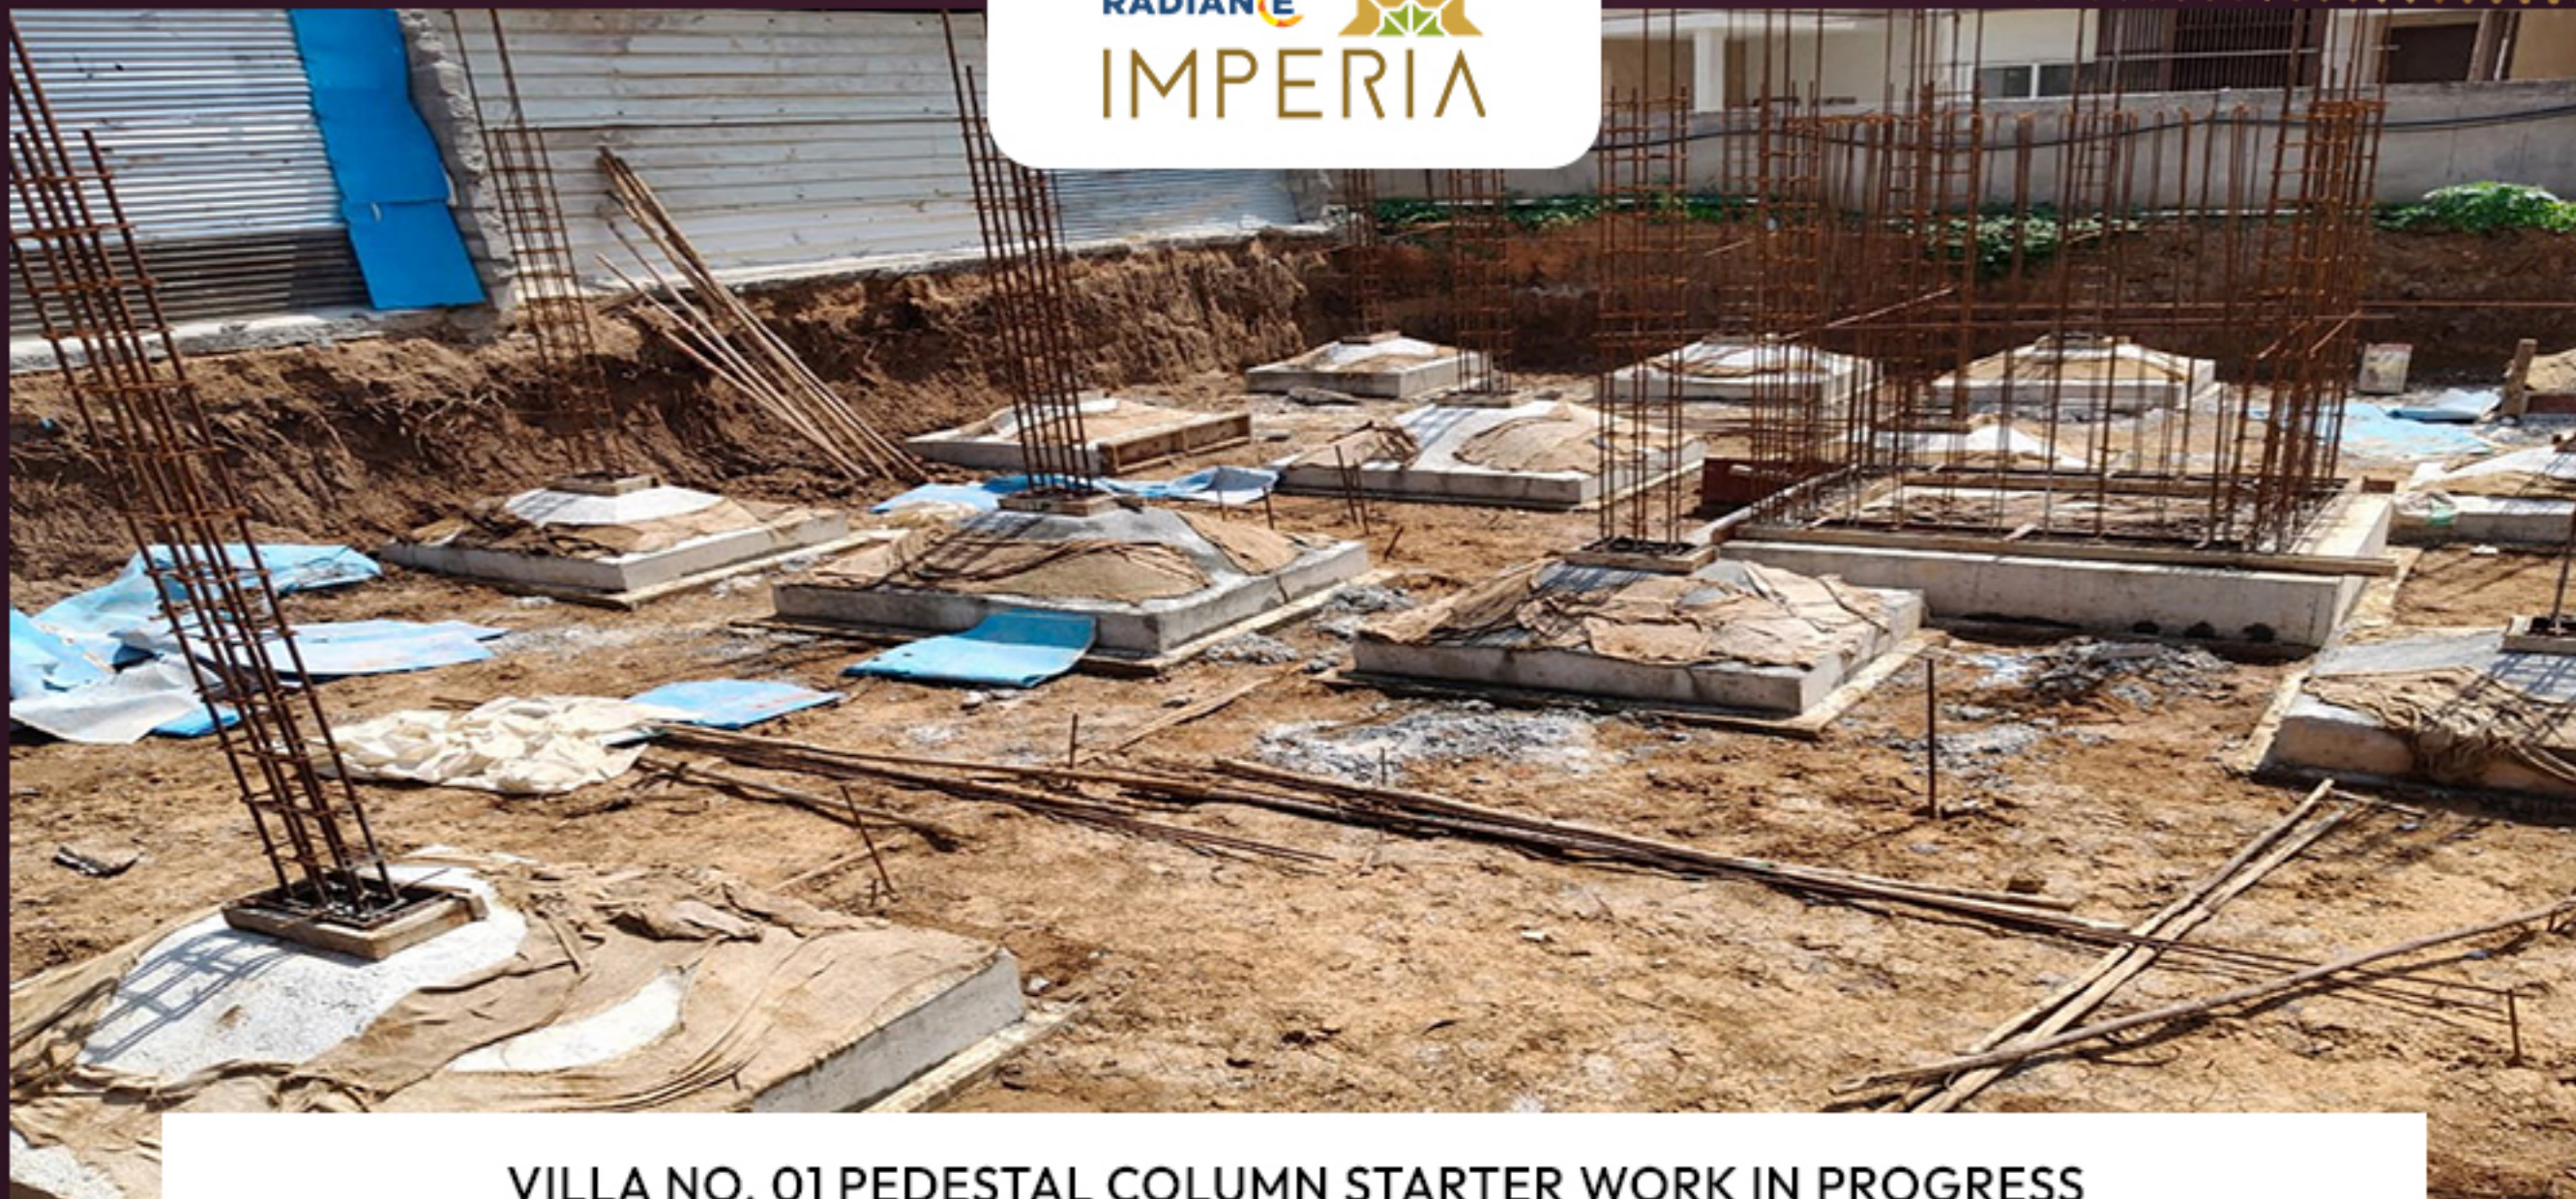
VILLA NO. 01 PEDESTAL COLUMN STARTER WORK IN PROGRESS

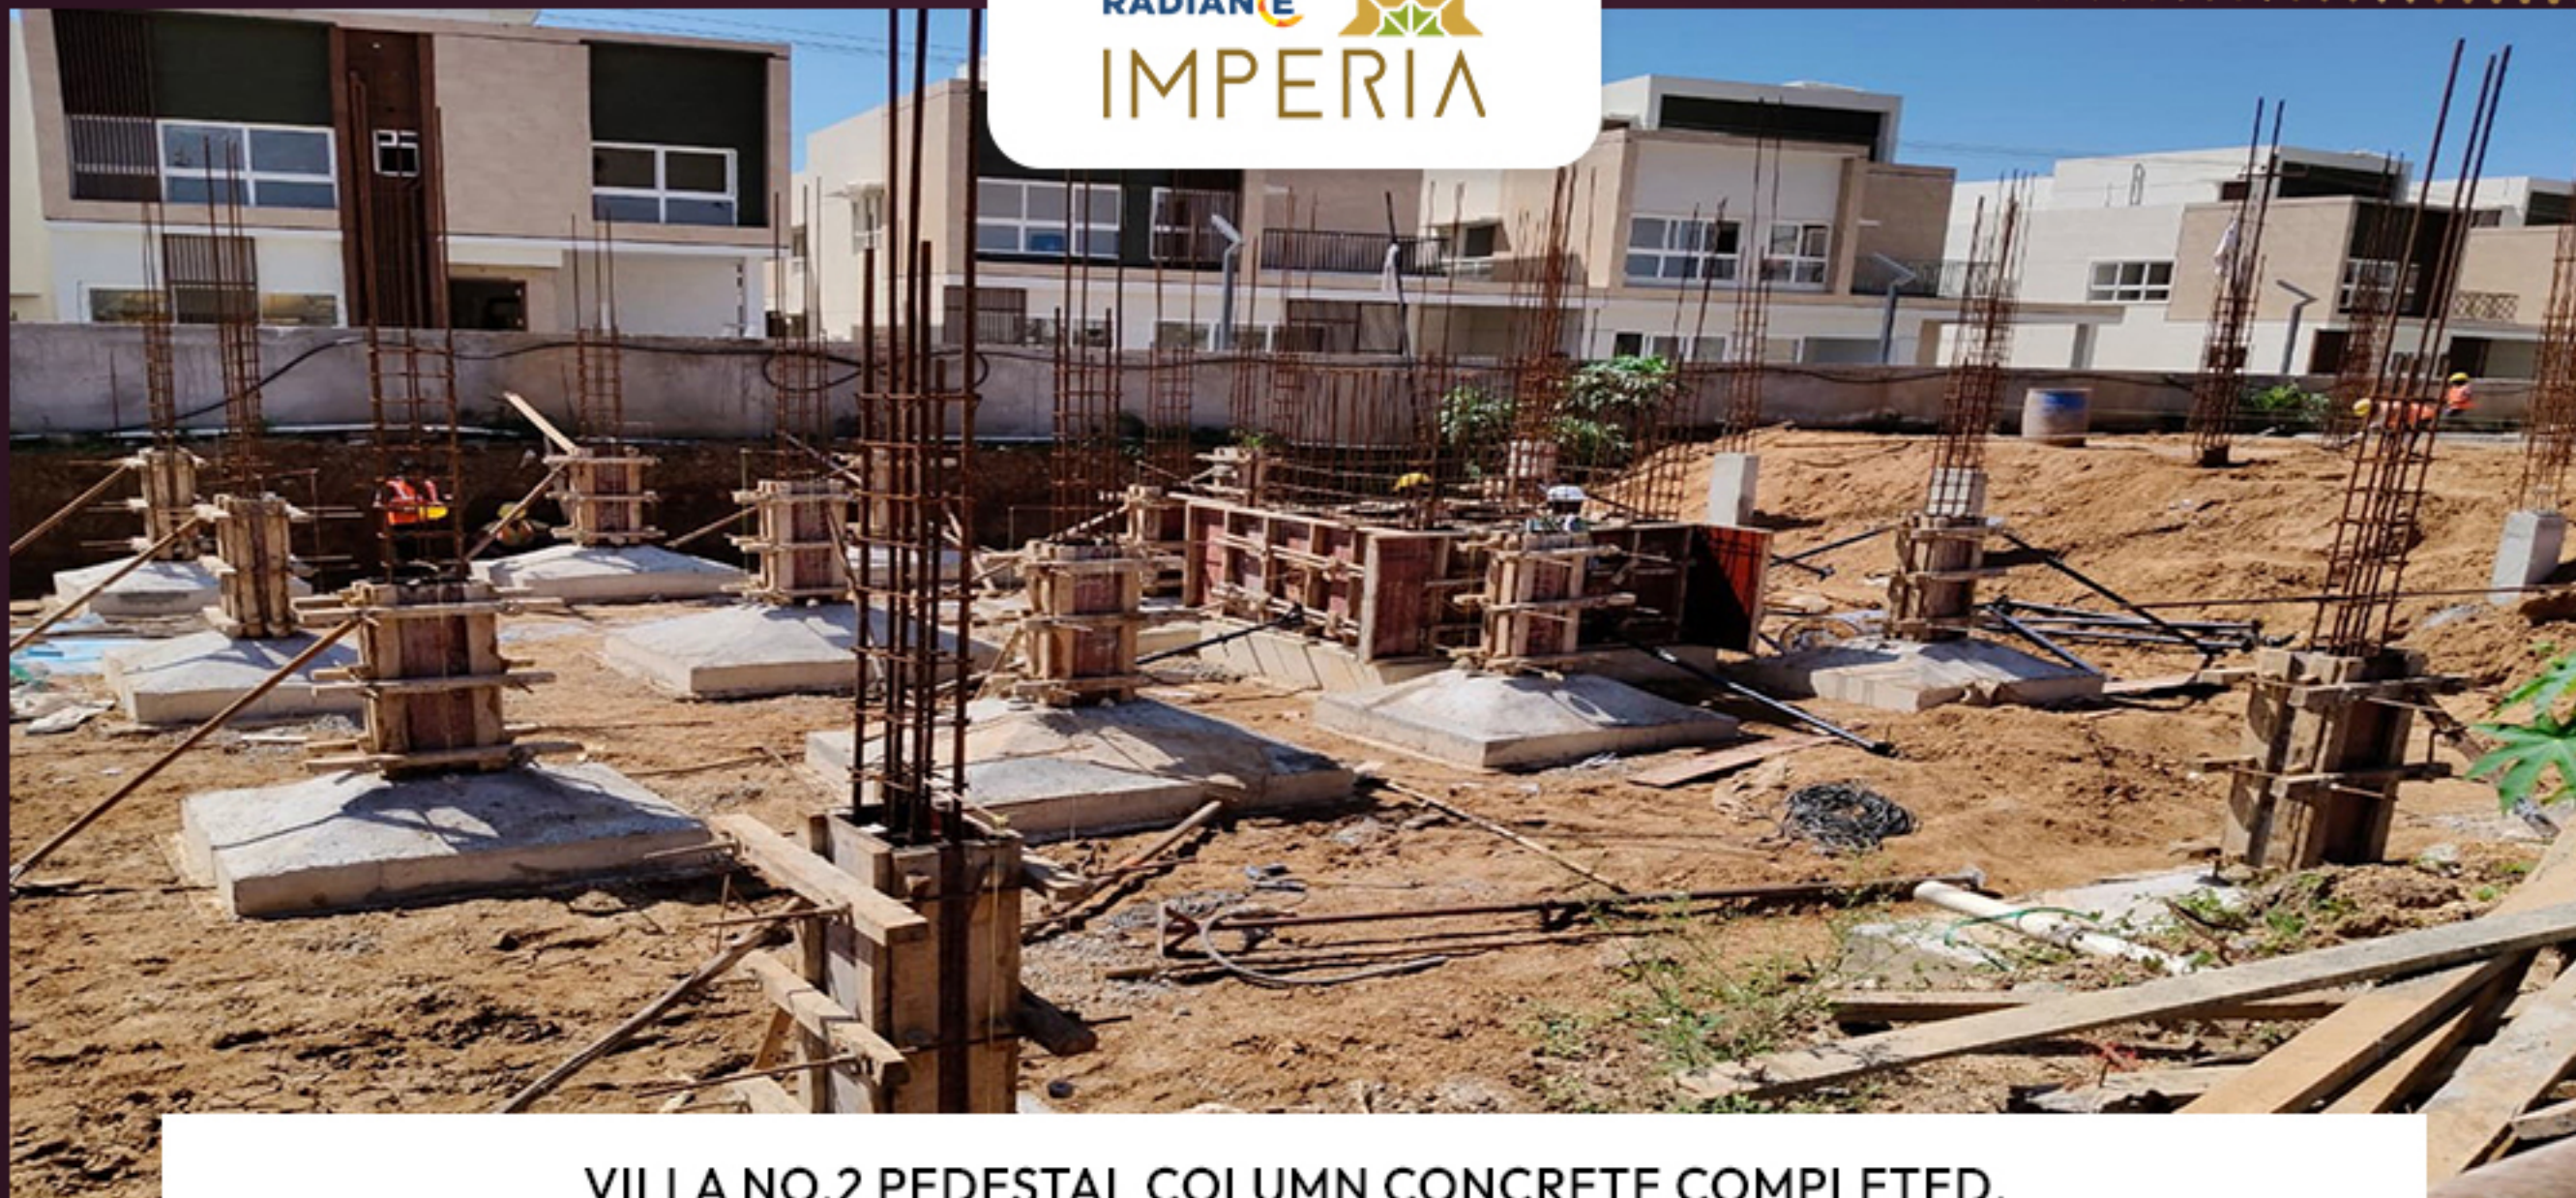
VILLA NO.2 PEDESTAL COLUMN CONCRETE COMPLETED.

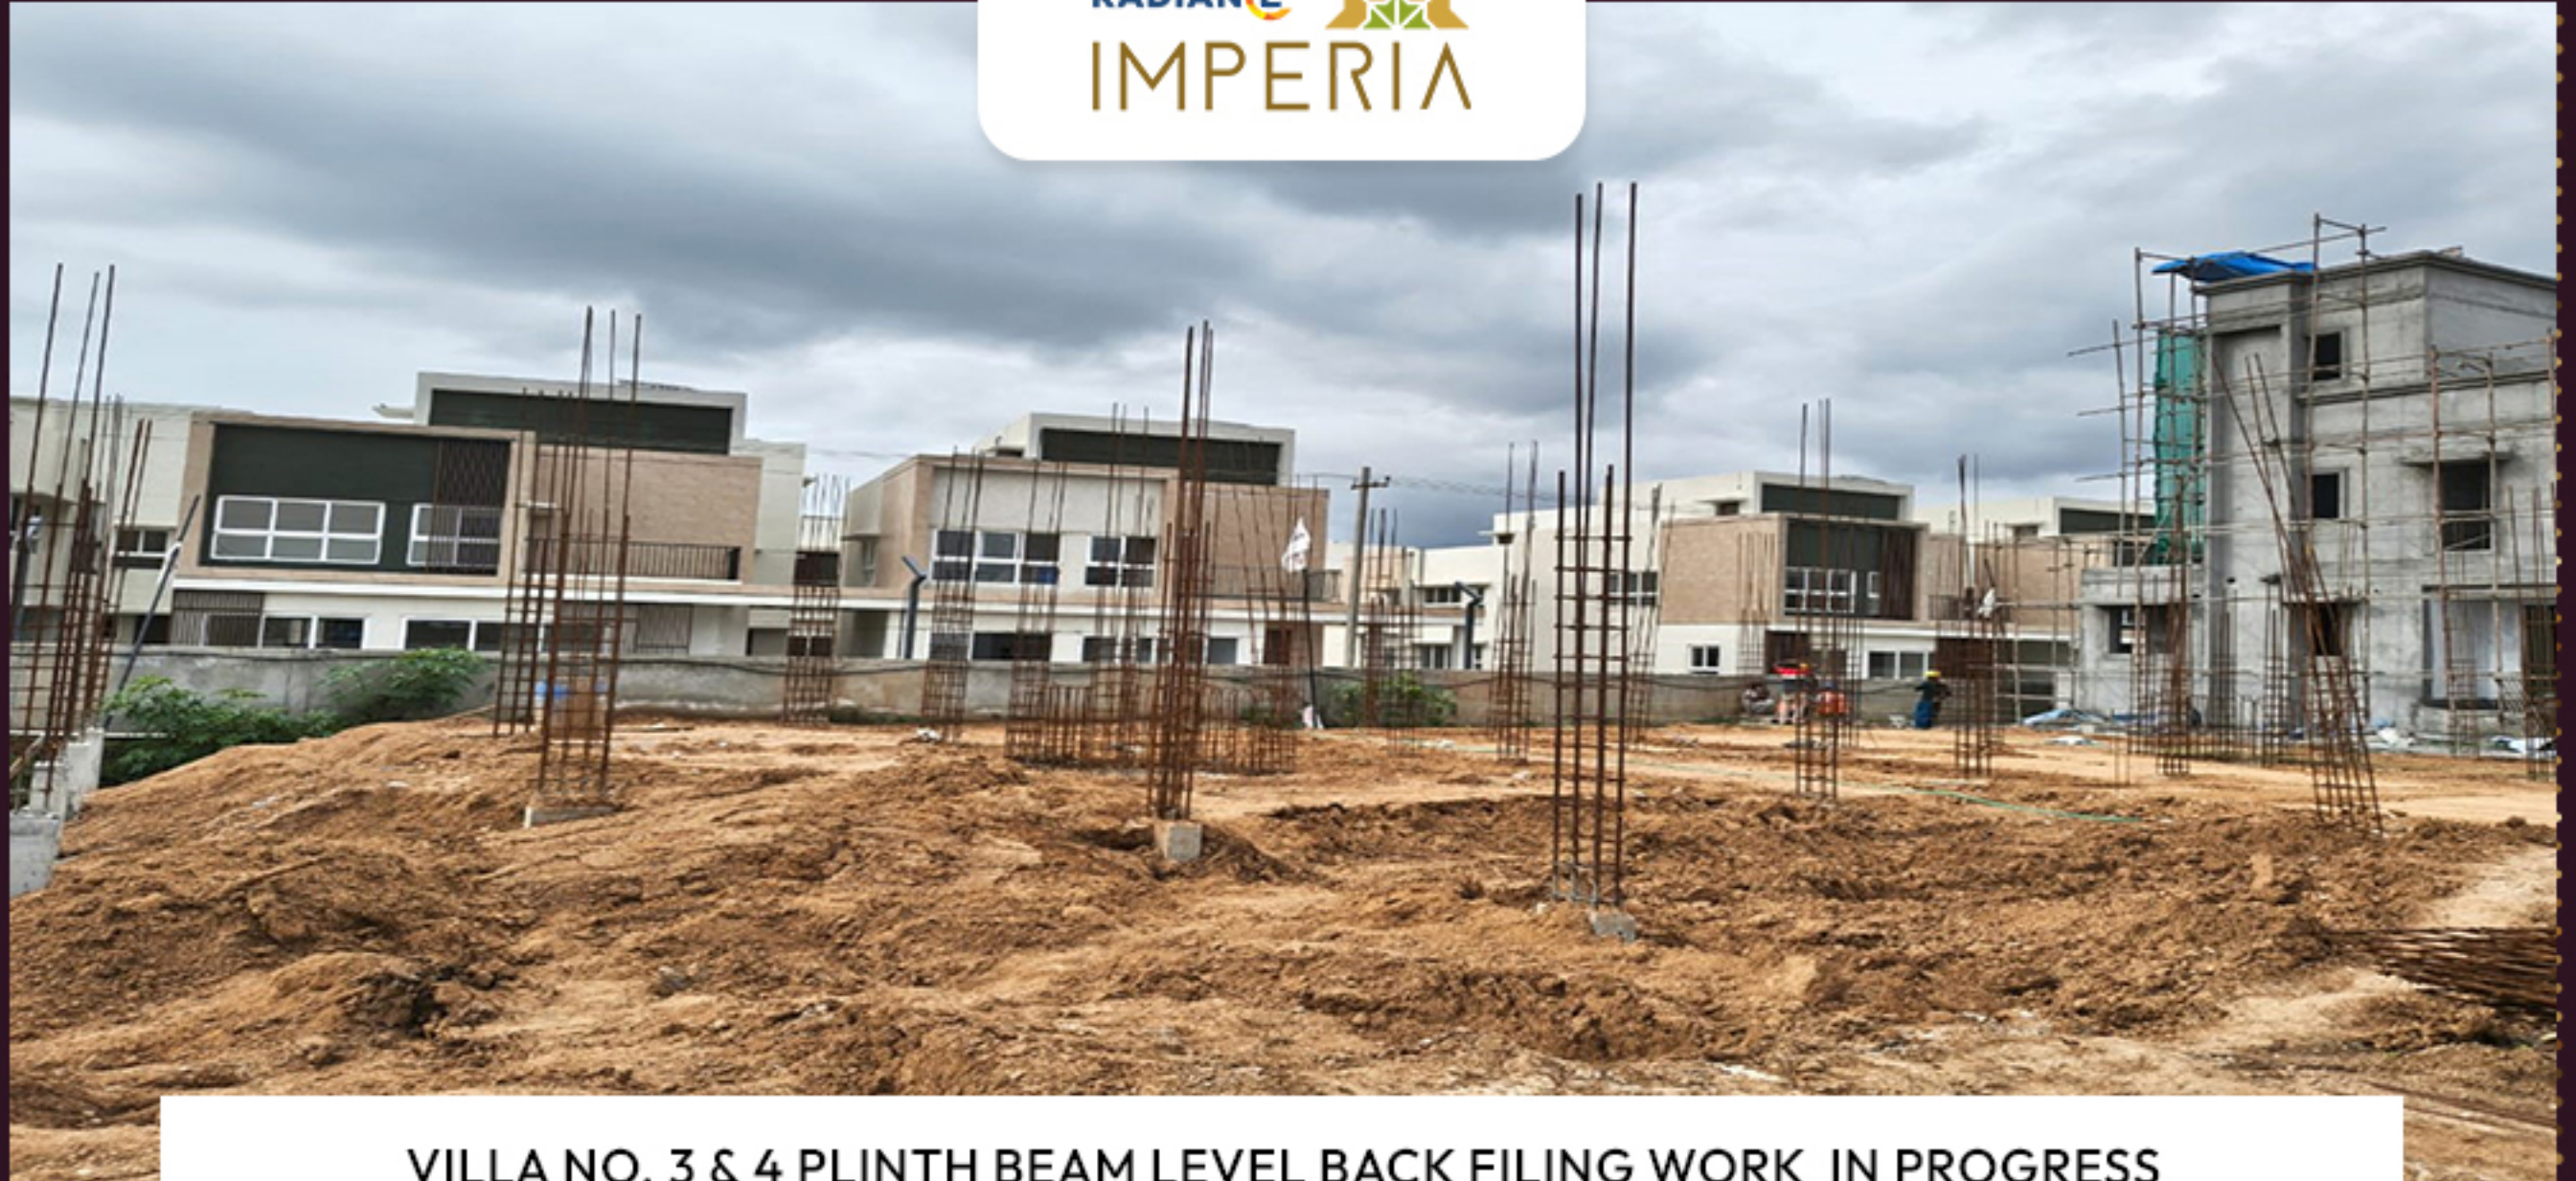
VILLA NO. 3 & 4 PLINTH BEAM LEVEL BACK FILING WORK IN PROGRESS

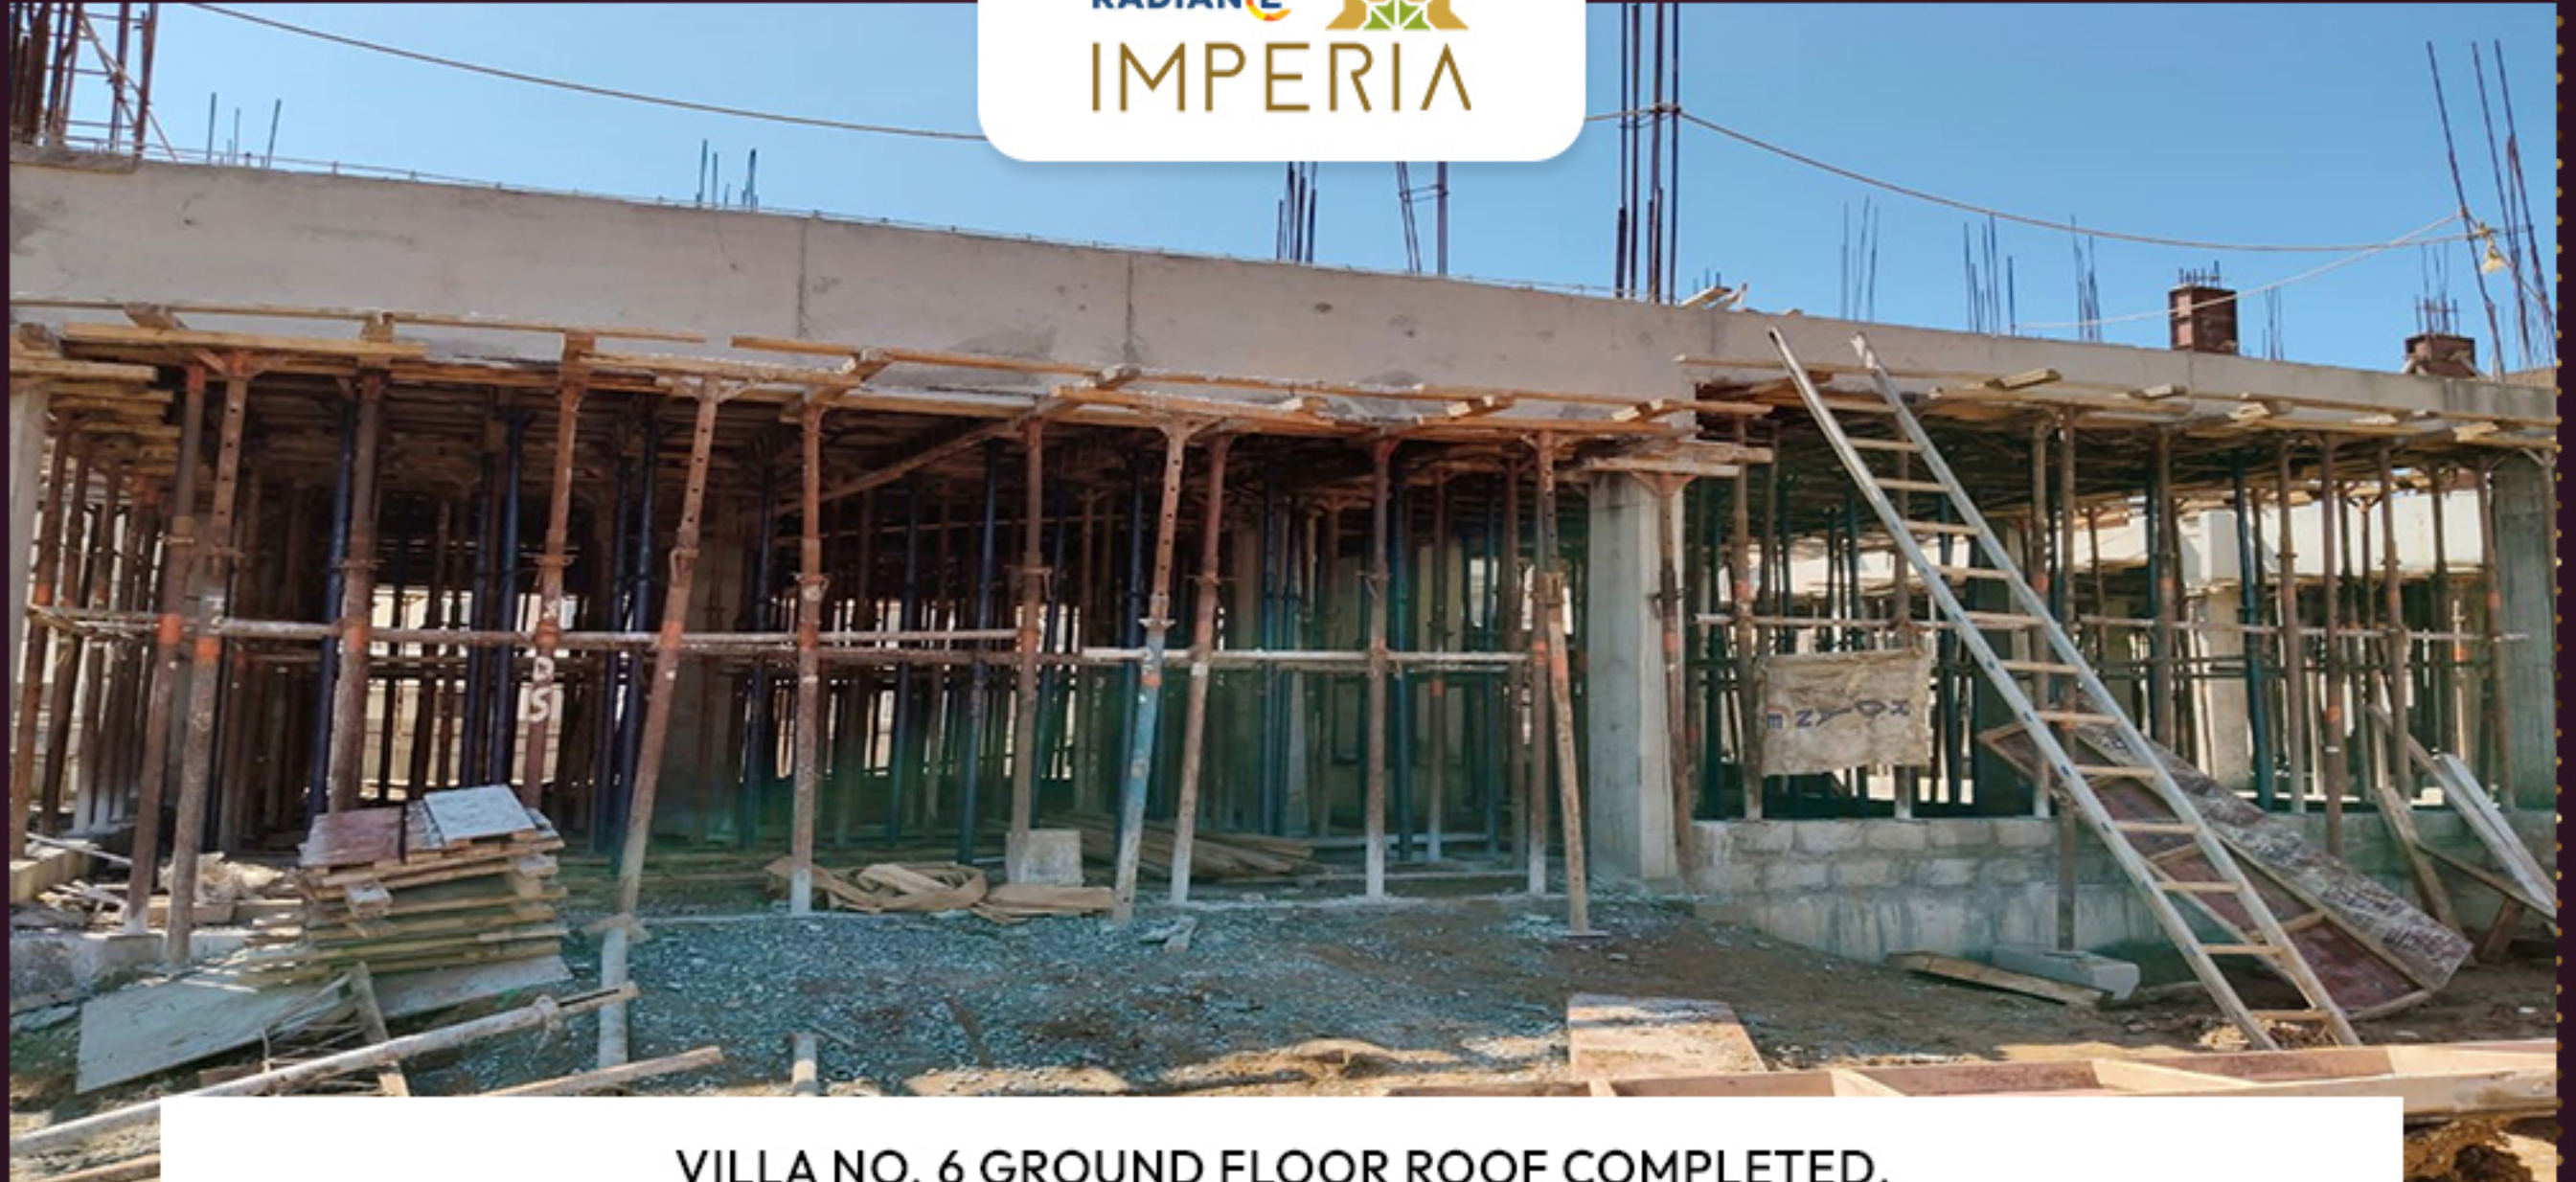
VILLA NO. 6 GROUND FLOOR ROOF COMPLETED.

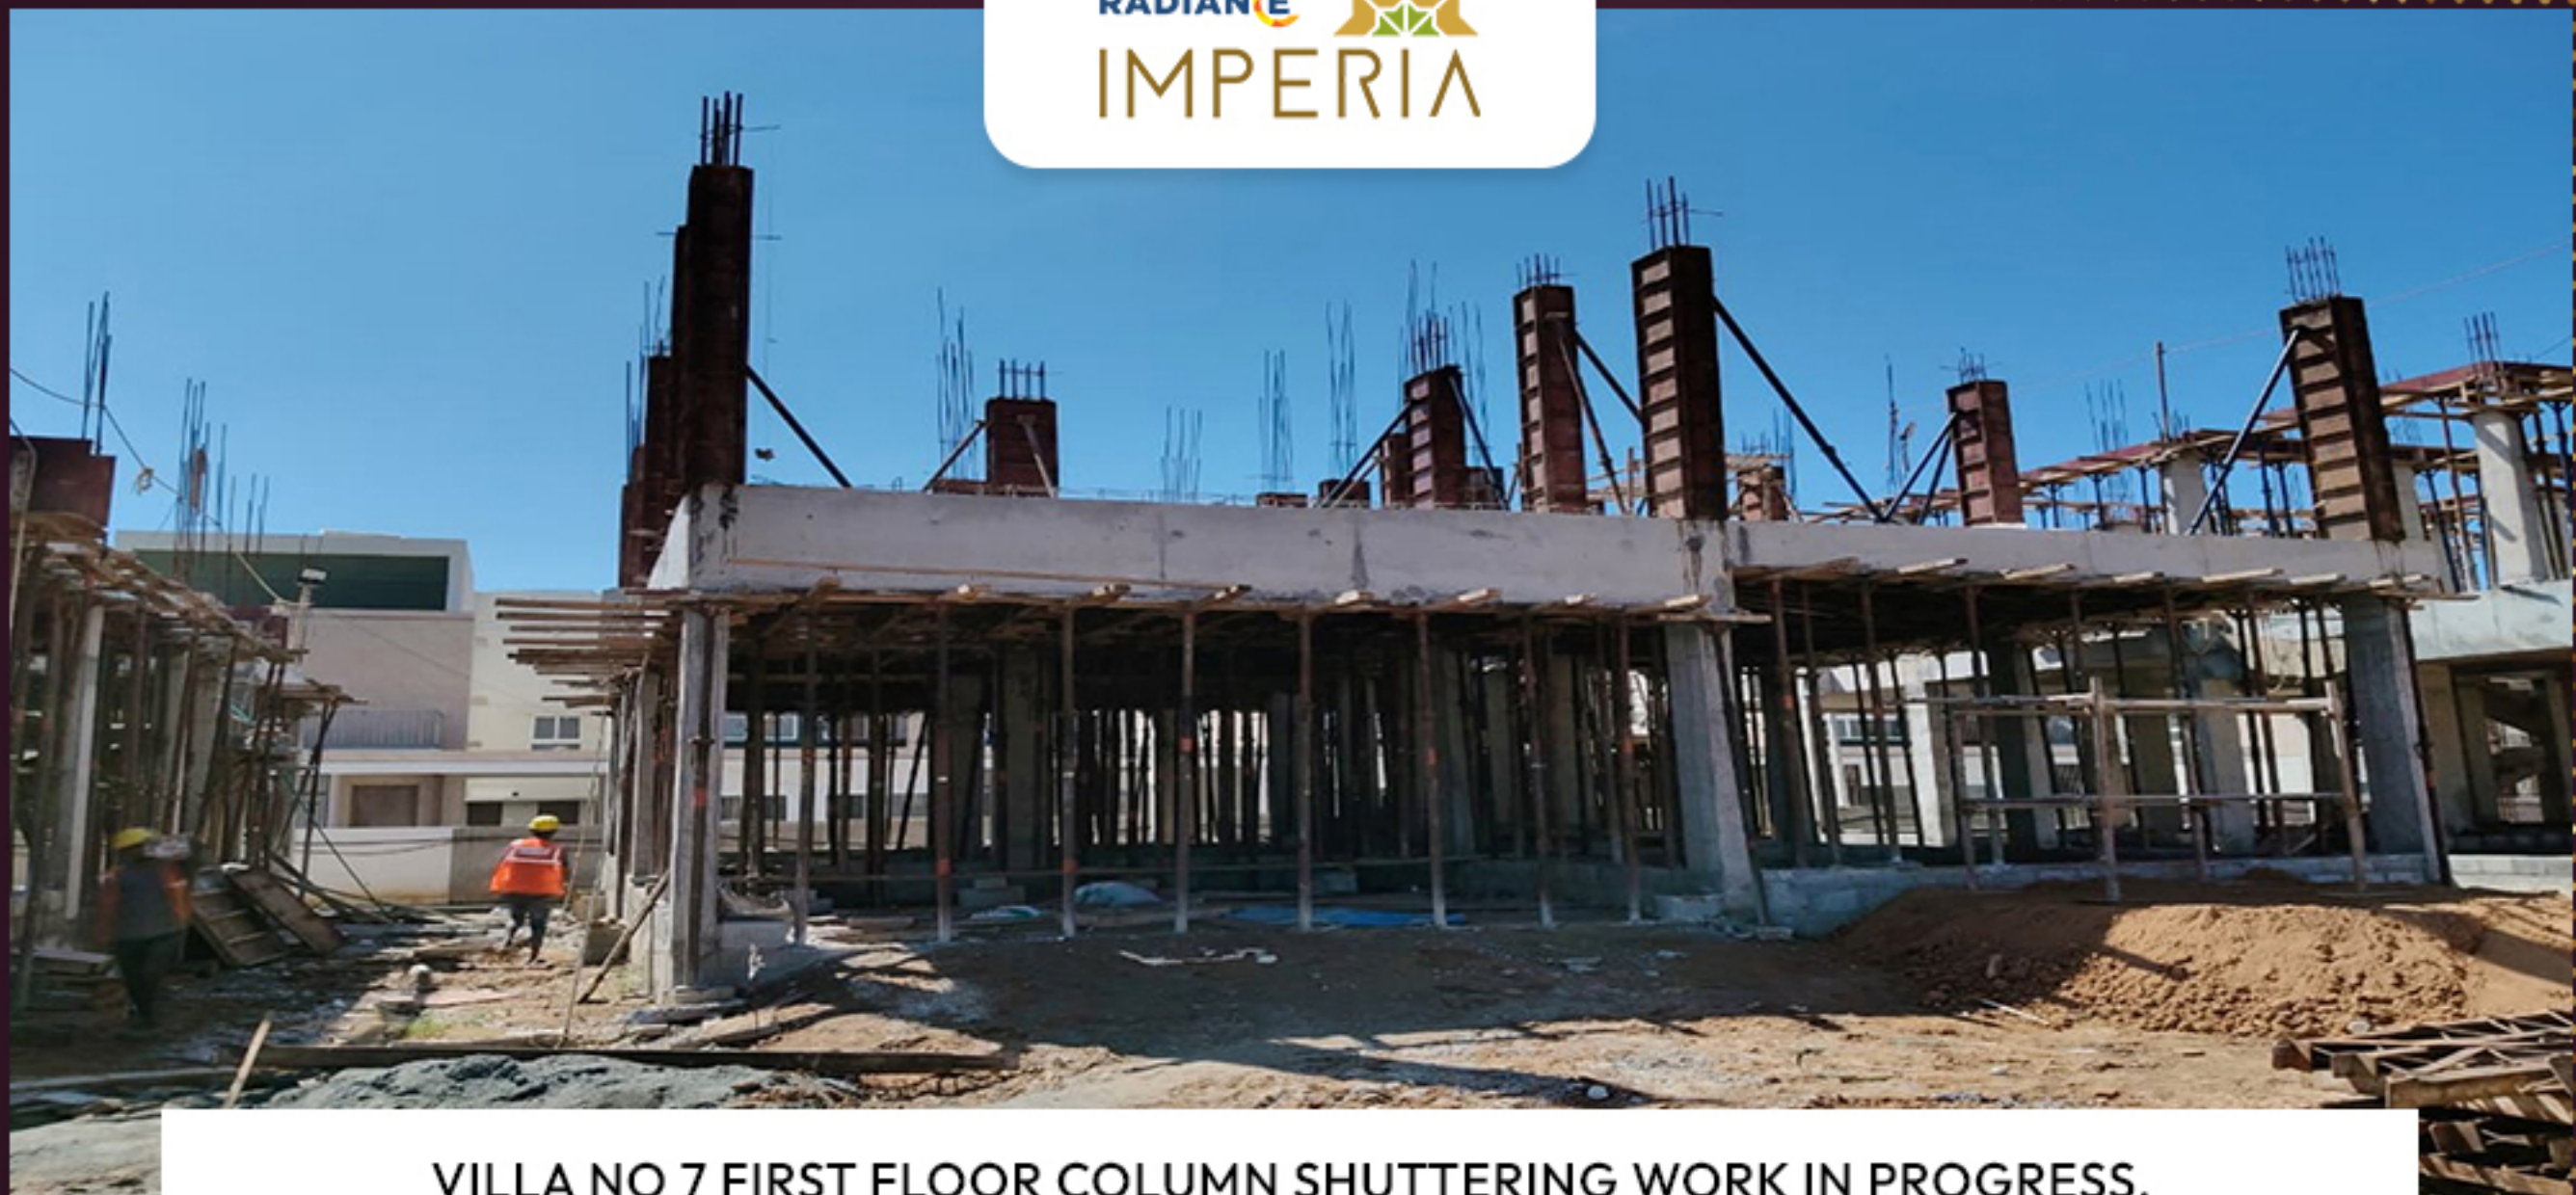
VILLA NO 7 FIRST FLOOR COLUMN SHUTTERING WORK IN PROGRESS.

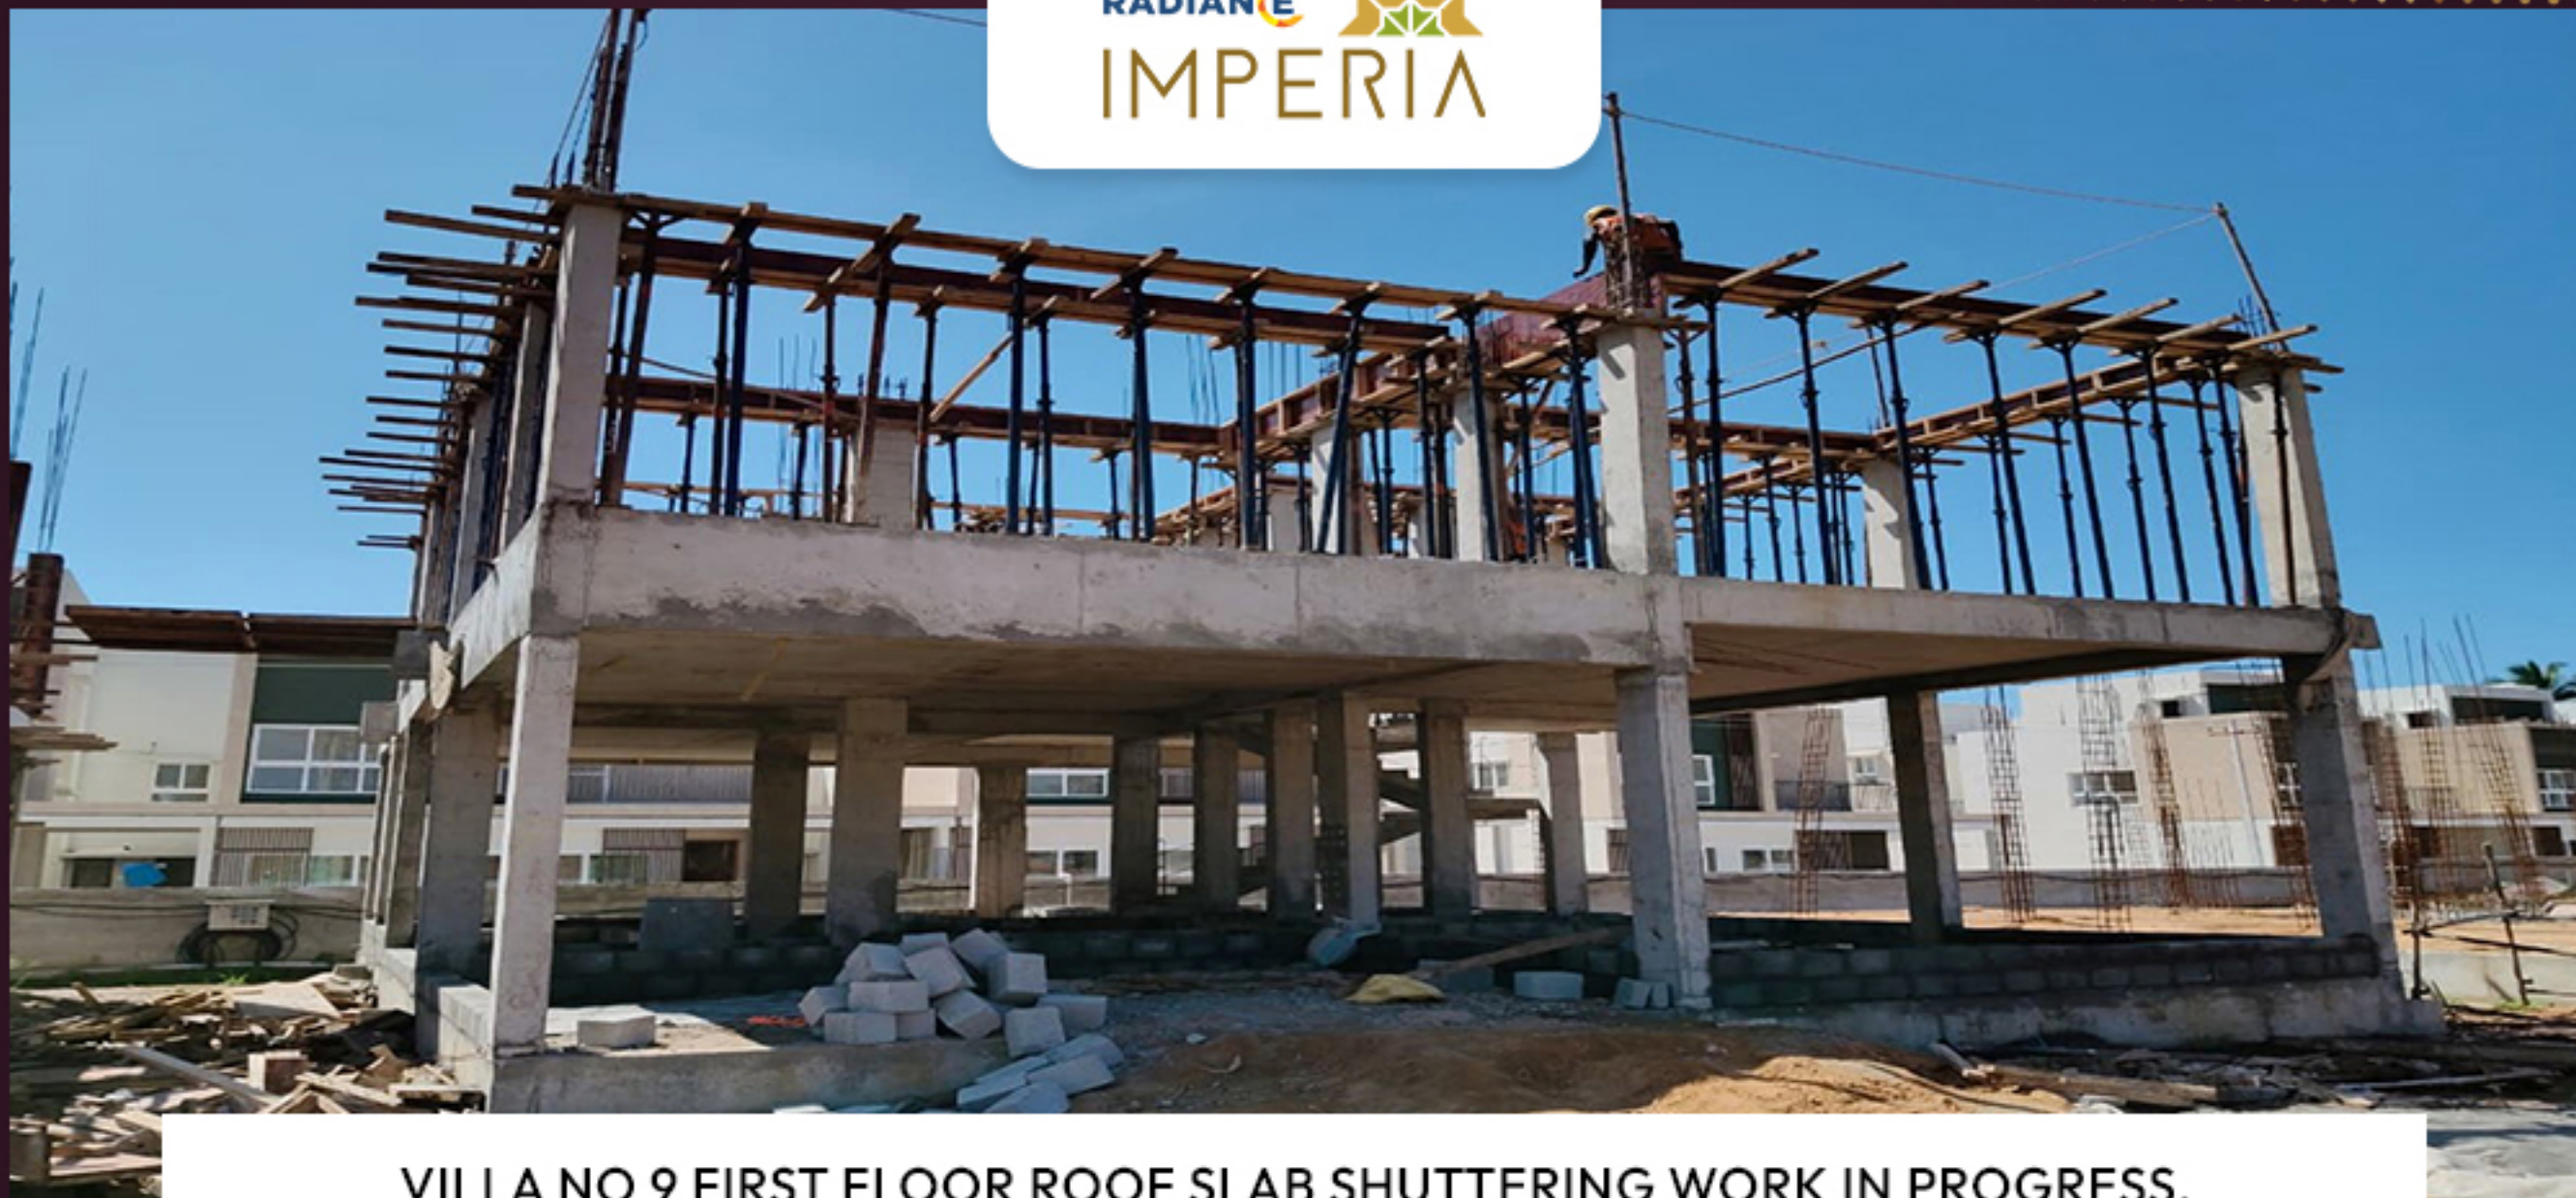
VILLA NO 9 FIRST FLOOR ROOF SLAB SHUTTERING WORK IN PROGRESS.
