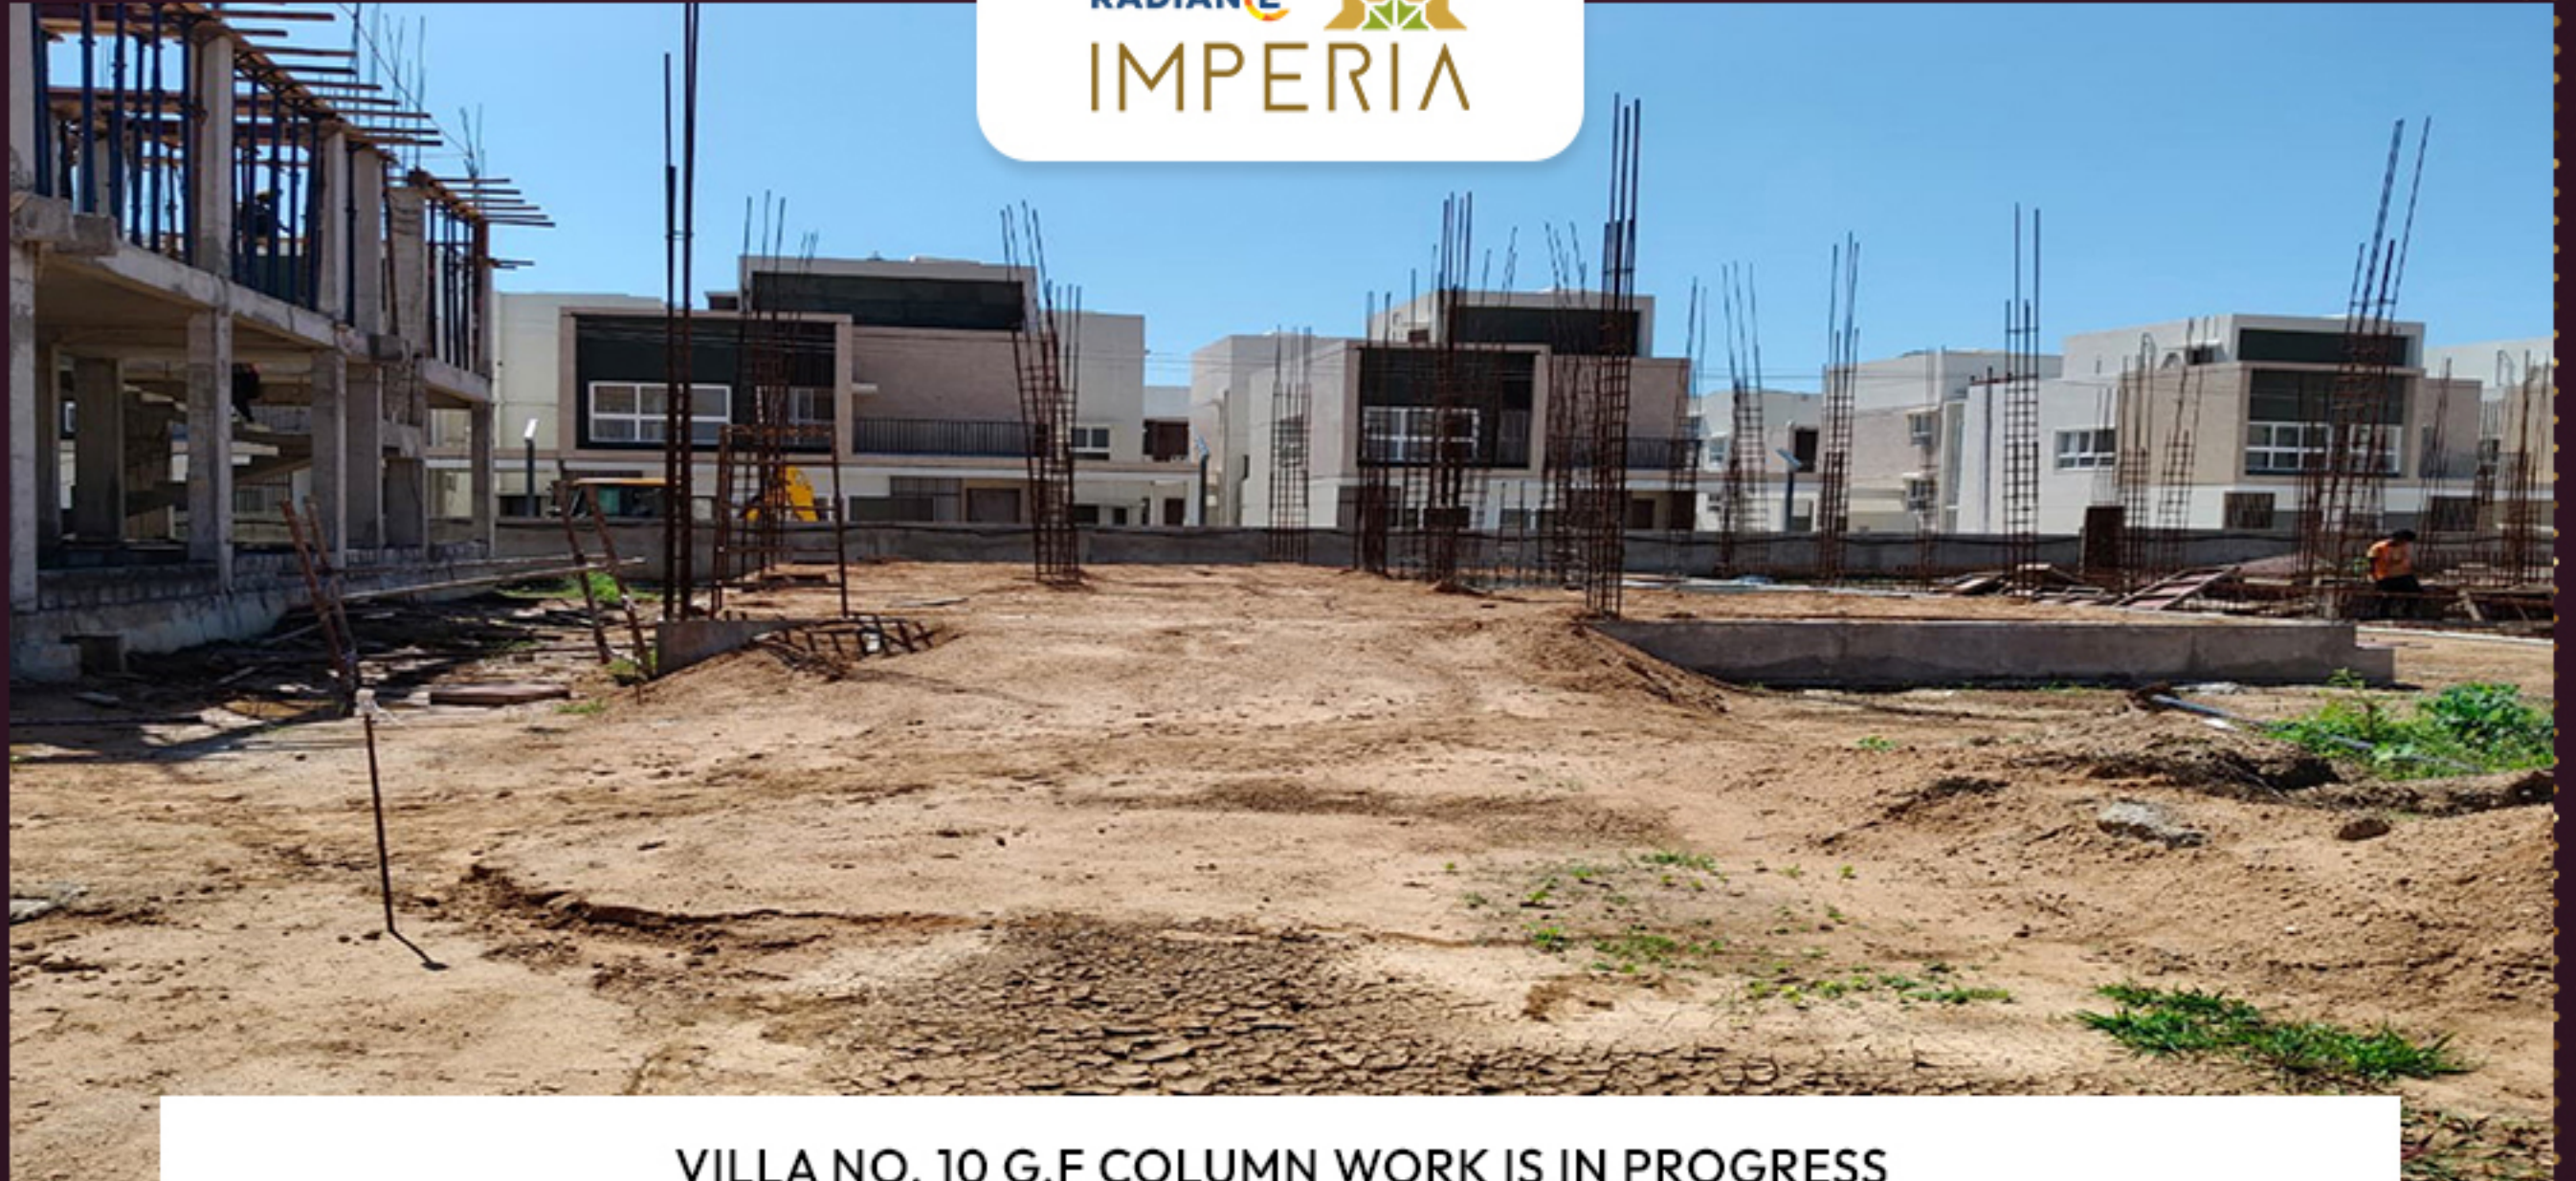
VILLA NO. 10 G.F COLUMN WORK IS IN PROGRESS

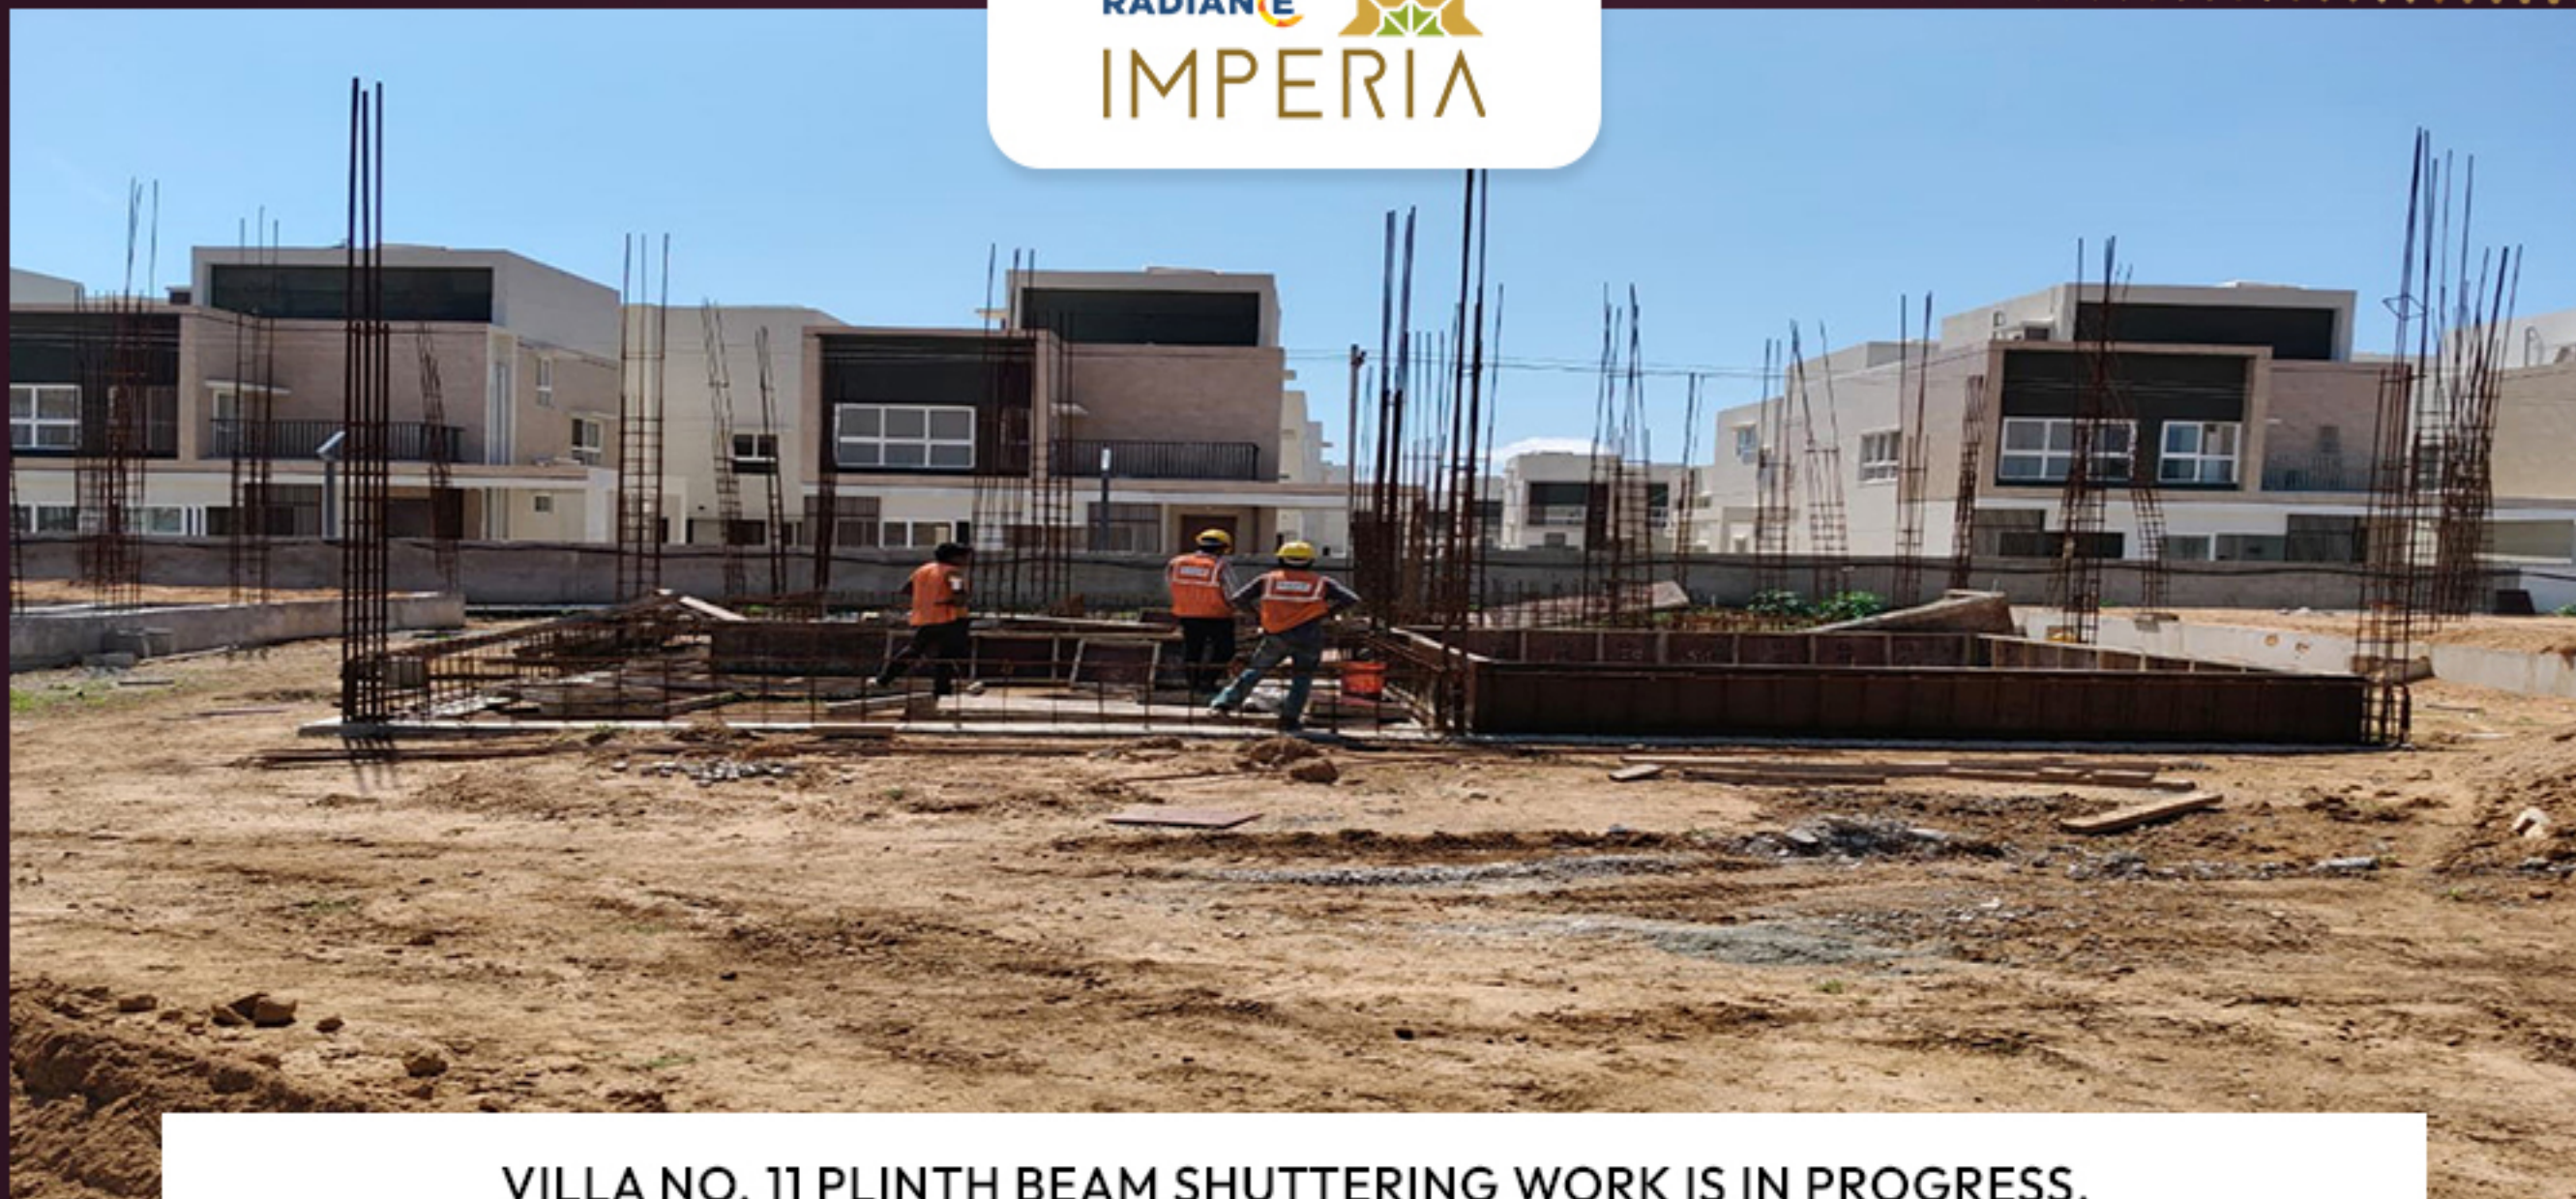
VILLA NO. 11 PLINTH BEAM SHUTTERING WORK IS IN PROGRESS.

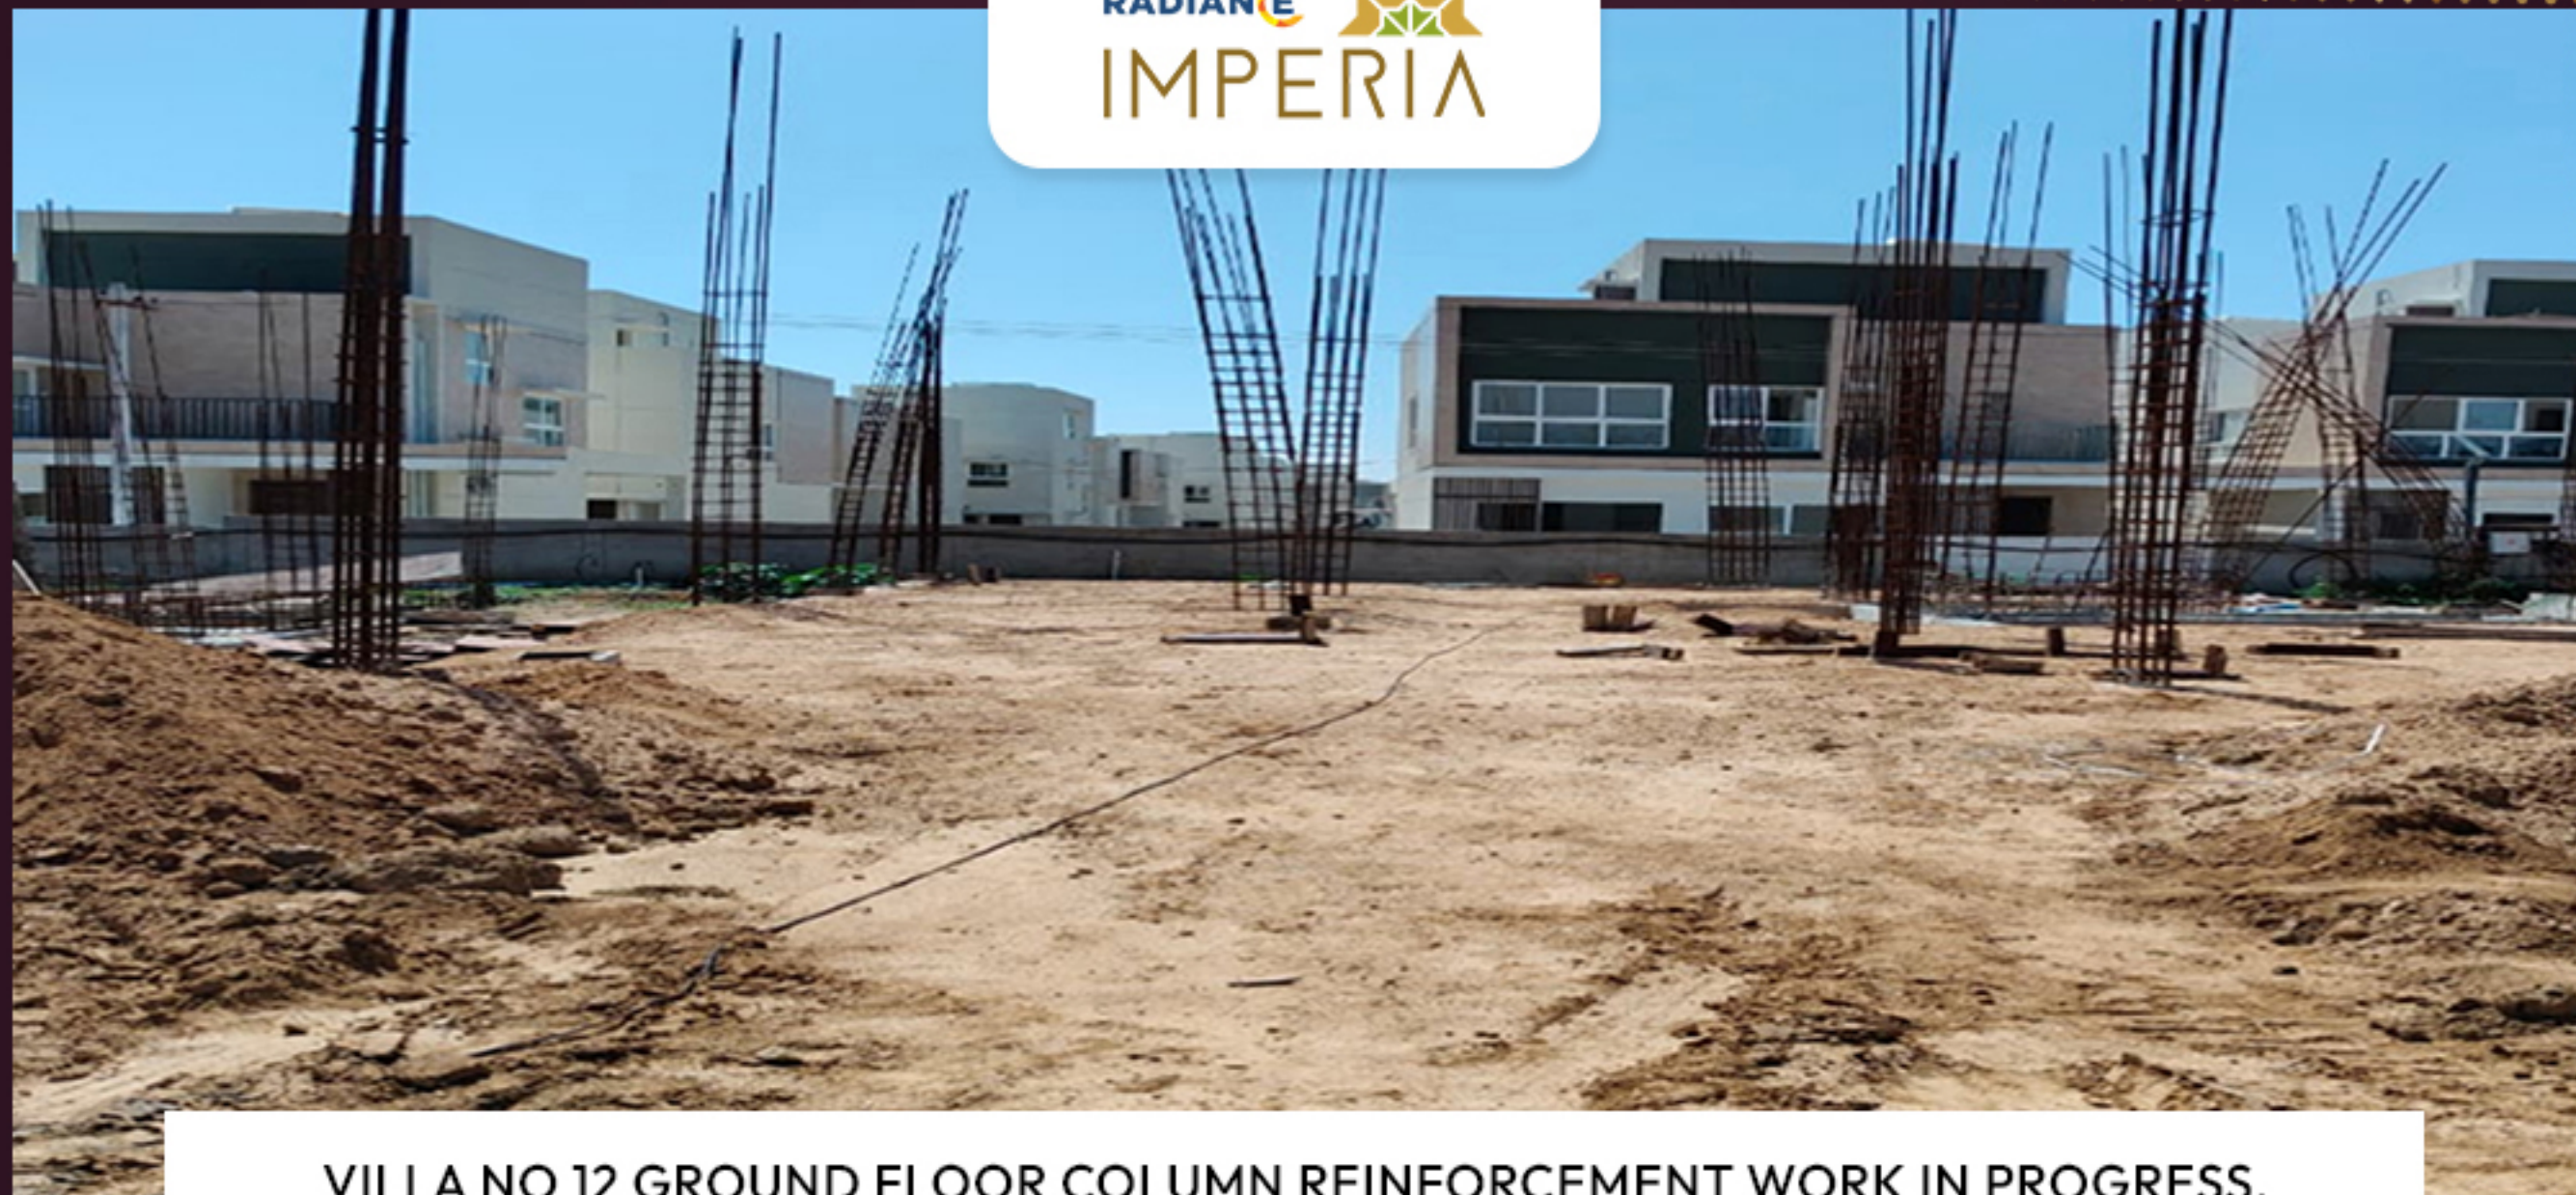
VILLA NO 12 GROUND FLOOR COLUMN REINFORCEMENT WORK IN PROGRESS.

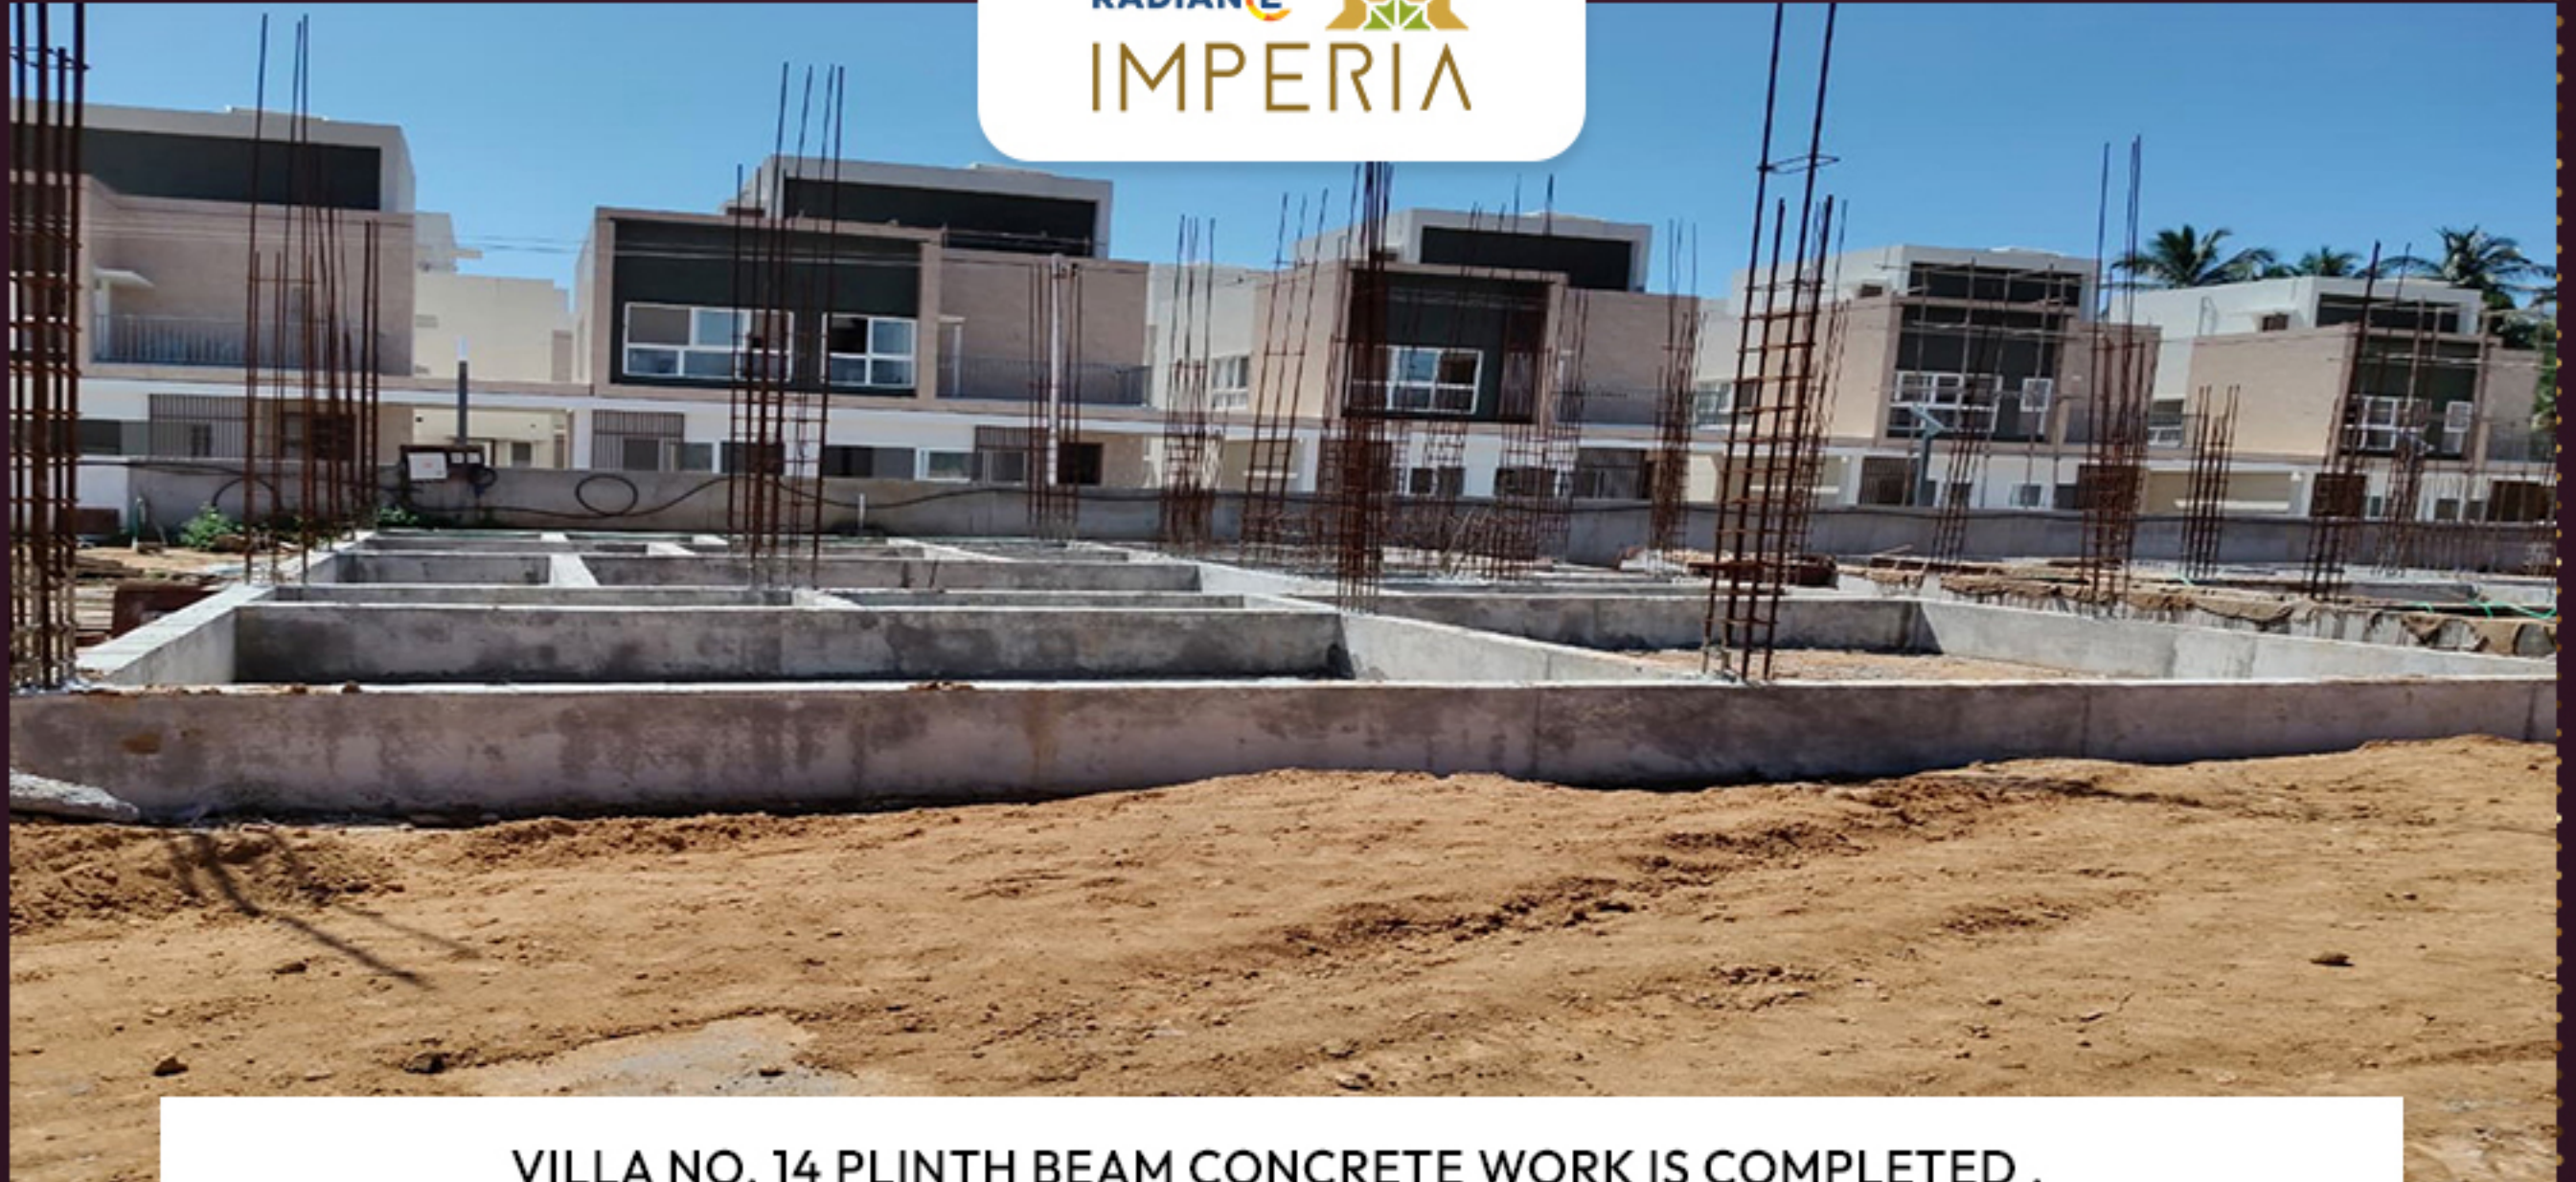
VILLA NO. 14 PLINTH BEAM CONCRETE WORK IS COMPLETED .

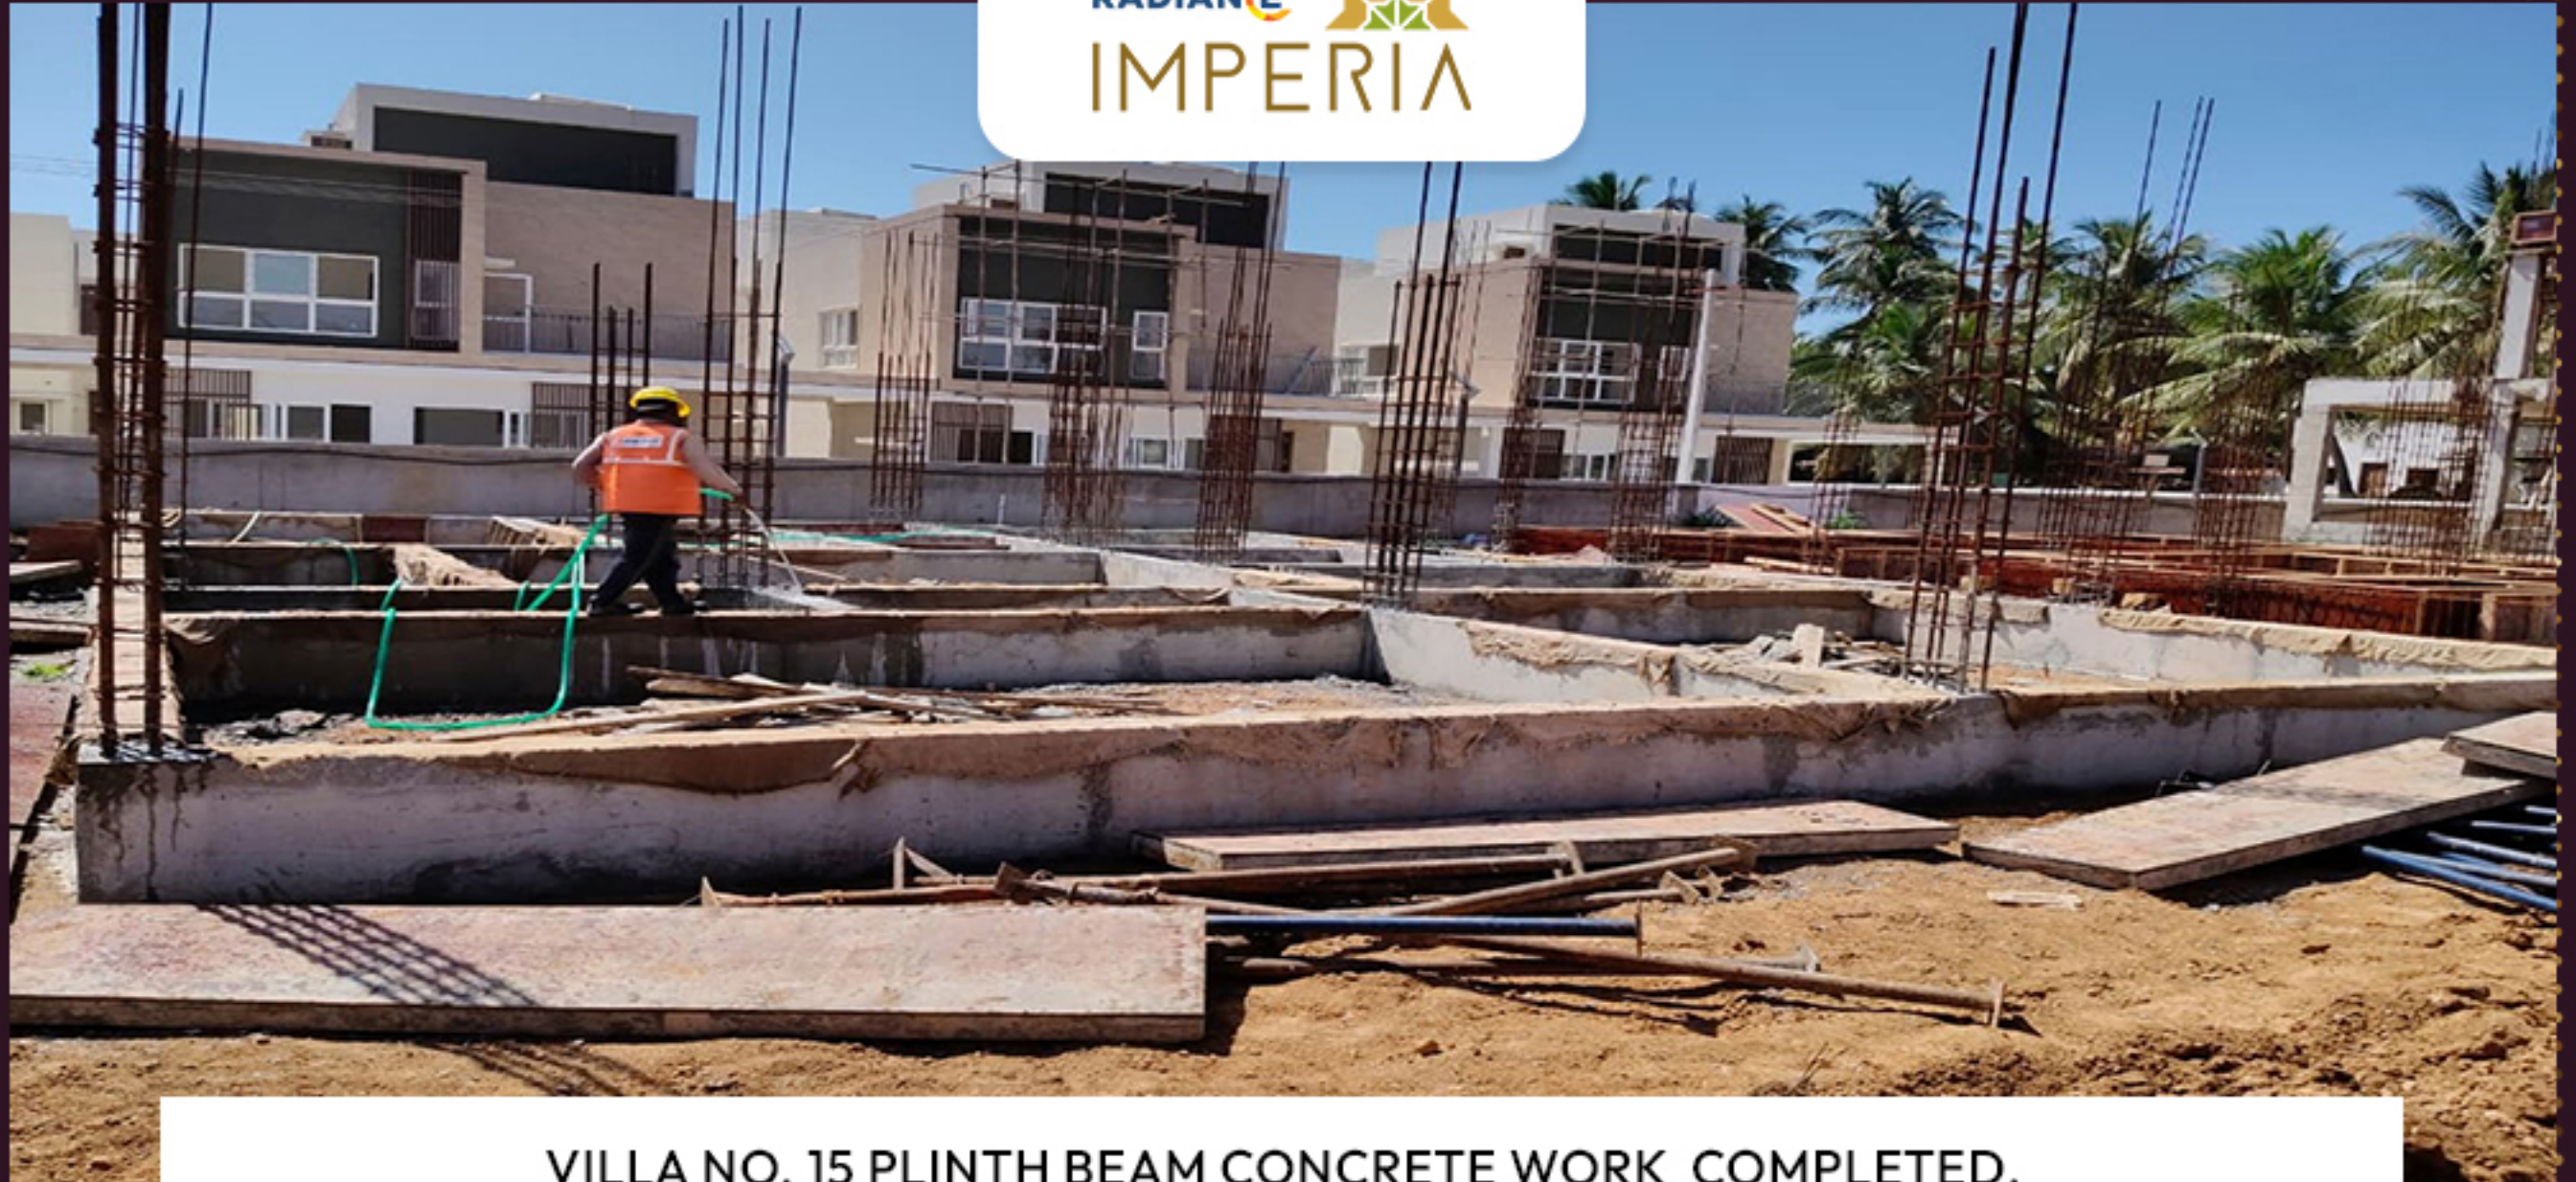
VILLA NO. 15 PLINTH BEAM CONCRETE WORK COMPLETED.

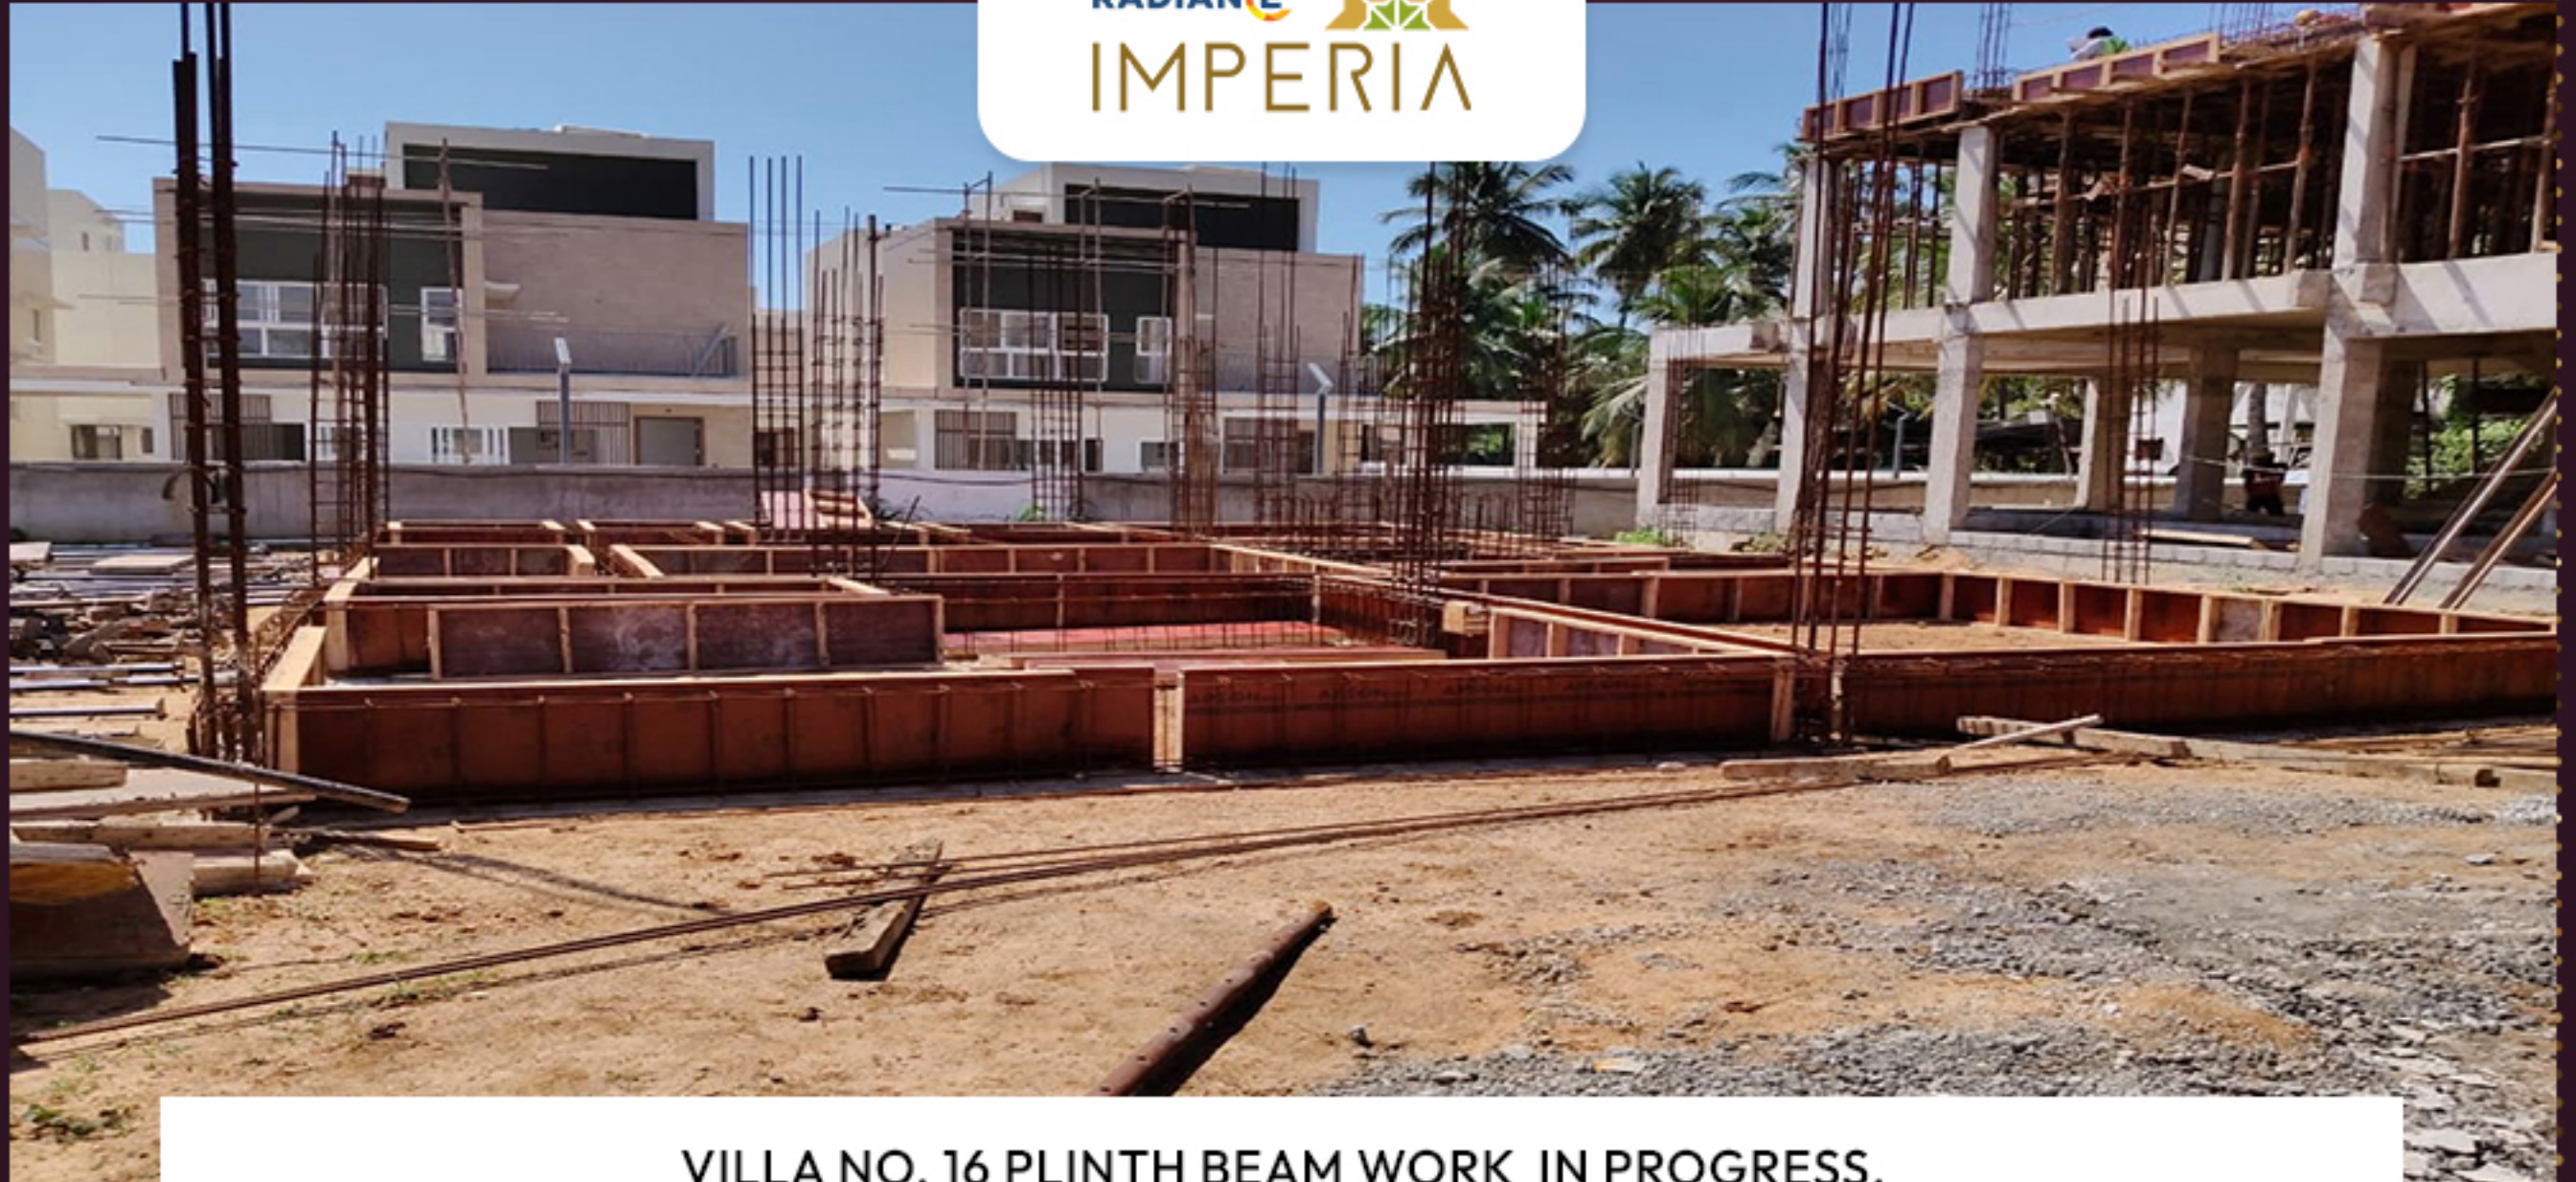
VILLA NO. 16 PLINTH BEAM WORK IN PROGRESS.

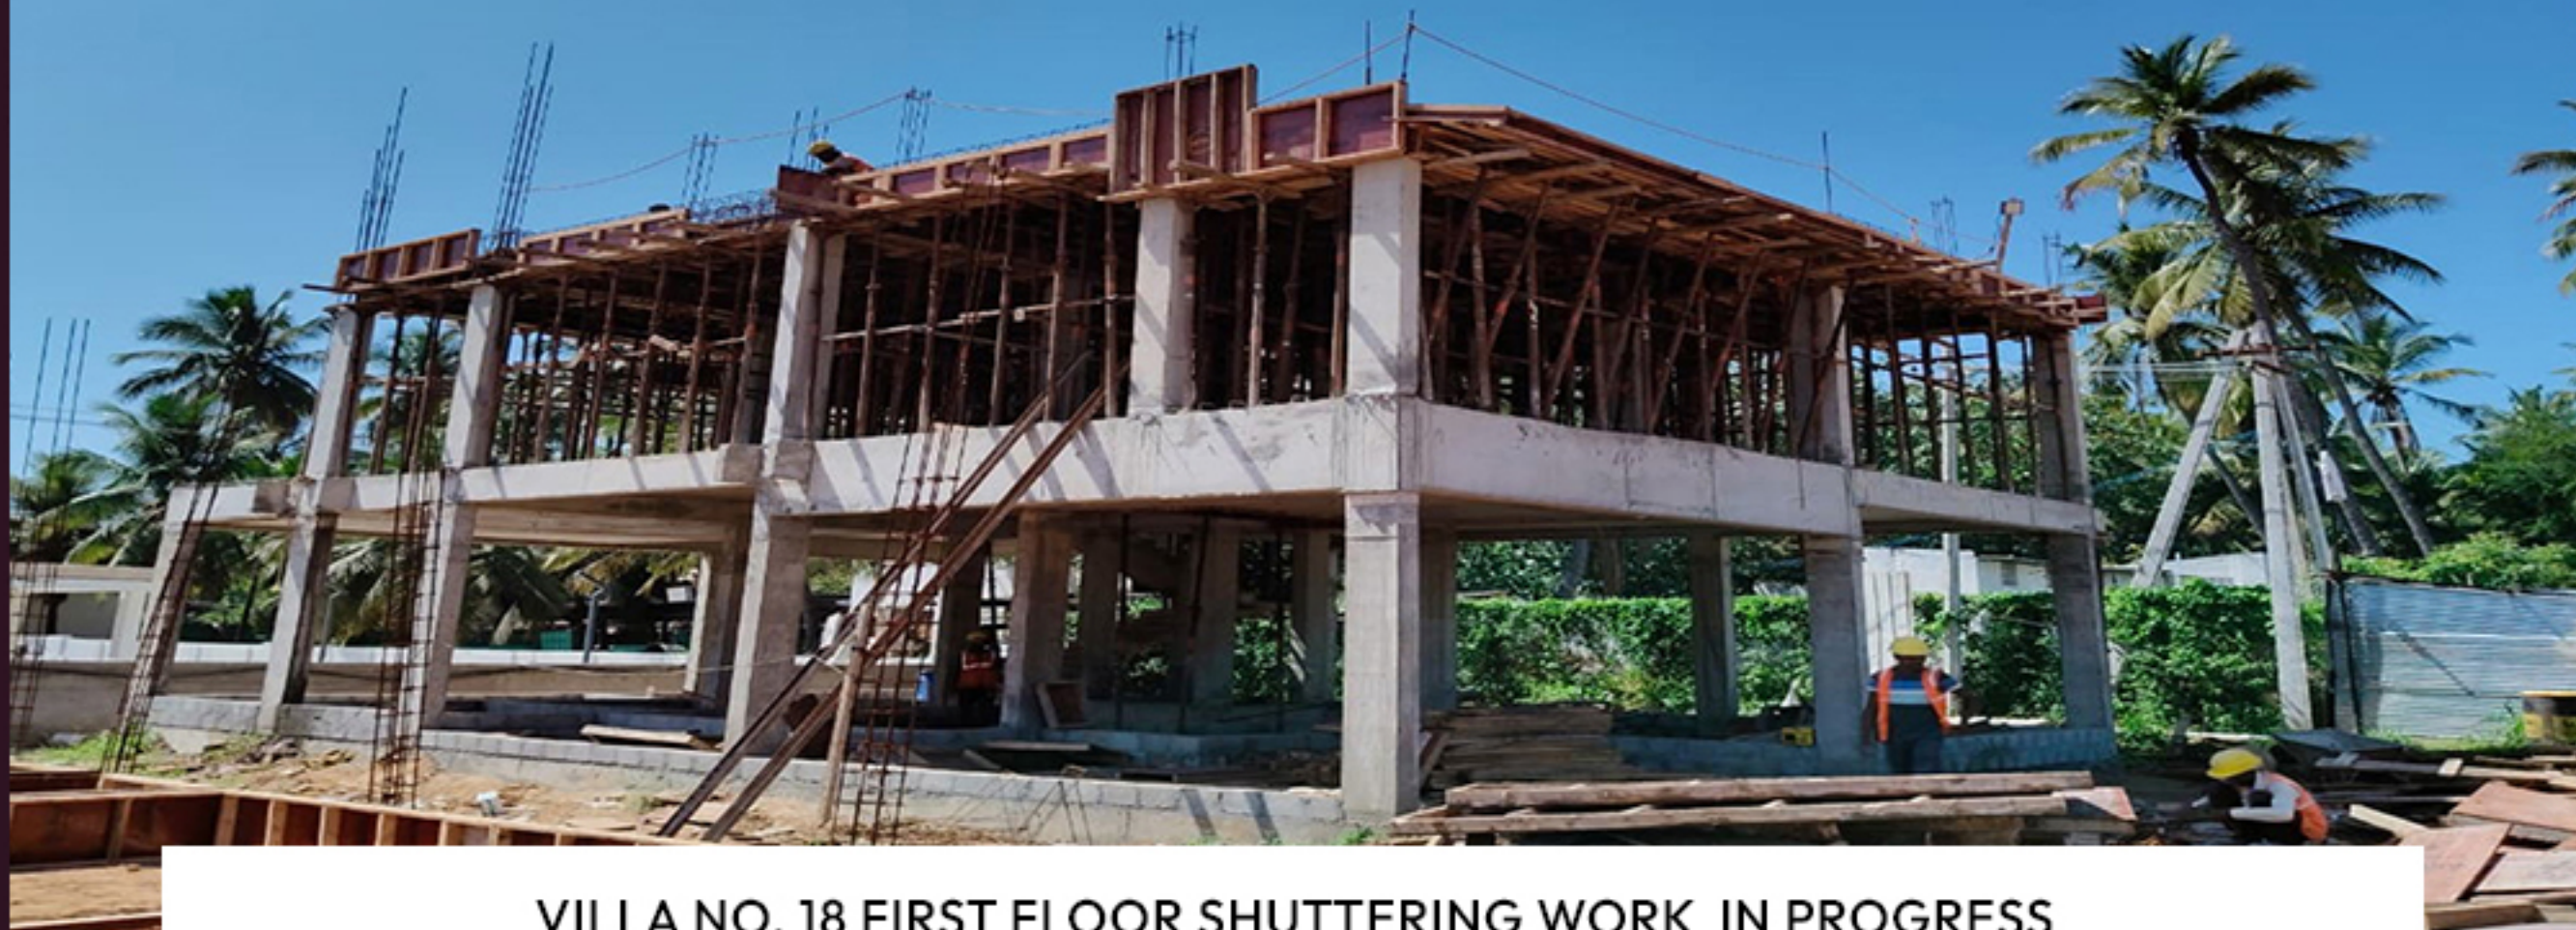
VILLA NO. 18 FIRST FLOOR SHUTTERING WORK IN PROGRESS
