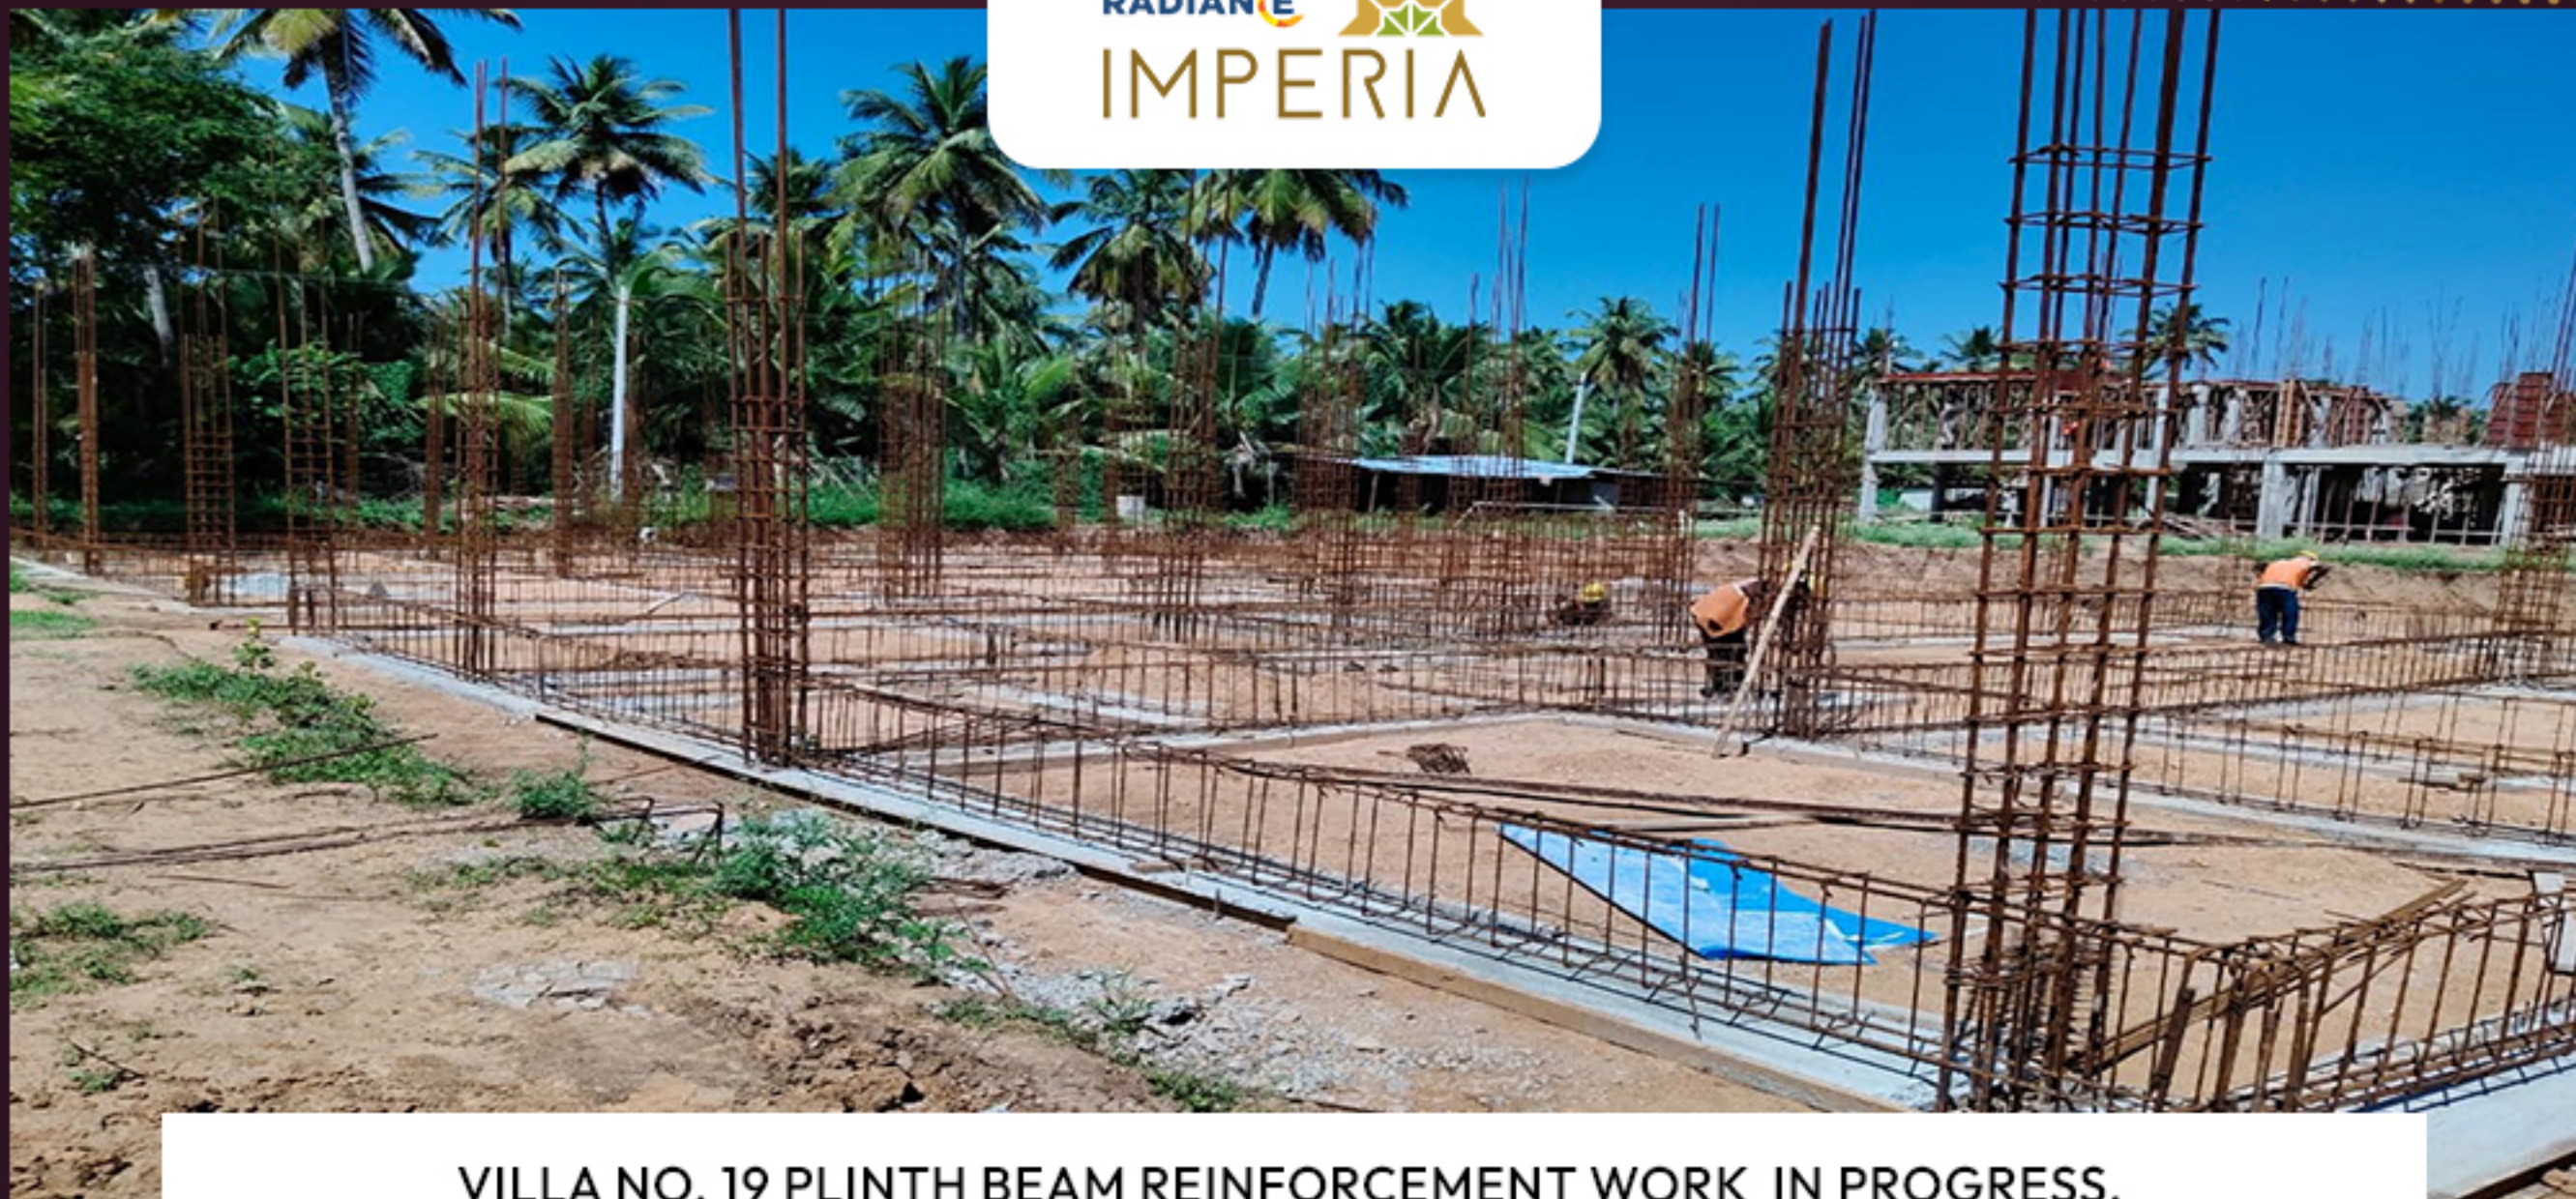
VILLA NO. 19 PLINTH BEAM REINFORCEMENT WORK IN PROGRESS.

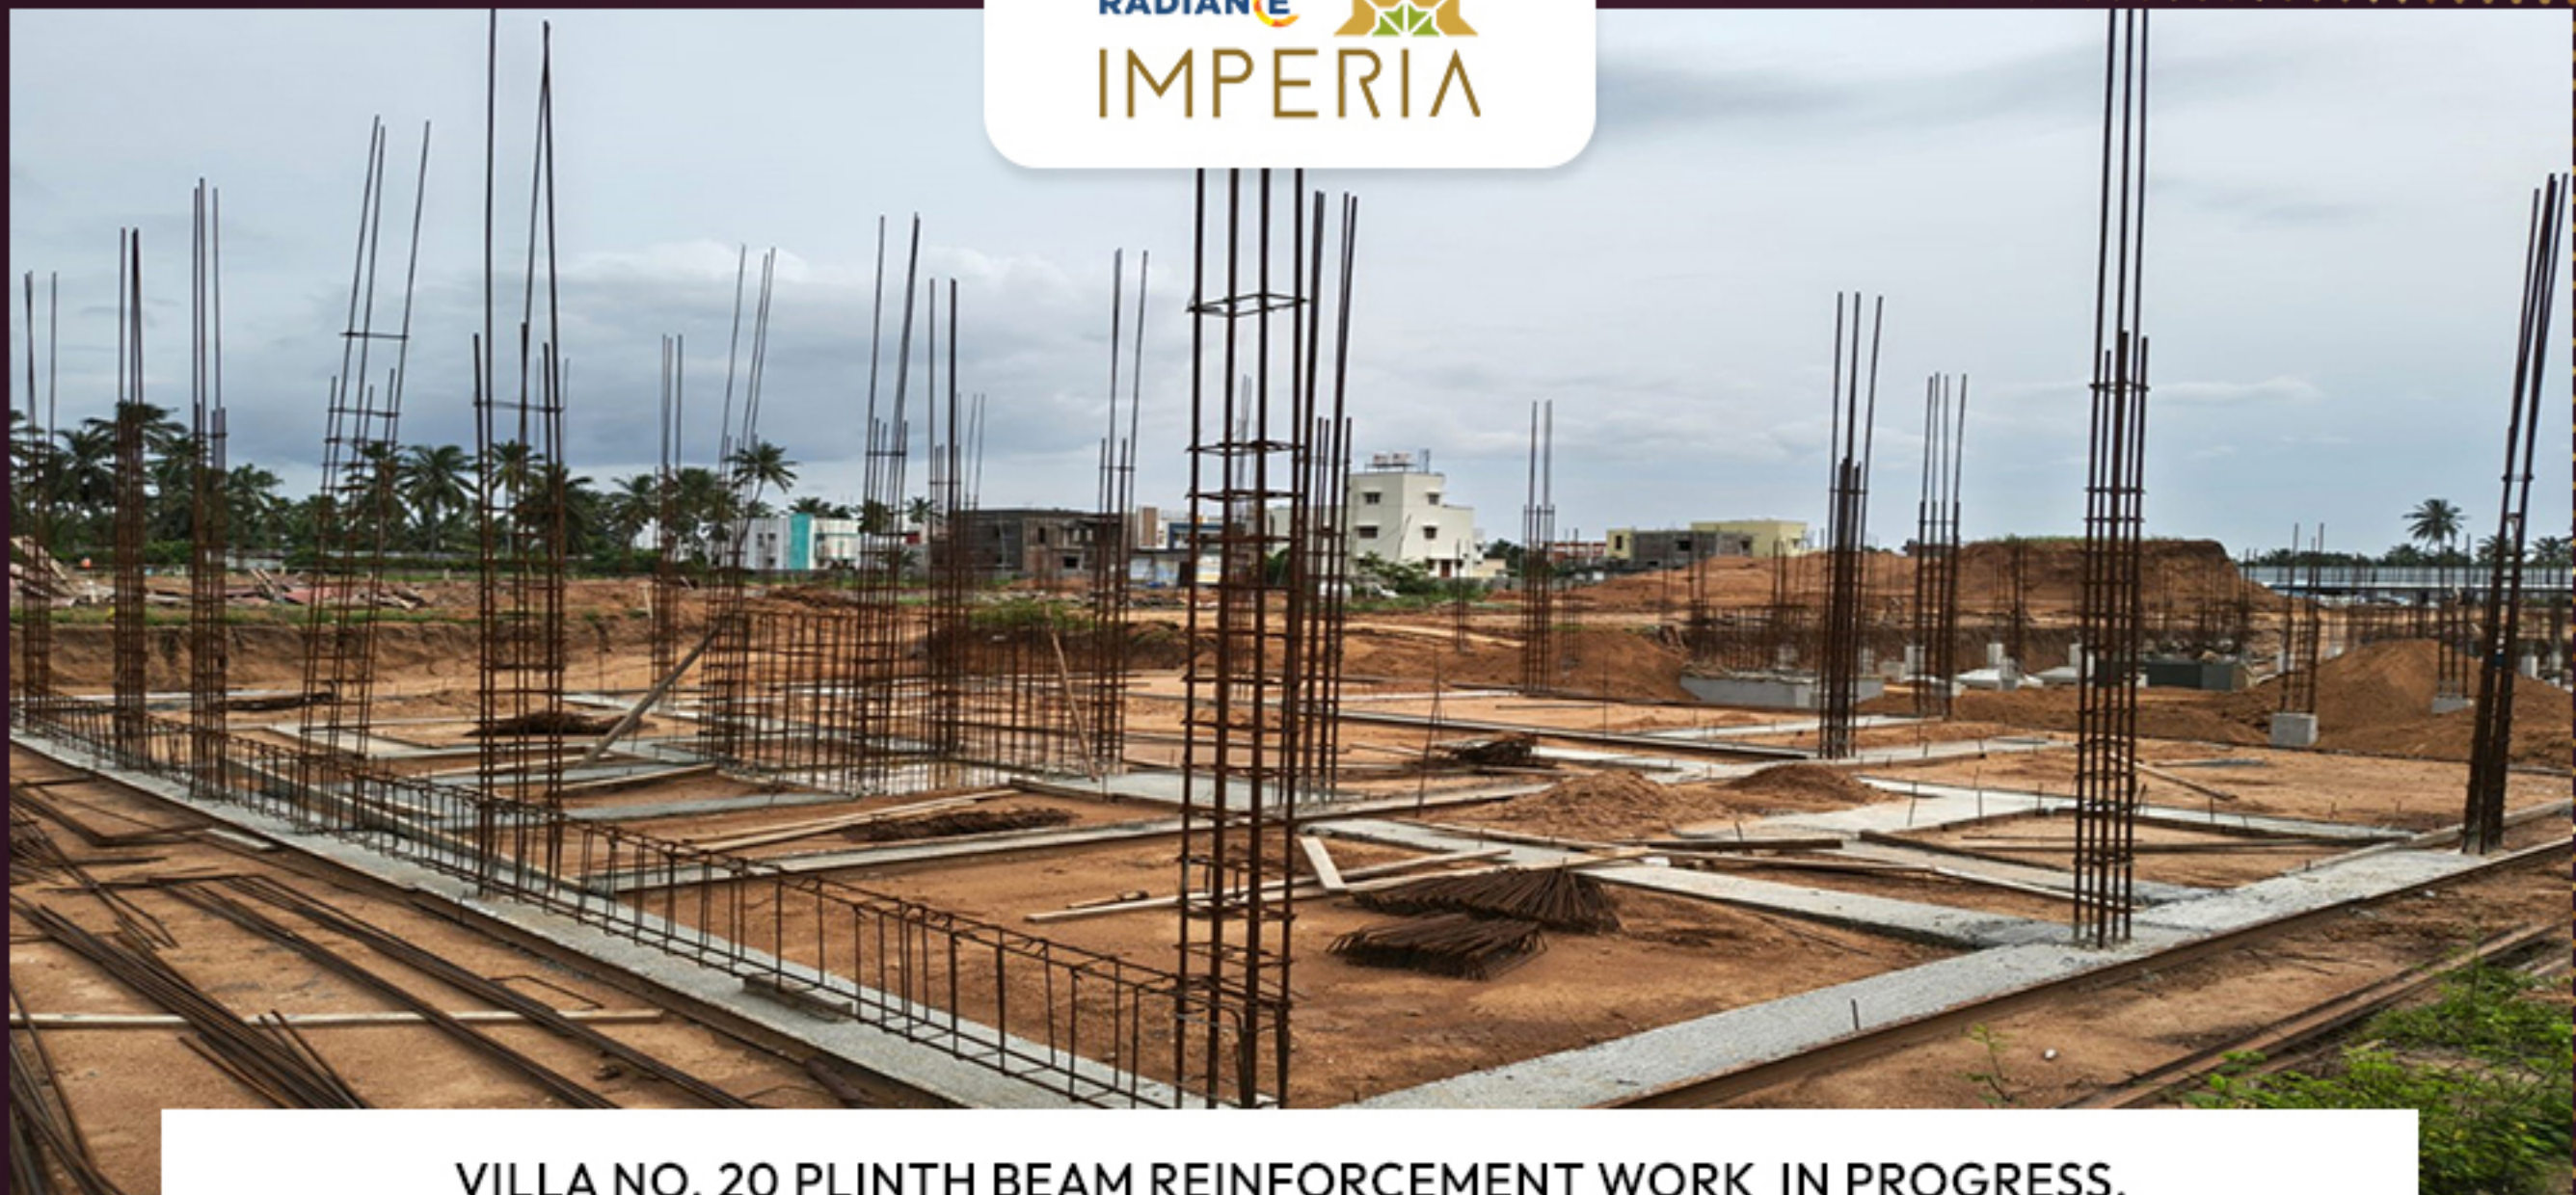
VILLA NO. 20 PLINTH BEAM REINFORCEMENT WORK IN PROGRESS.

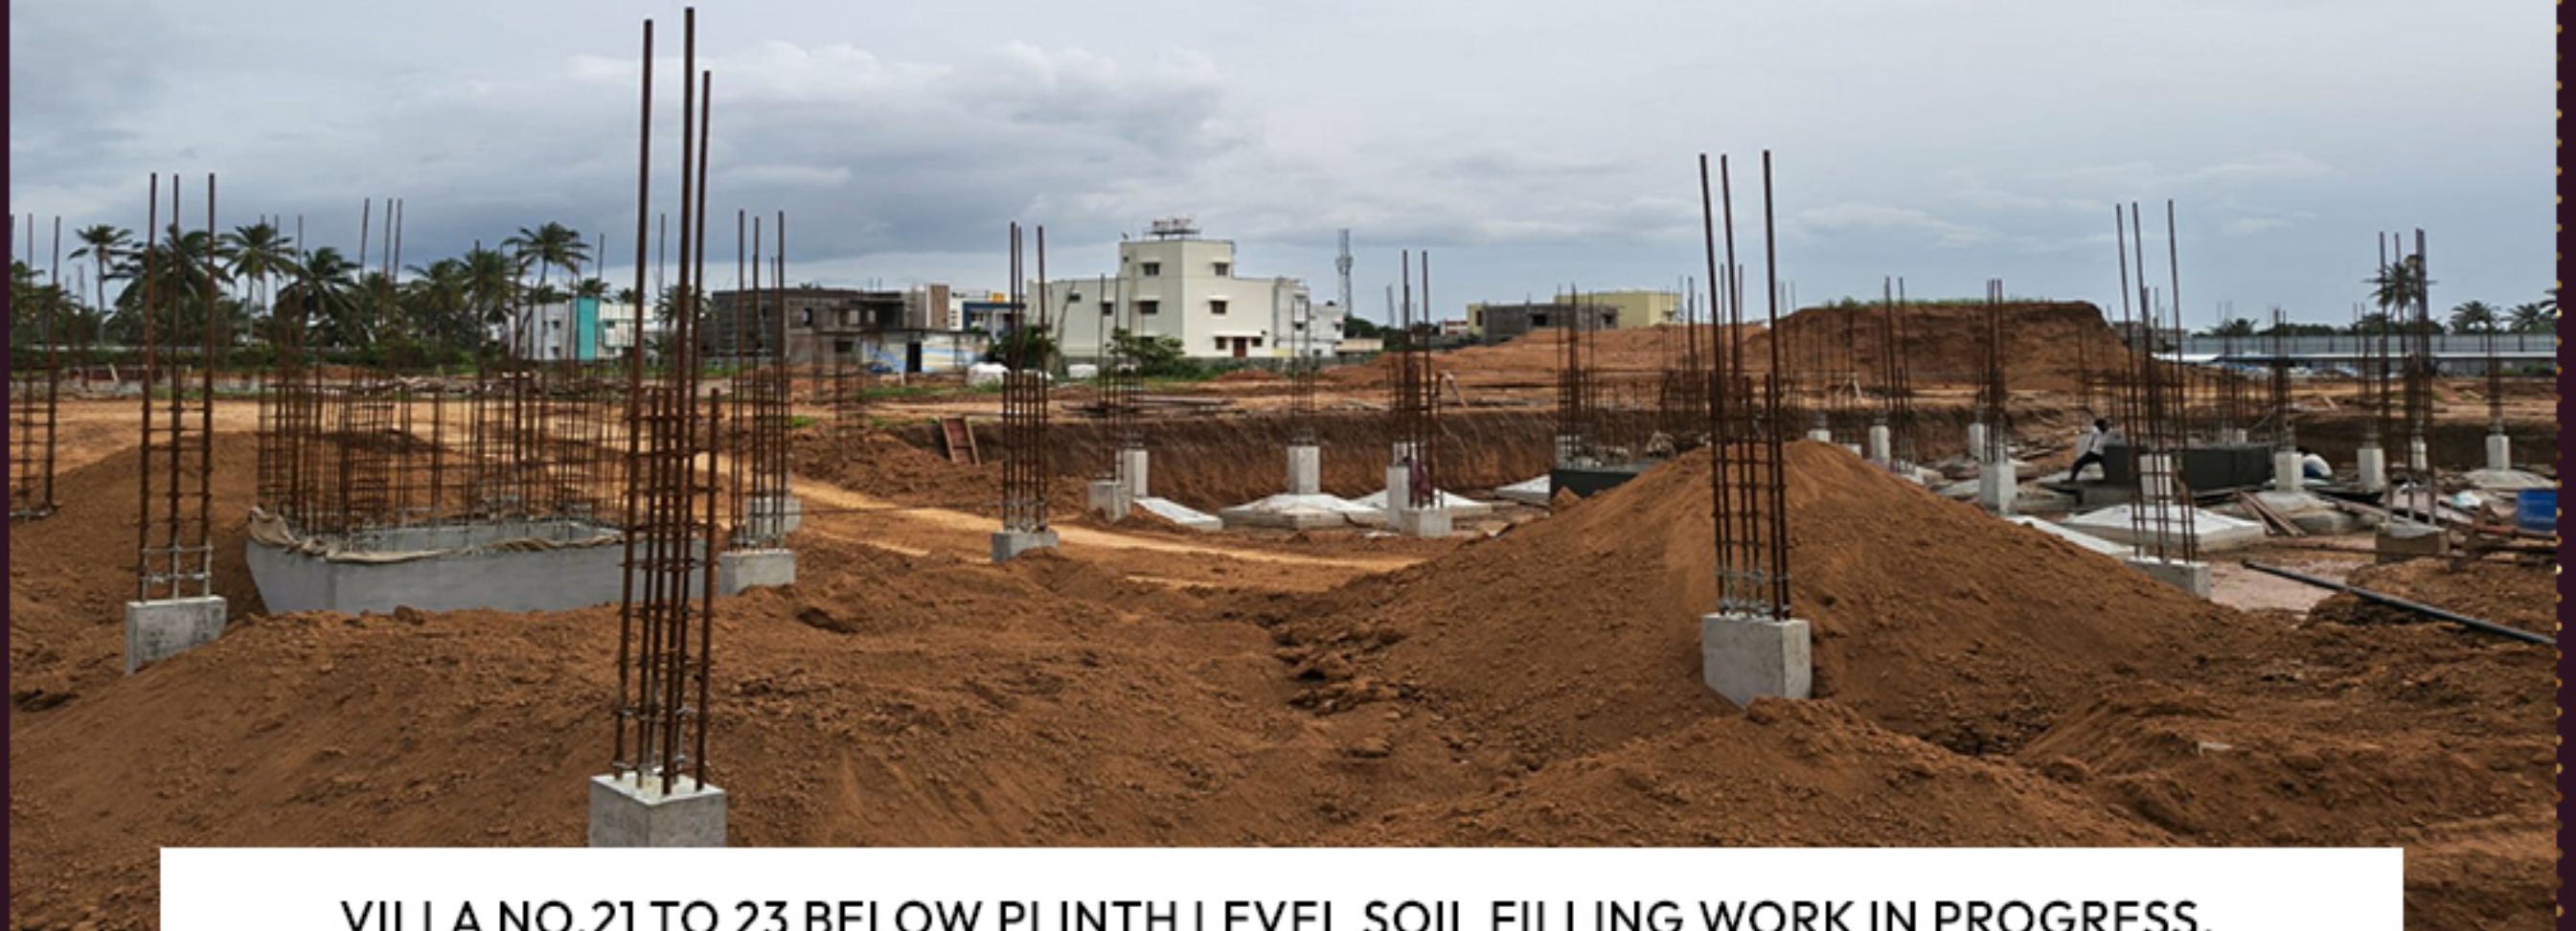
VILLA NO.21 TO 23 BELOW PLINTH LEVEL SOIL FILLING WORK IN PROGRESS.

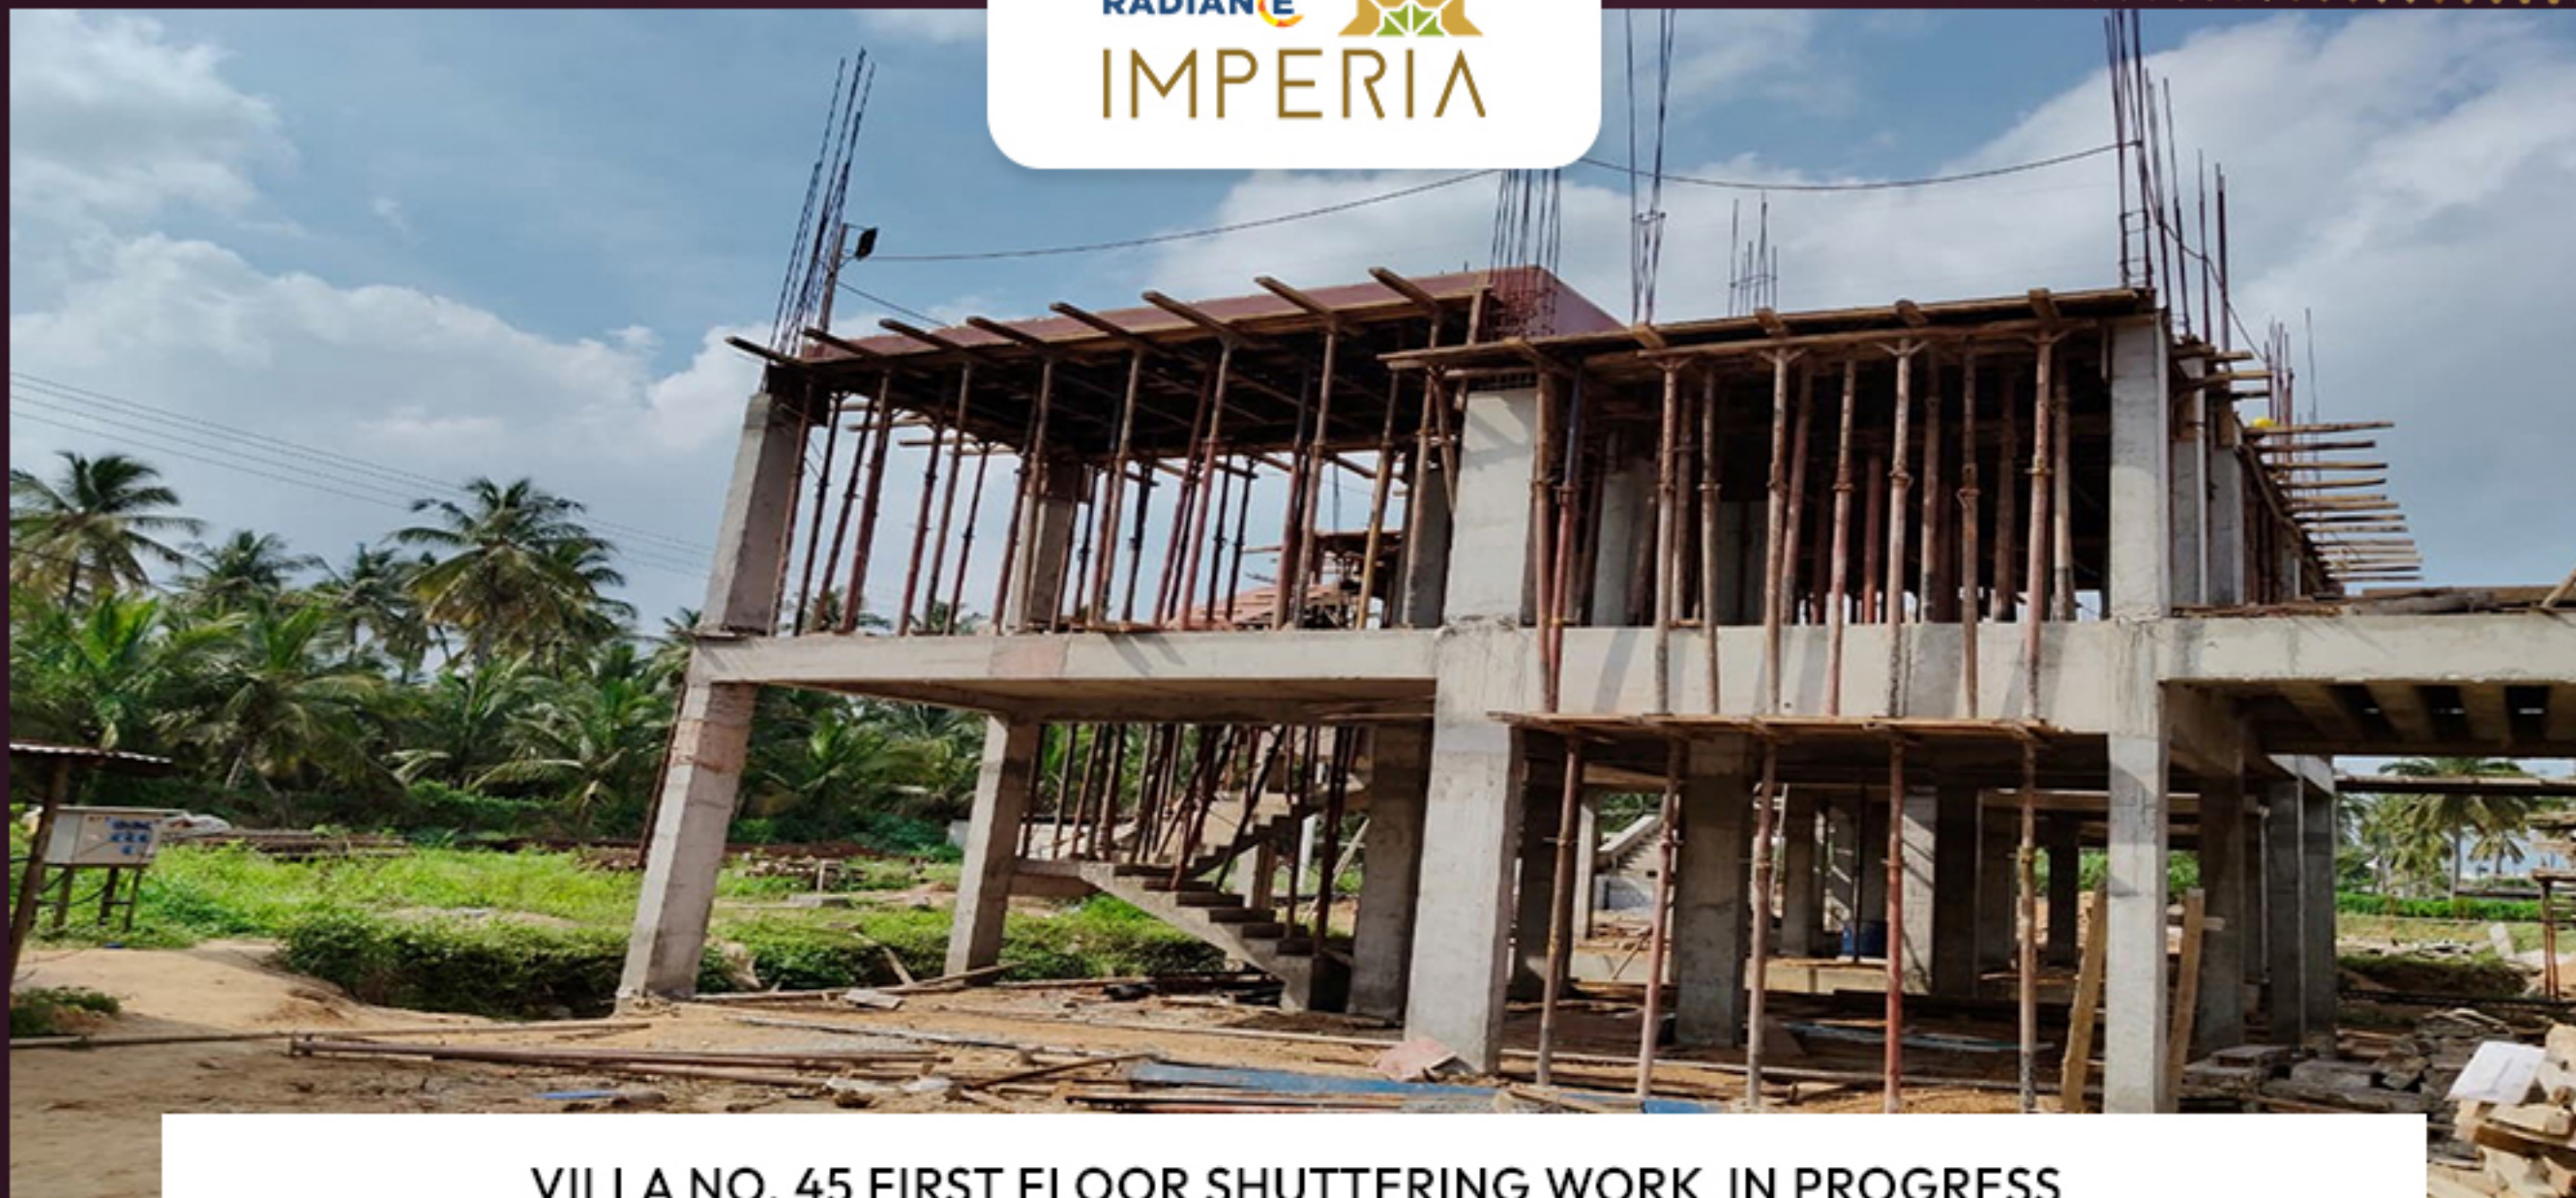
VILLA NO. 45 FIRST FLOOR SHUTTERING WORK IN PROGRESS

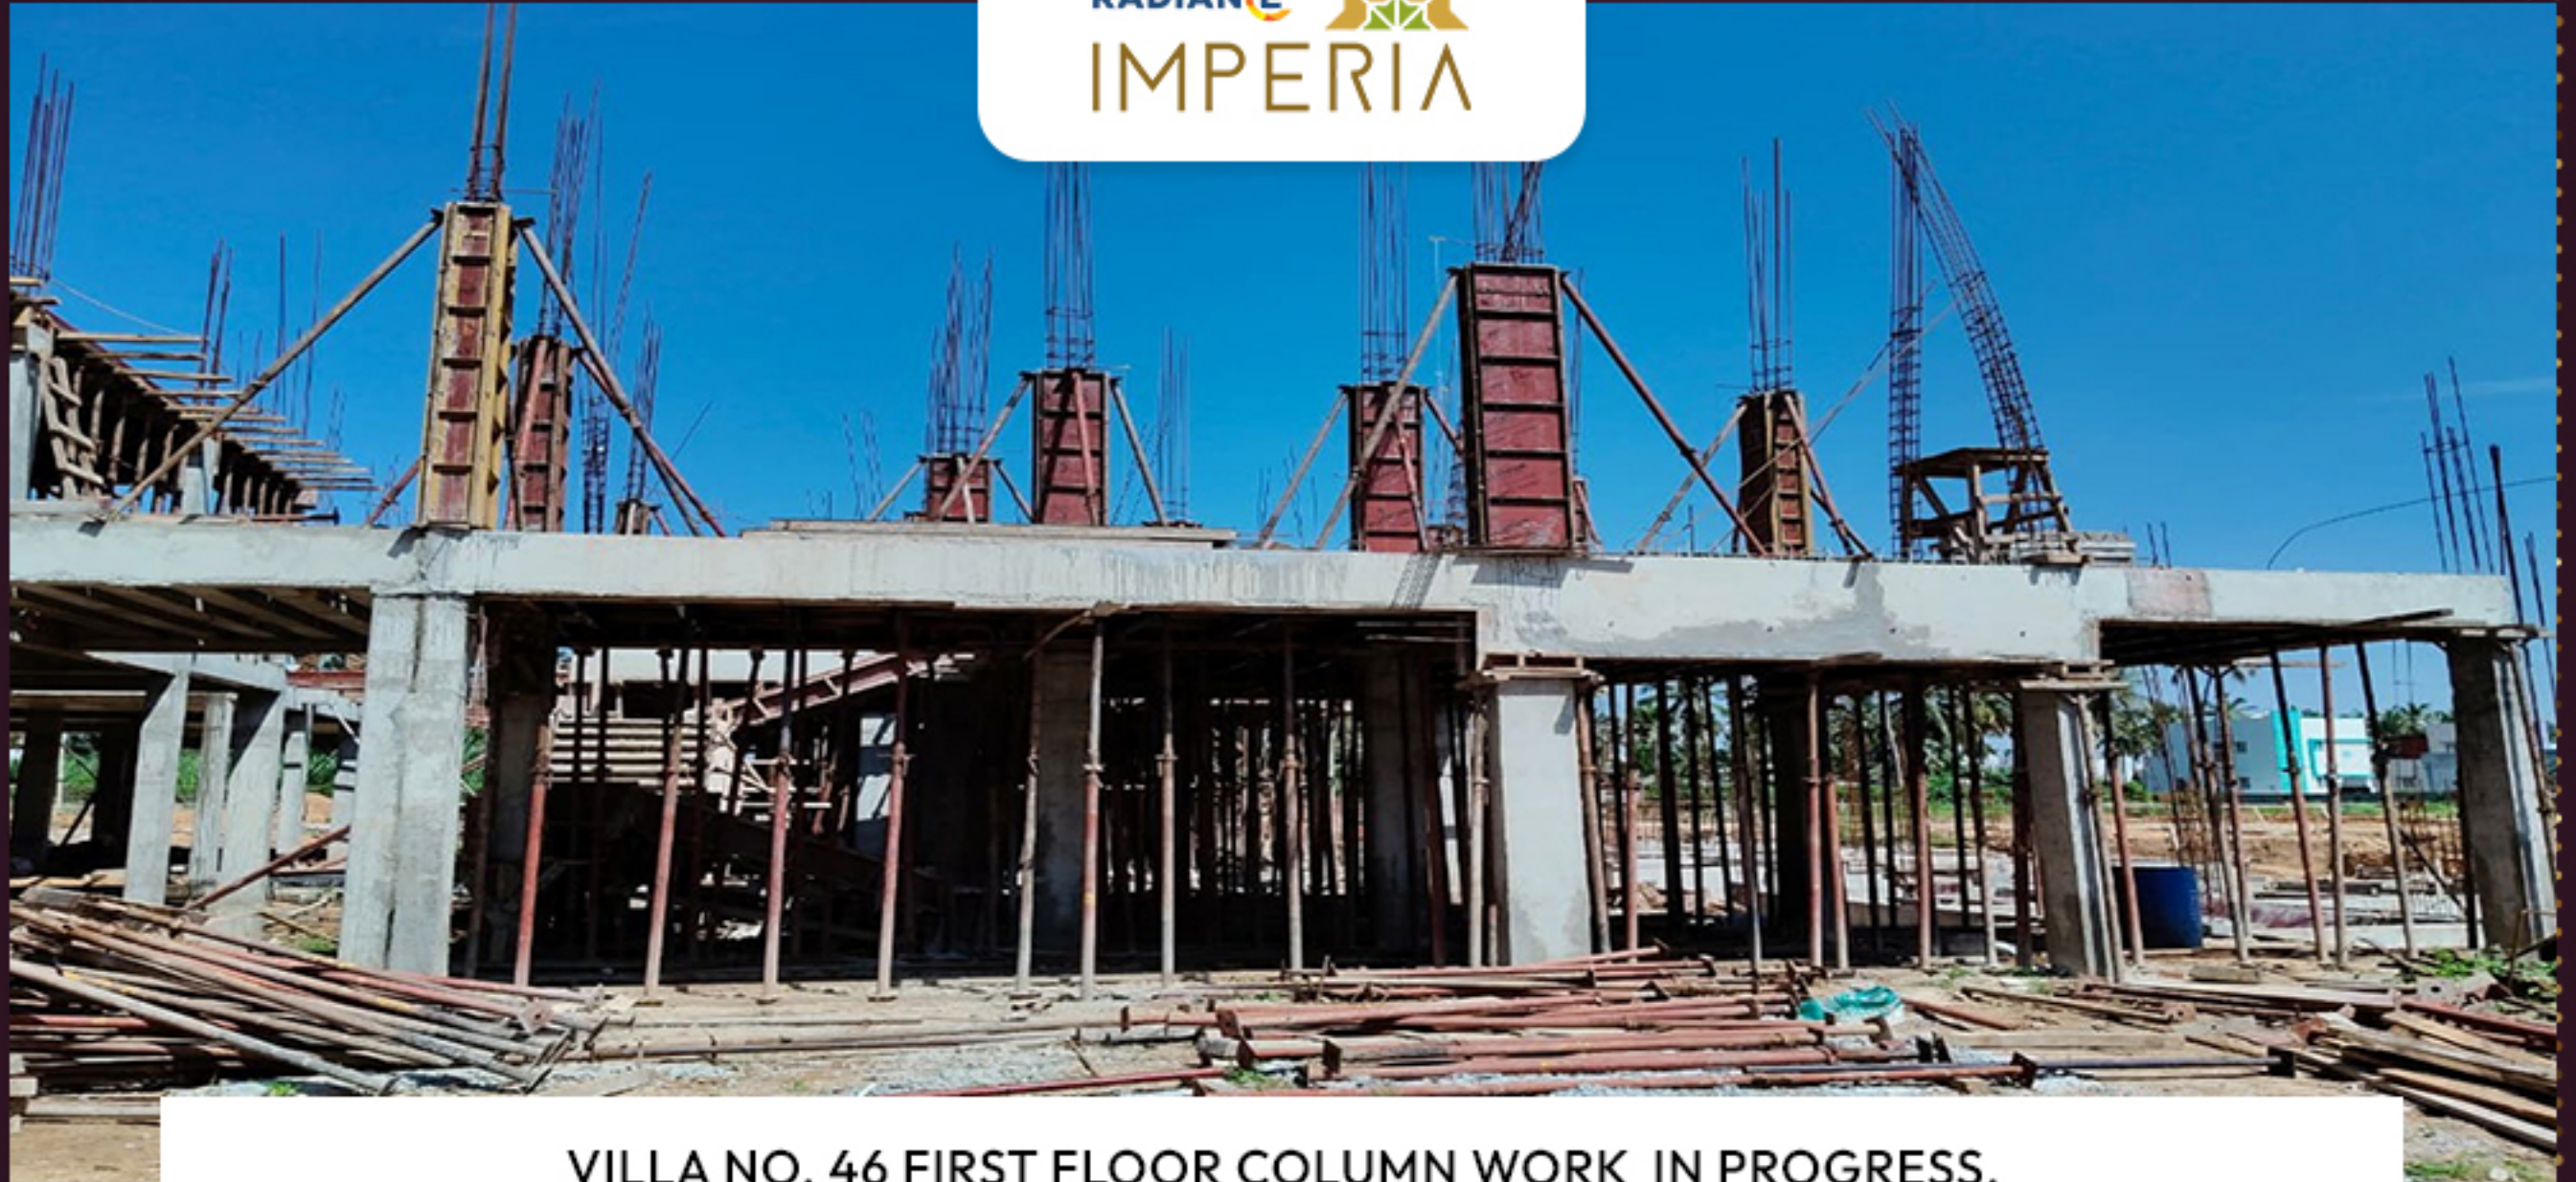
VILLA NO. 46 FIRST FLOOR COLUMN WORK IN PROGRESS.

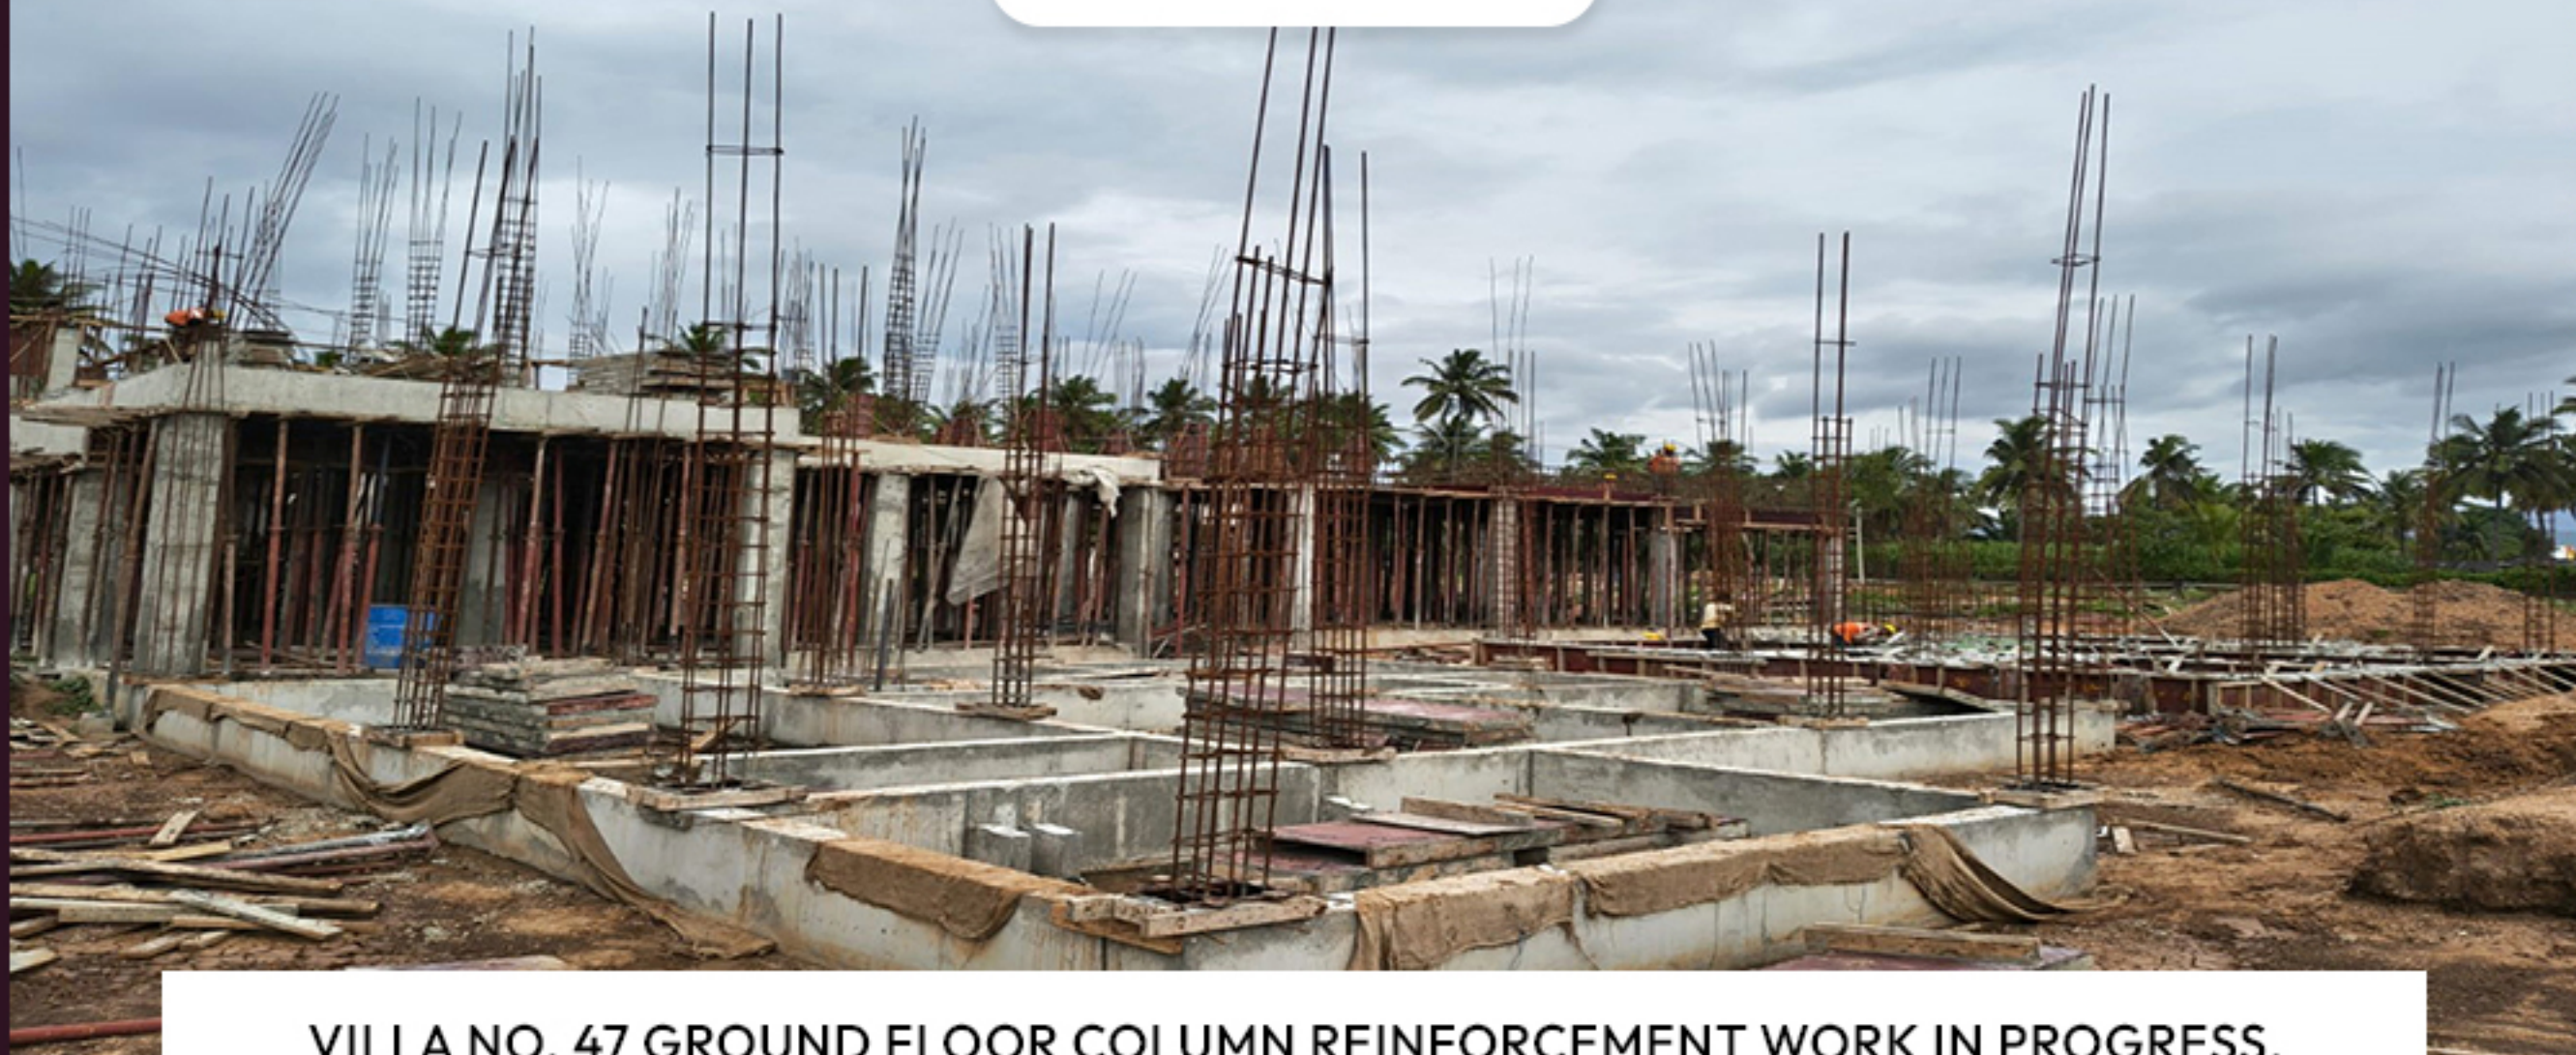
VILLA NO. 47 GROUND FLOOR COLUMN REINFORCEMENT WORK IN PROGRESS.

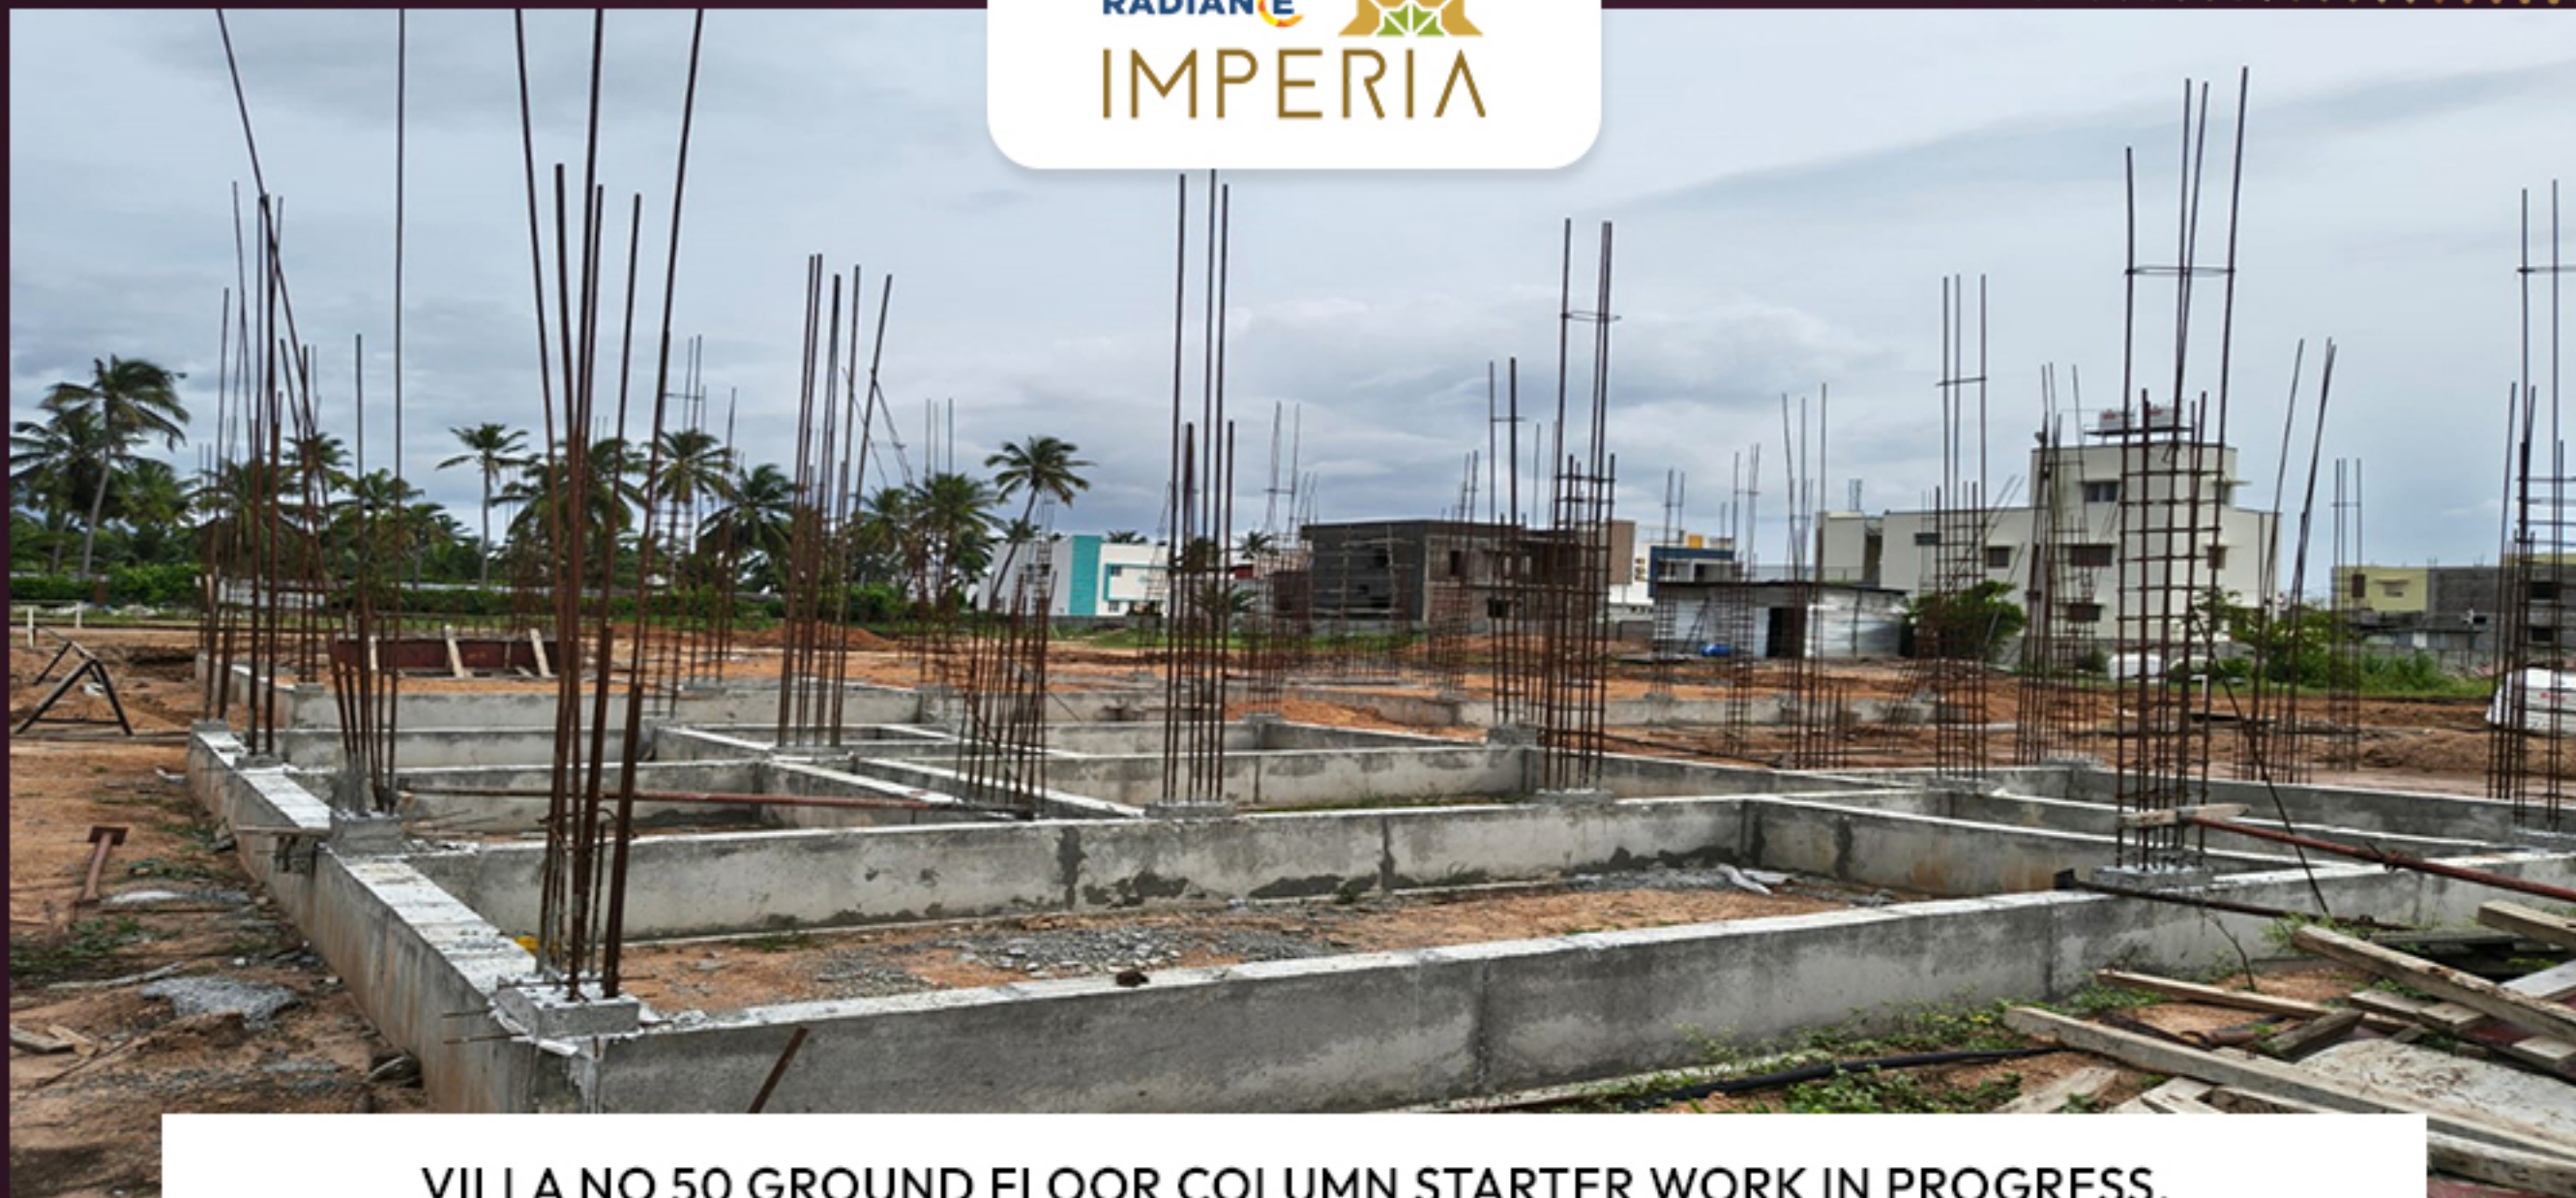
VILLA NO 50 GROUND FLOOR COLUMN STARTER WORK IN PROGRESS.
