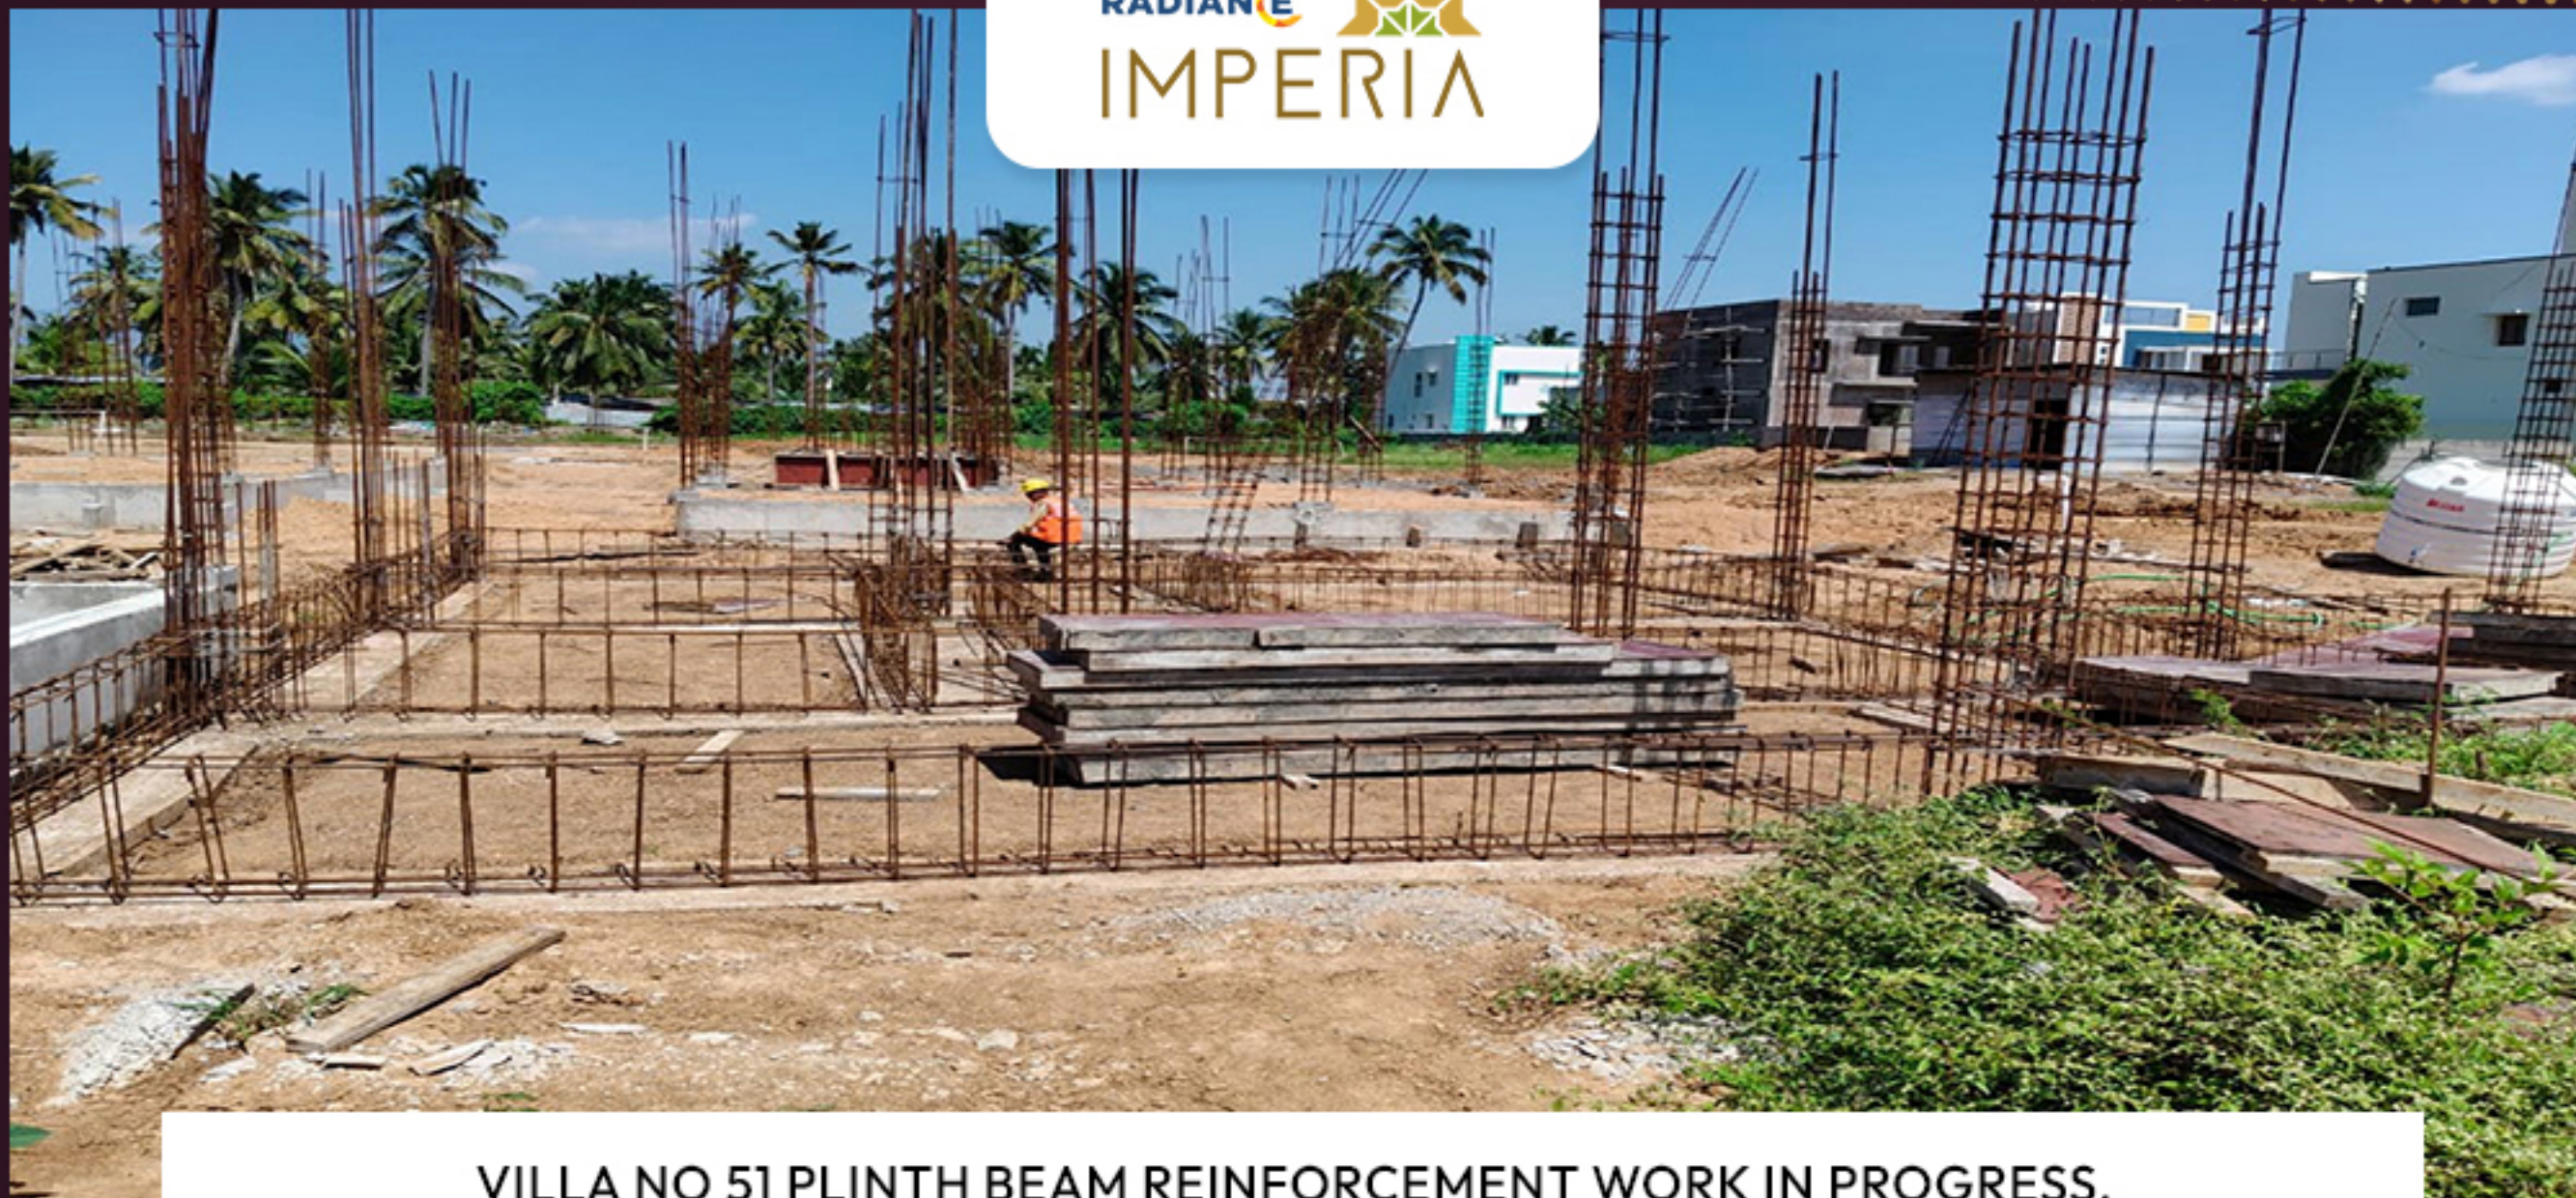
VILLA NO 51 PLINTH BEAM REINFORCEMENT WORK IN PROGRESS.

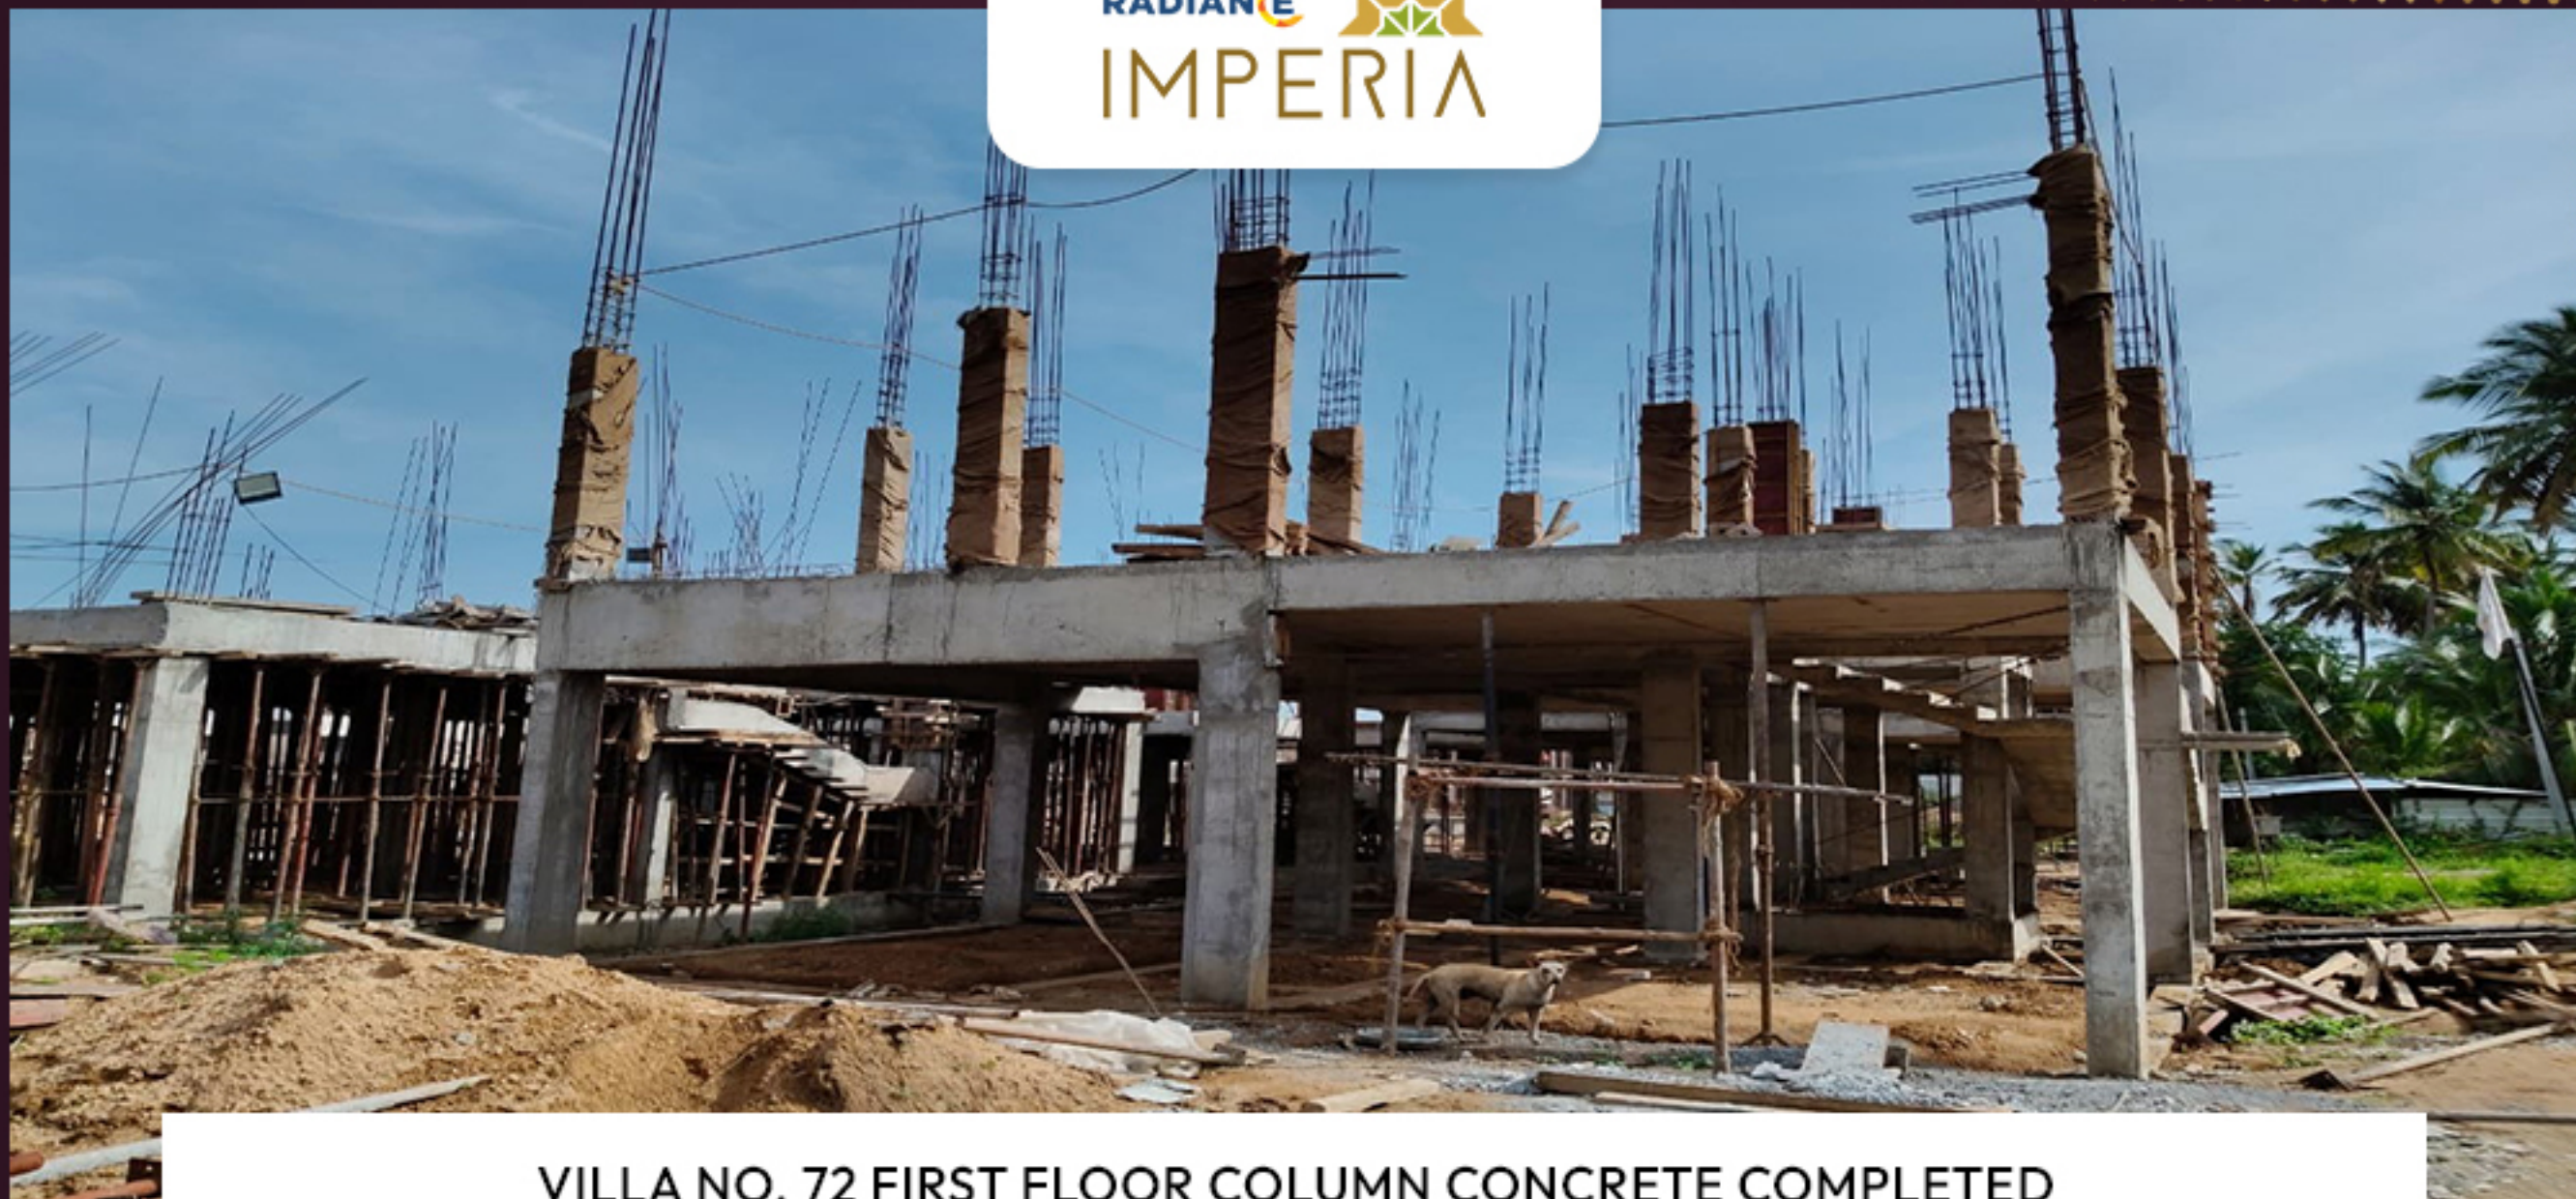
VILLA NO. 72 FIRST FLOOR COLUMN CONCRETE COMPLETED

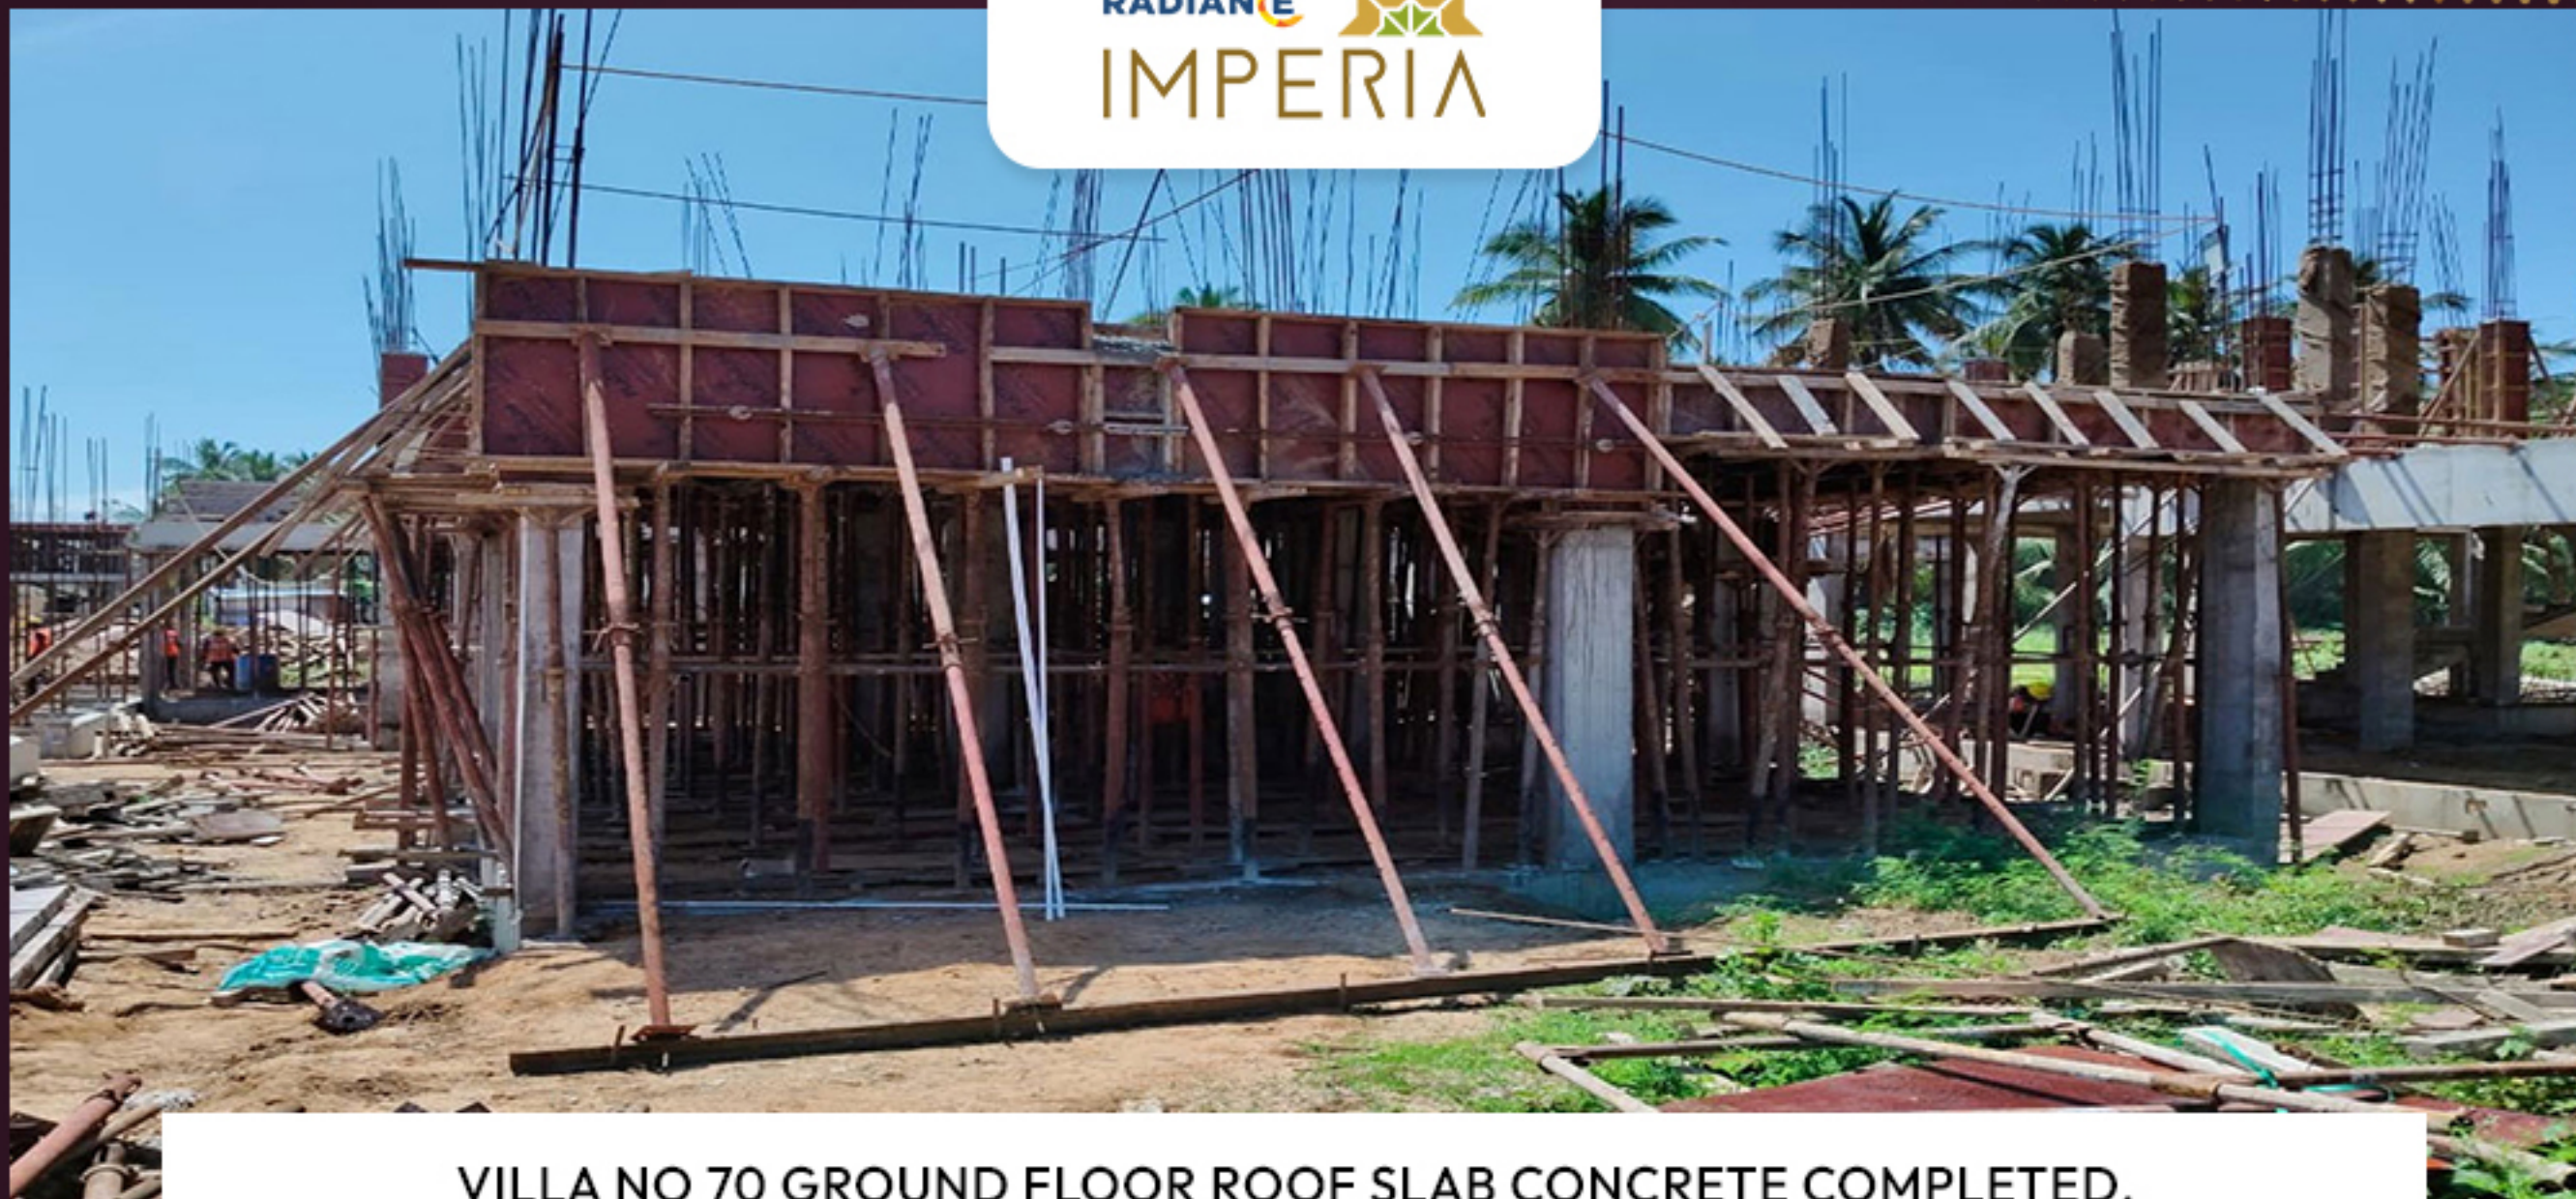
VILLA NO 70 GROUND FLOOR ROOF SLAB CONCRETE COMPLETED.

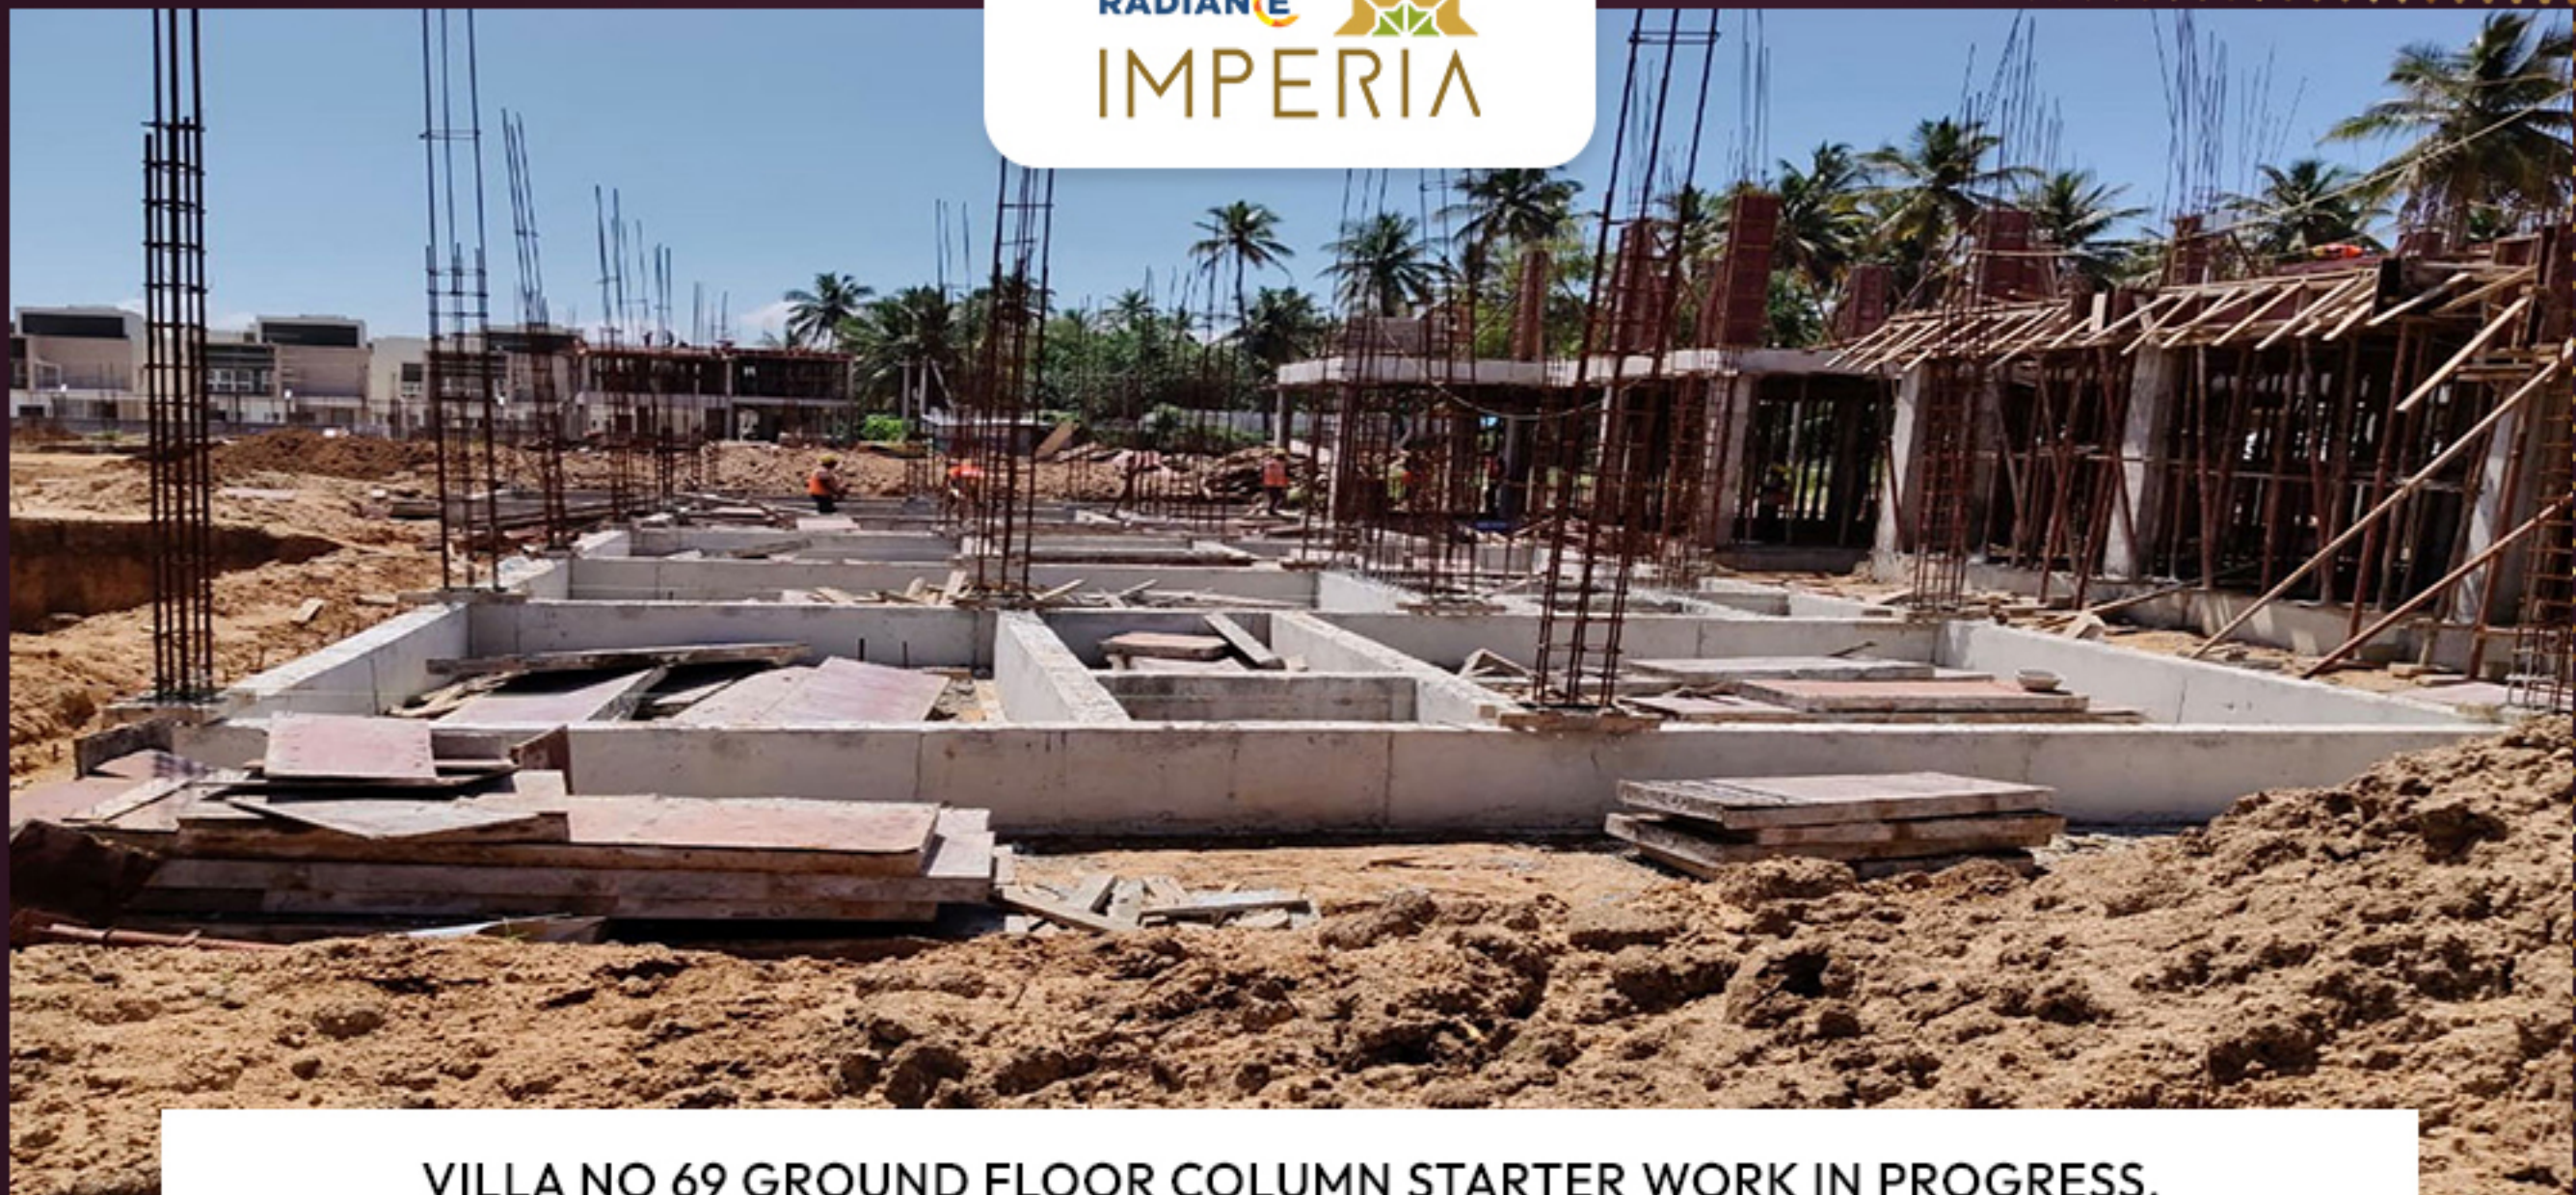
VILLA NO 69 GROUND FLOOR COLUMN STARTER WORK IN PROGRESS.

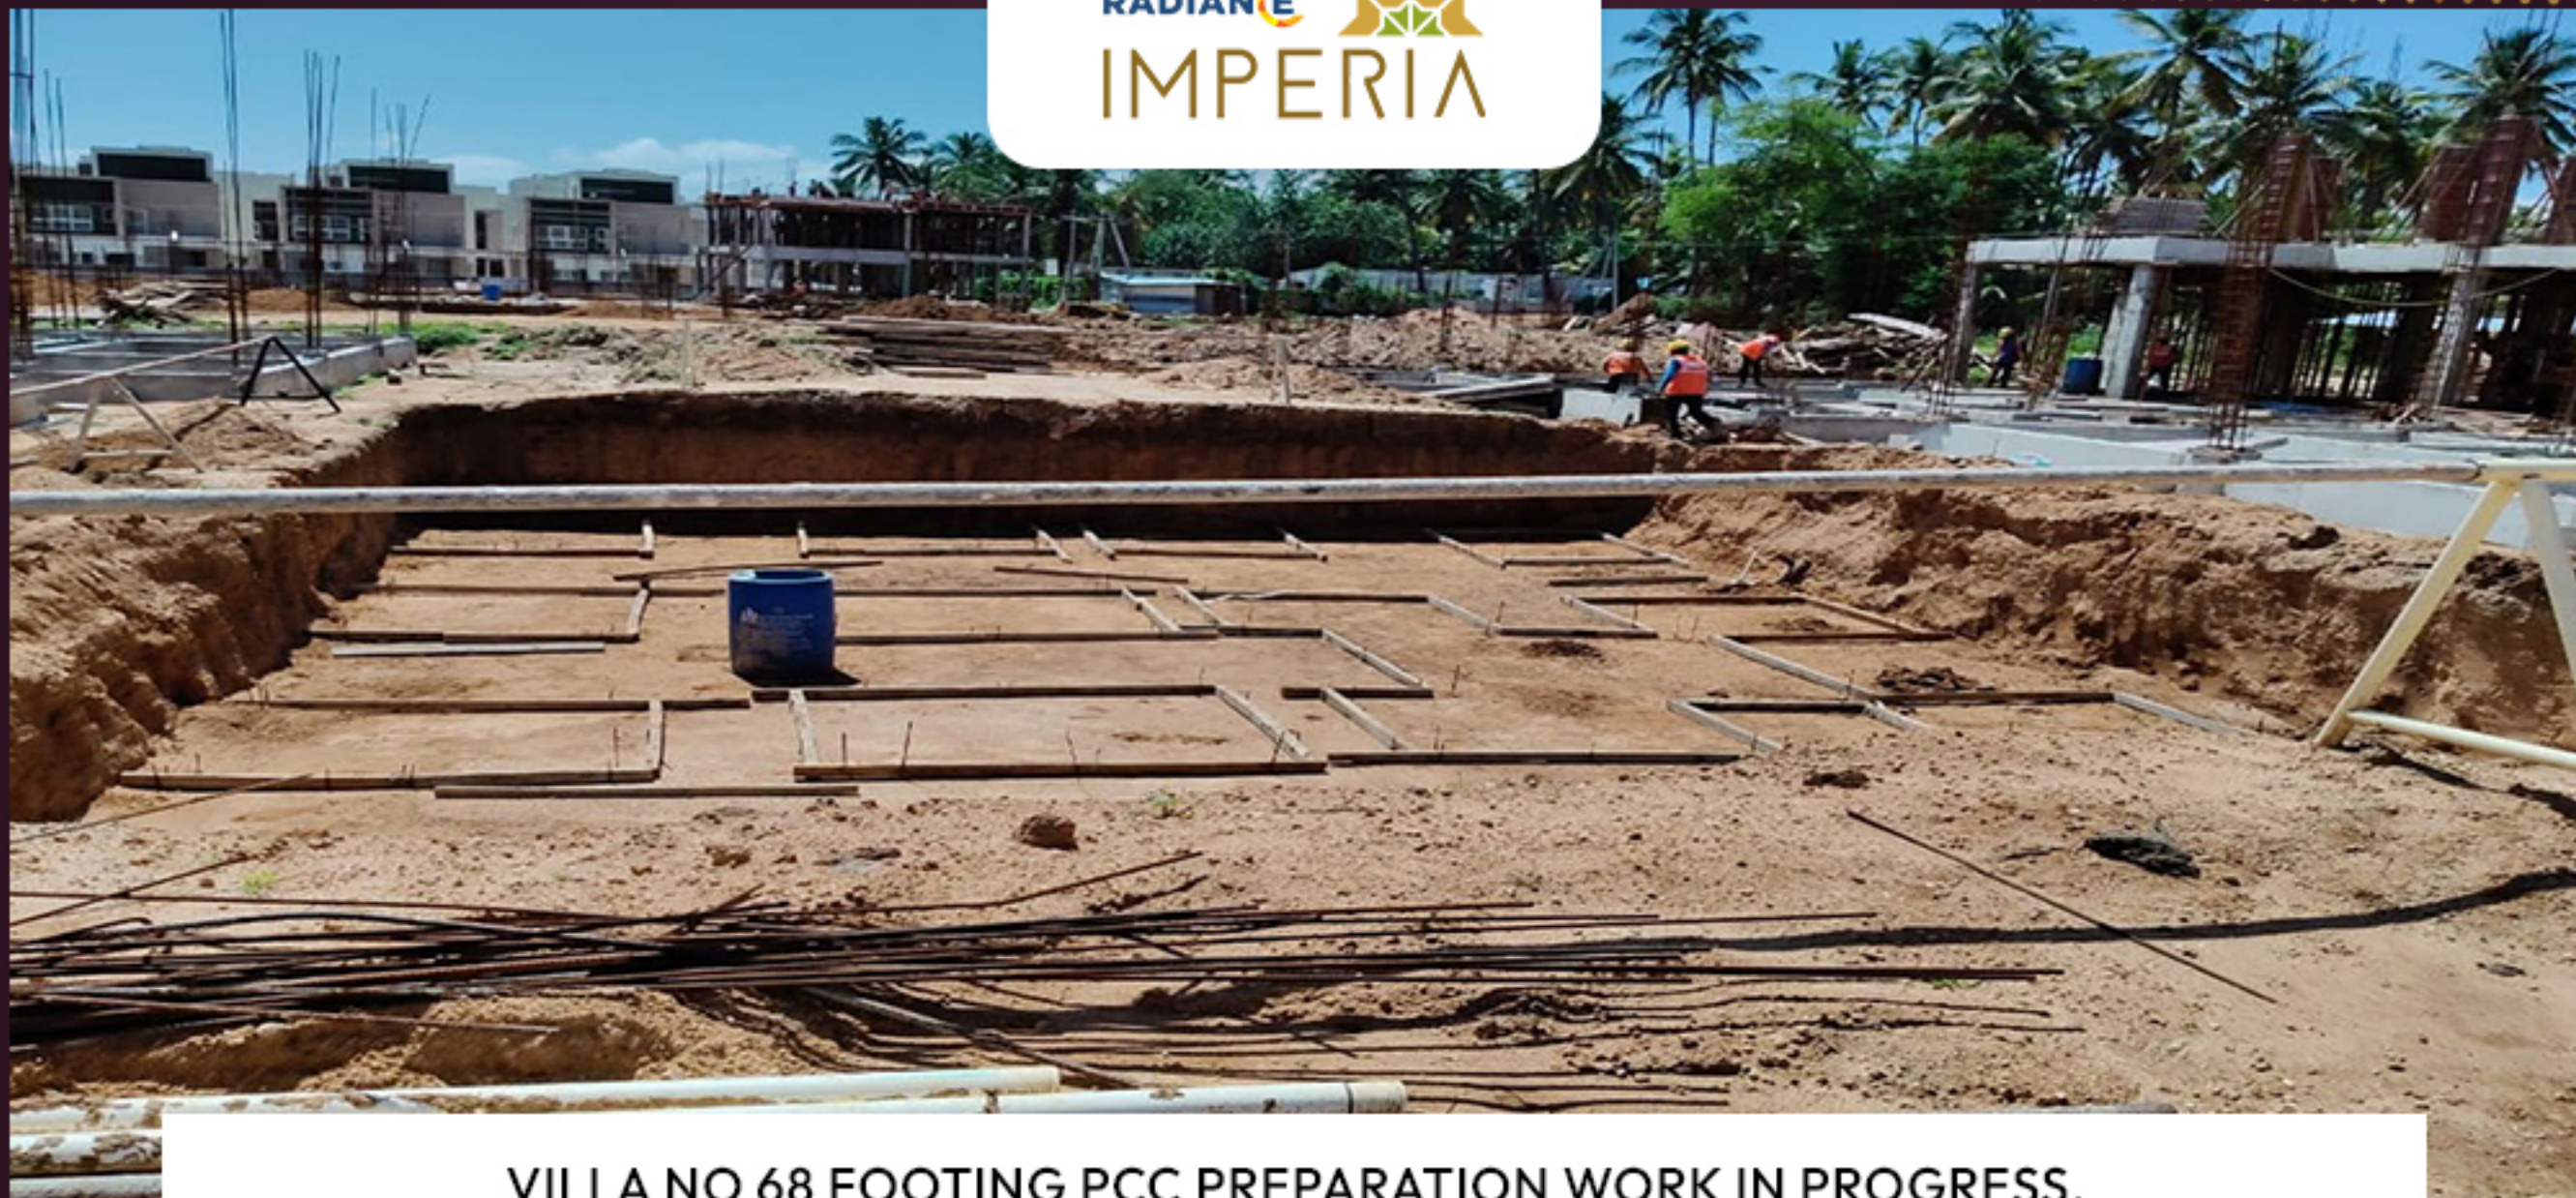
VILLA NO 68 FOOTING PCC PREPARATION WORK IN PROGRESS.

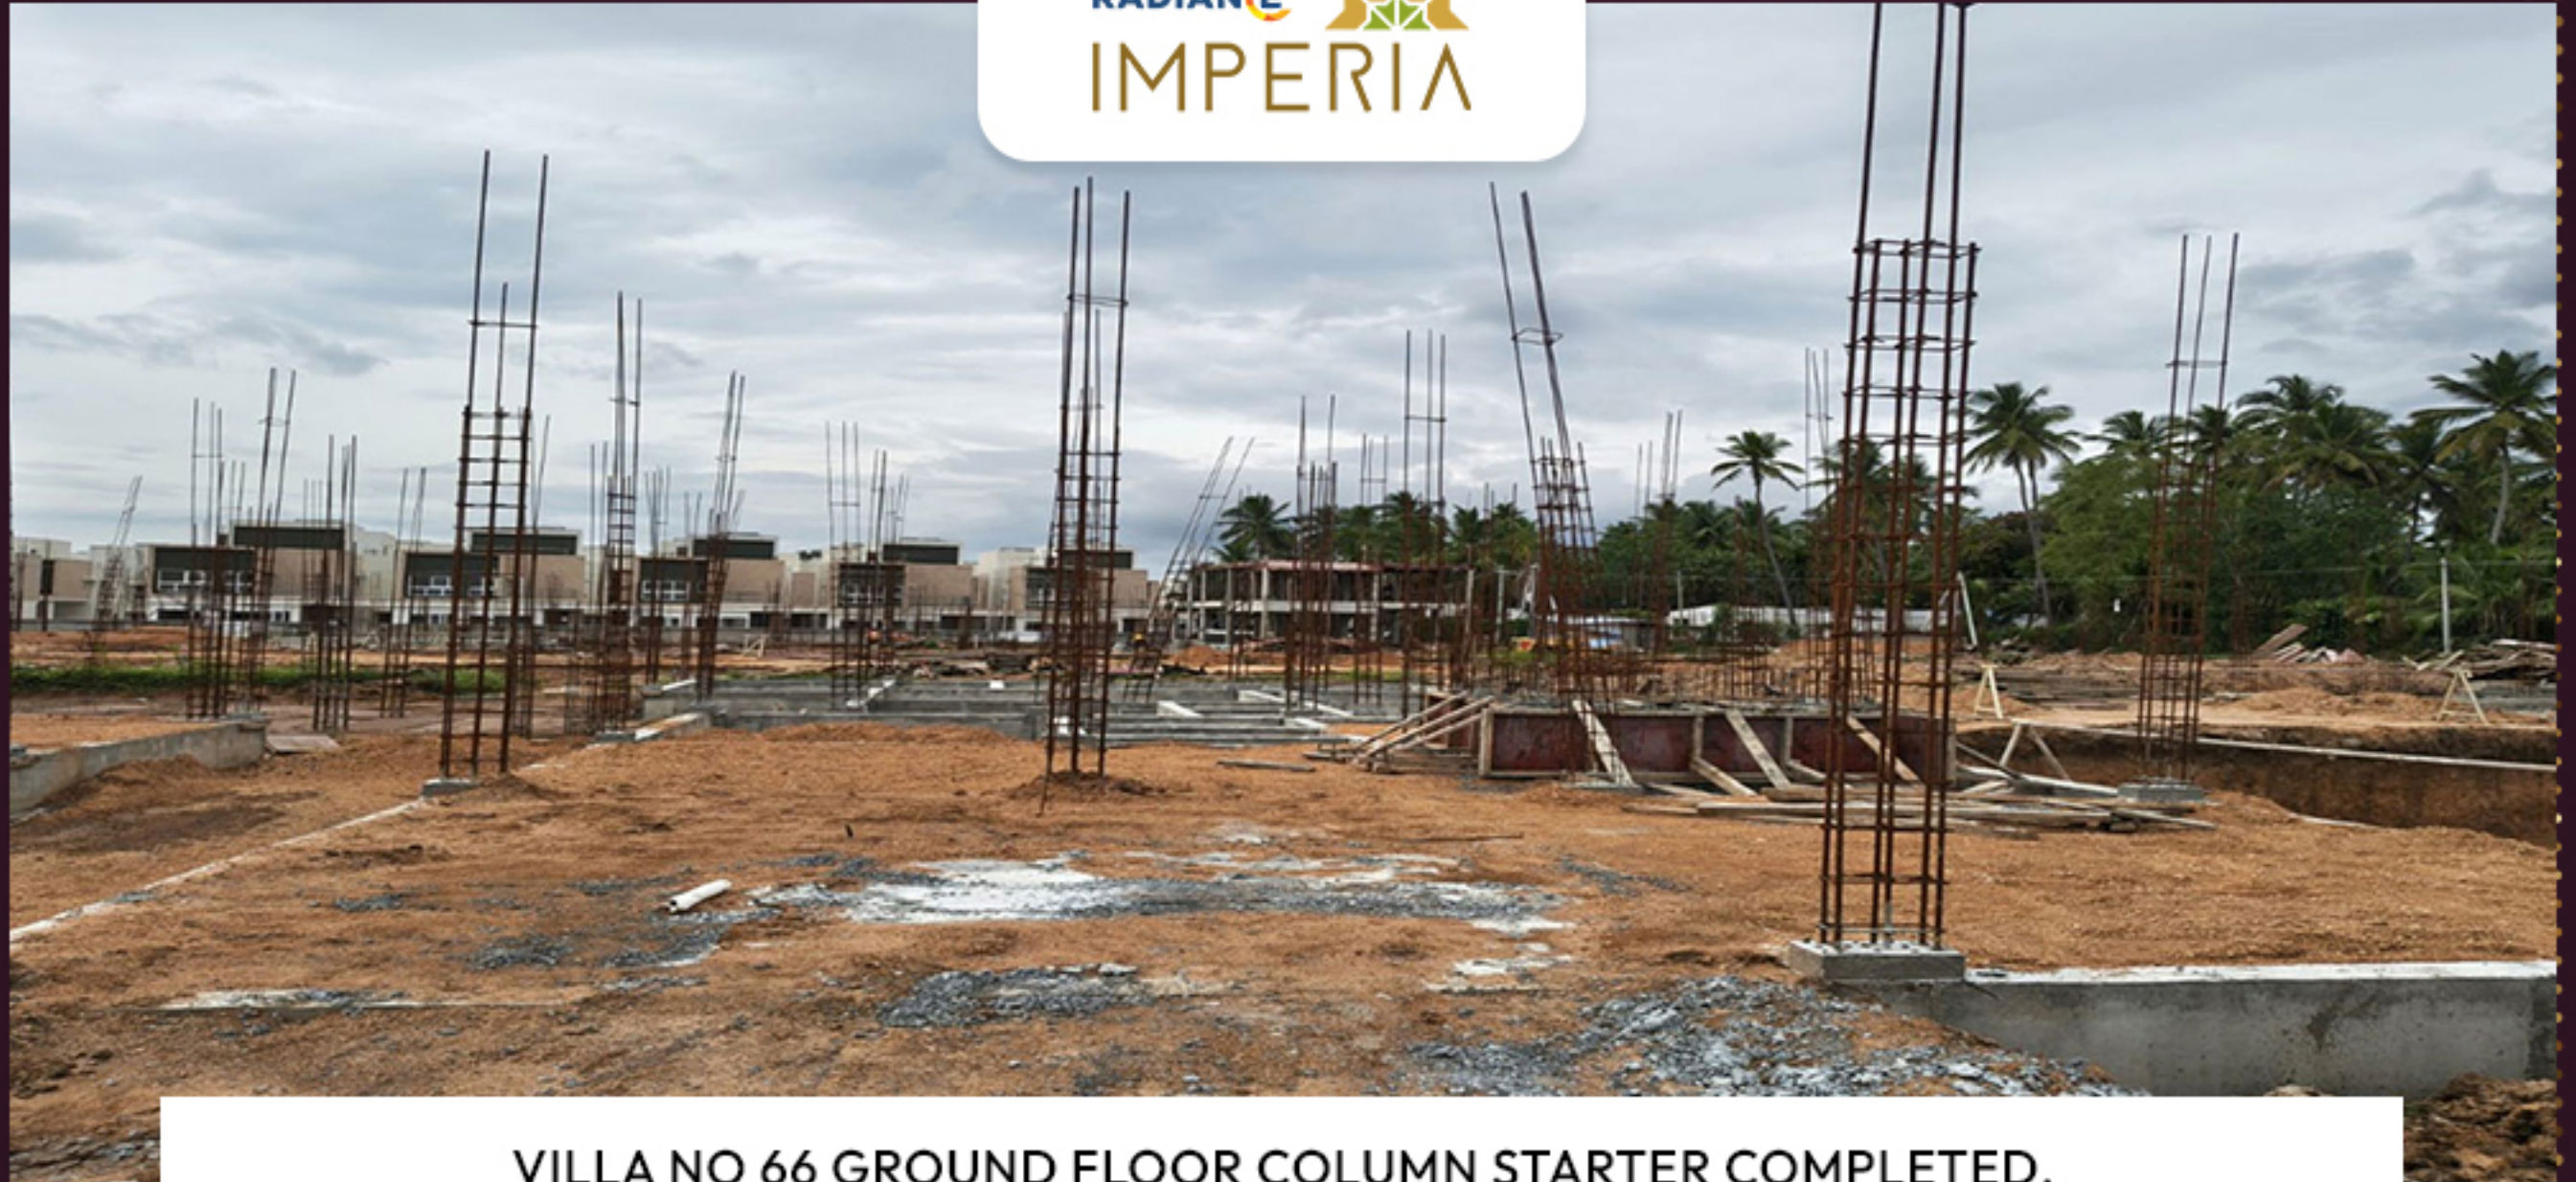
VILLA NO 66 GROUND FLOOR COLUMN STARTER COMPLETED.

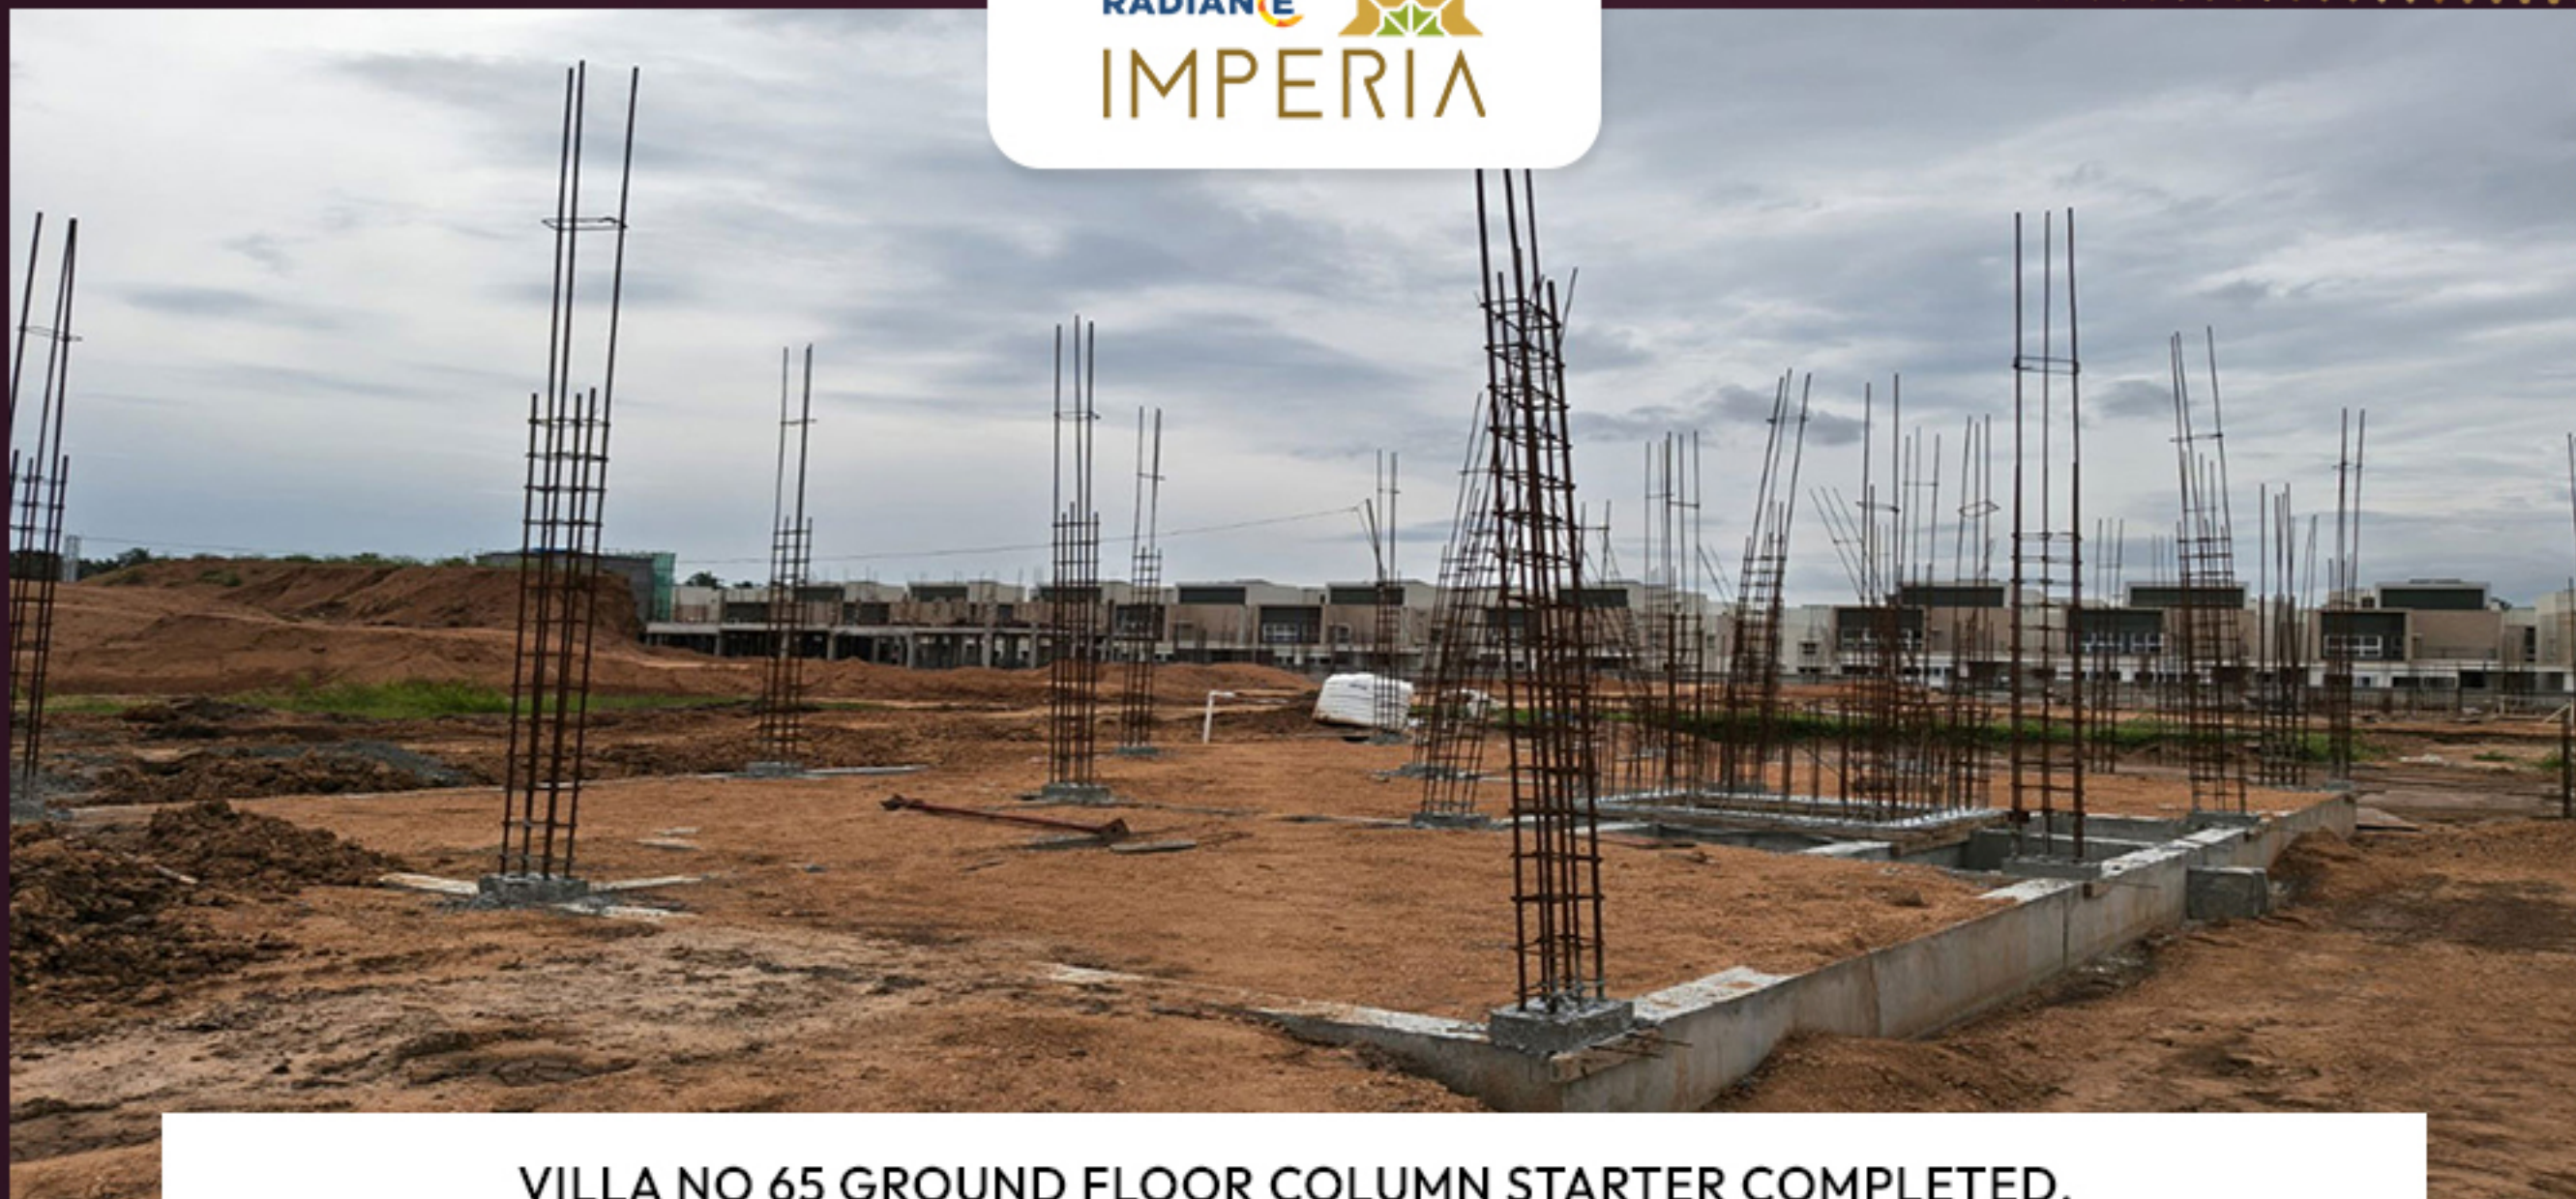
VILLA NO 65 GROUND FLOOR COLUMN STARTER COMPLETED.
