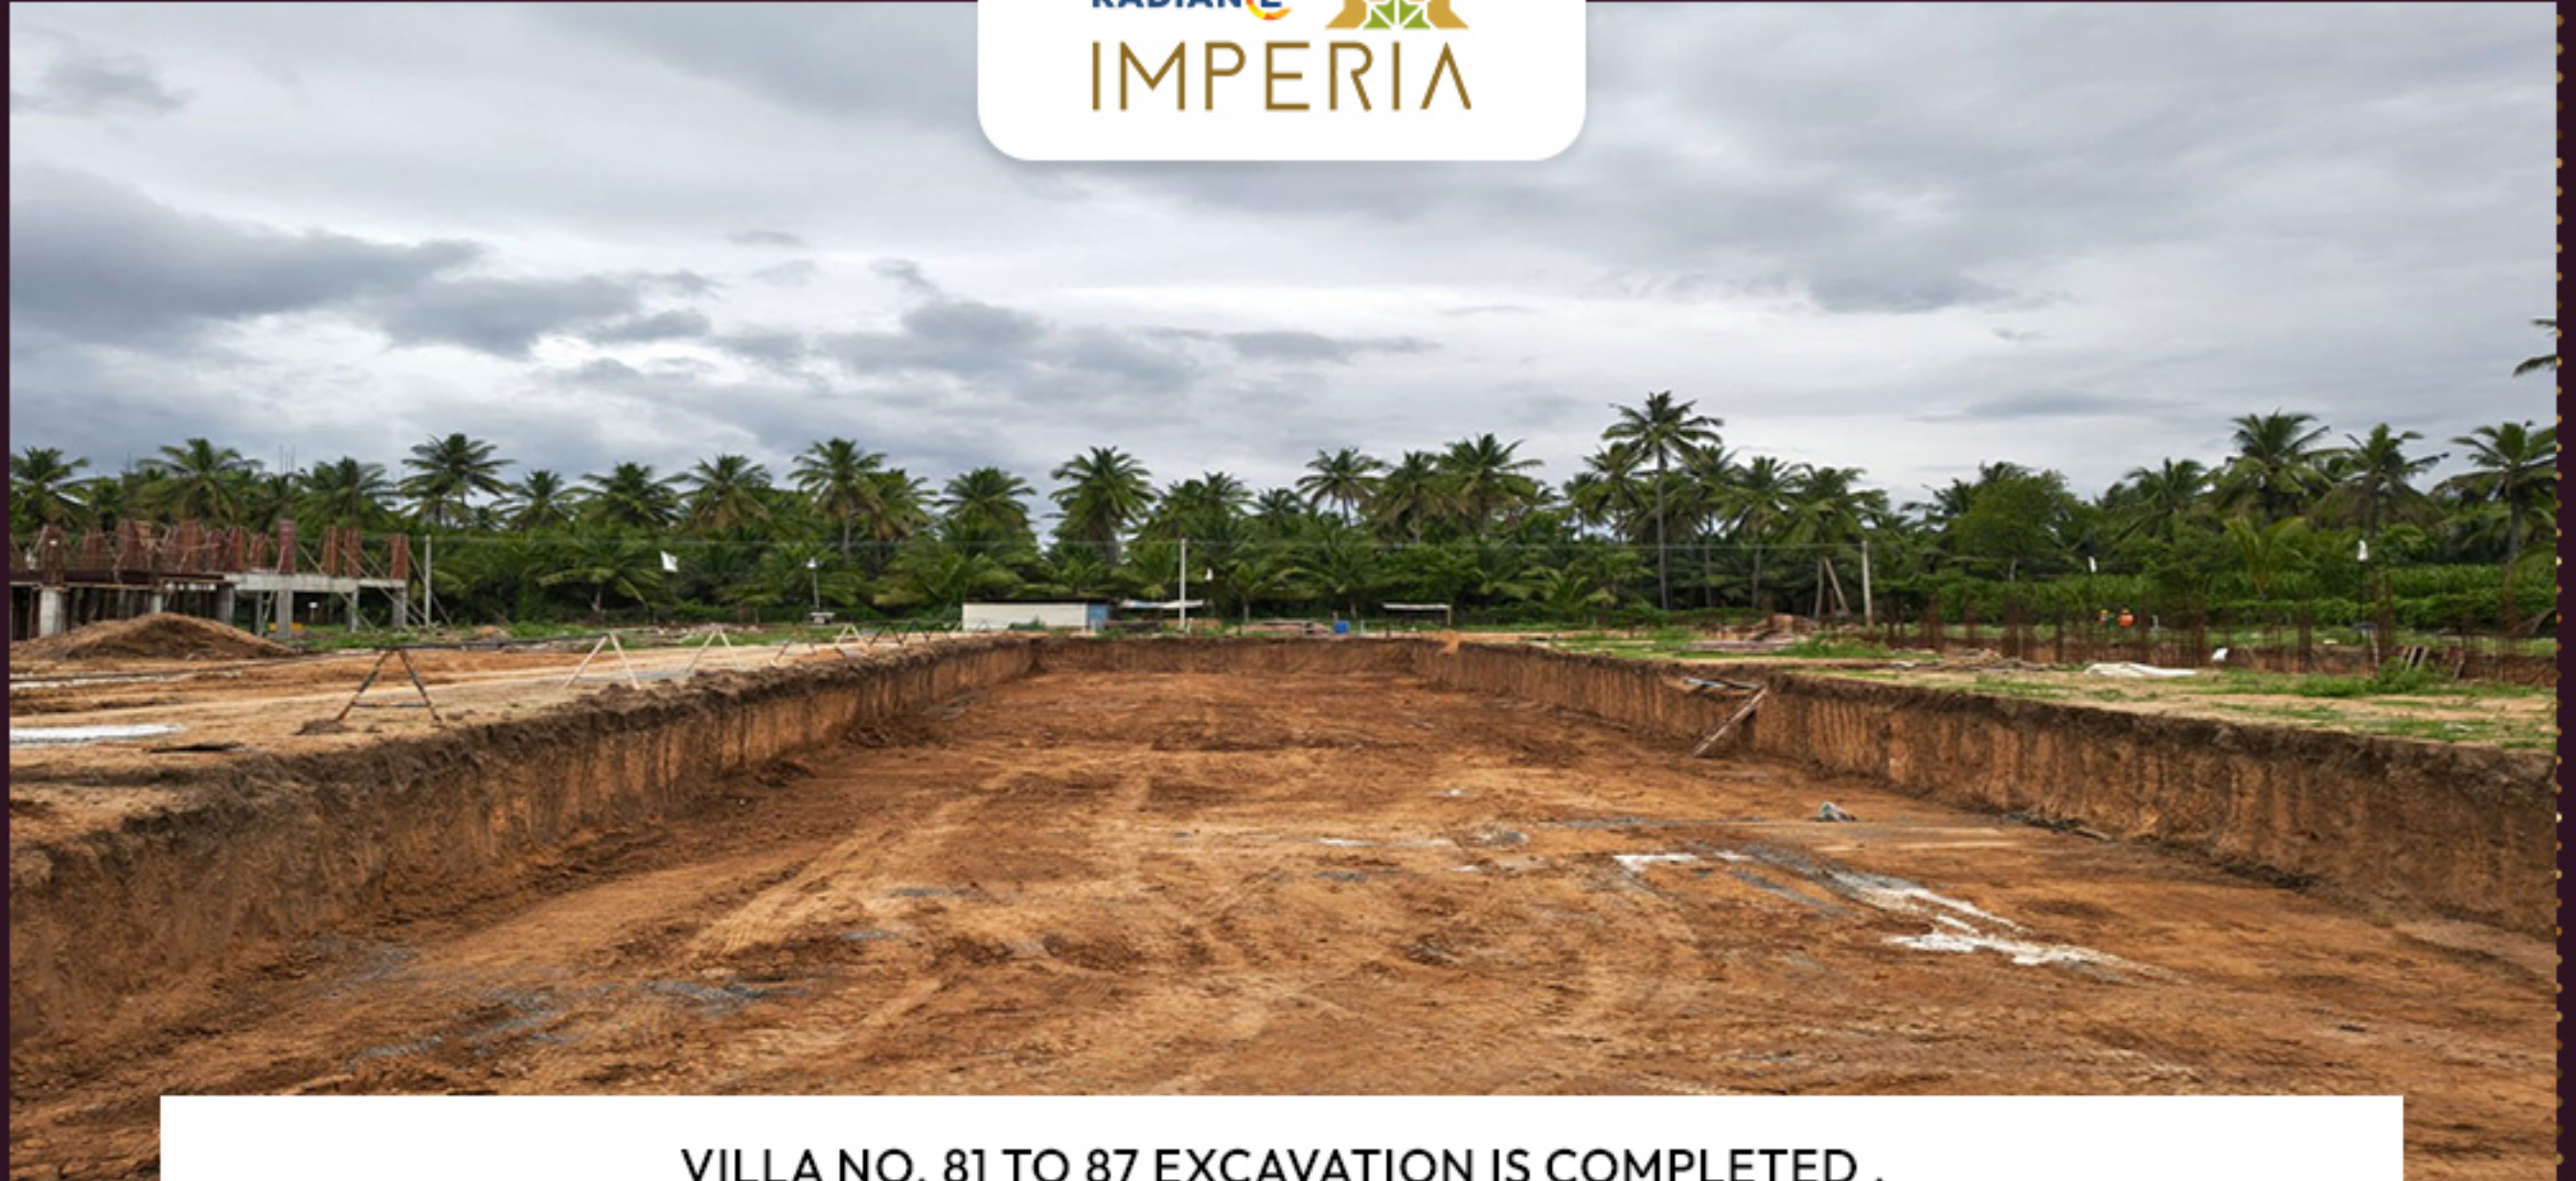
VILLA NO. 81 TO 87 EXCAVATION IS COMPLETED .

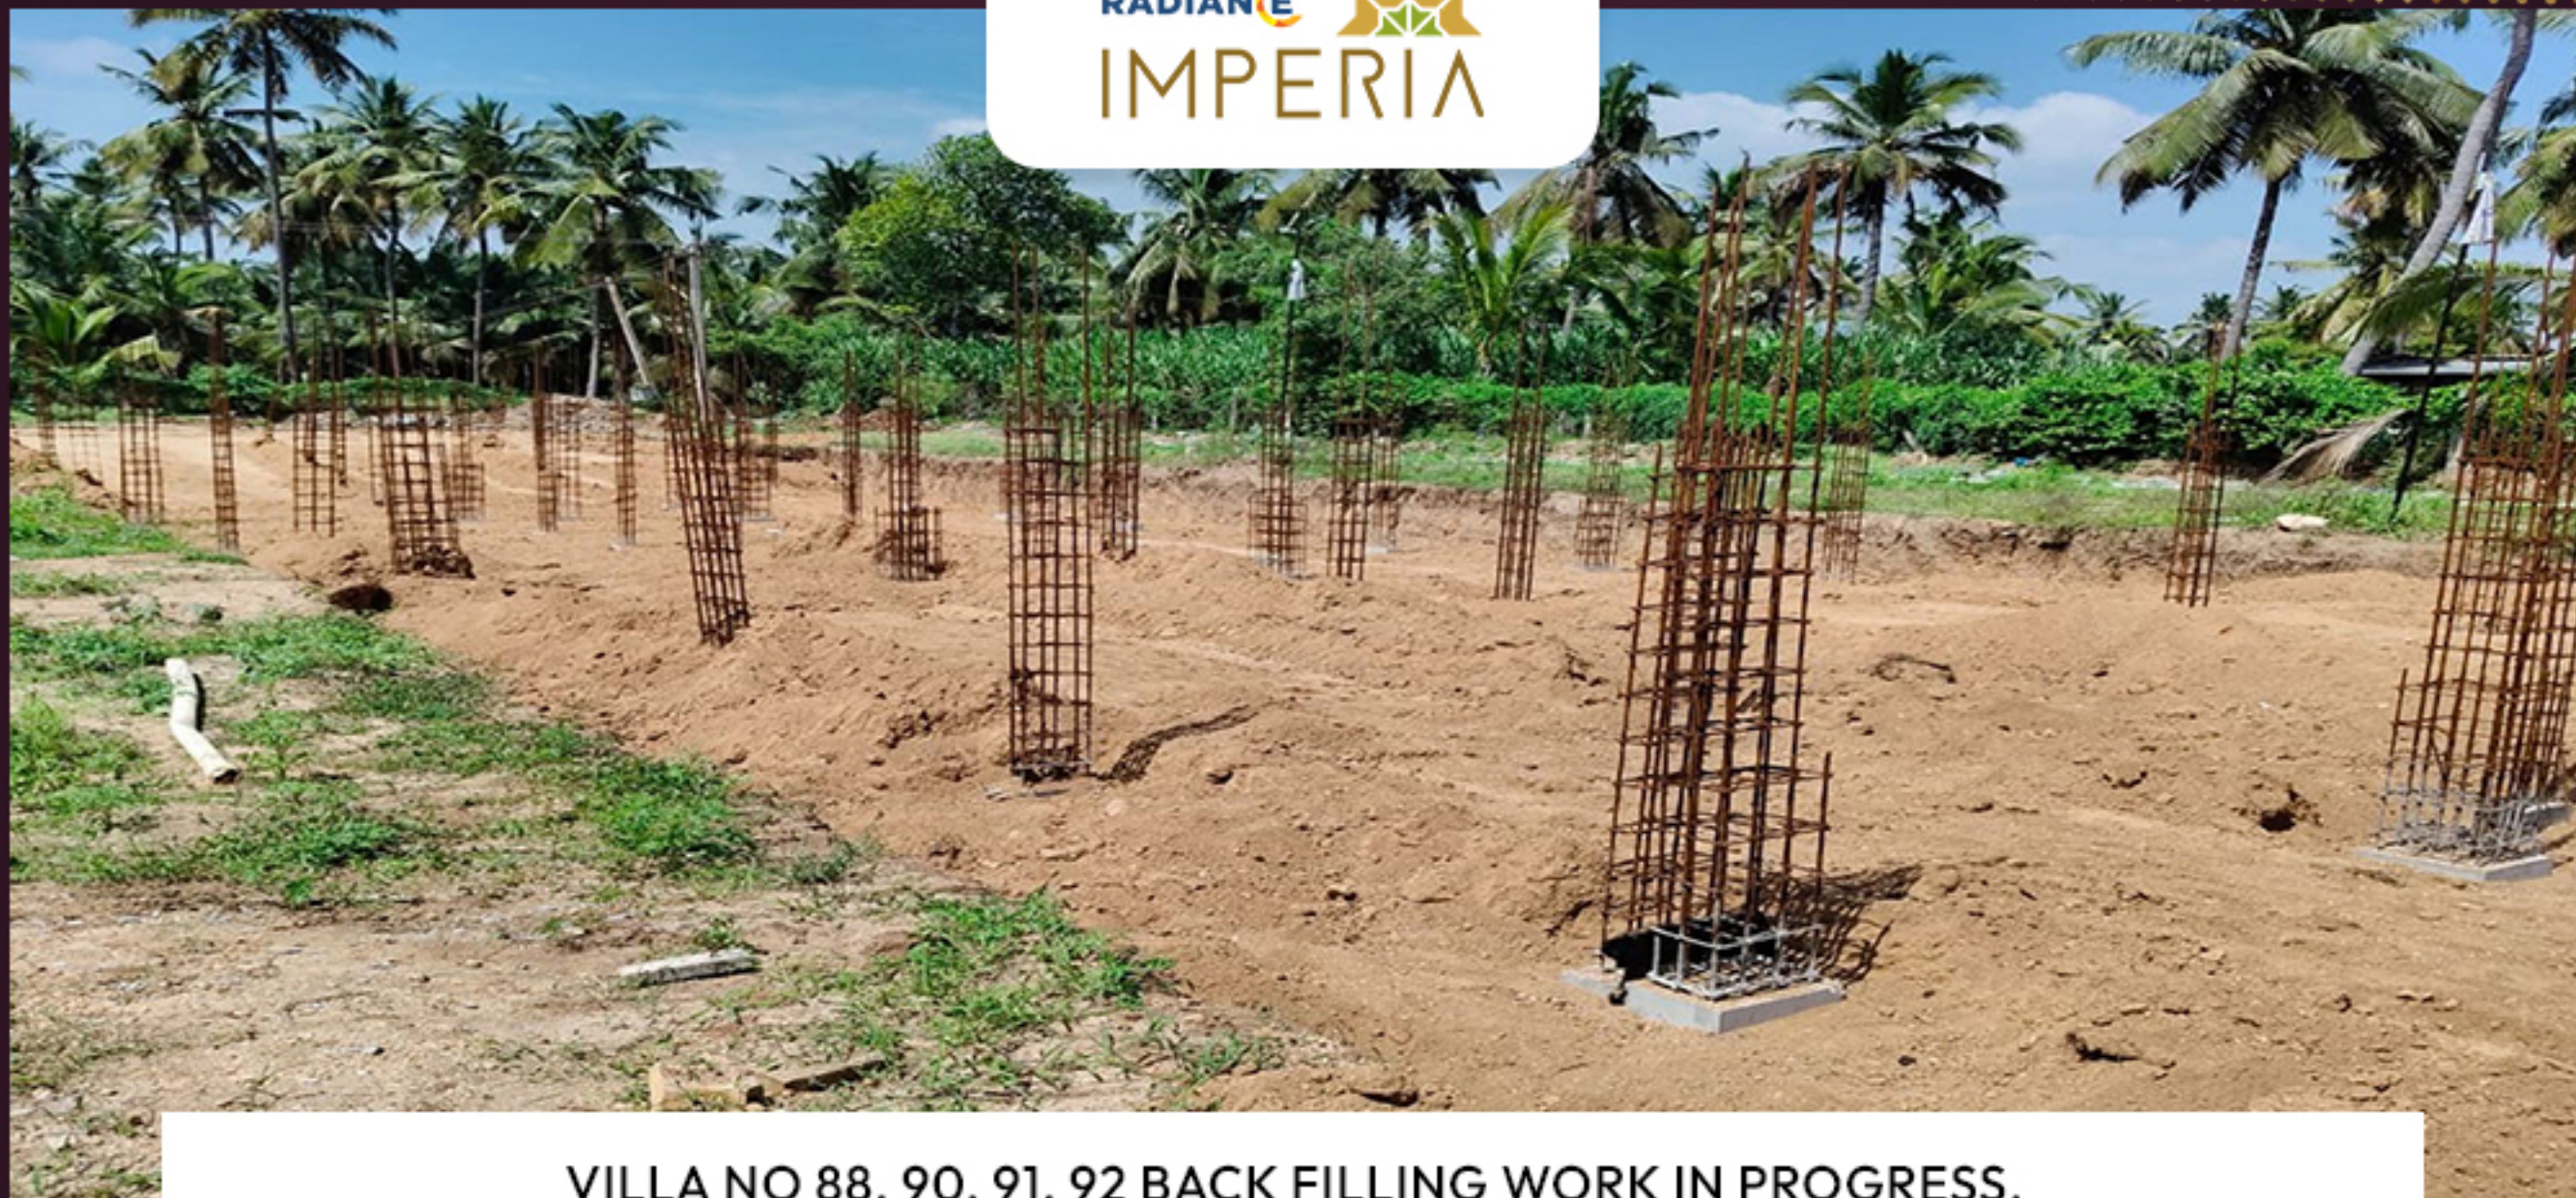
VILLA NO 88, 90, 91, 92 BACK FILLING WORK IN PROGRESS.

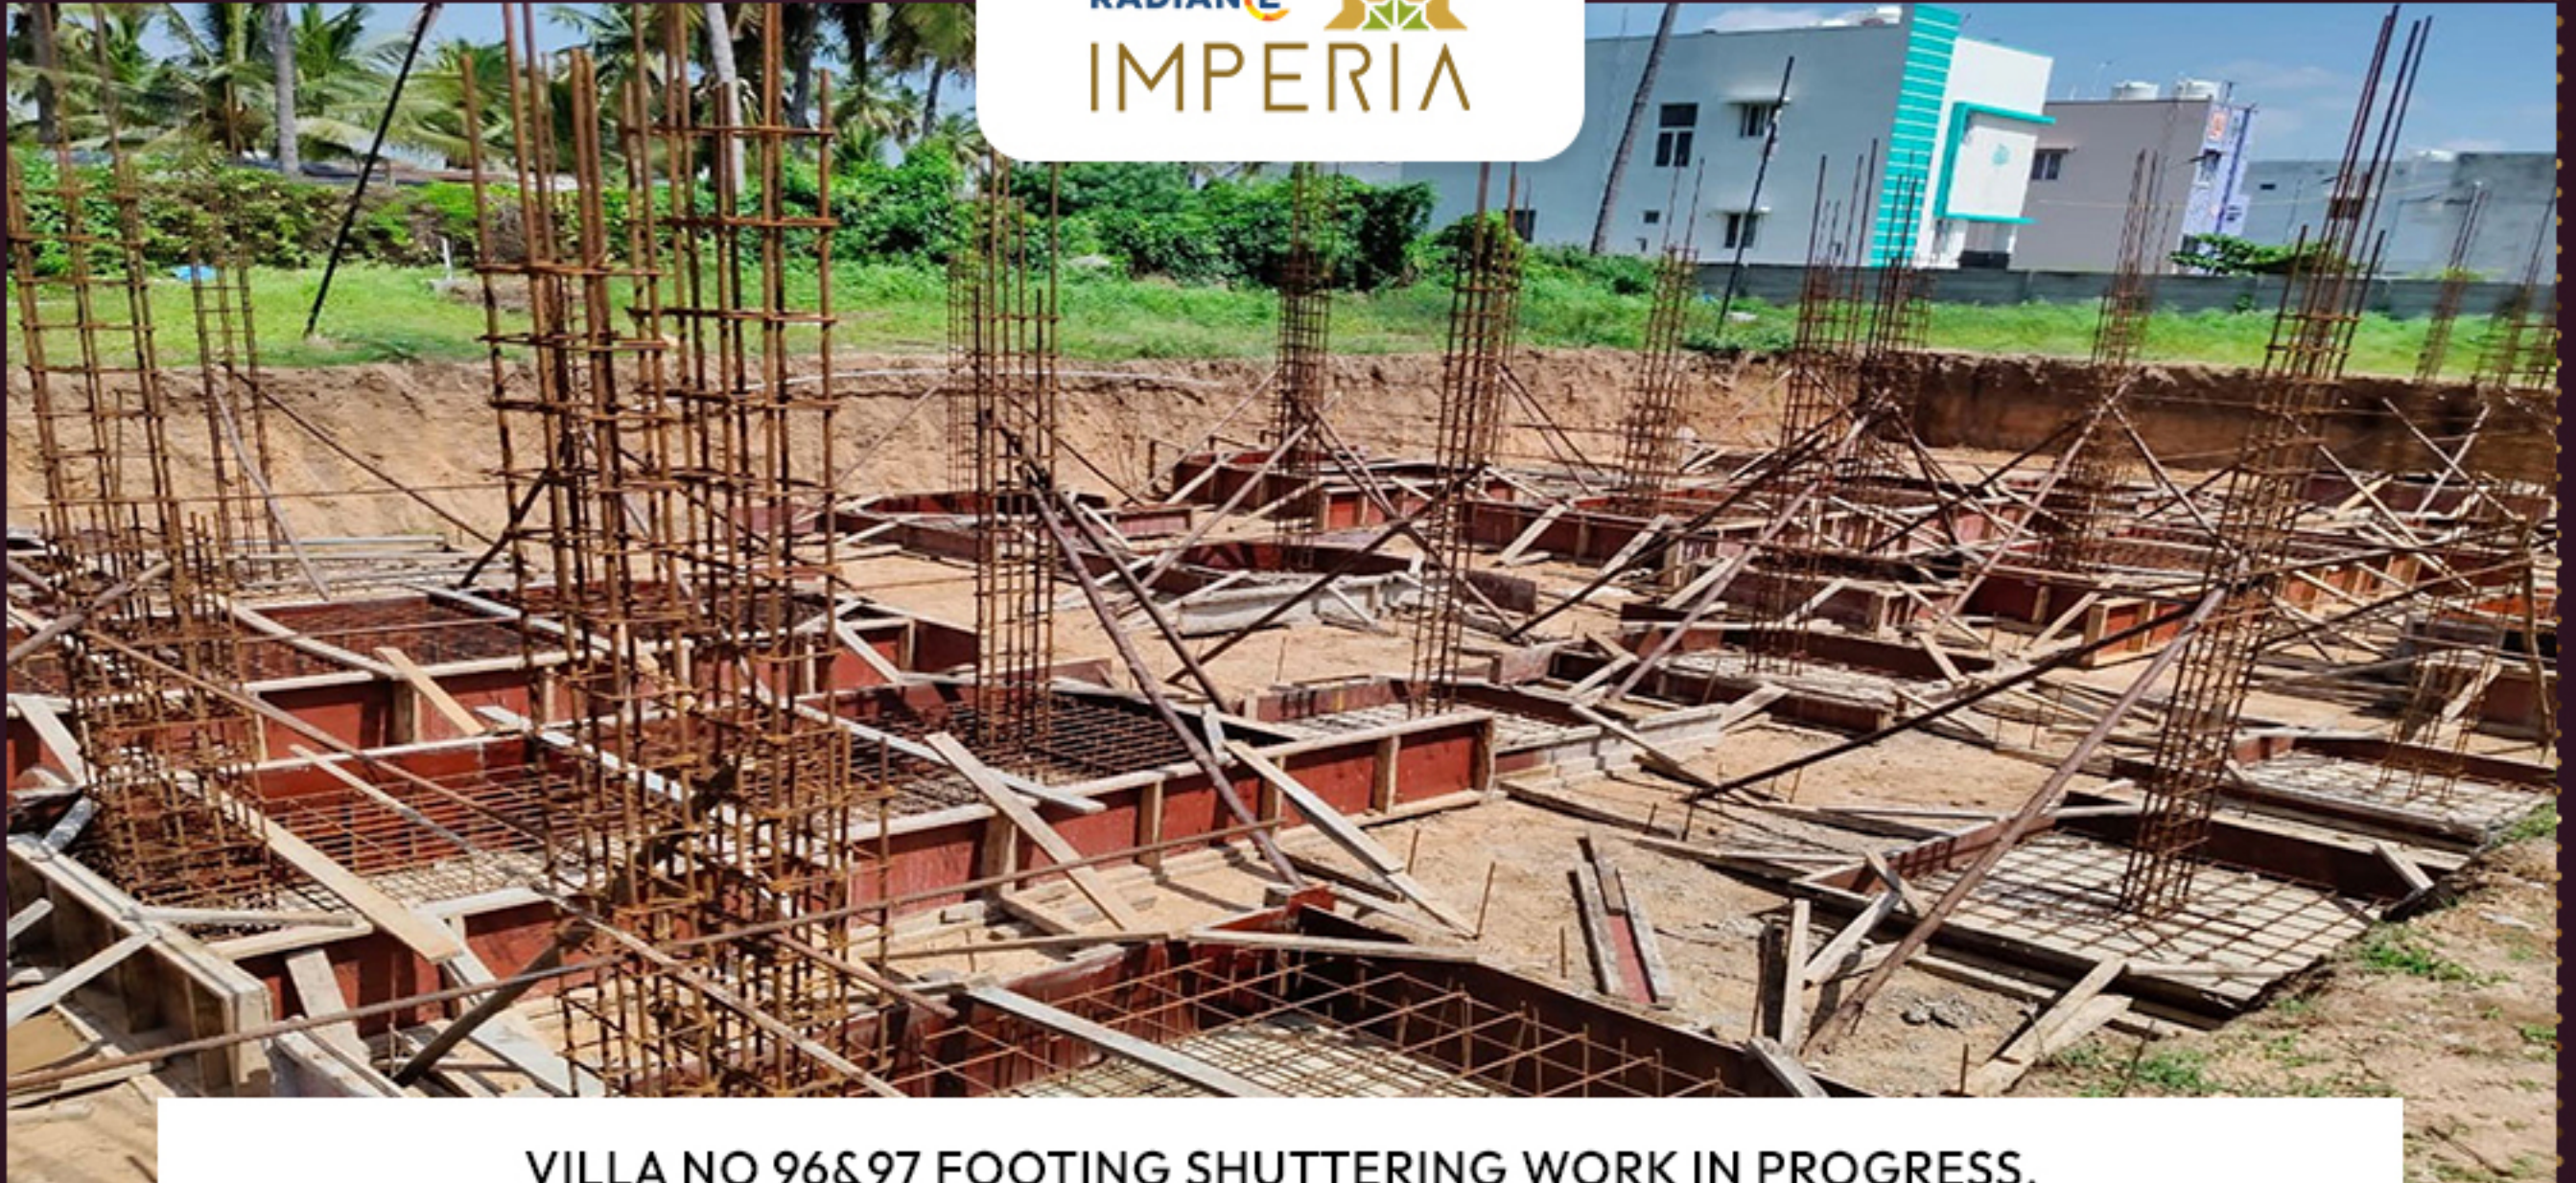
VILLA NO 96&97 FOOTING SHUTTERING WORK IN PROGRESS.

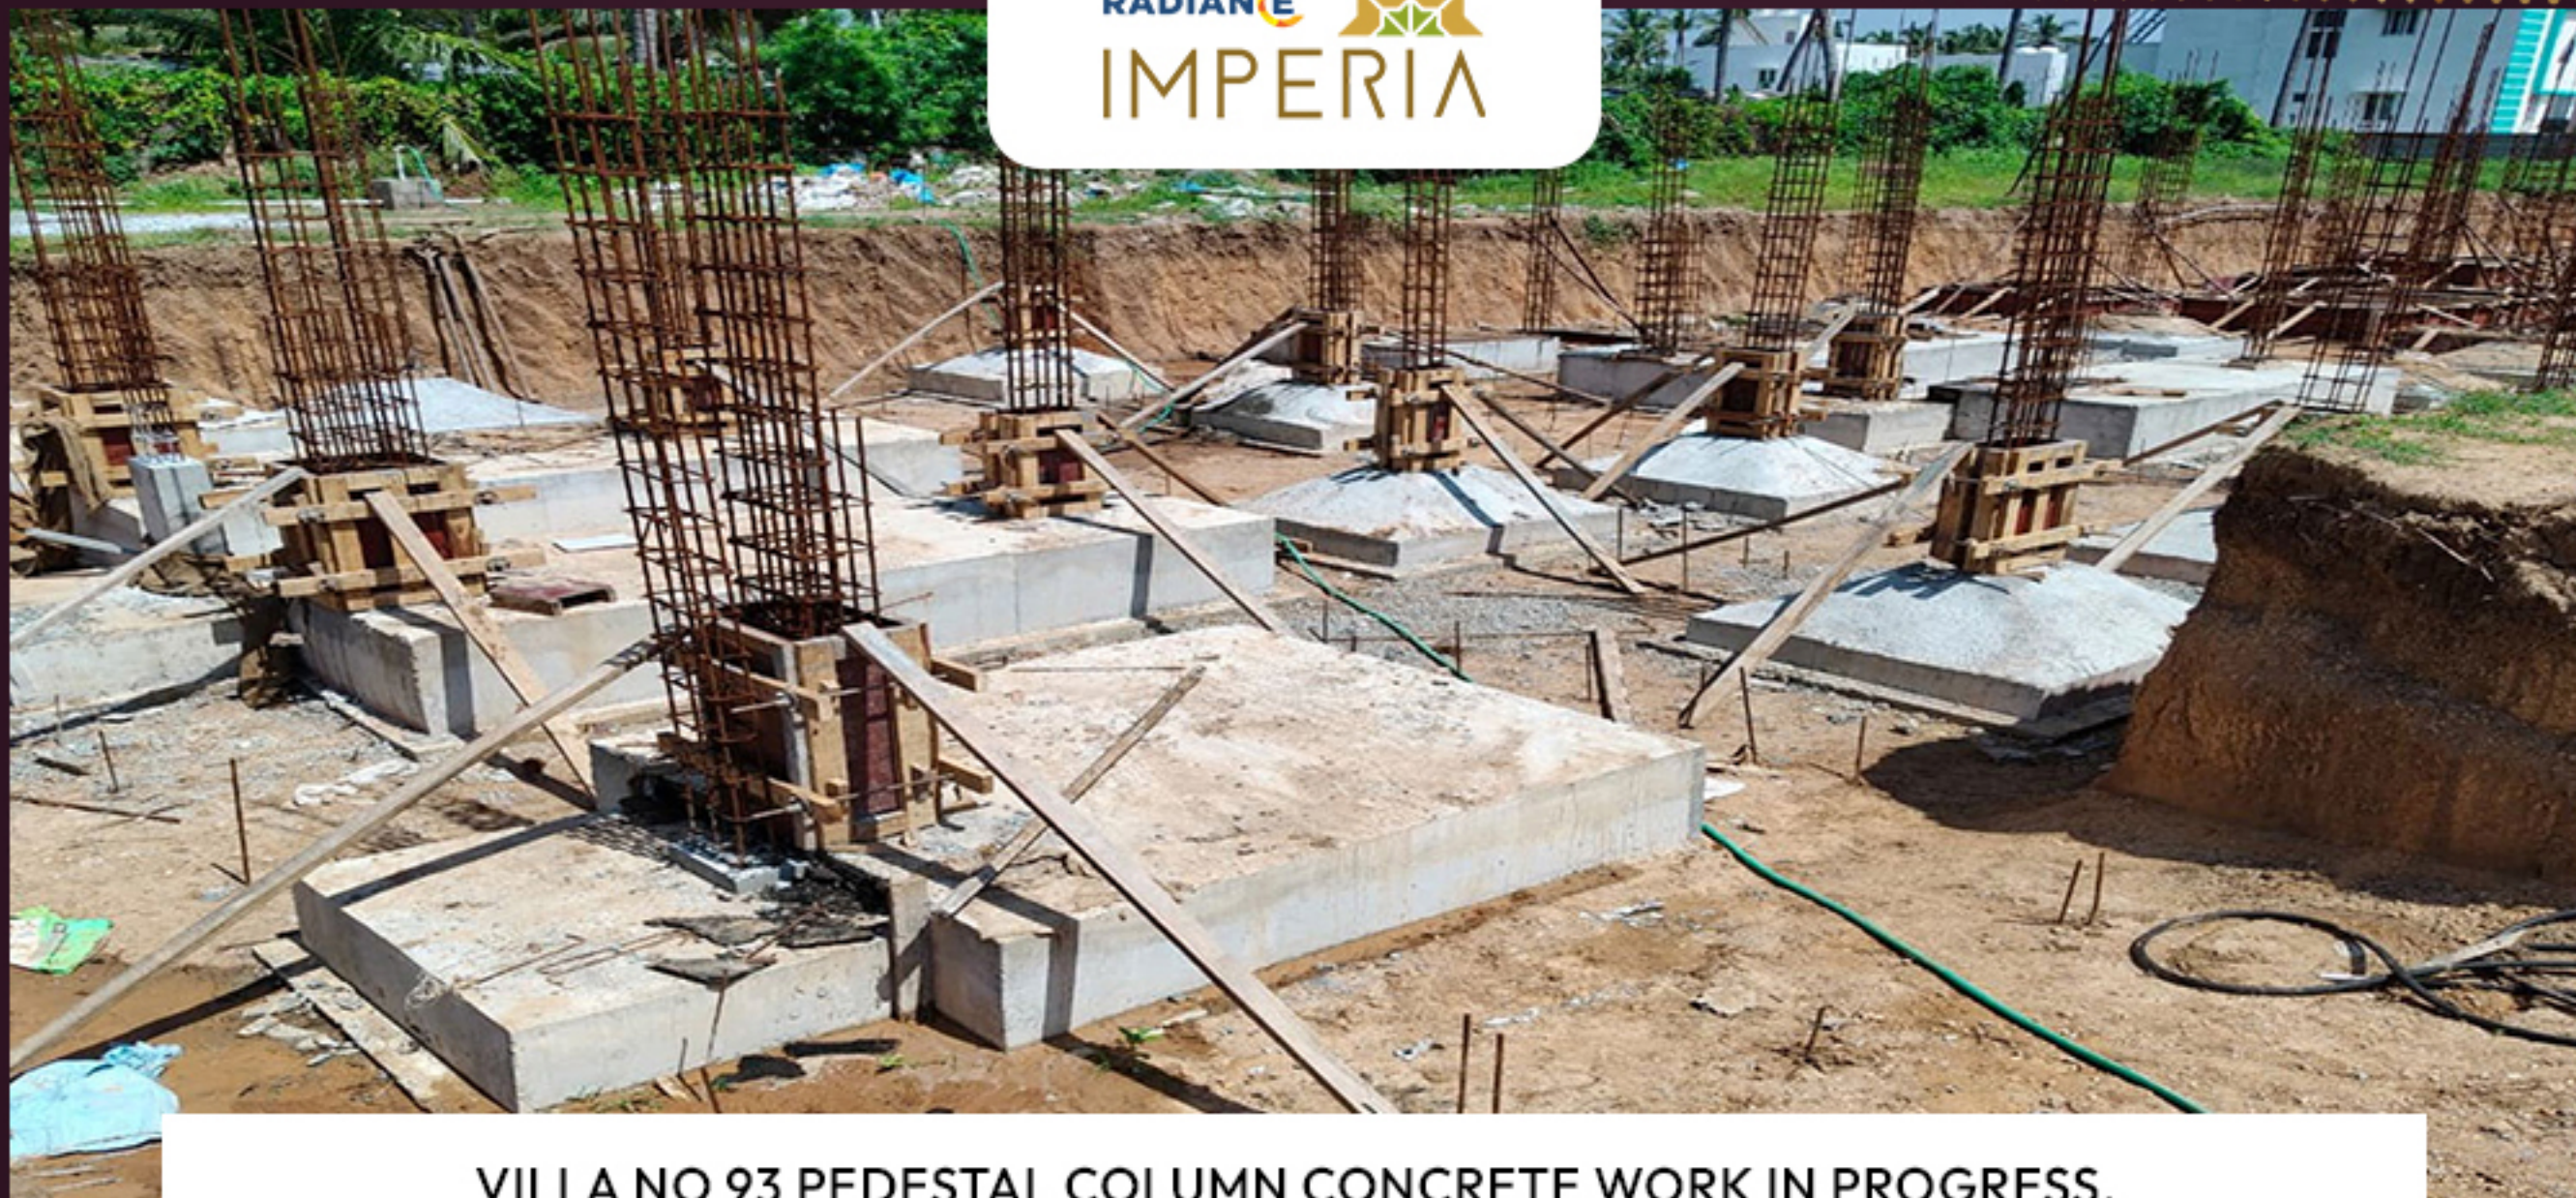
VILLA NO 93 PEDESTAL COLUMN CONCRETE WORK IN PROGRESS.

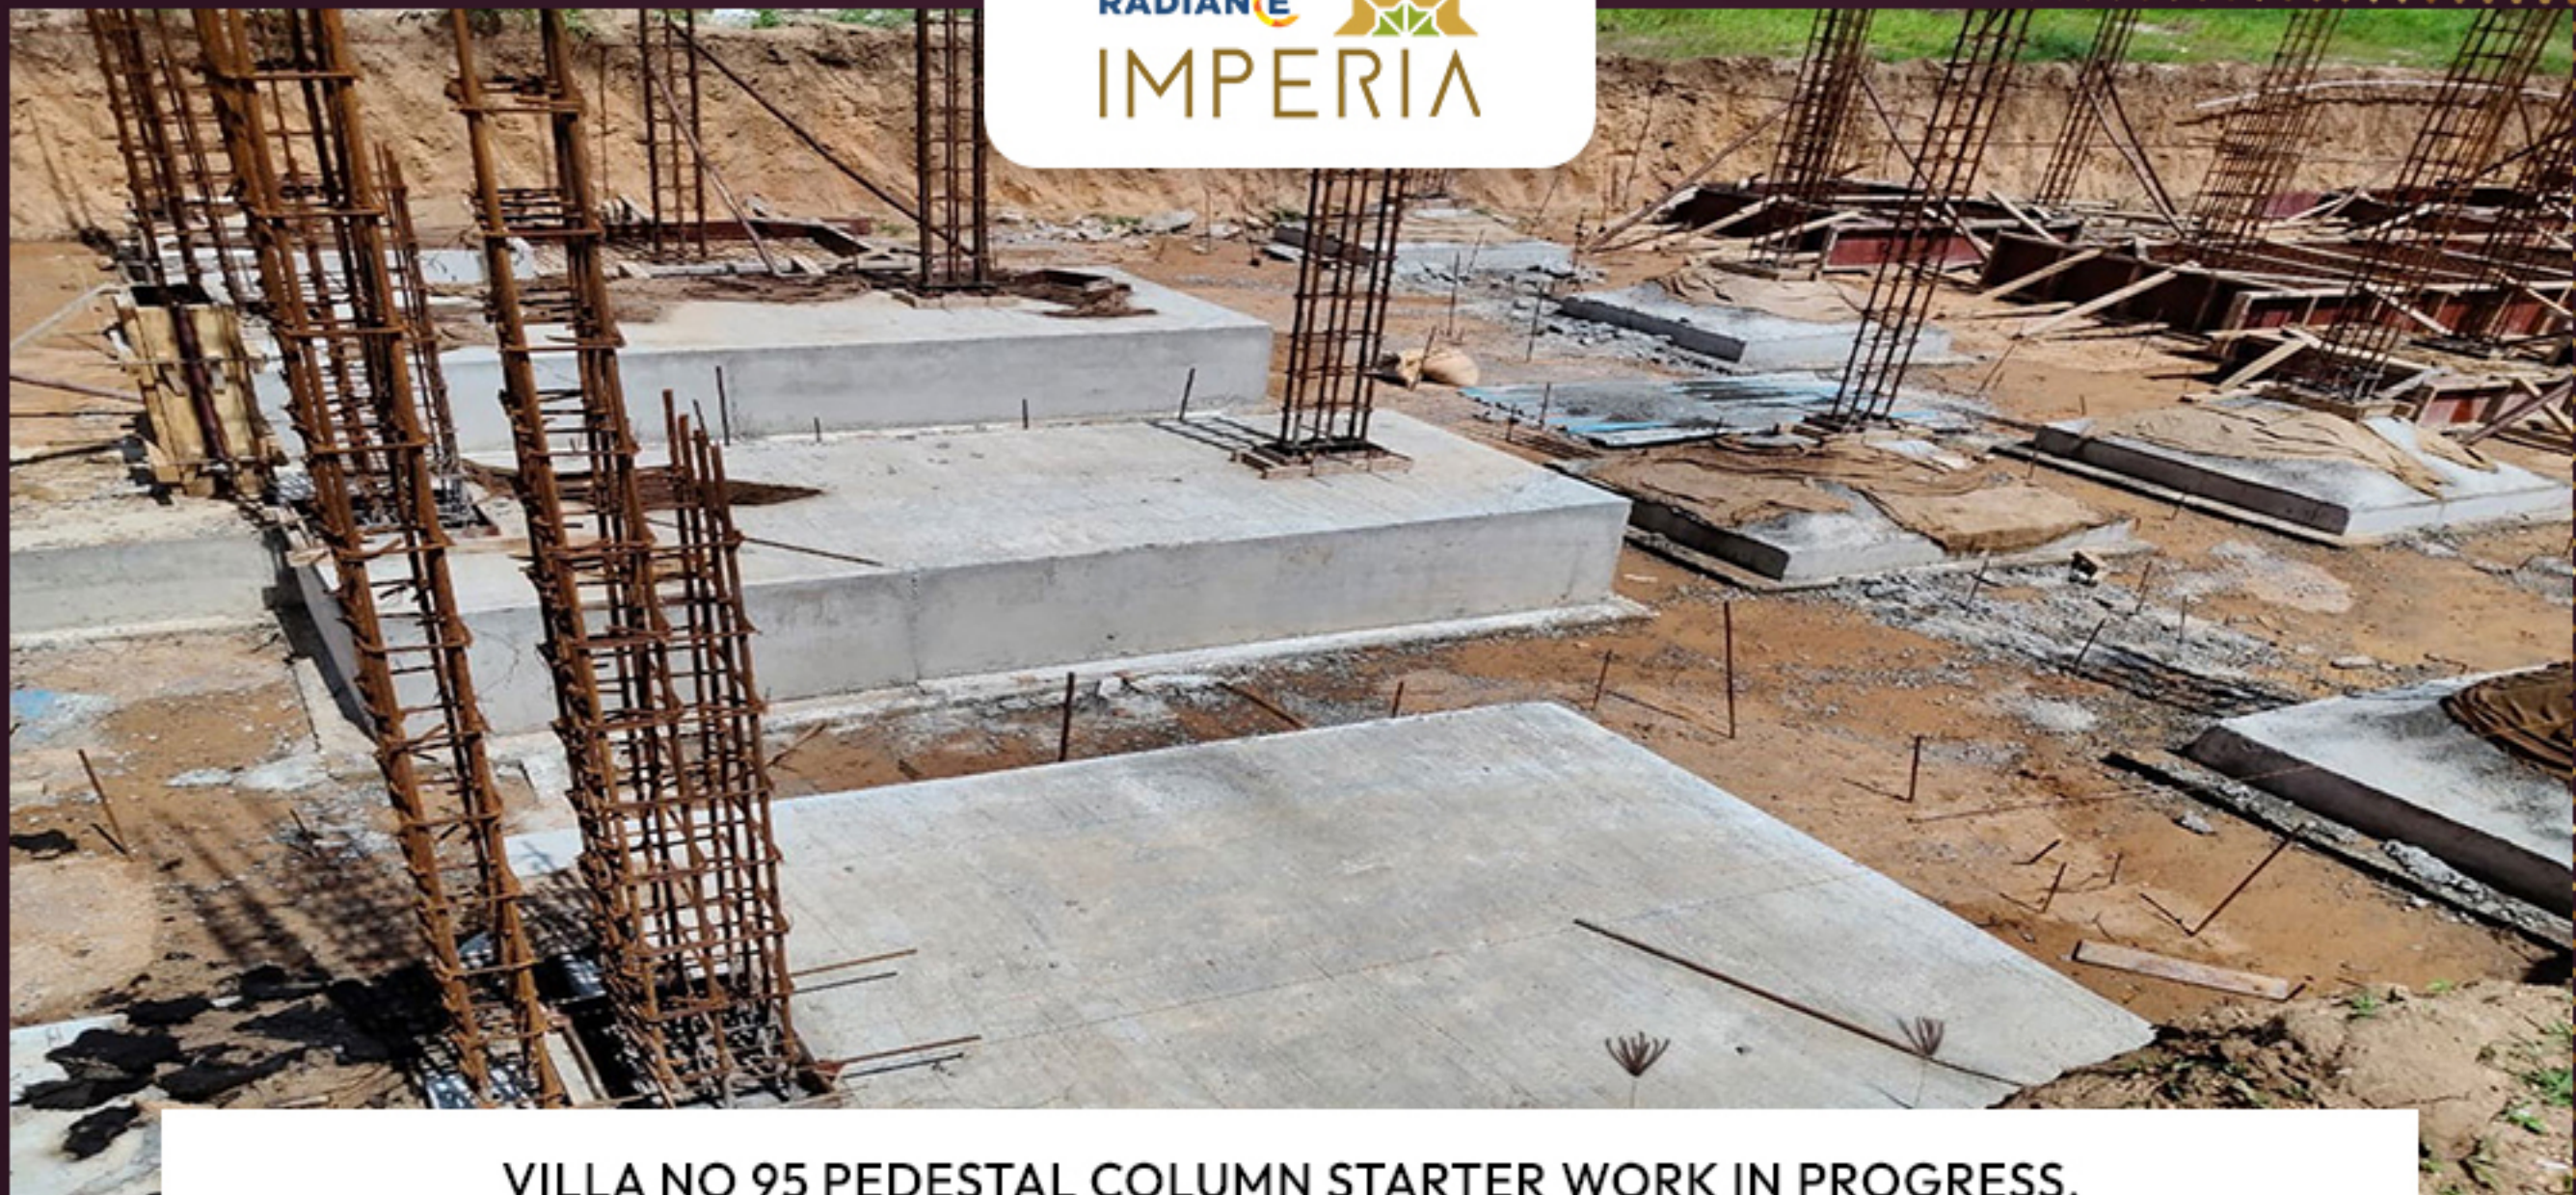
VILLA NO 95 PEDESTAL COLUMN STARTER WORK IN PROGRESS.
