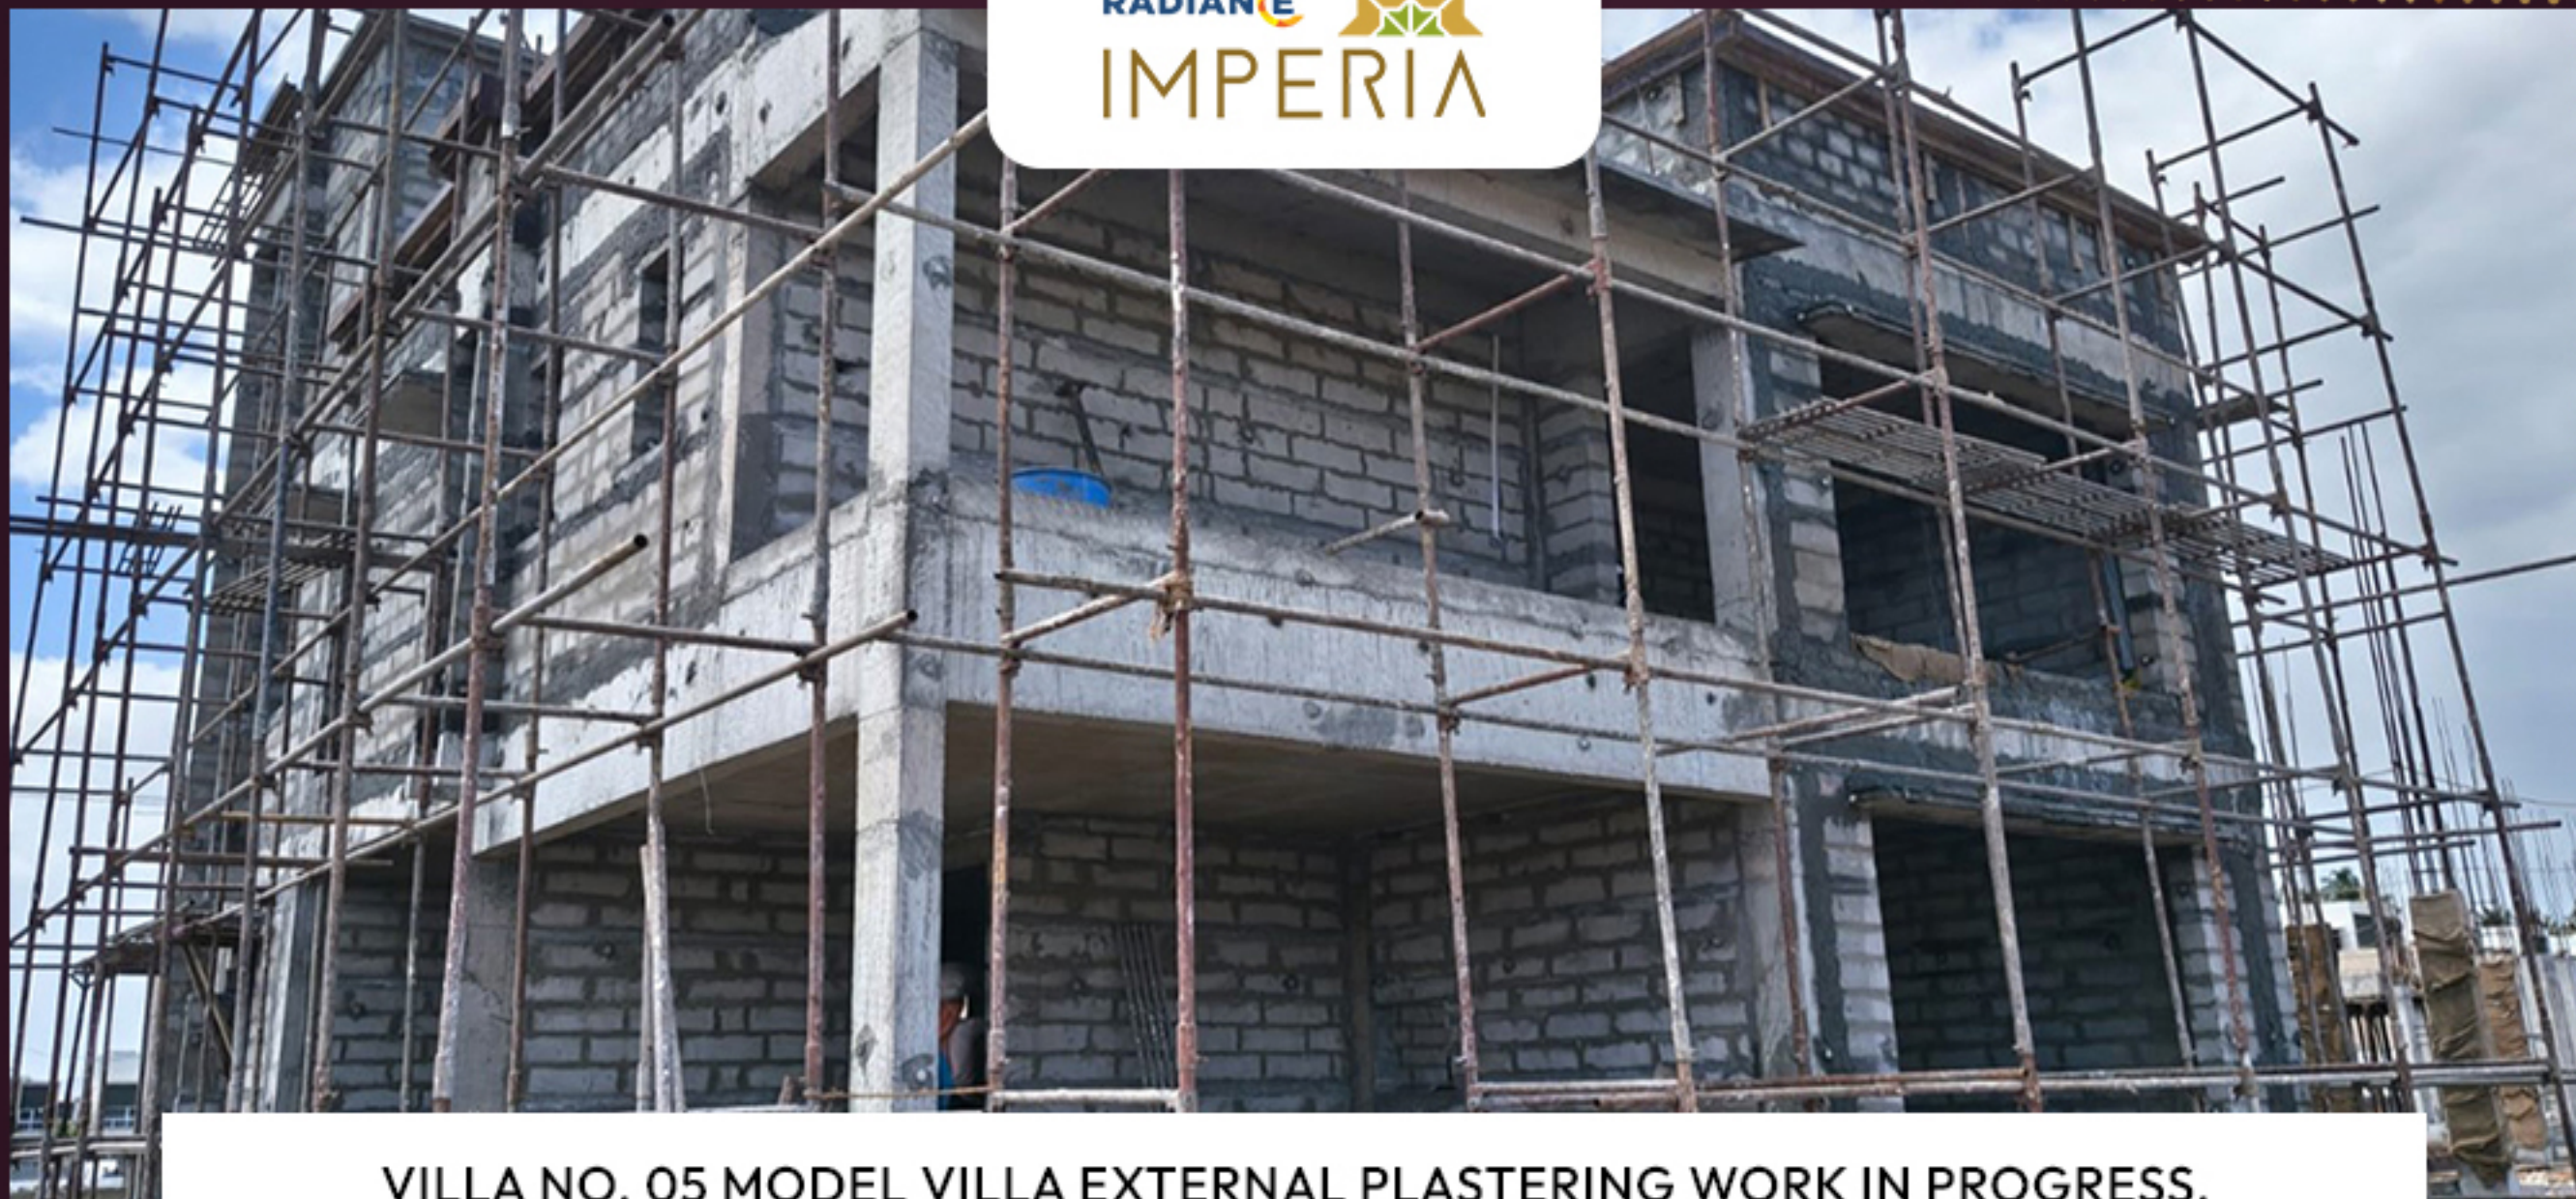
VILLA NO. 05 MODEL VILLA EXTERNAL PLASTERING WORK IN PROGRESS.

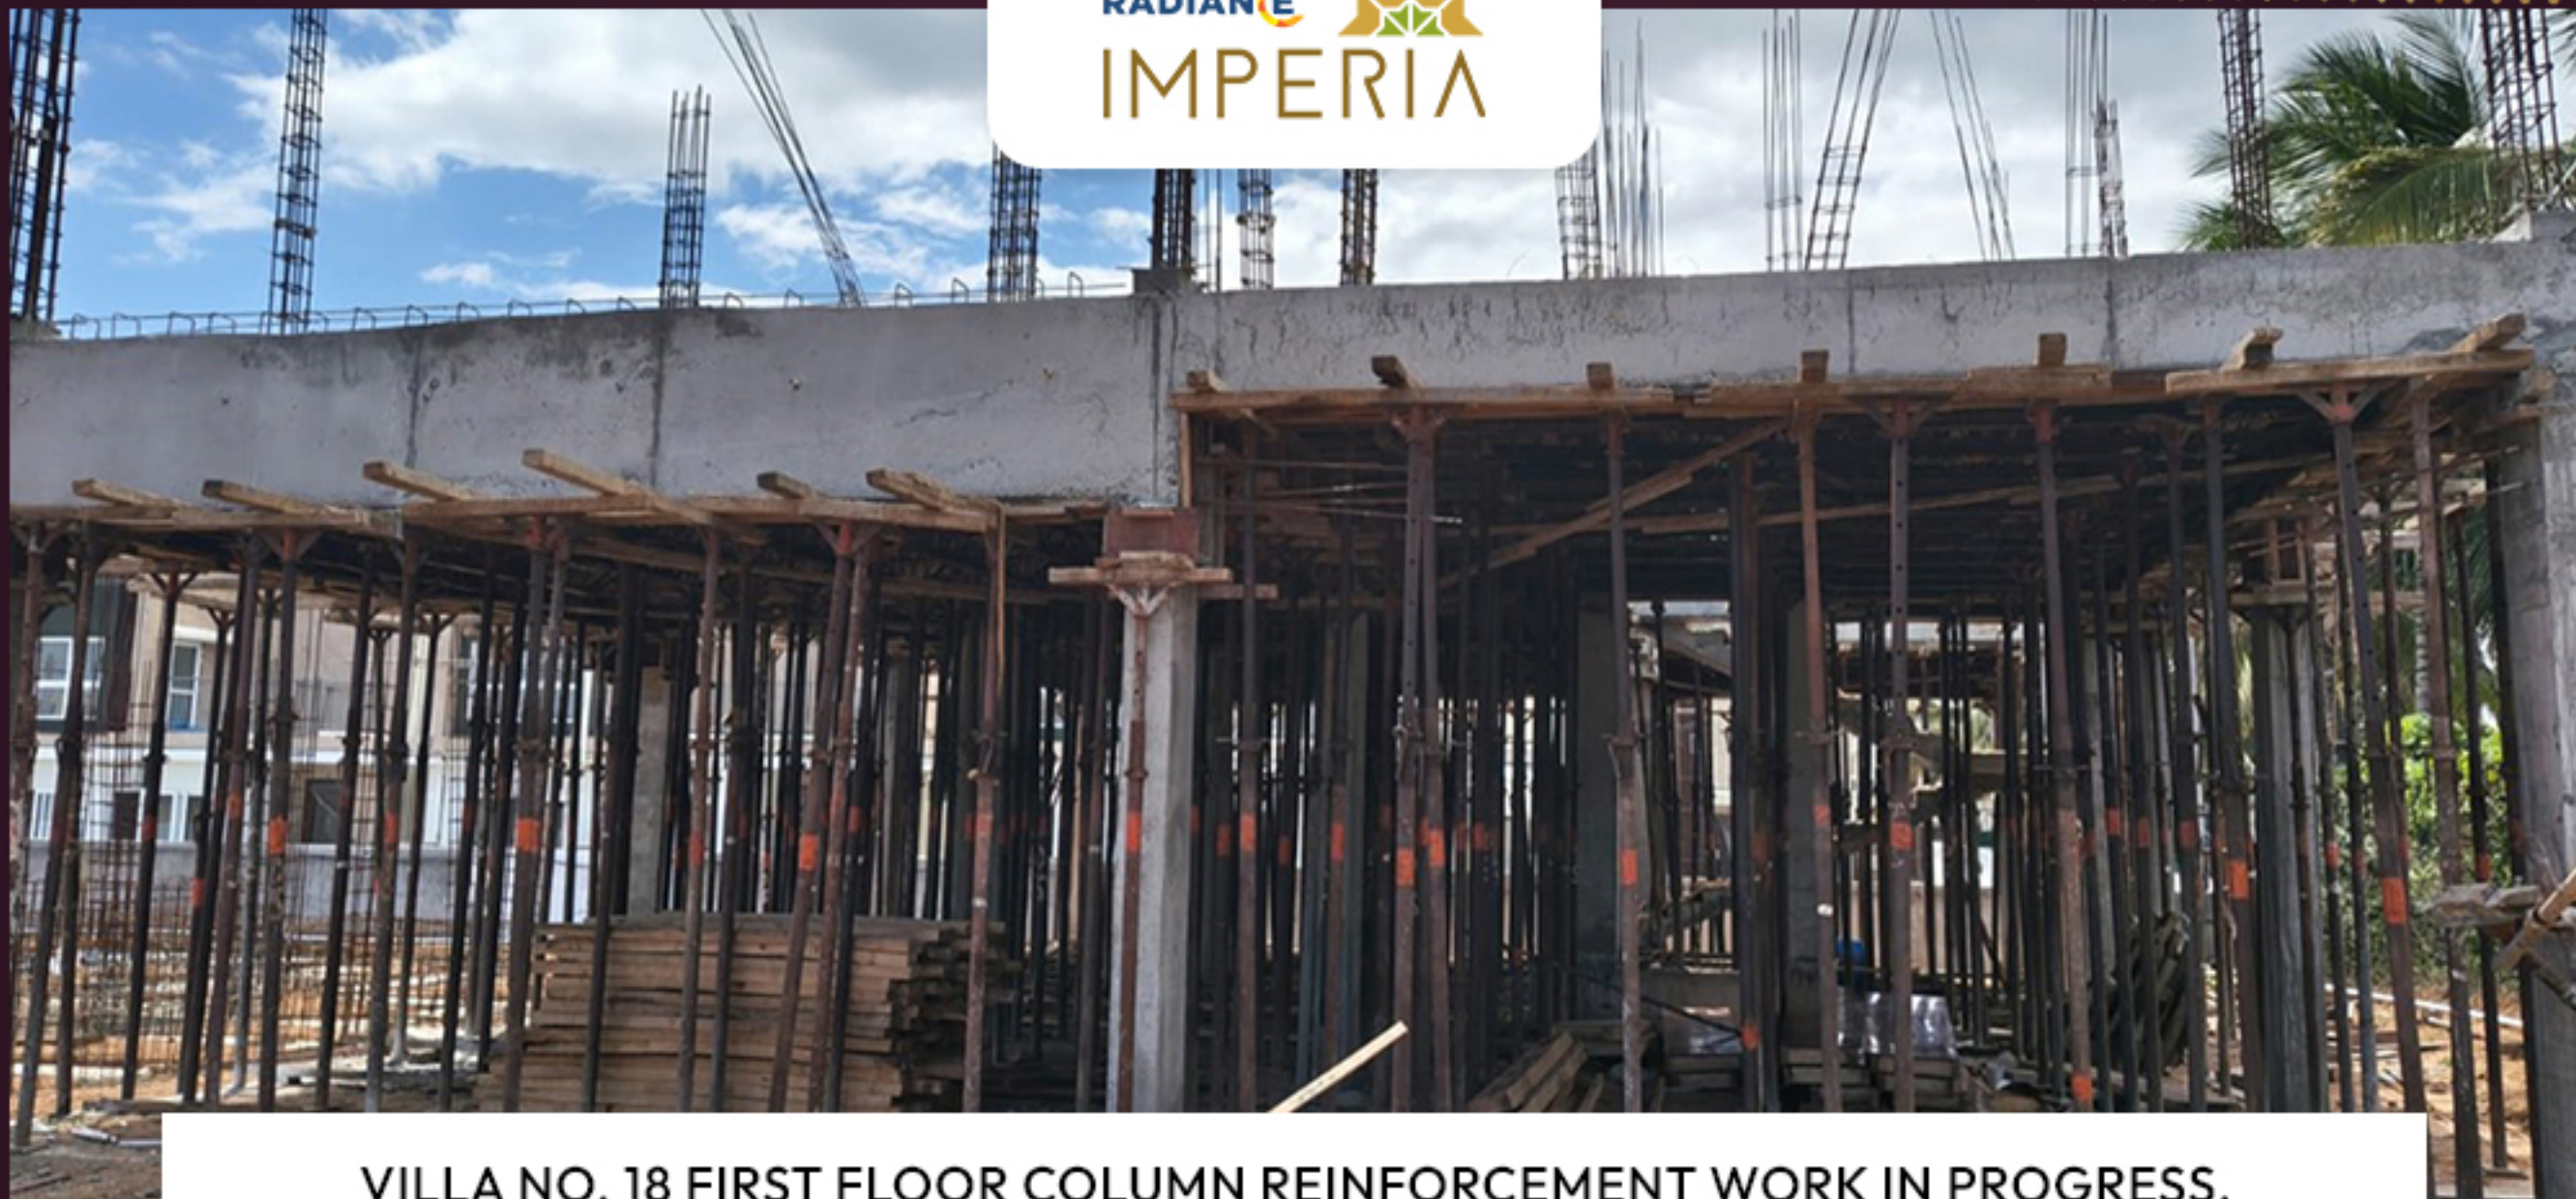
VILLA NO. 18 FIRST FLOOR COLUMN REINFORCEMENT WORK IN PROGRESS.

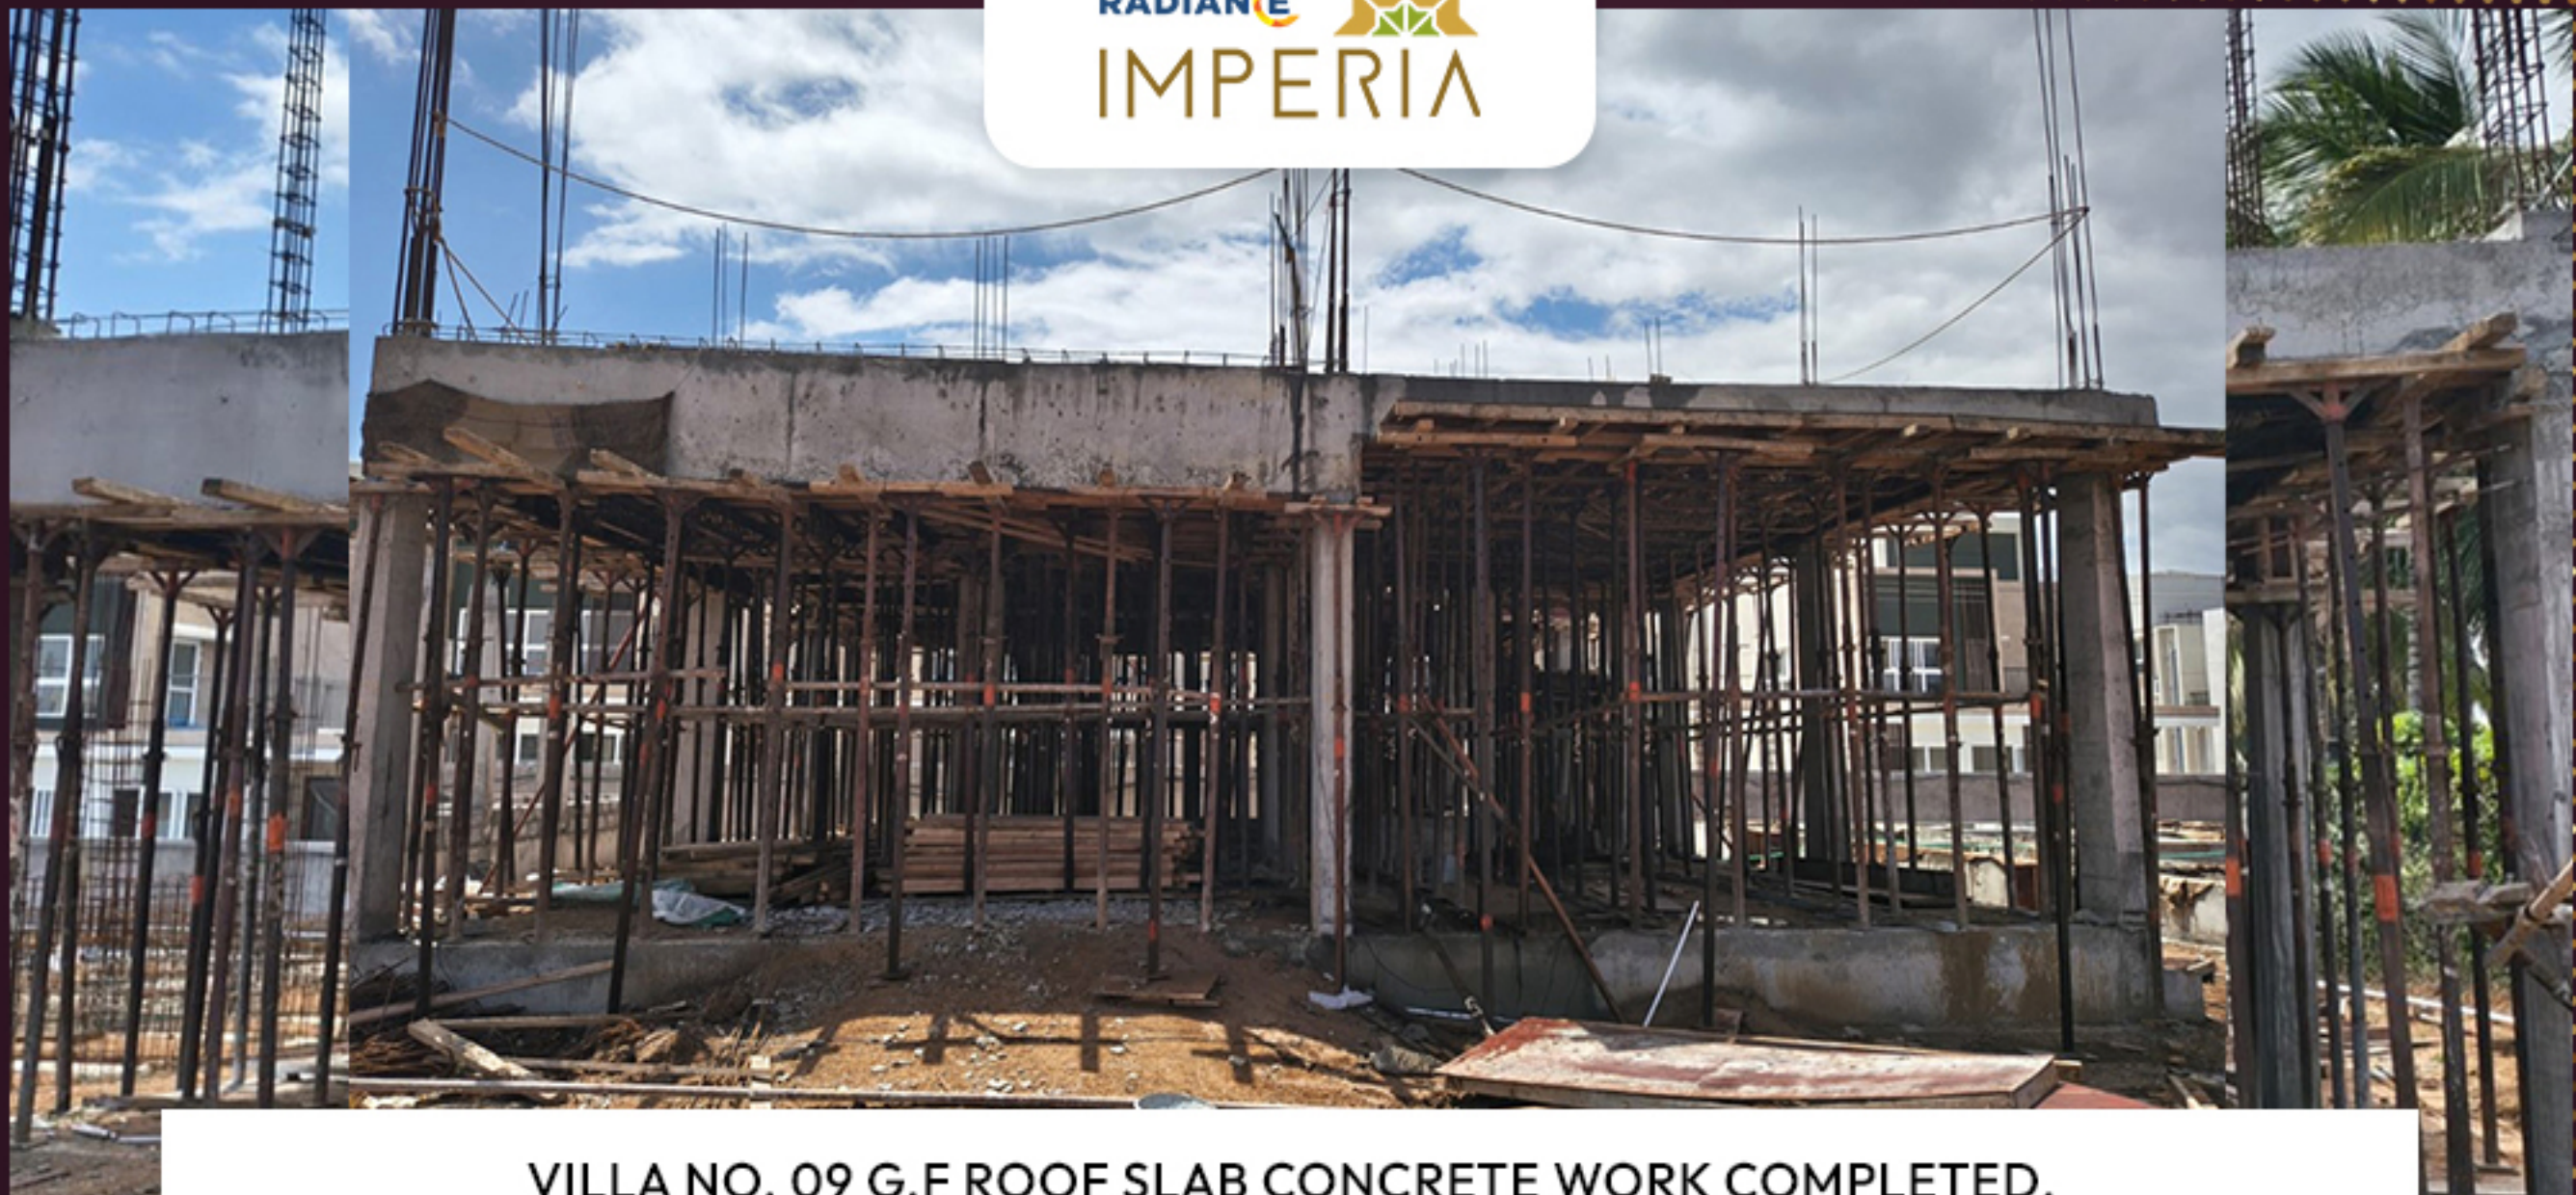
VILLA NO. 09 G.F ROOF SLAB CONCRETE WORK COMPLETED.

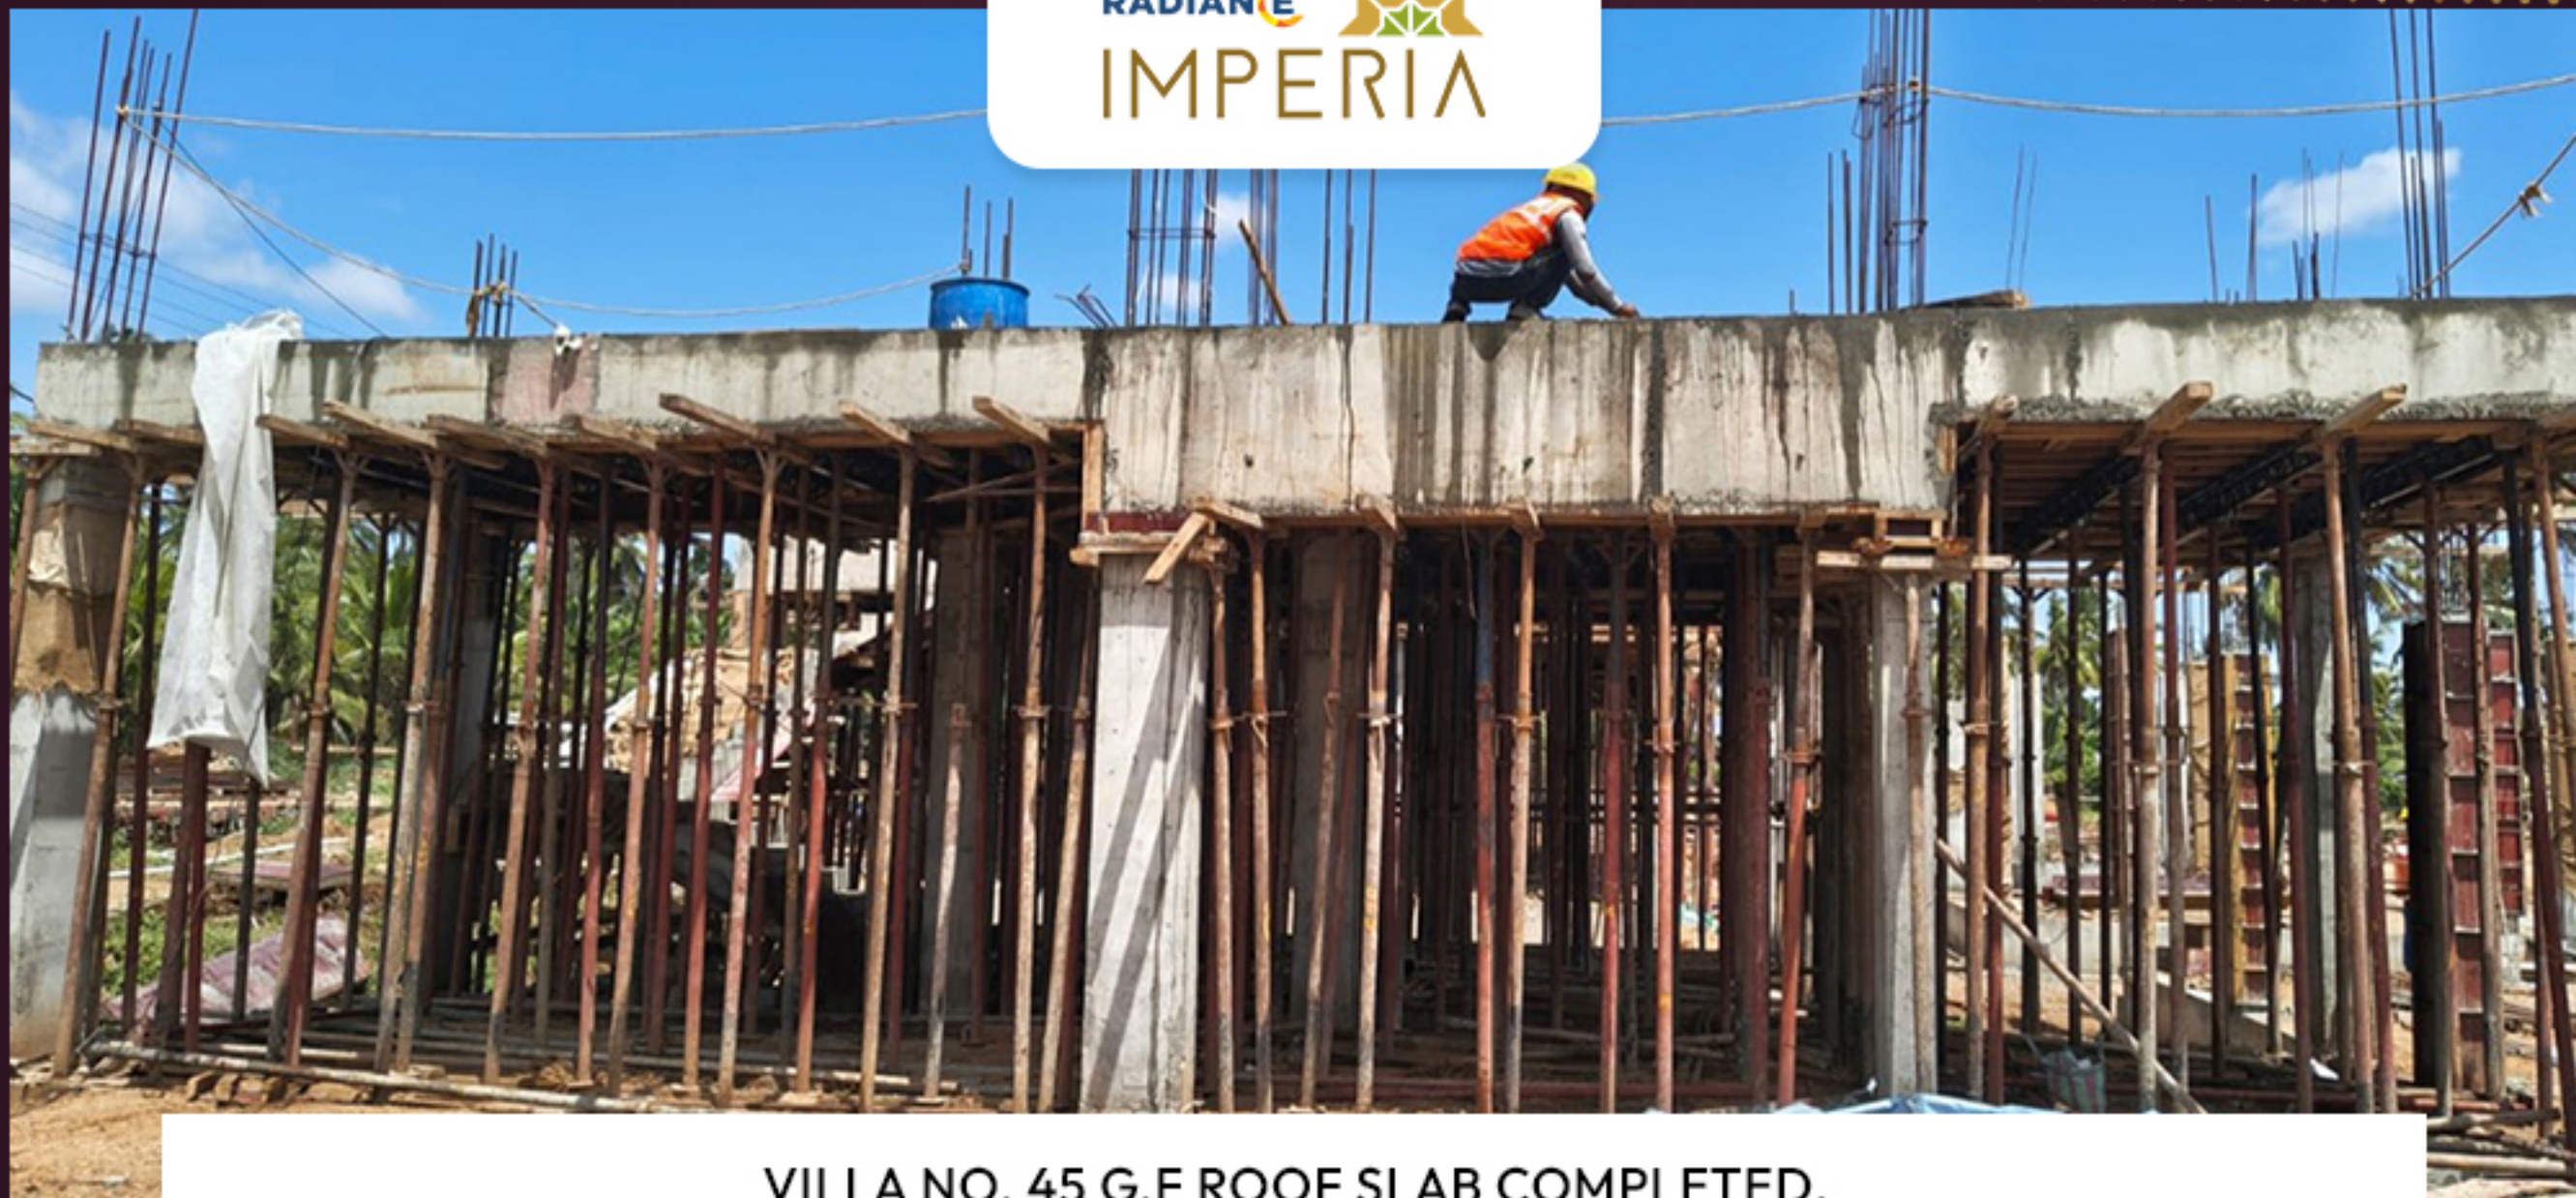
VILLA NO. 45 G.F ROOF SLAB COMPLETED.

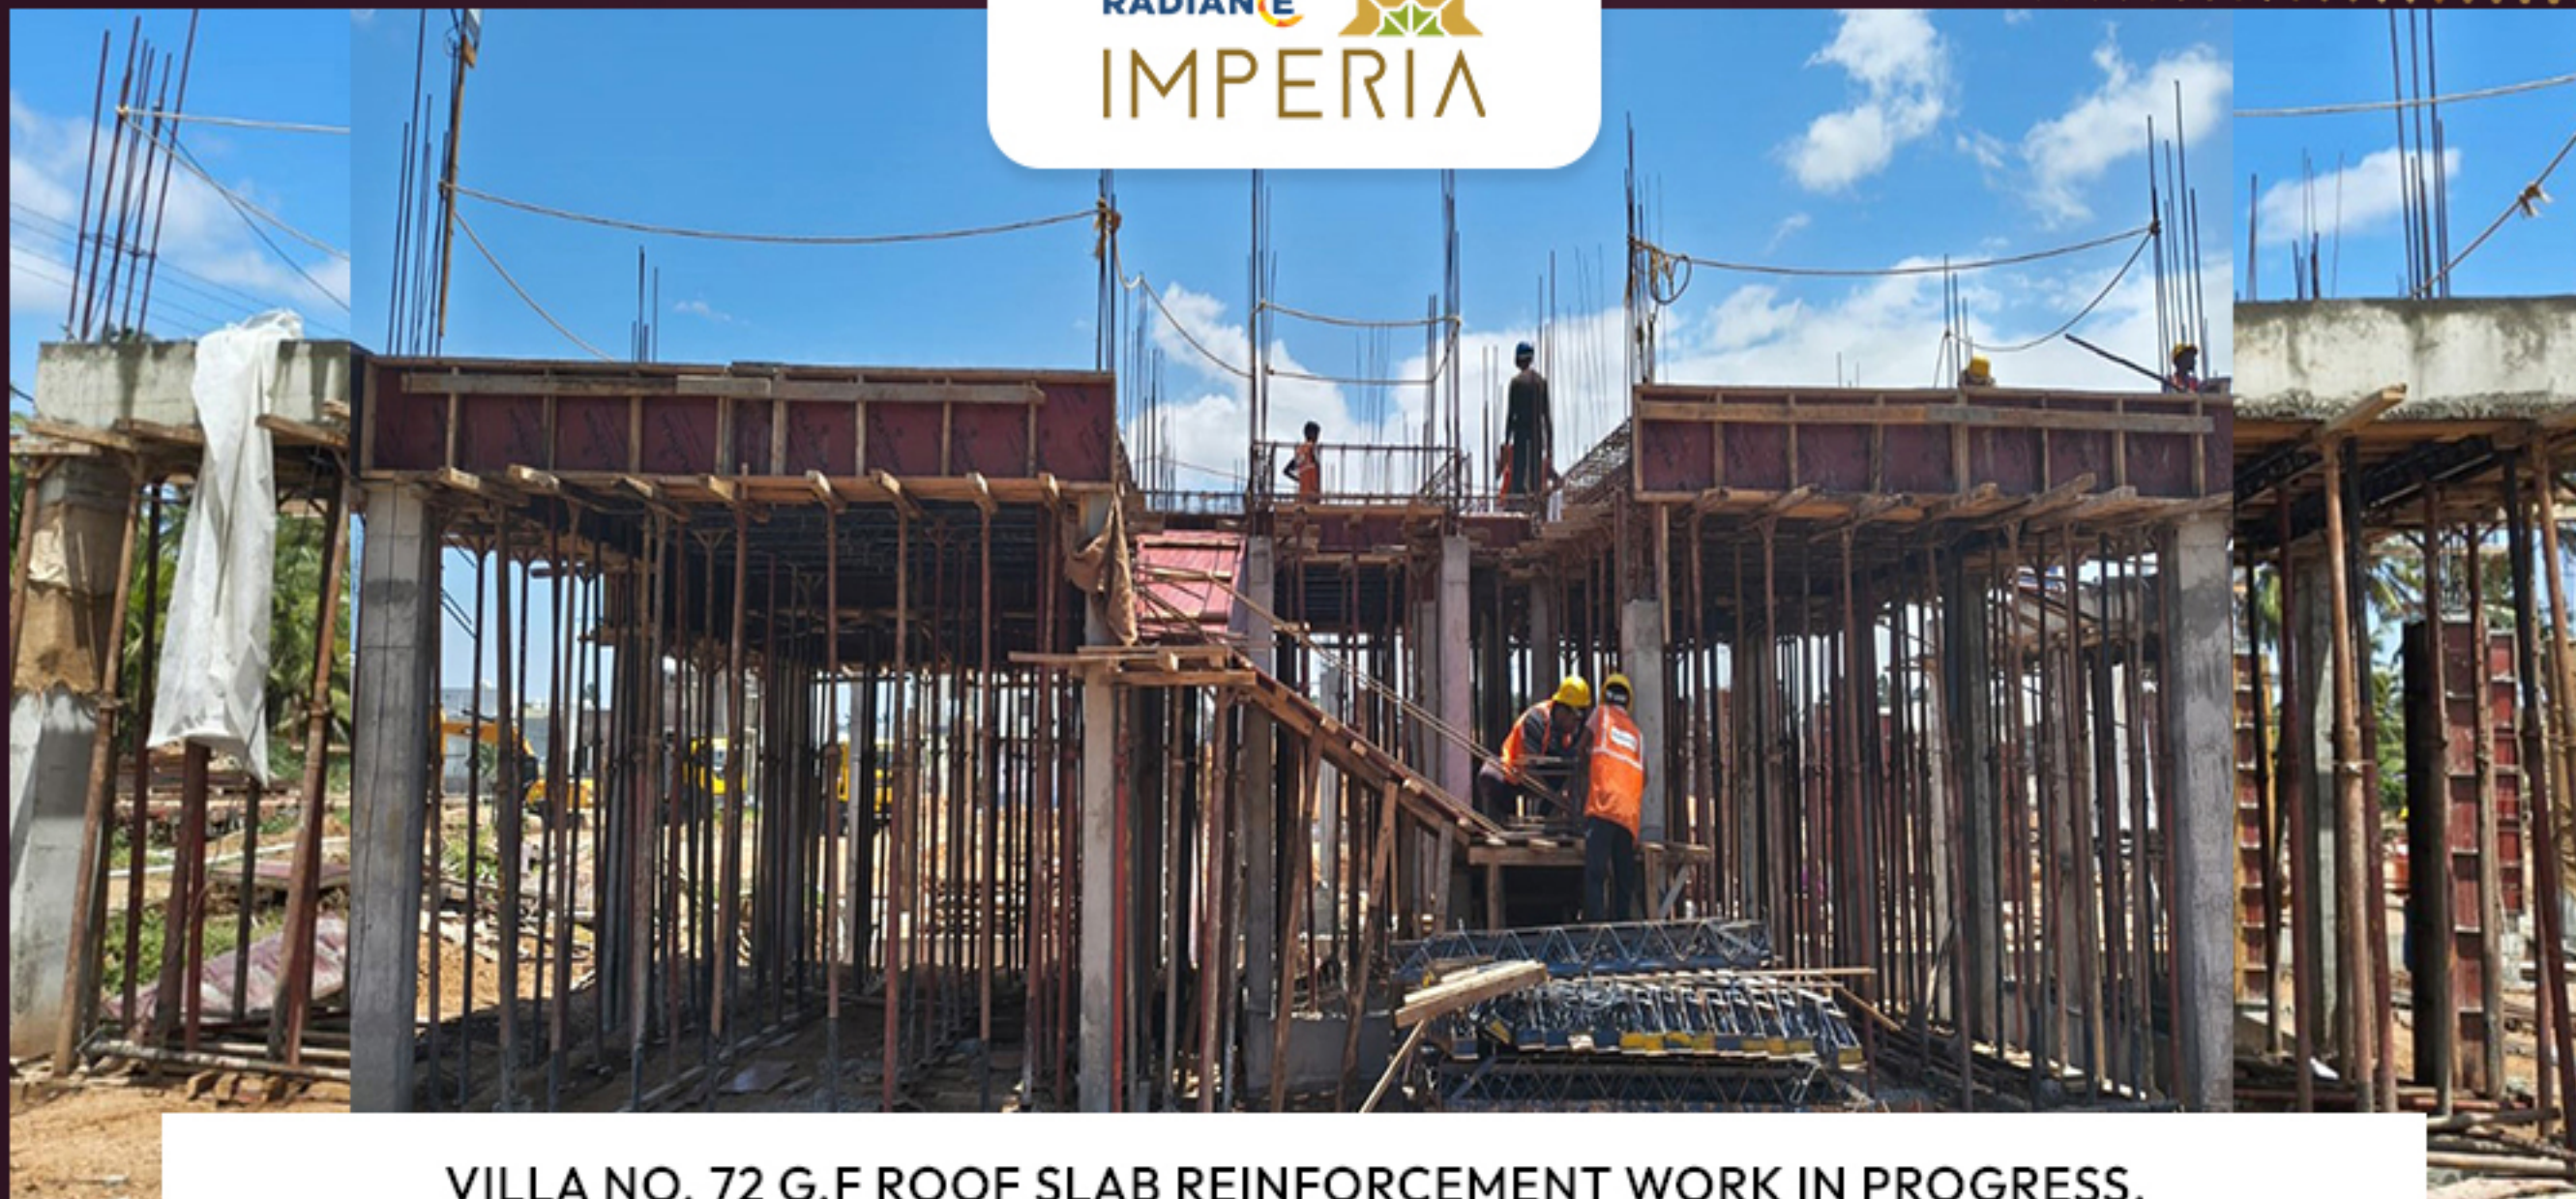
VILLA NO. 72 G.F ROOF SLAB REINFORCEMENT WORK IN PROGRESS.

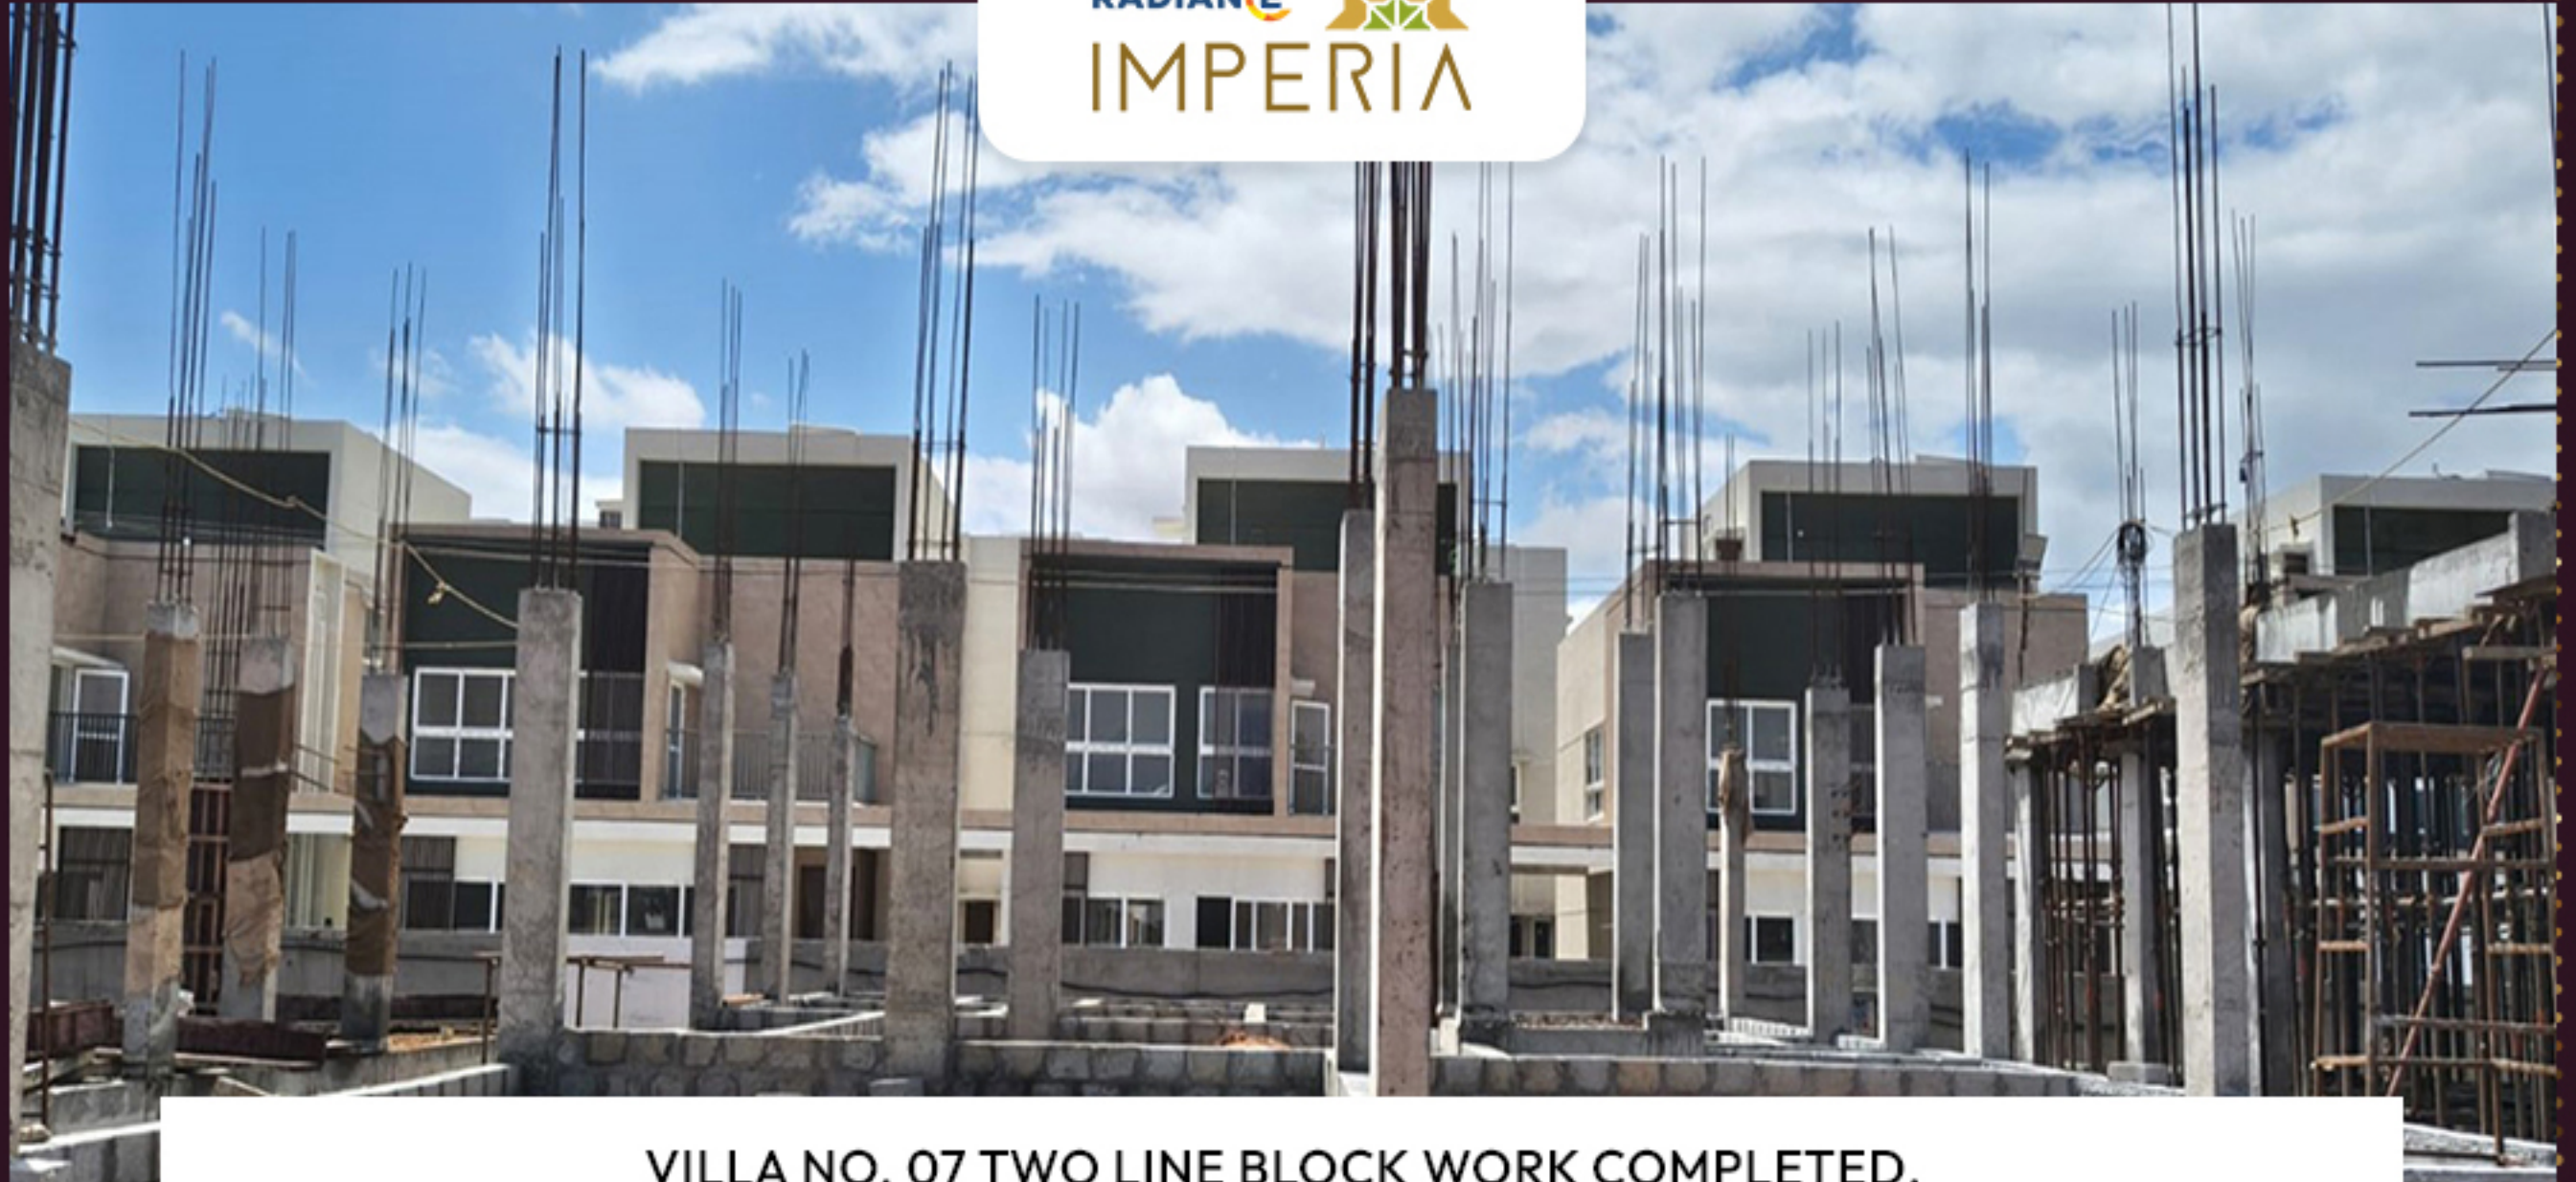
VILLA NO. 07 TWO LINE BLOCK WORK COMPLETED.

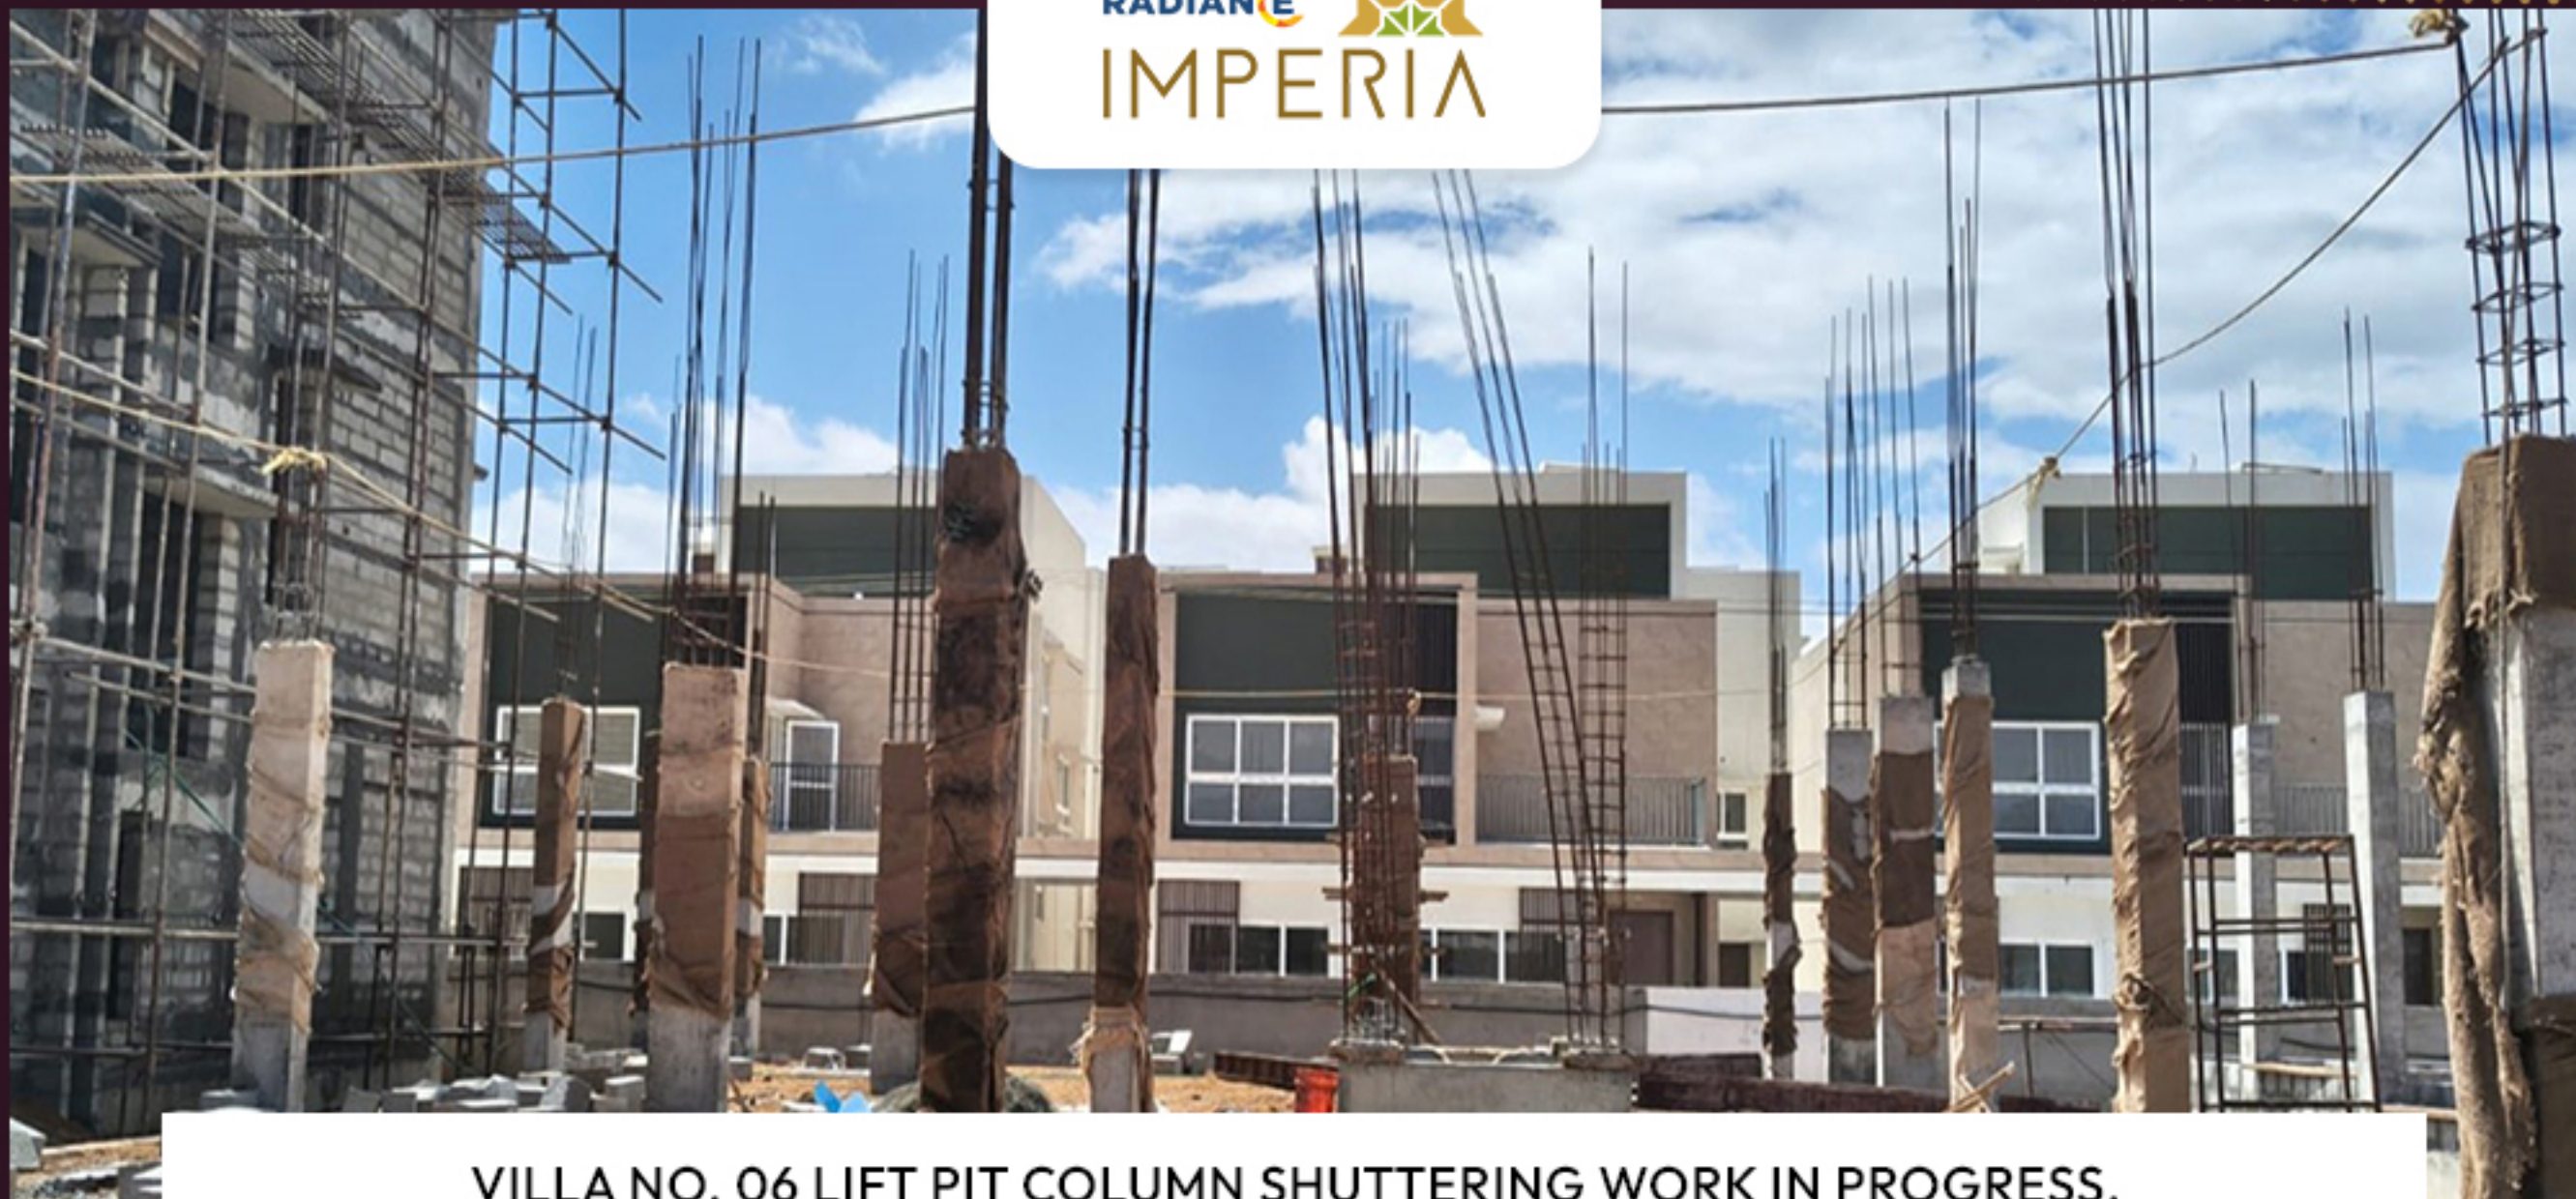
VILLA NO. 06 LIFT PIT COLUMN SHUTTERING WORK IN PROGRESS.
