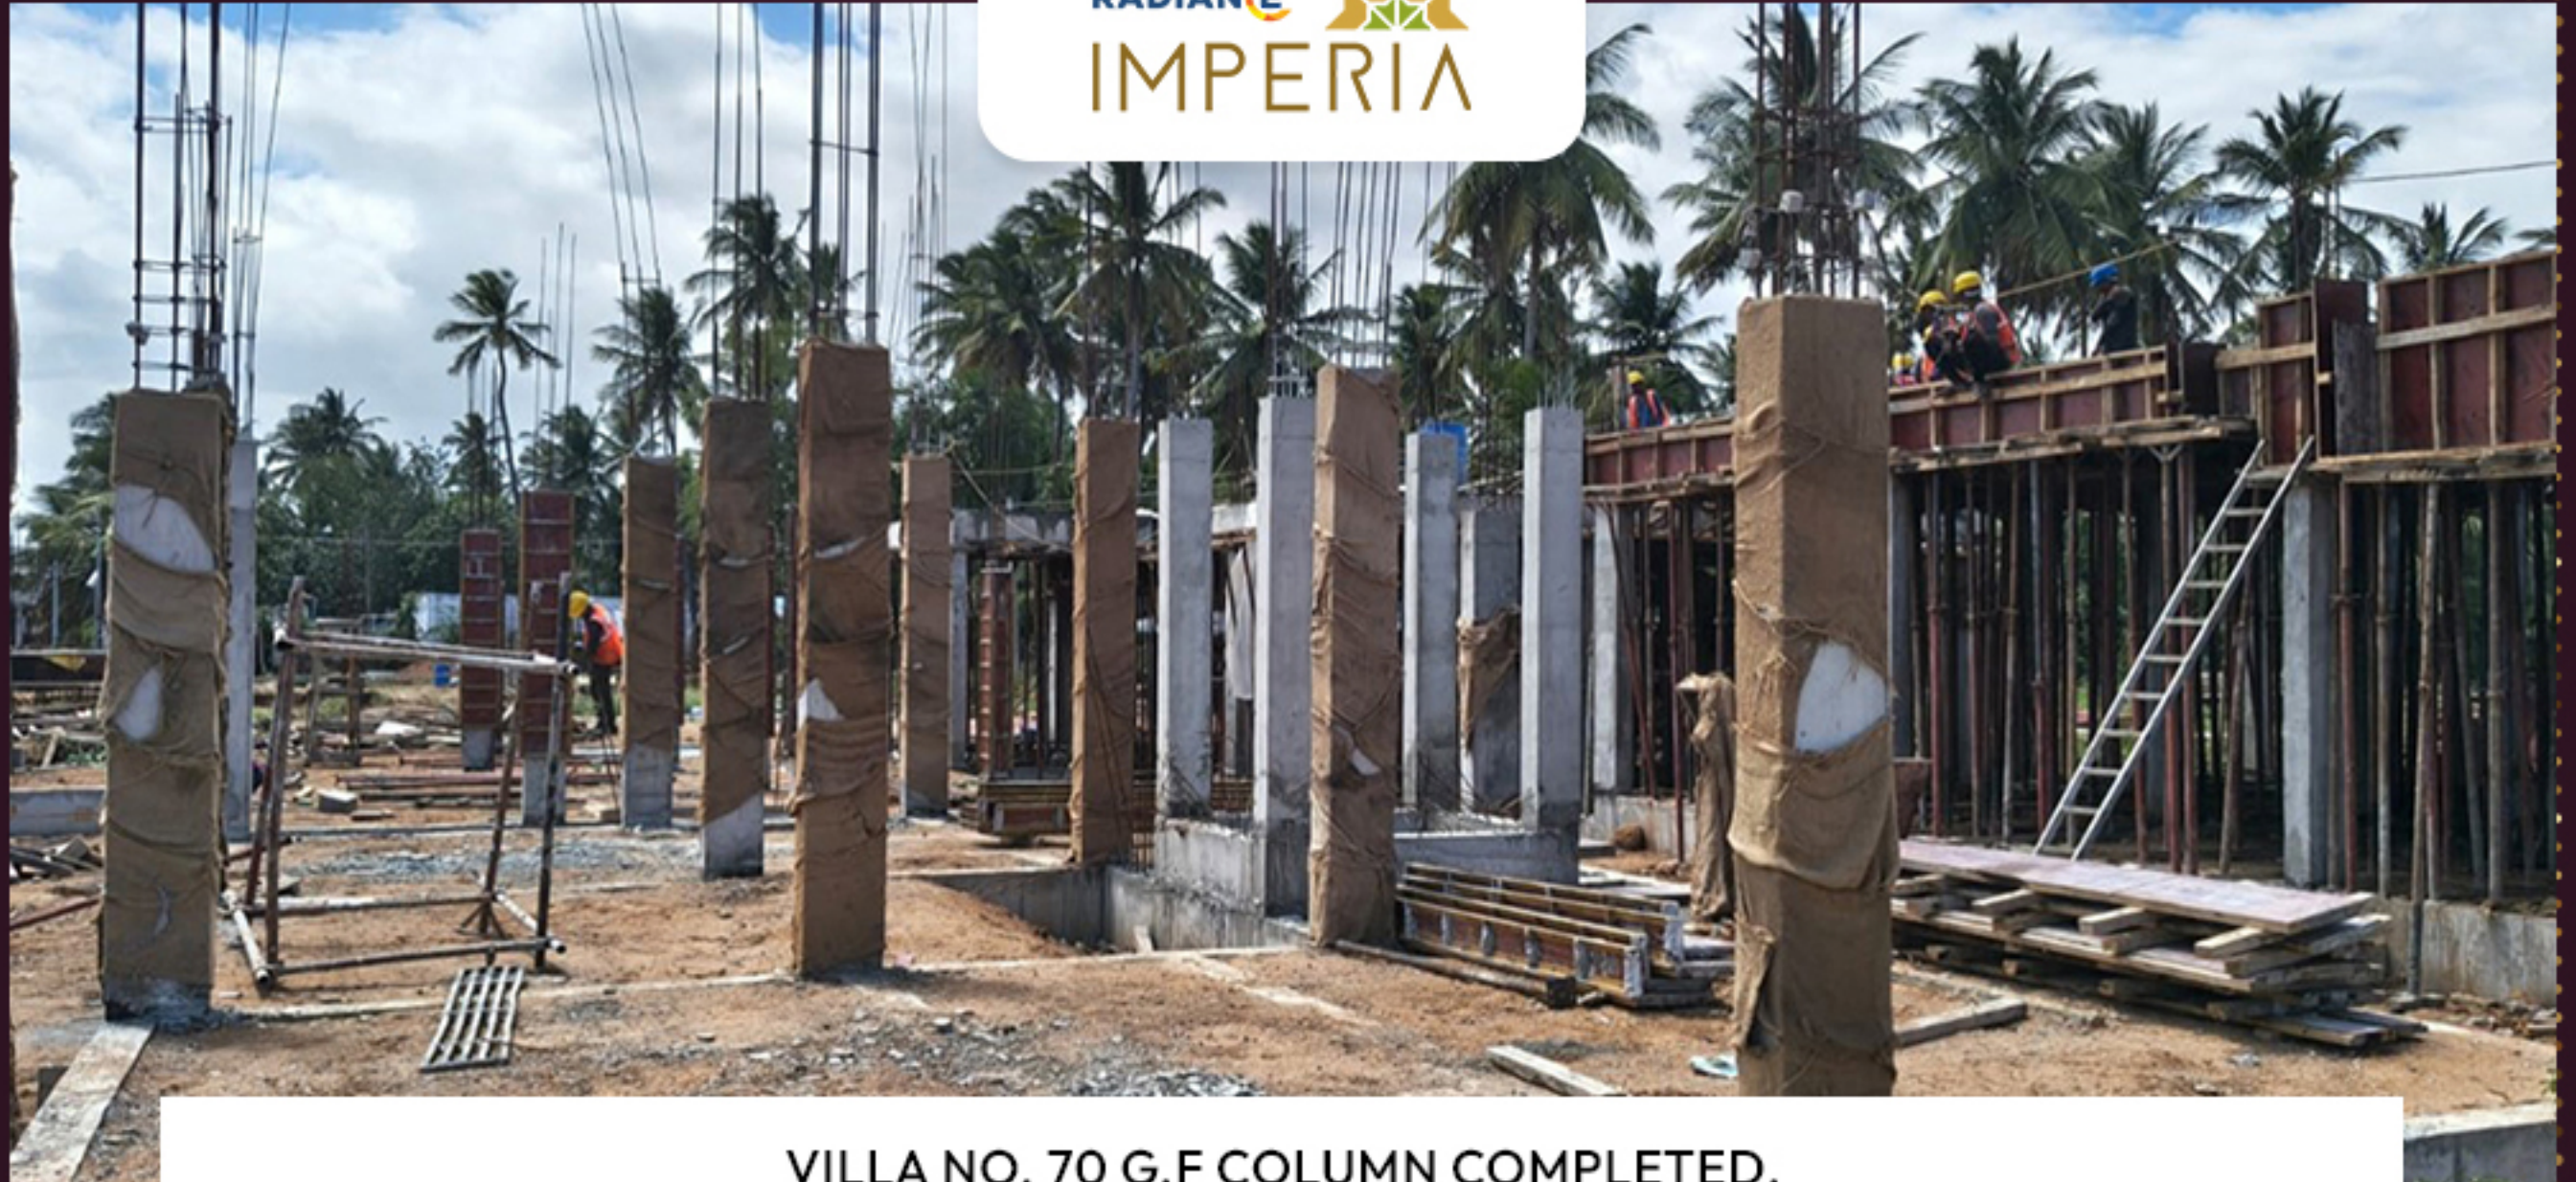
VILLA NO. 70 G.F COLUMN COMPLETED.

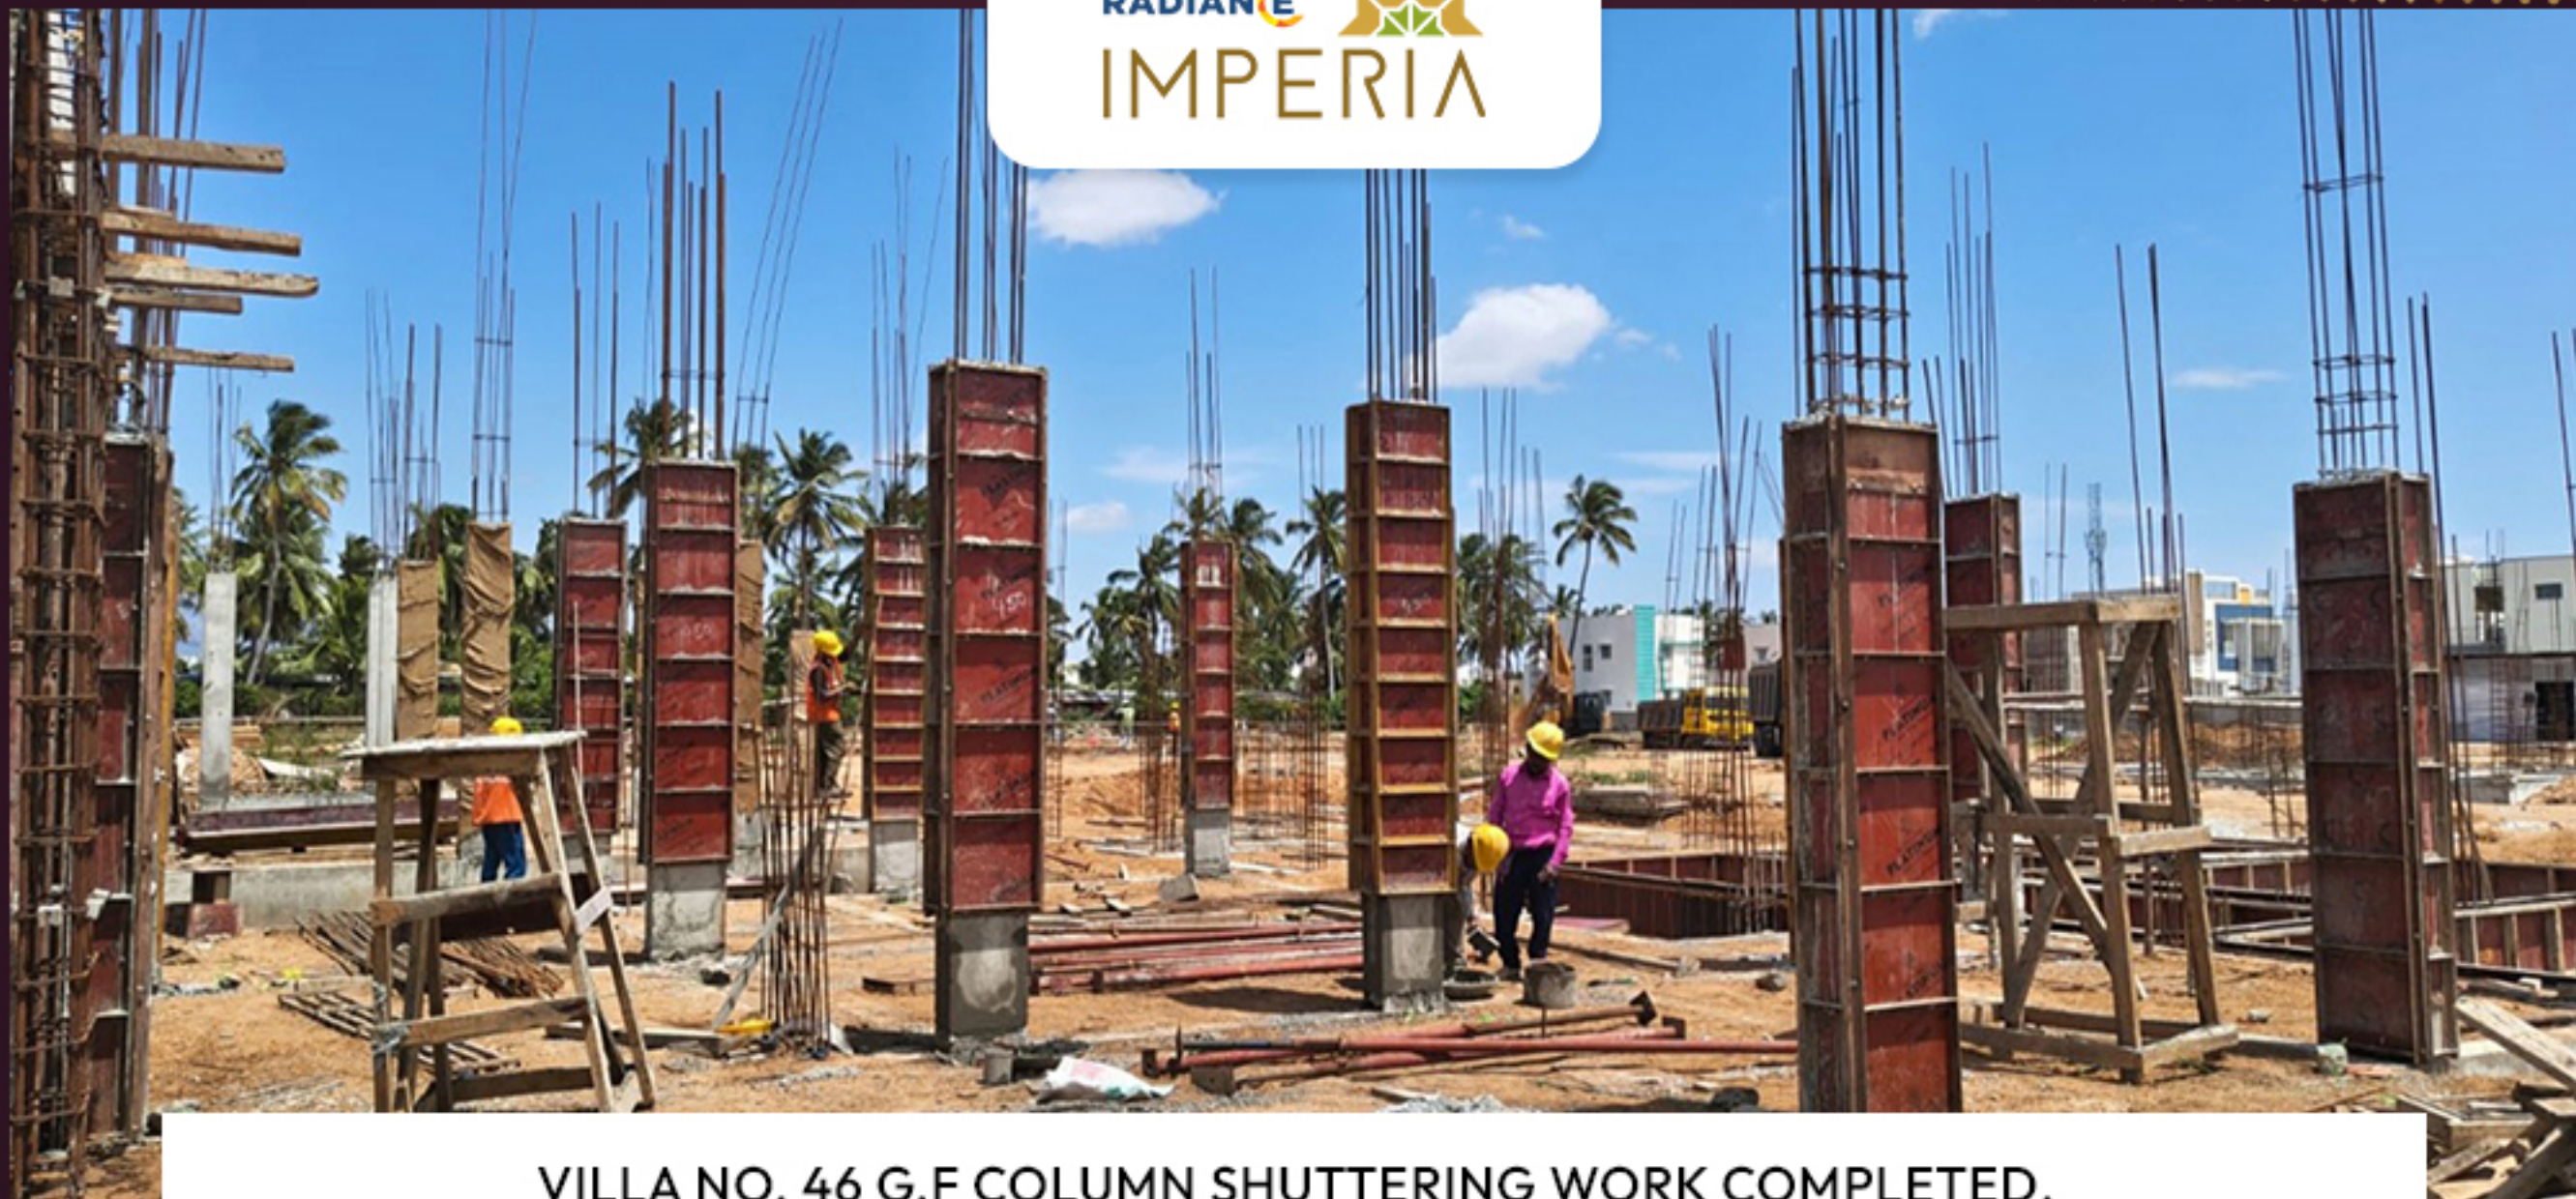
VILLA NO. 46 G.F COLUMN SHUTTERING WORK COMPLETED.

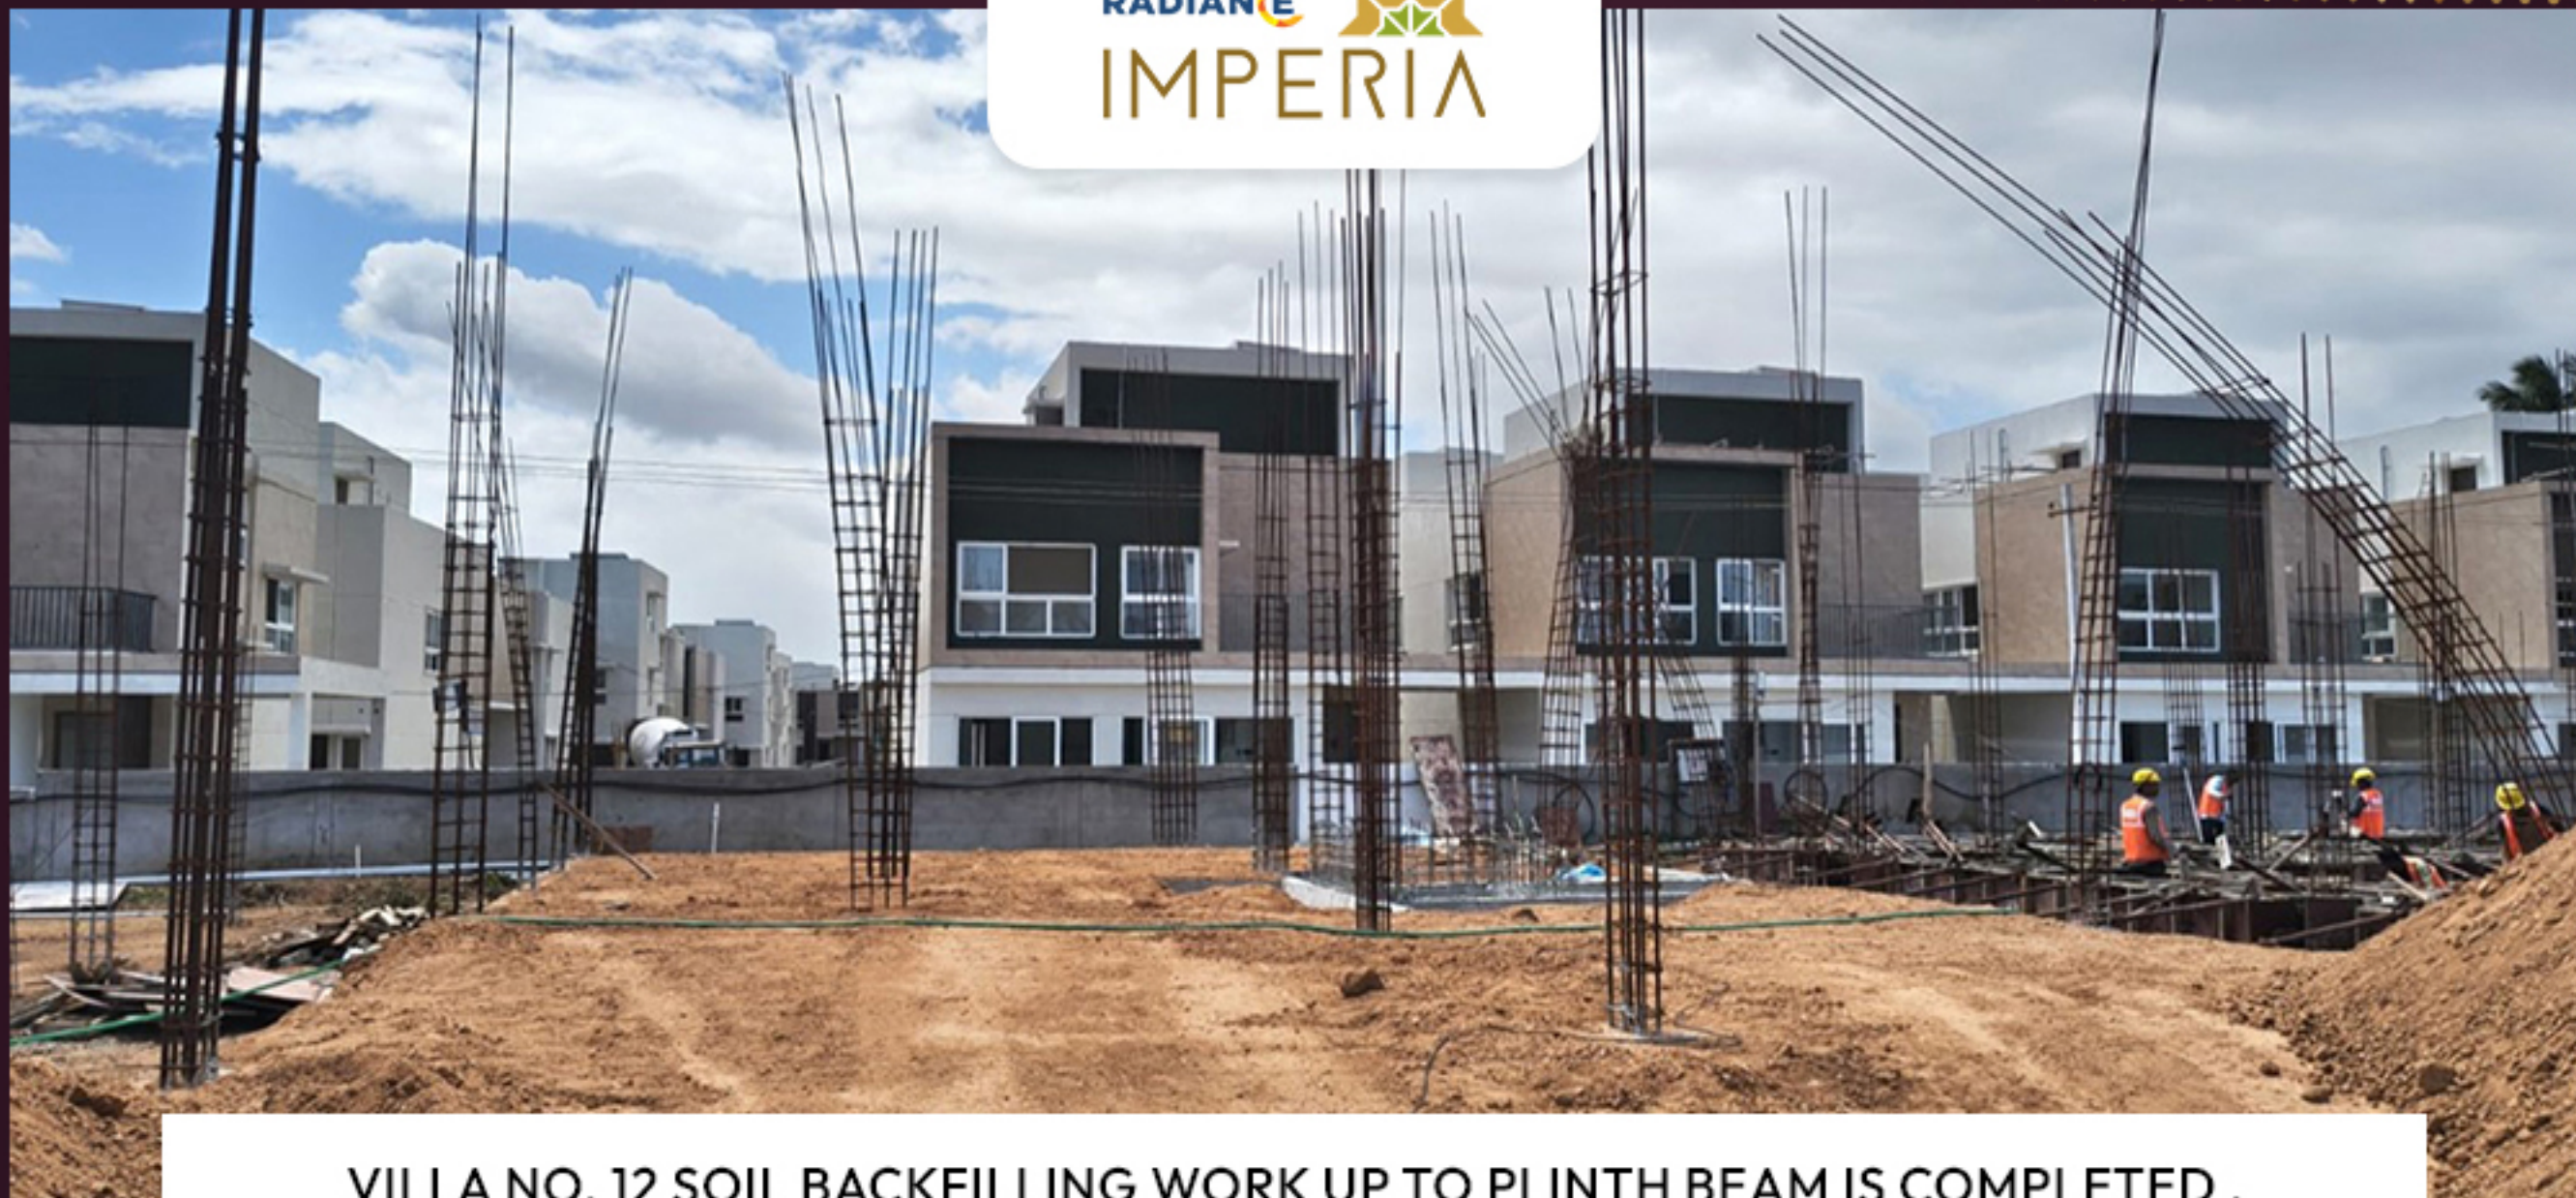
VILLA NO. 12 SOIL BACKFILLING WORK UP TO PLINTH BEAM IS COMPLETED .

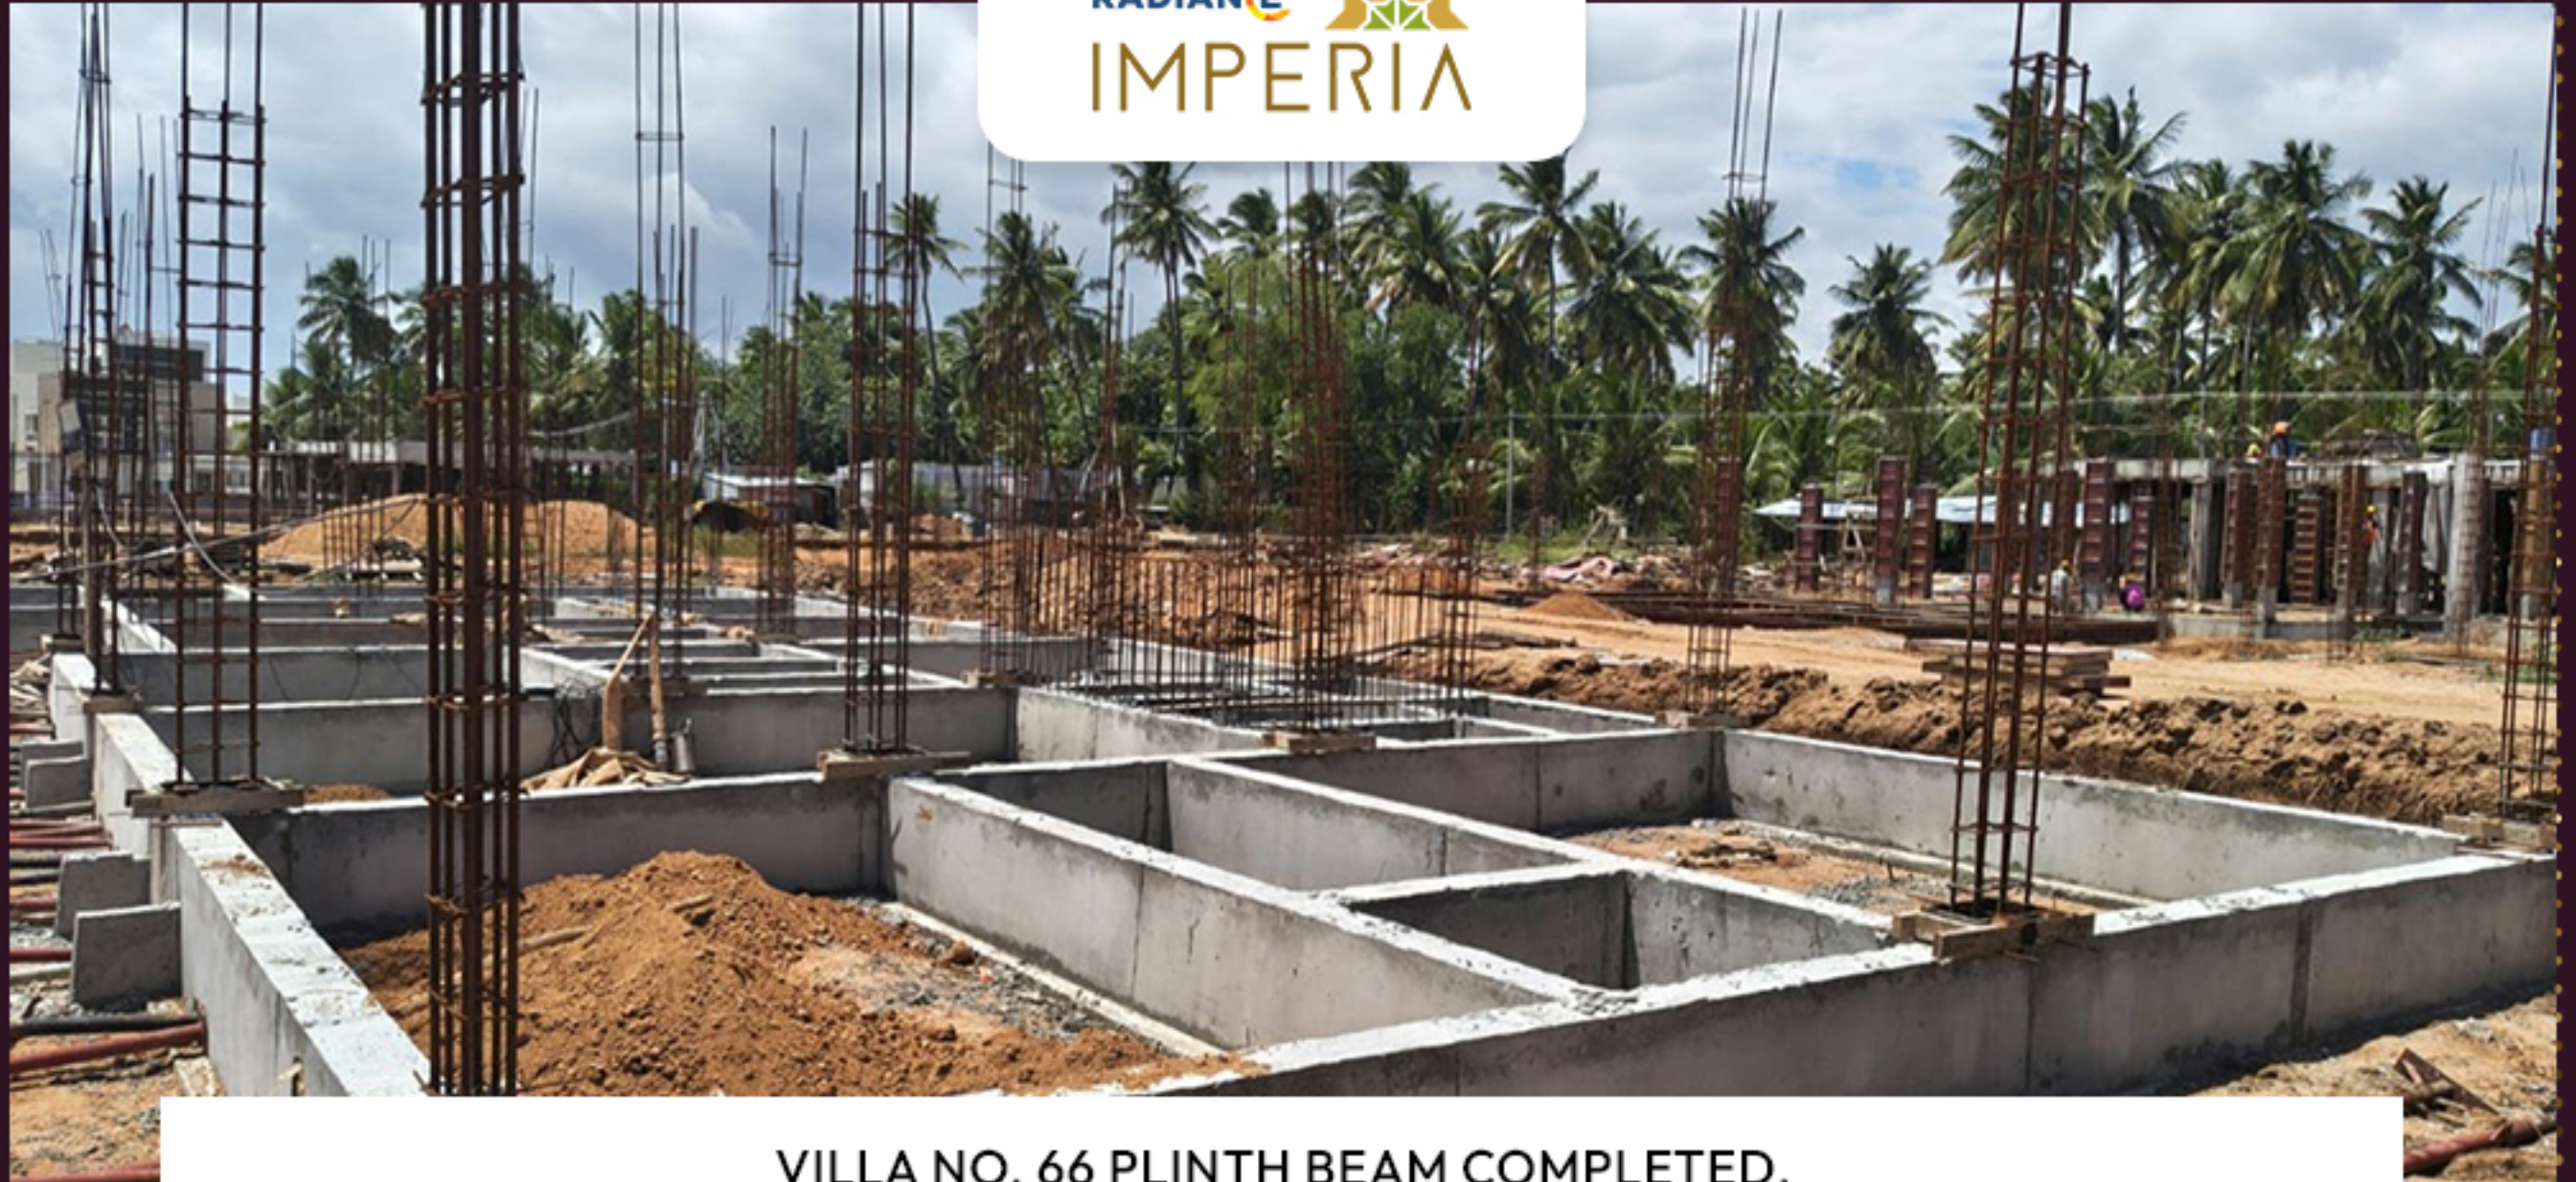
VILLA NO. 66 PLINTH BEAM COMPLETED.

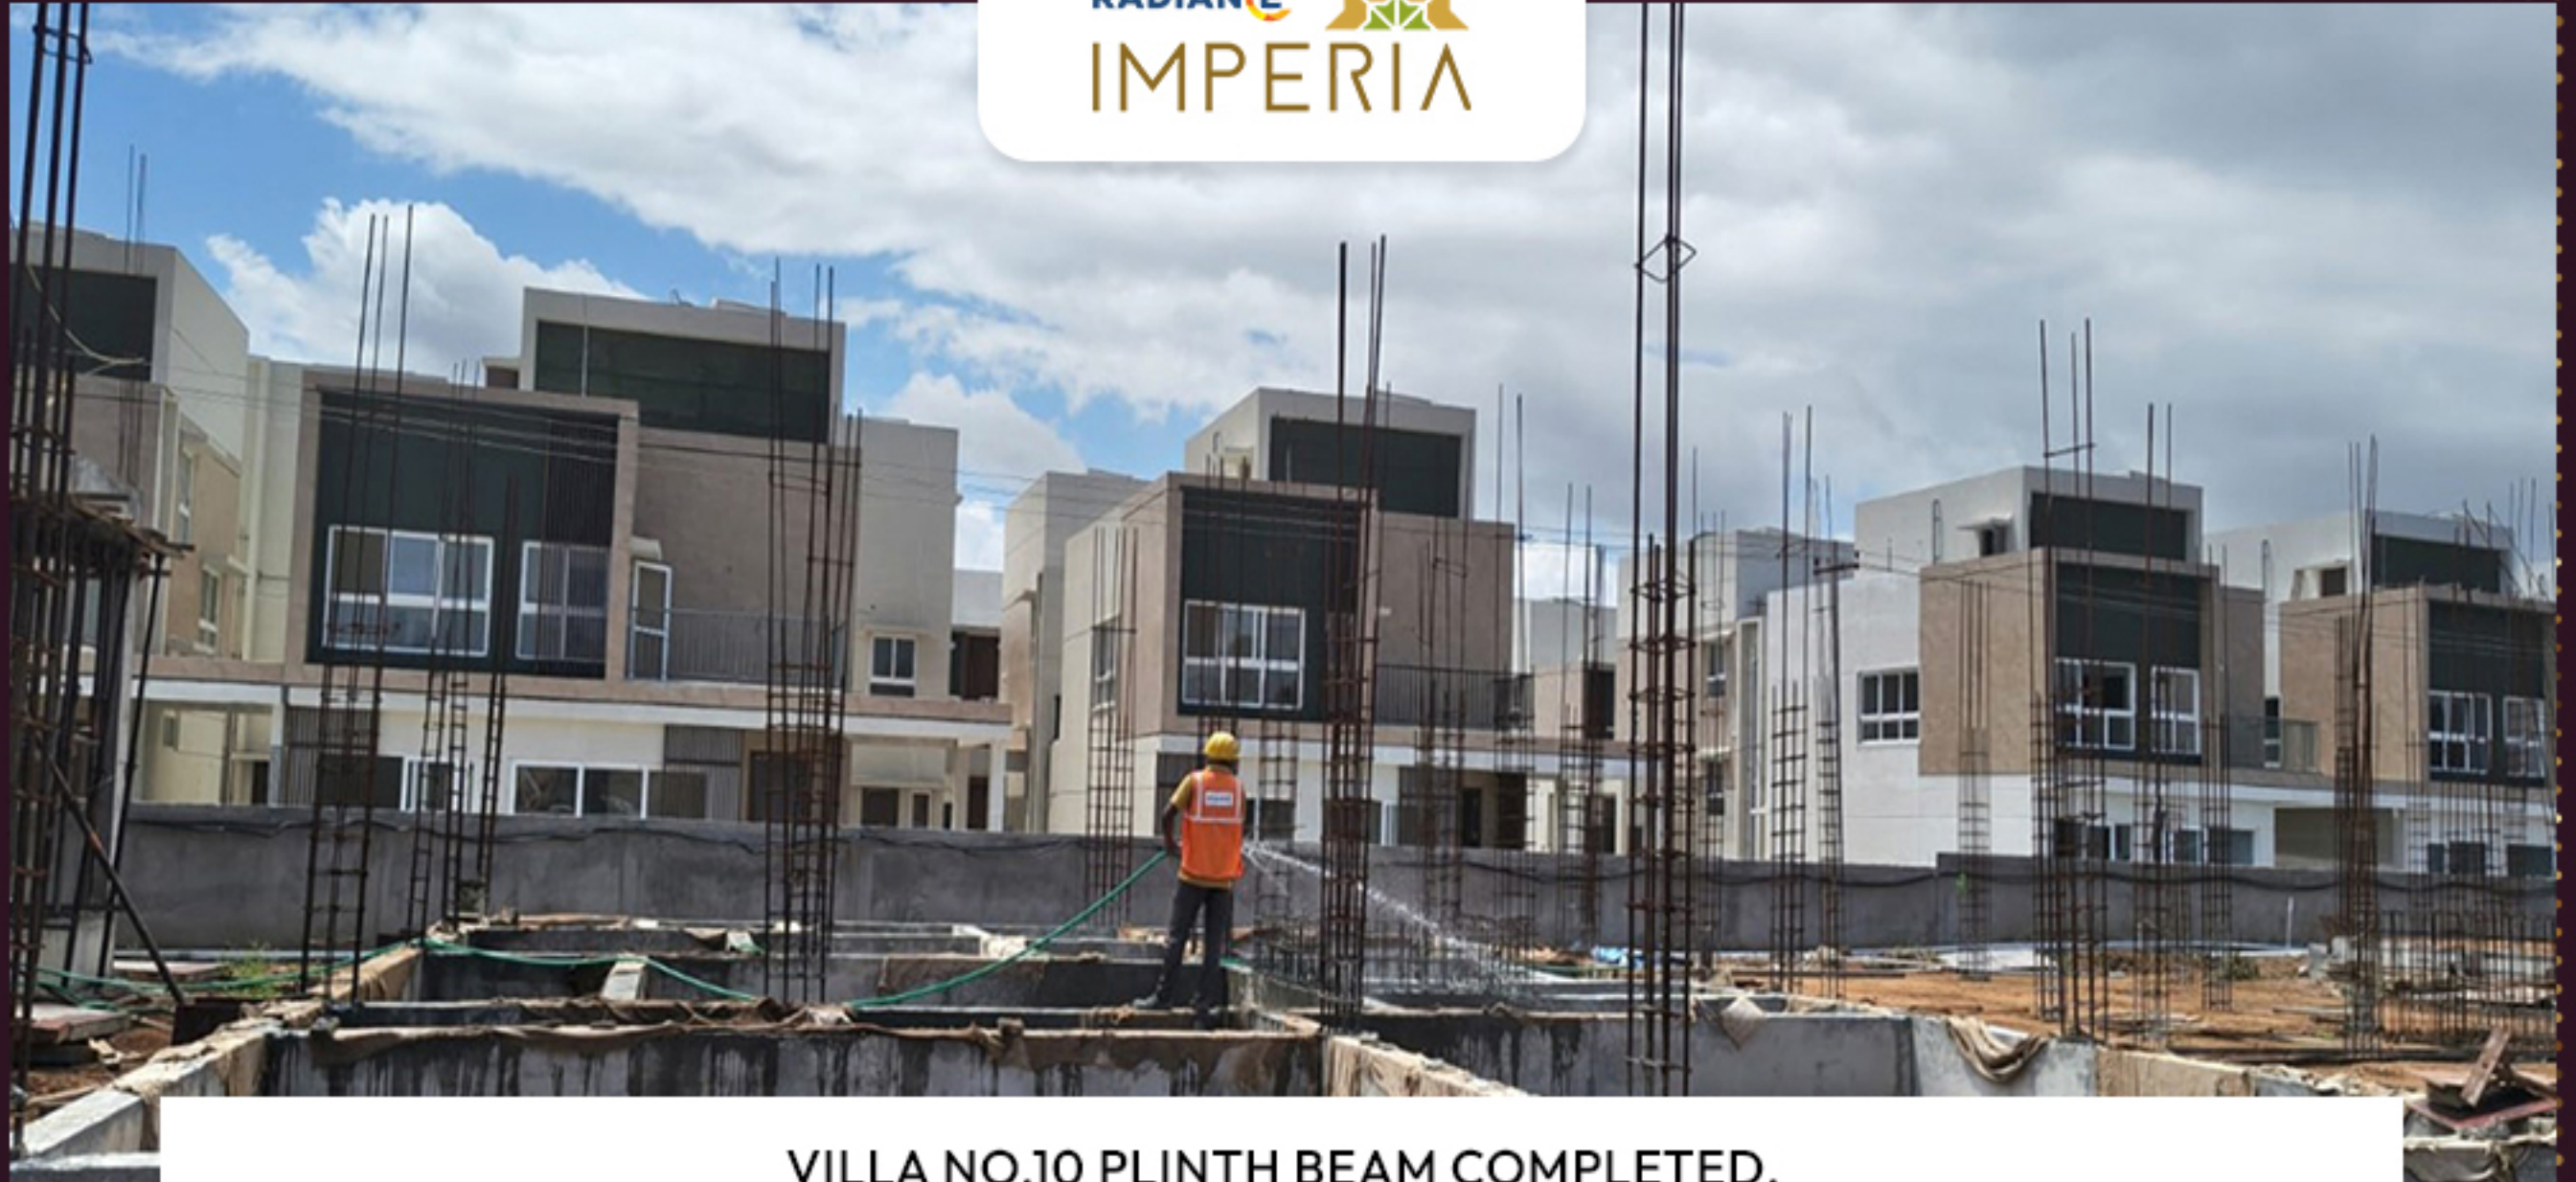
VILLA NO.10 PLINTH BEAM COMPLETED.

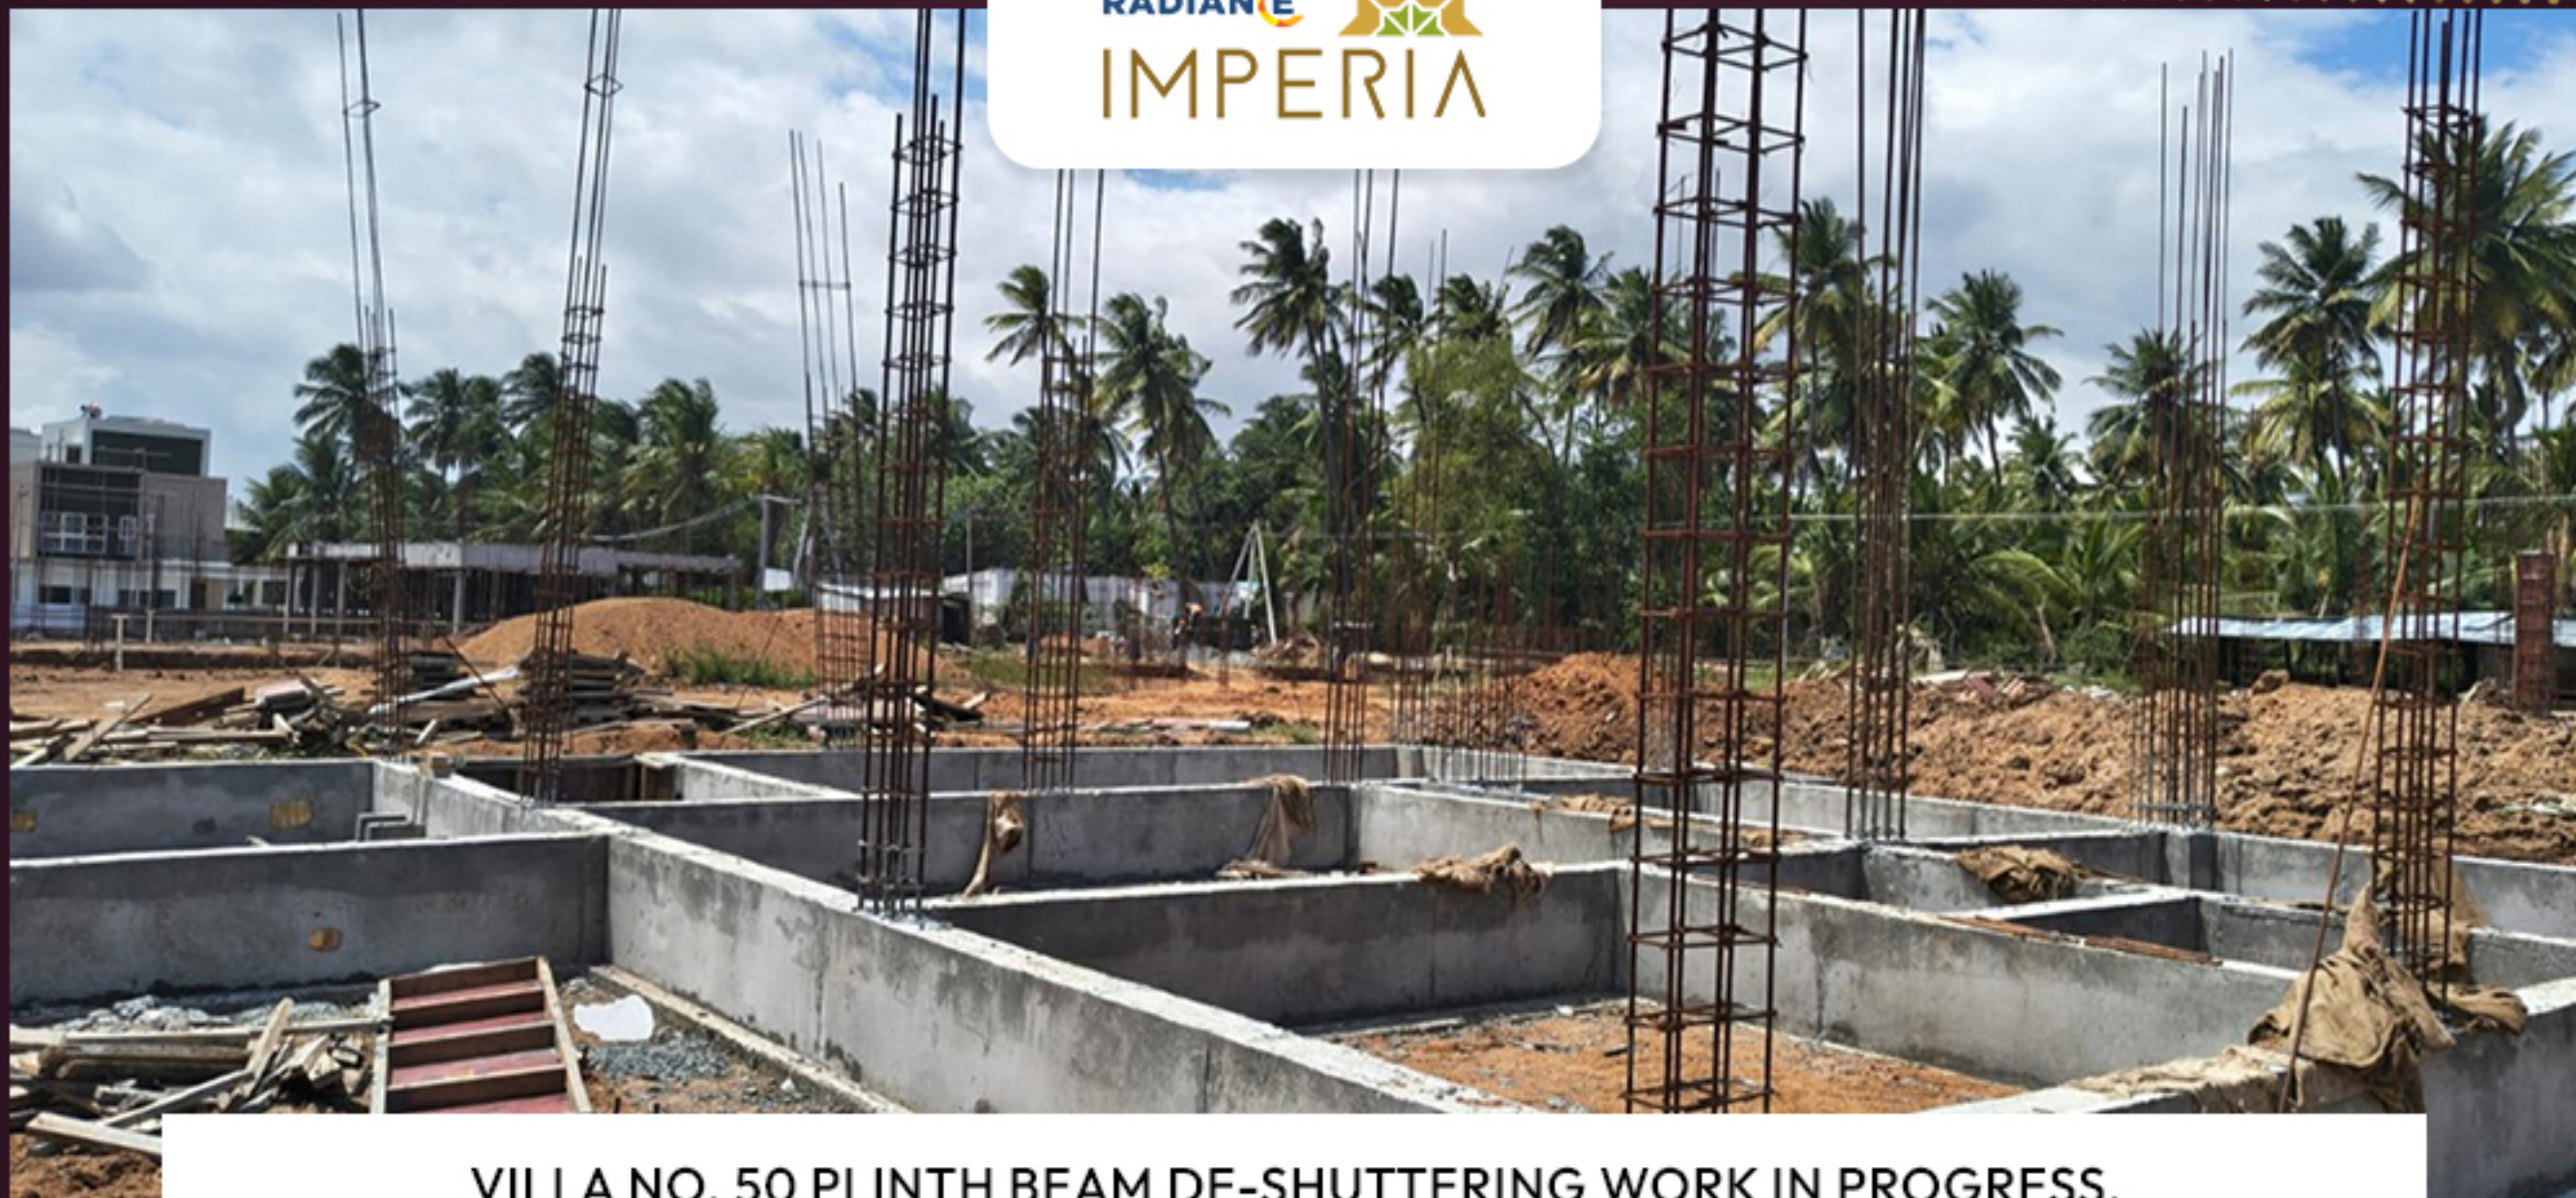
VILLA NO. 50 PLINTH BEAM DE-SHUTTERING WORK IN PROGRESS.

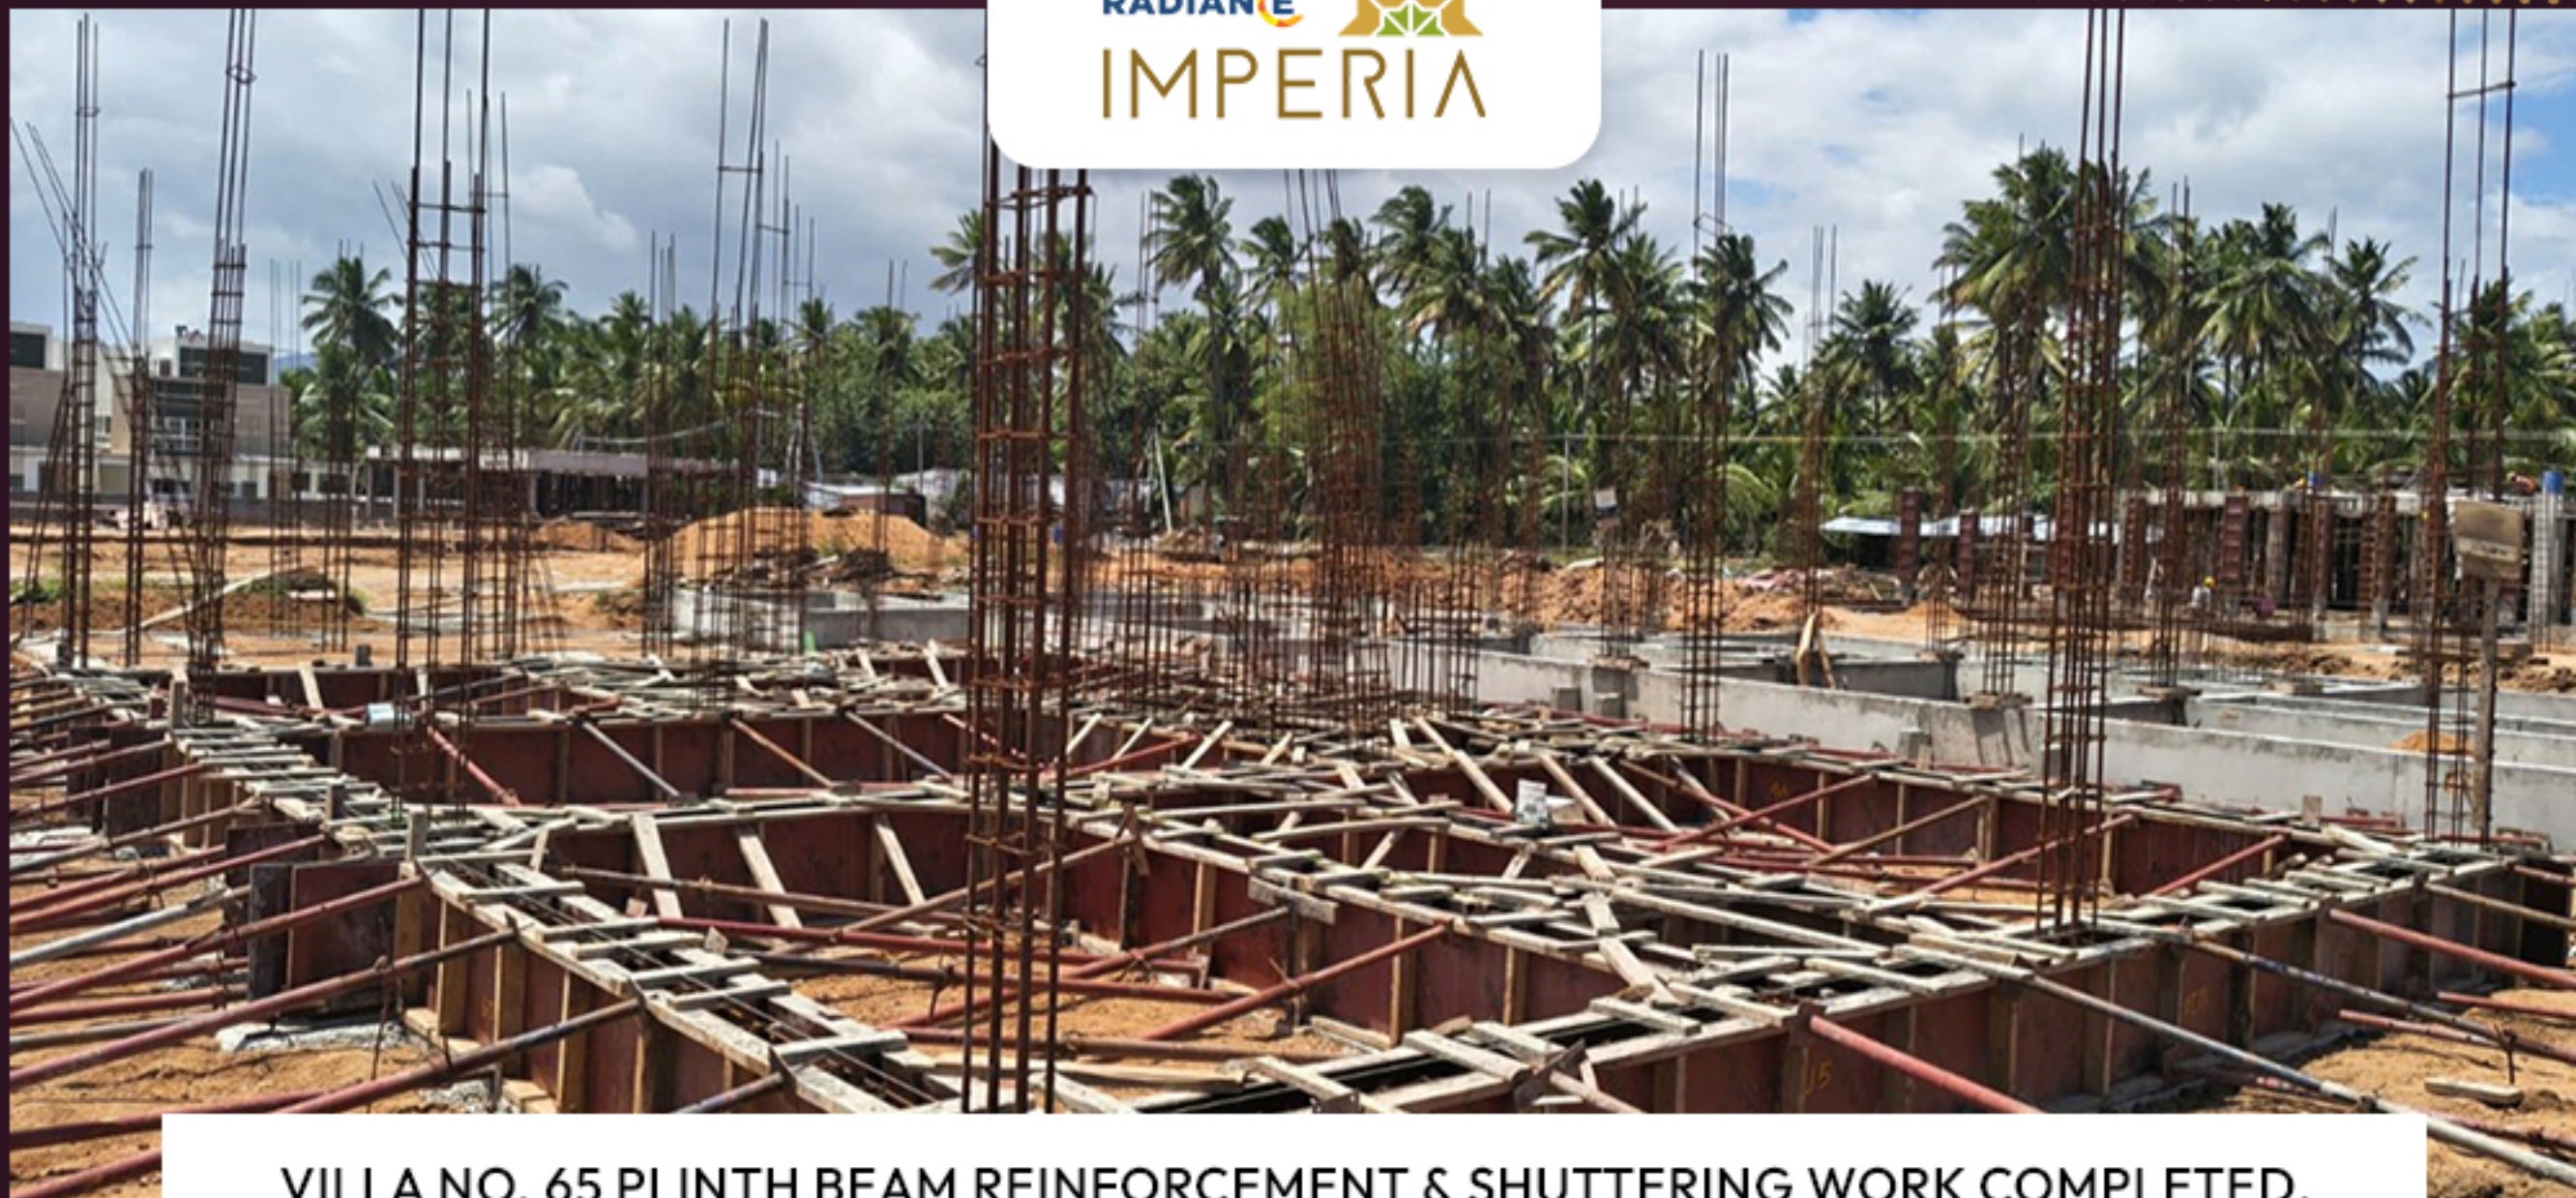
VILLA NO. 65 PLINTH BEAM REINFORCEMENT & SHUTTERING WORK COMPLETED.
