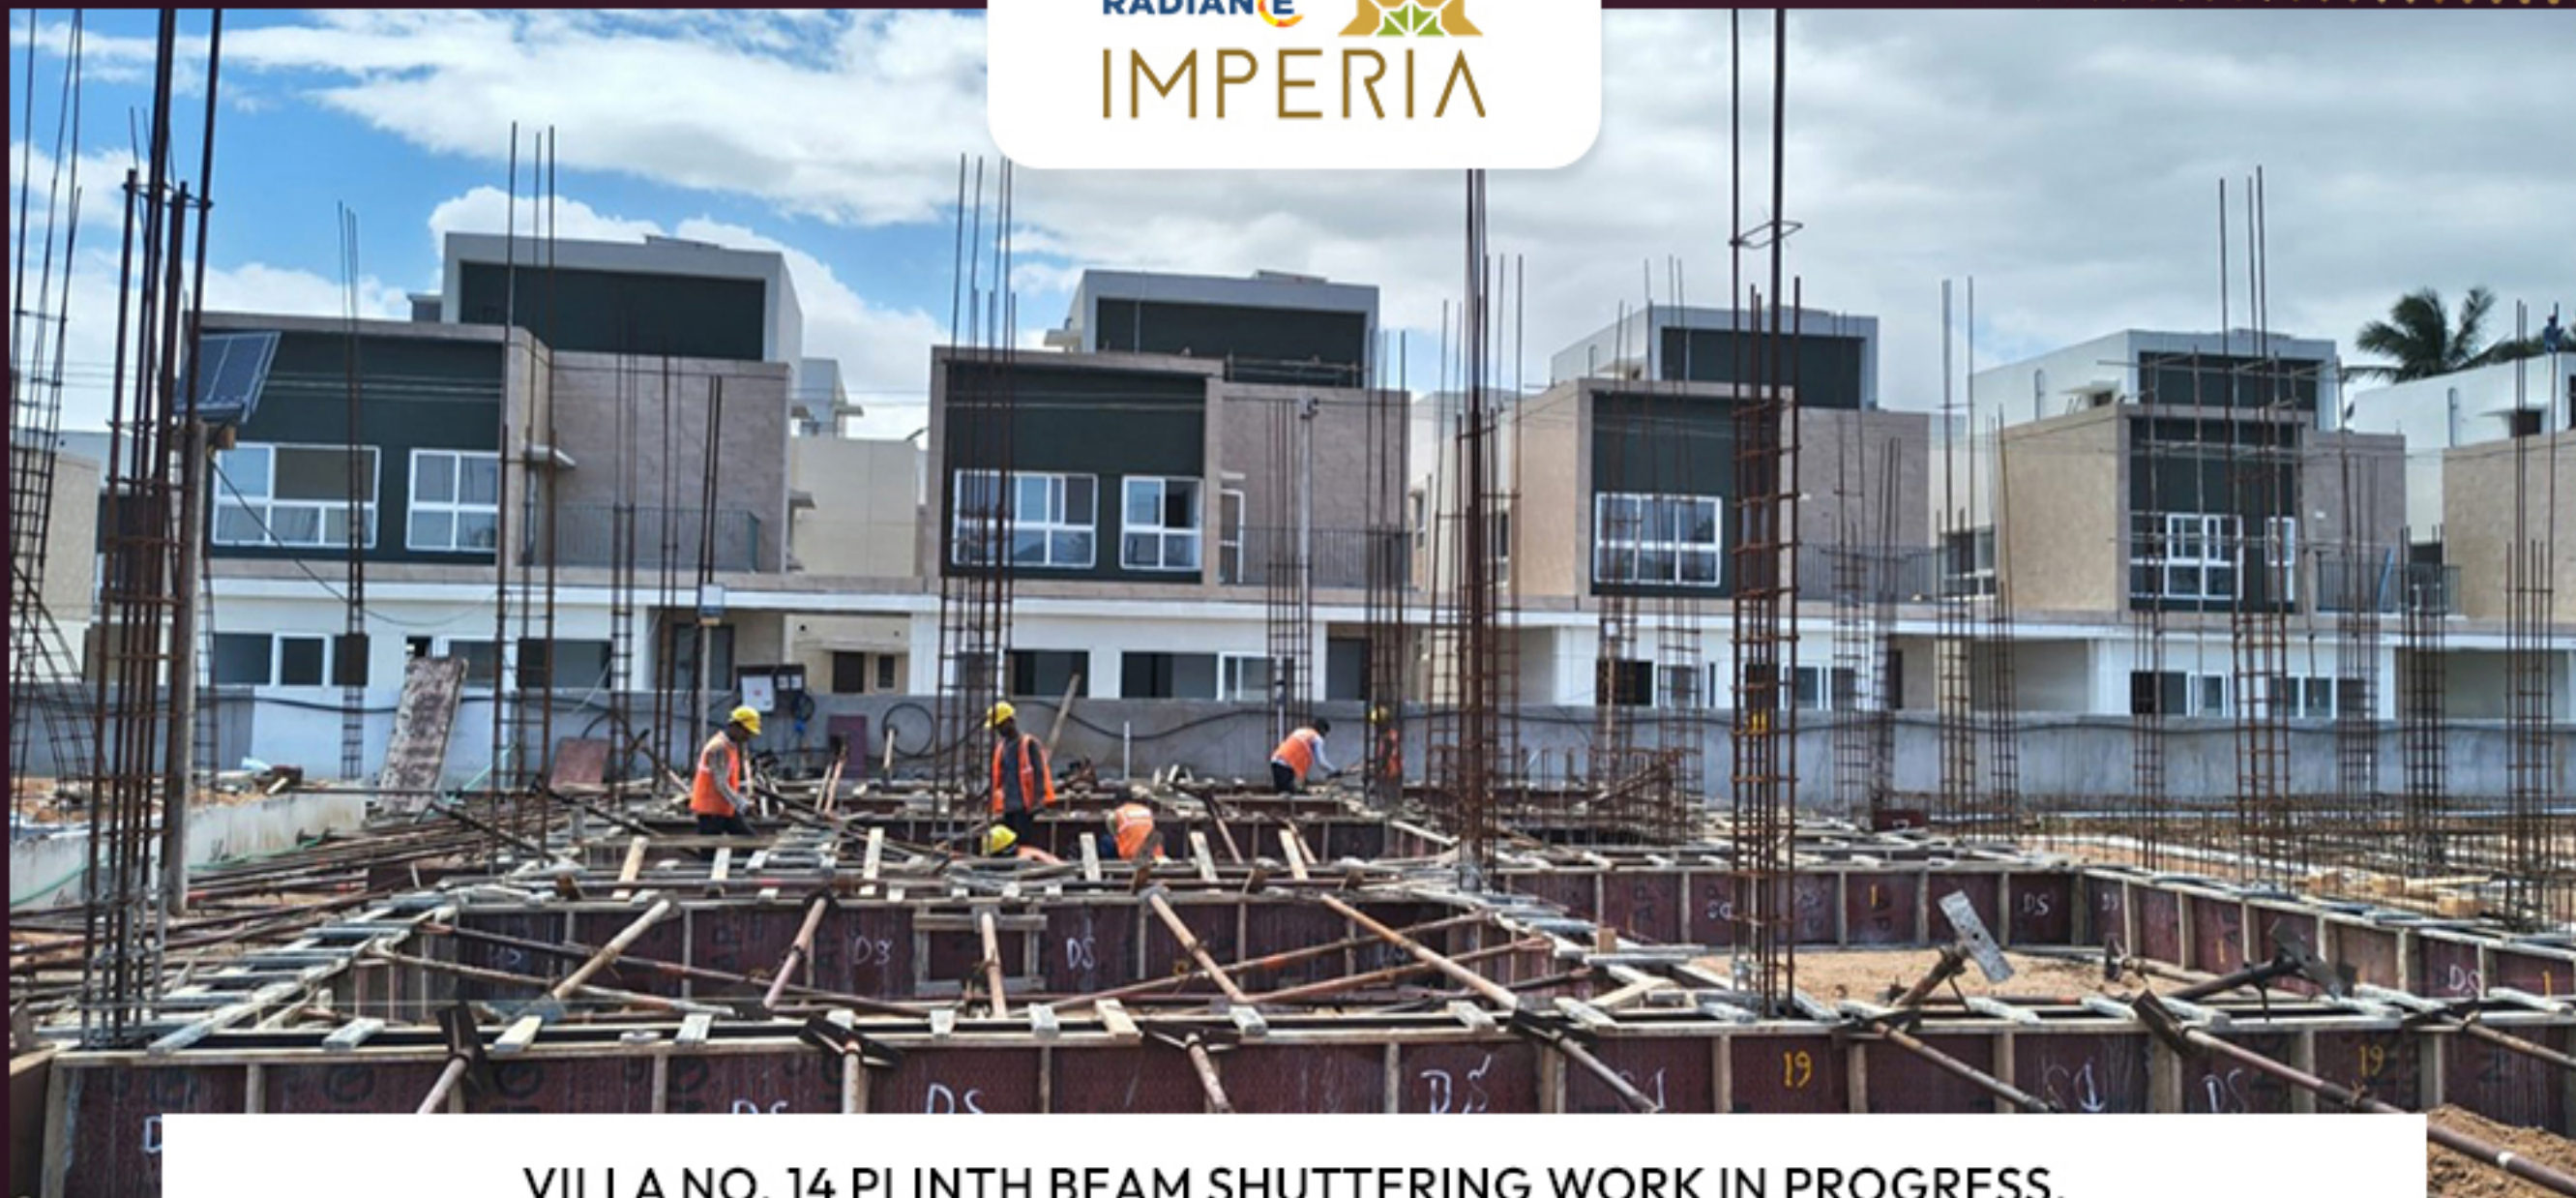
VILLA NO. 14 PLINTH BEAM SHUTTERING WORK IN PROGRESS.

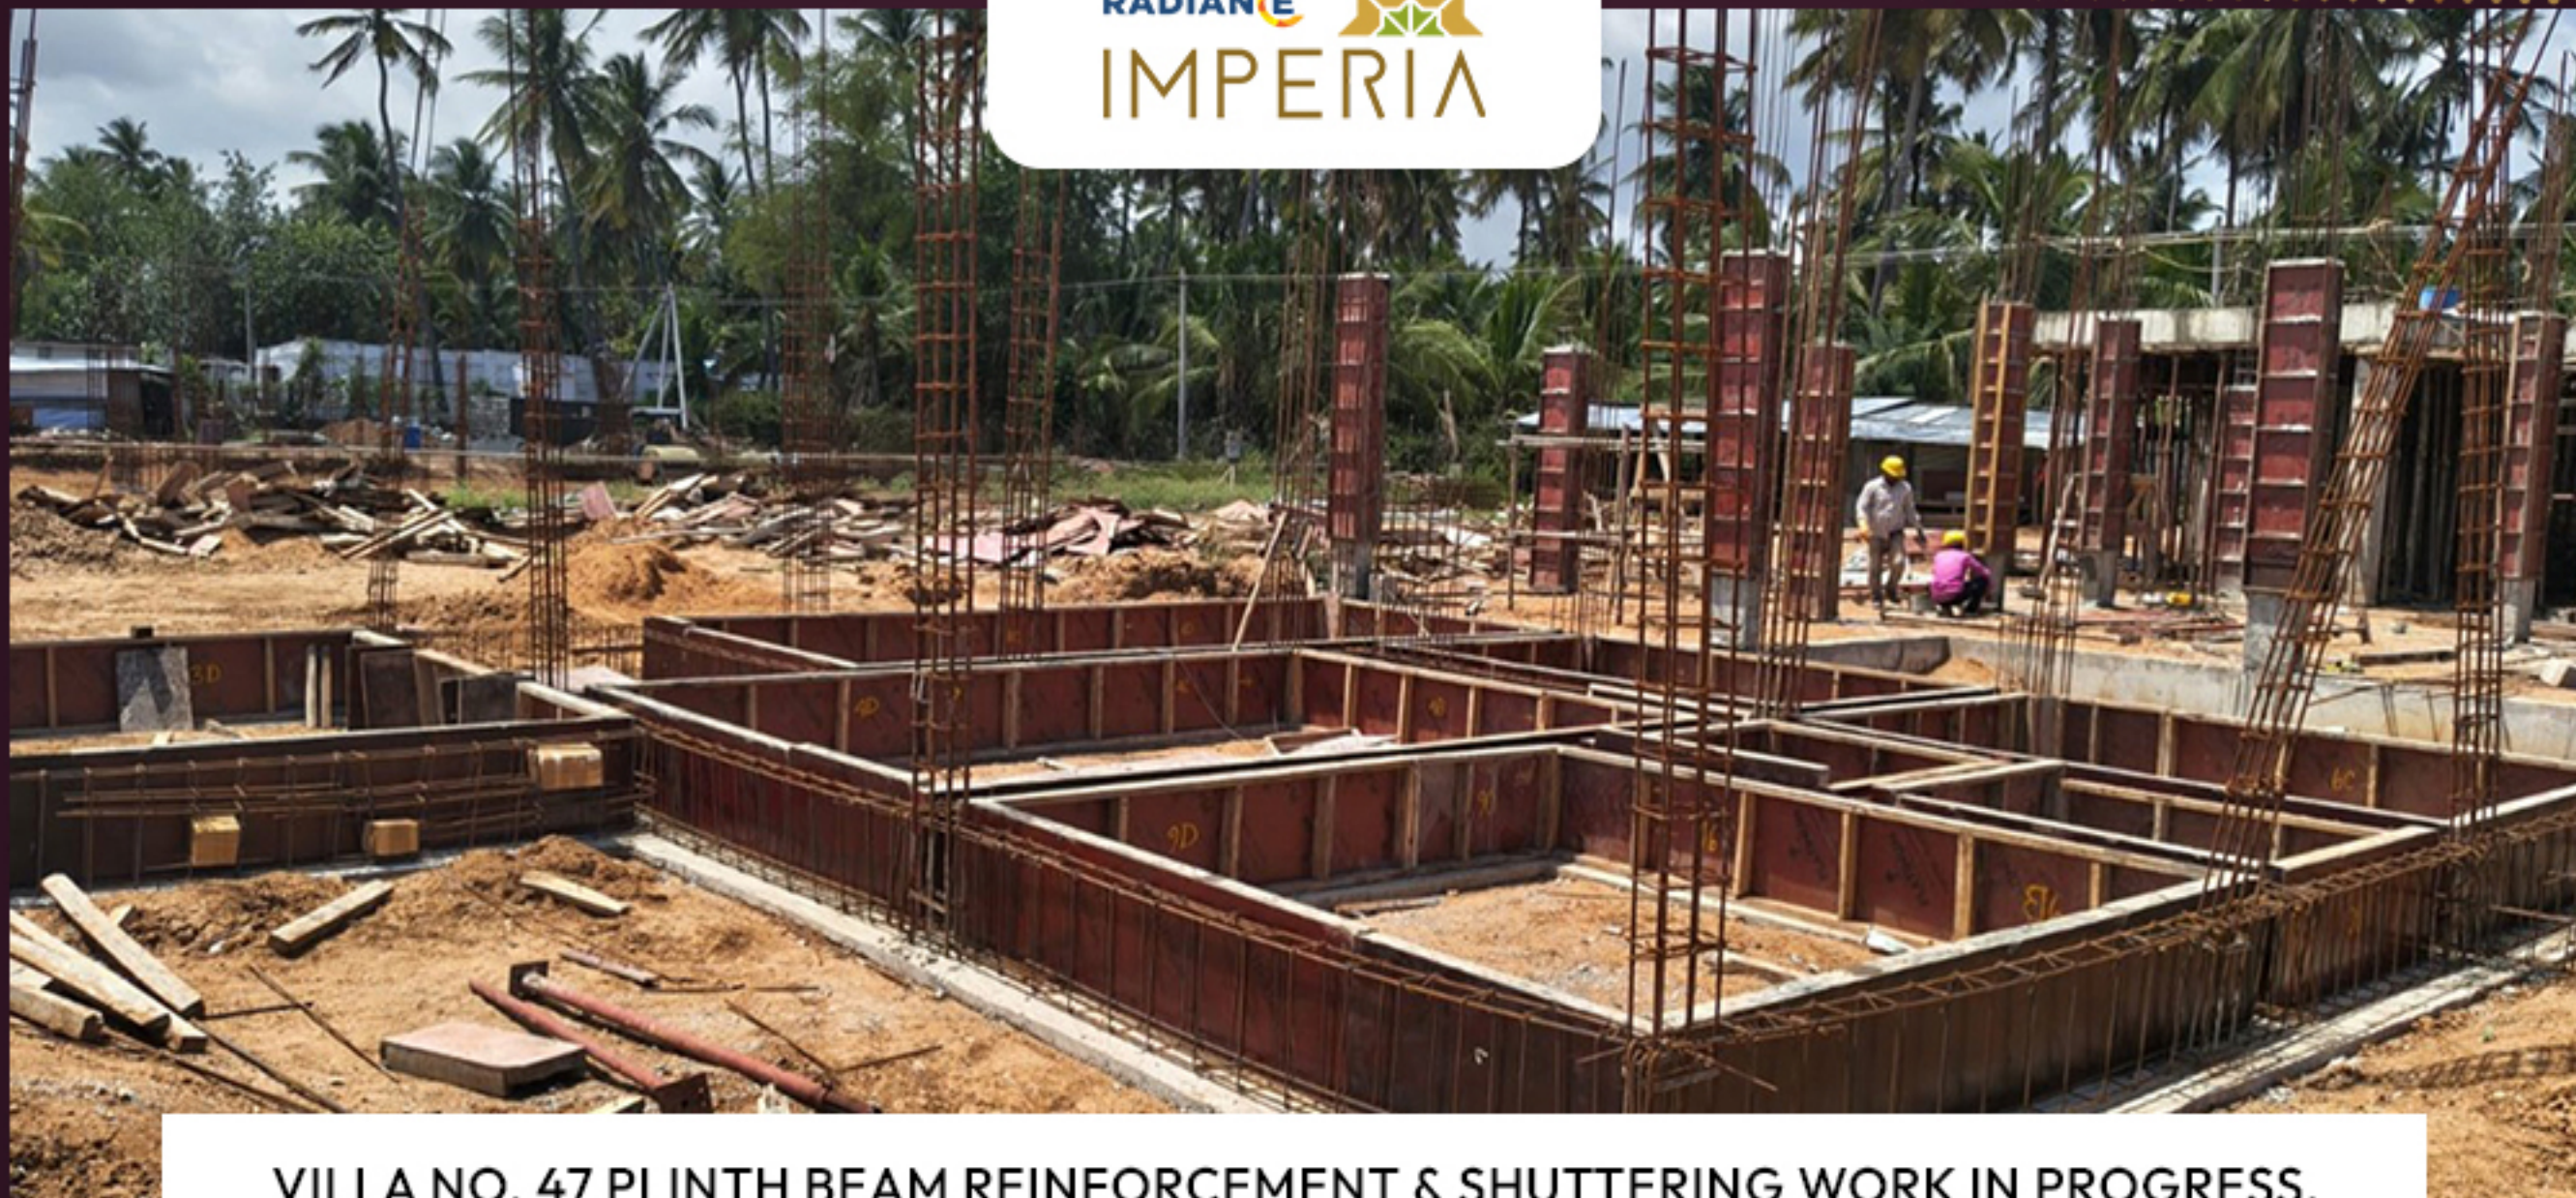
VILLA NO. 47 PLINTH BEAM REINFORCEMENT & SHUTTERING WORK IN PROGRESS.

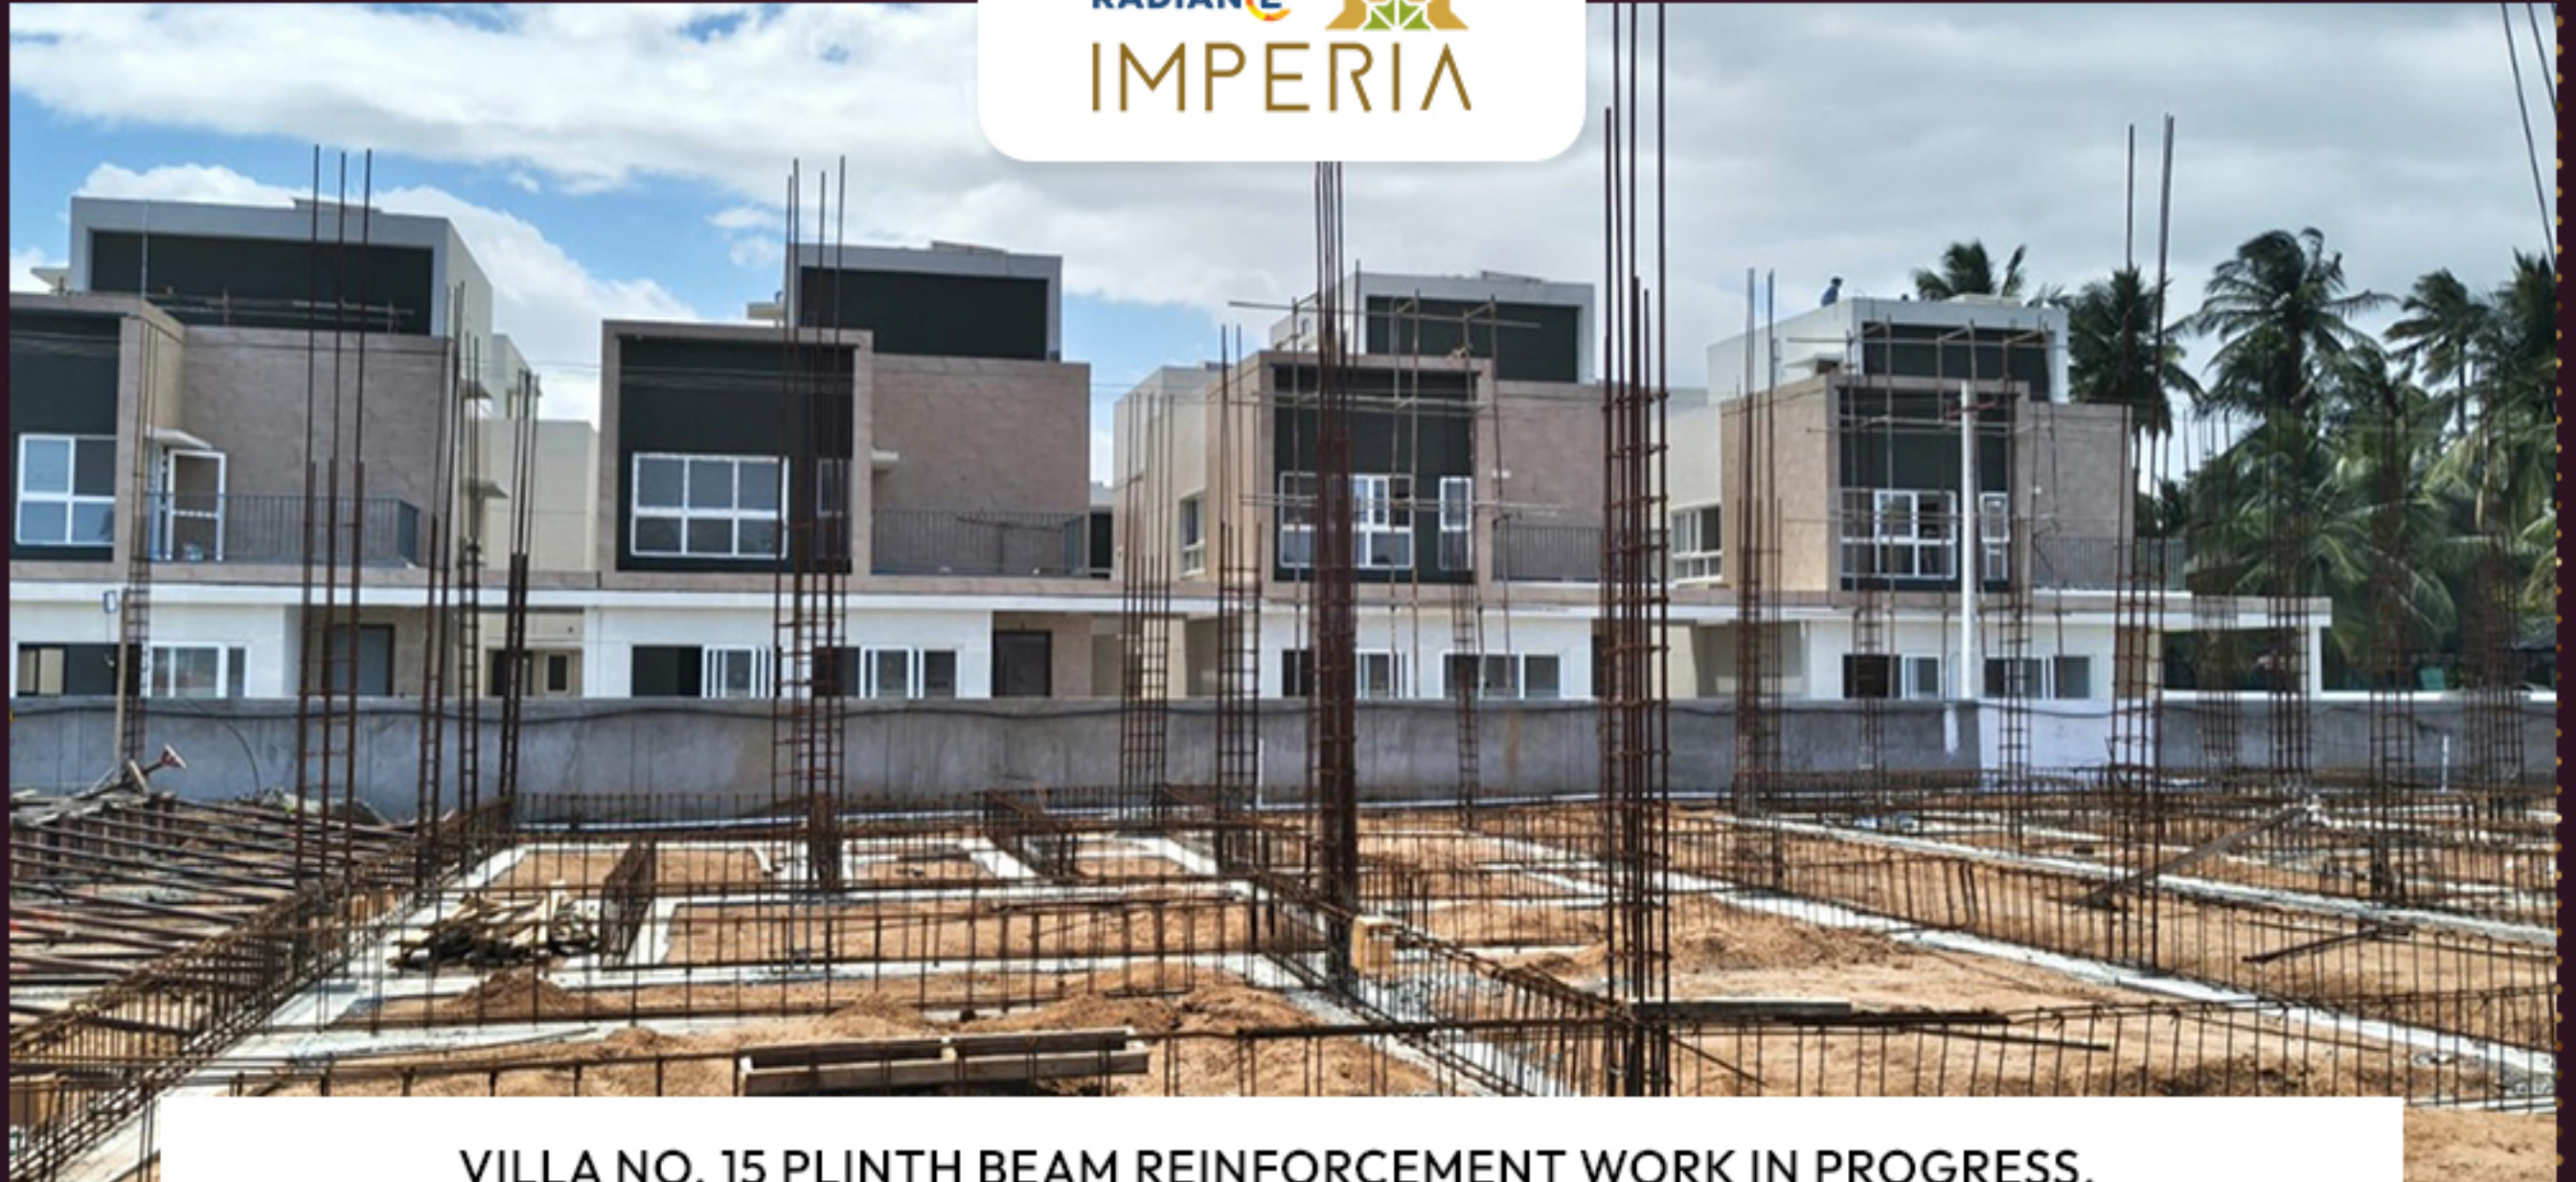
VILLA NO. 15 PLINTH BEAM REINFORCEMENT WORK IN PROGRESS.

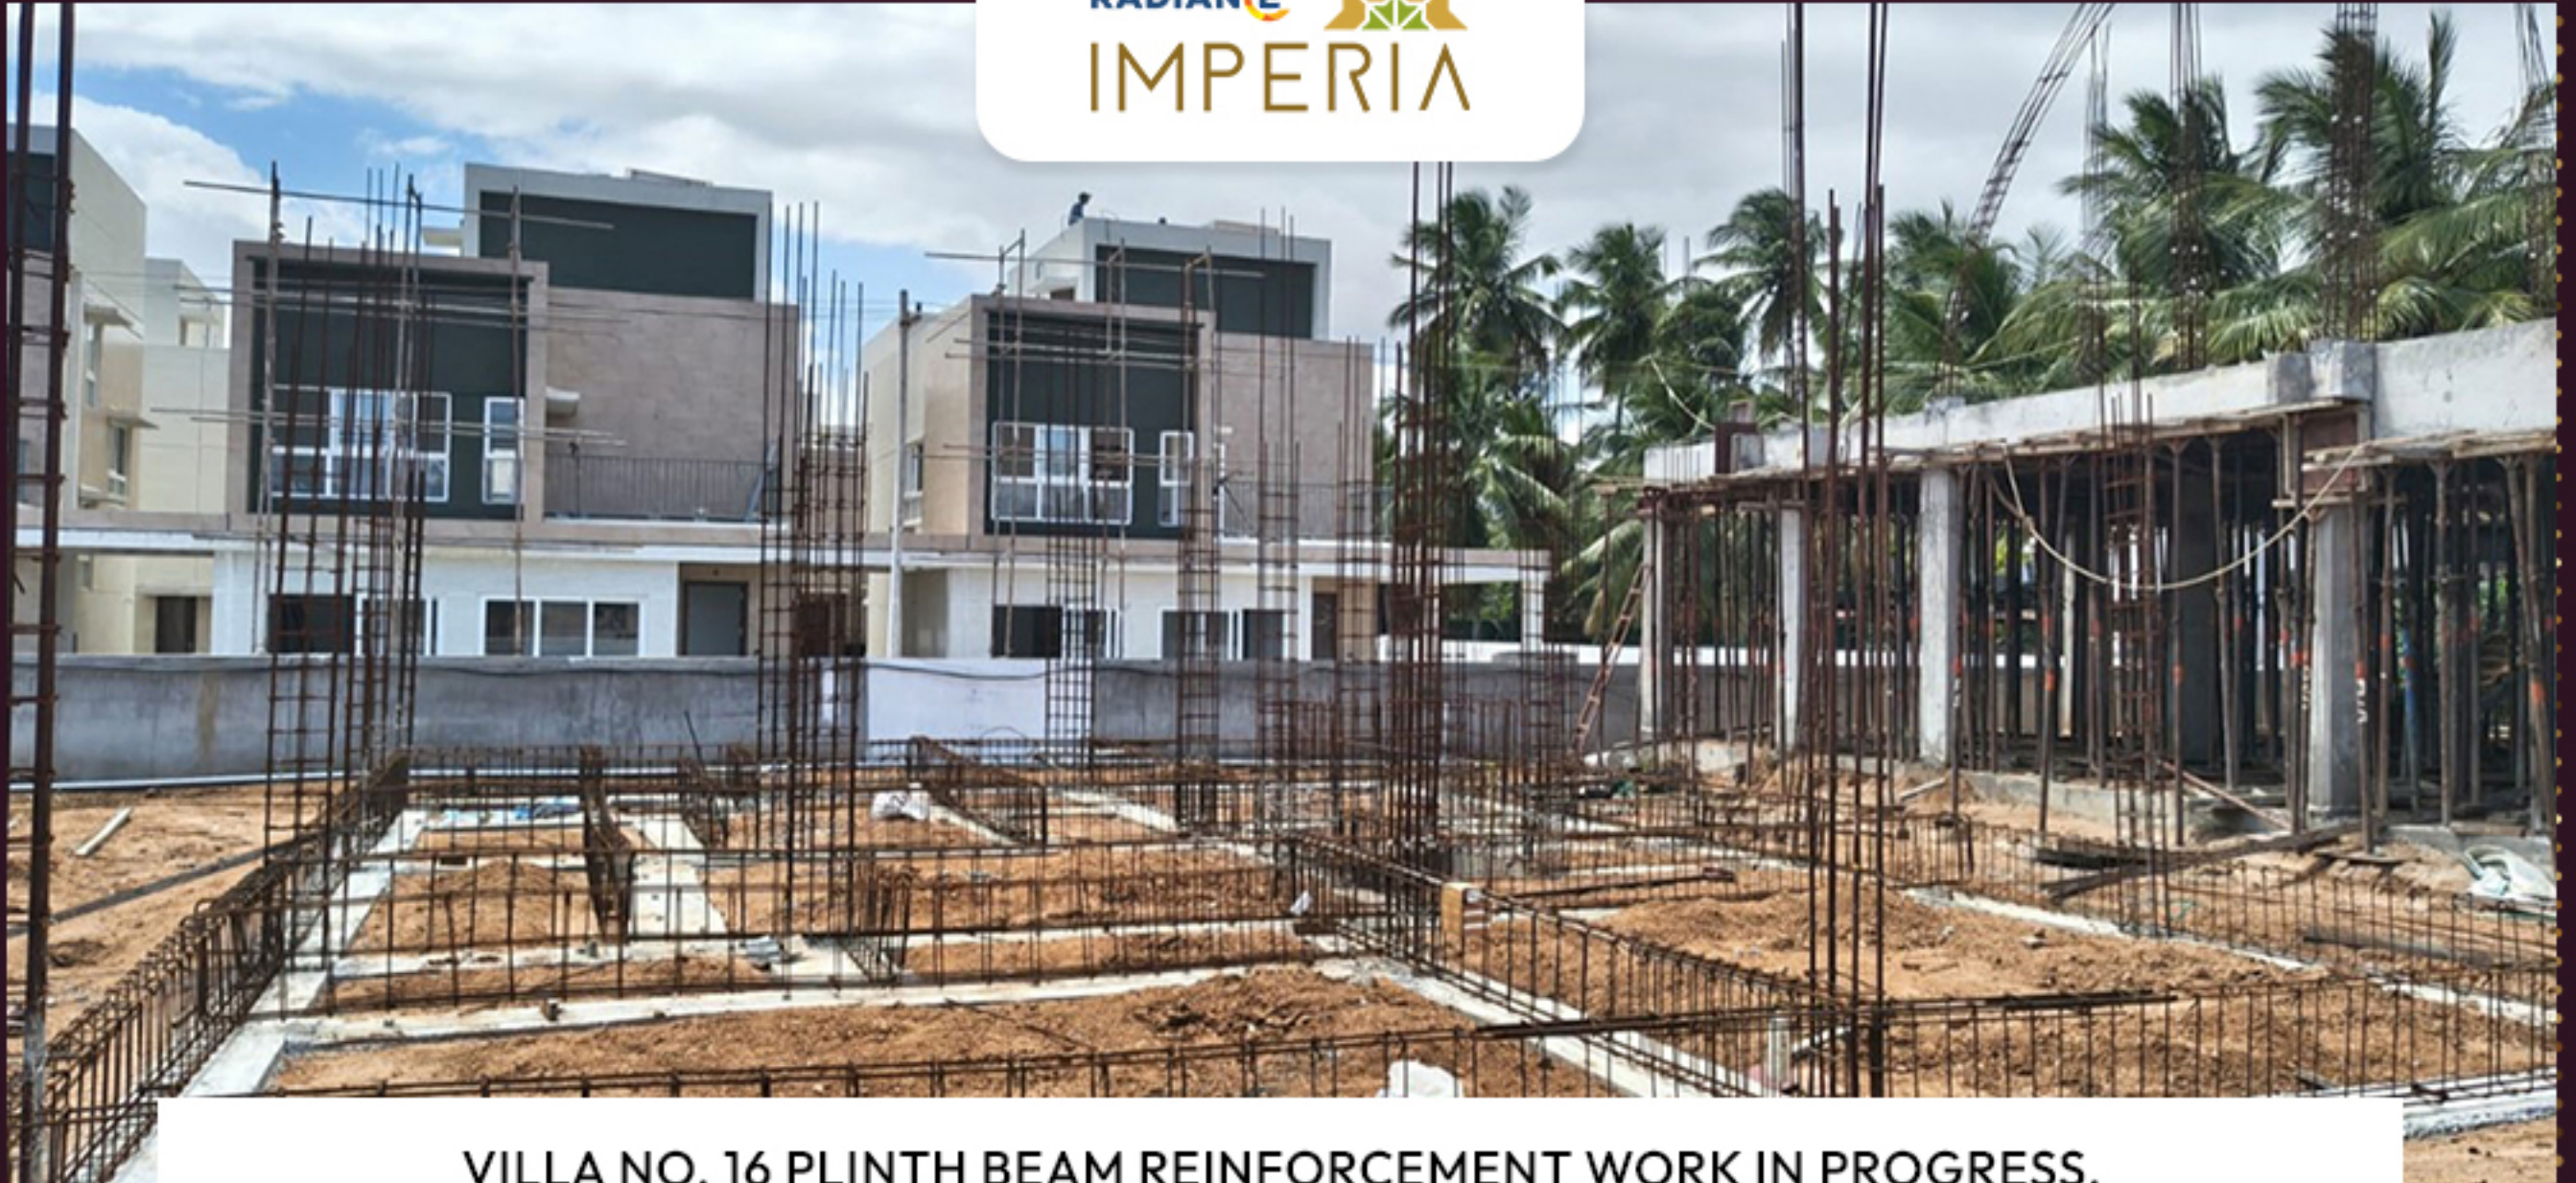
VILLA NO. 16 PLINTH BEAM REINFORCEMENT WORK IN PROGRESS.

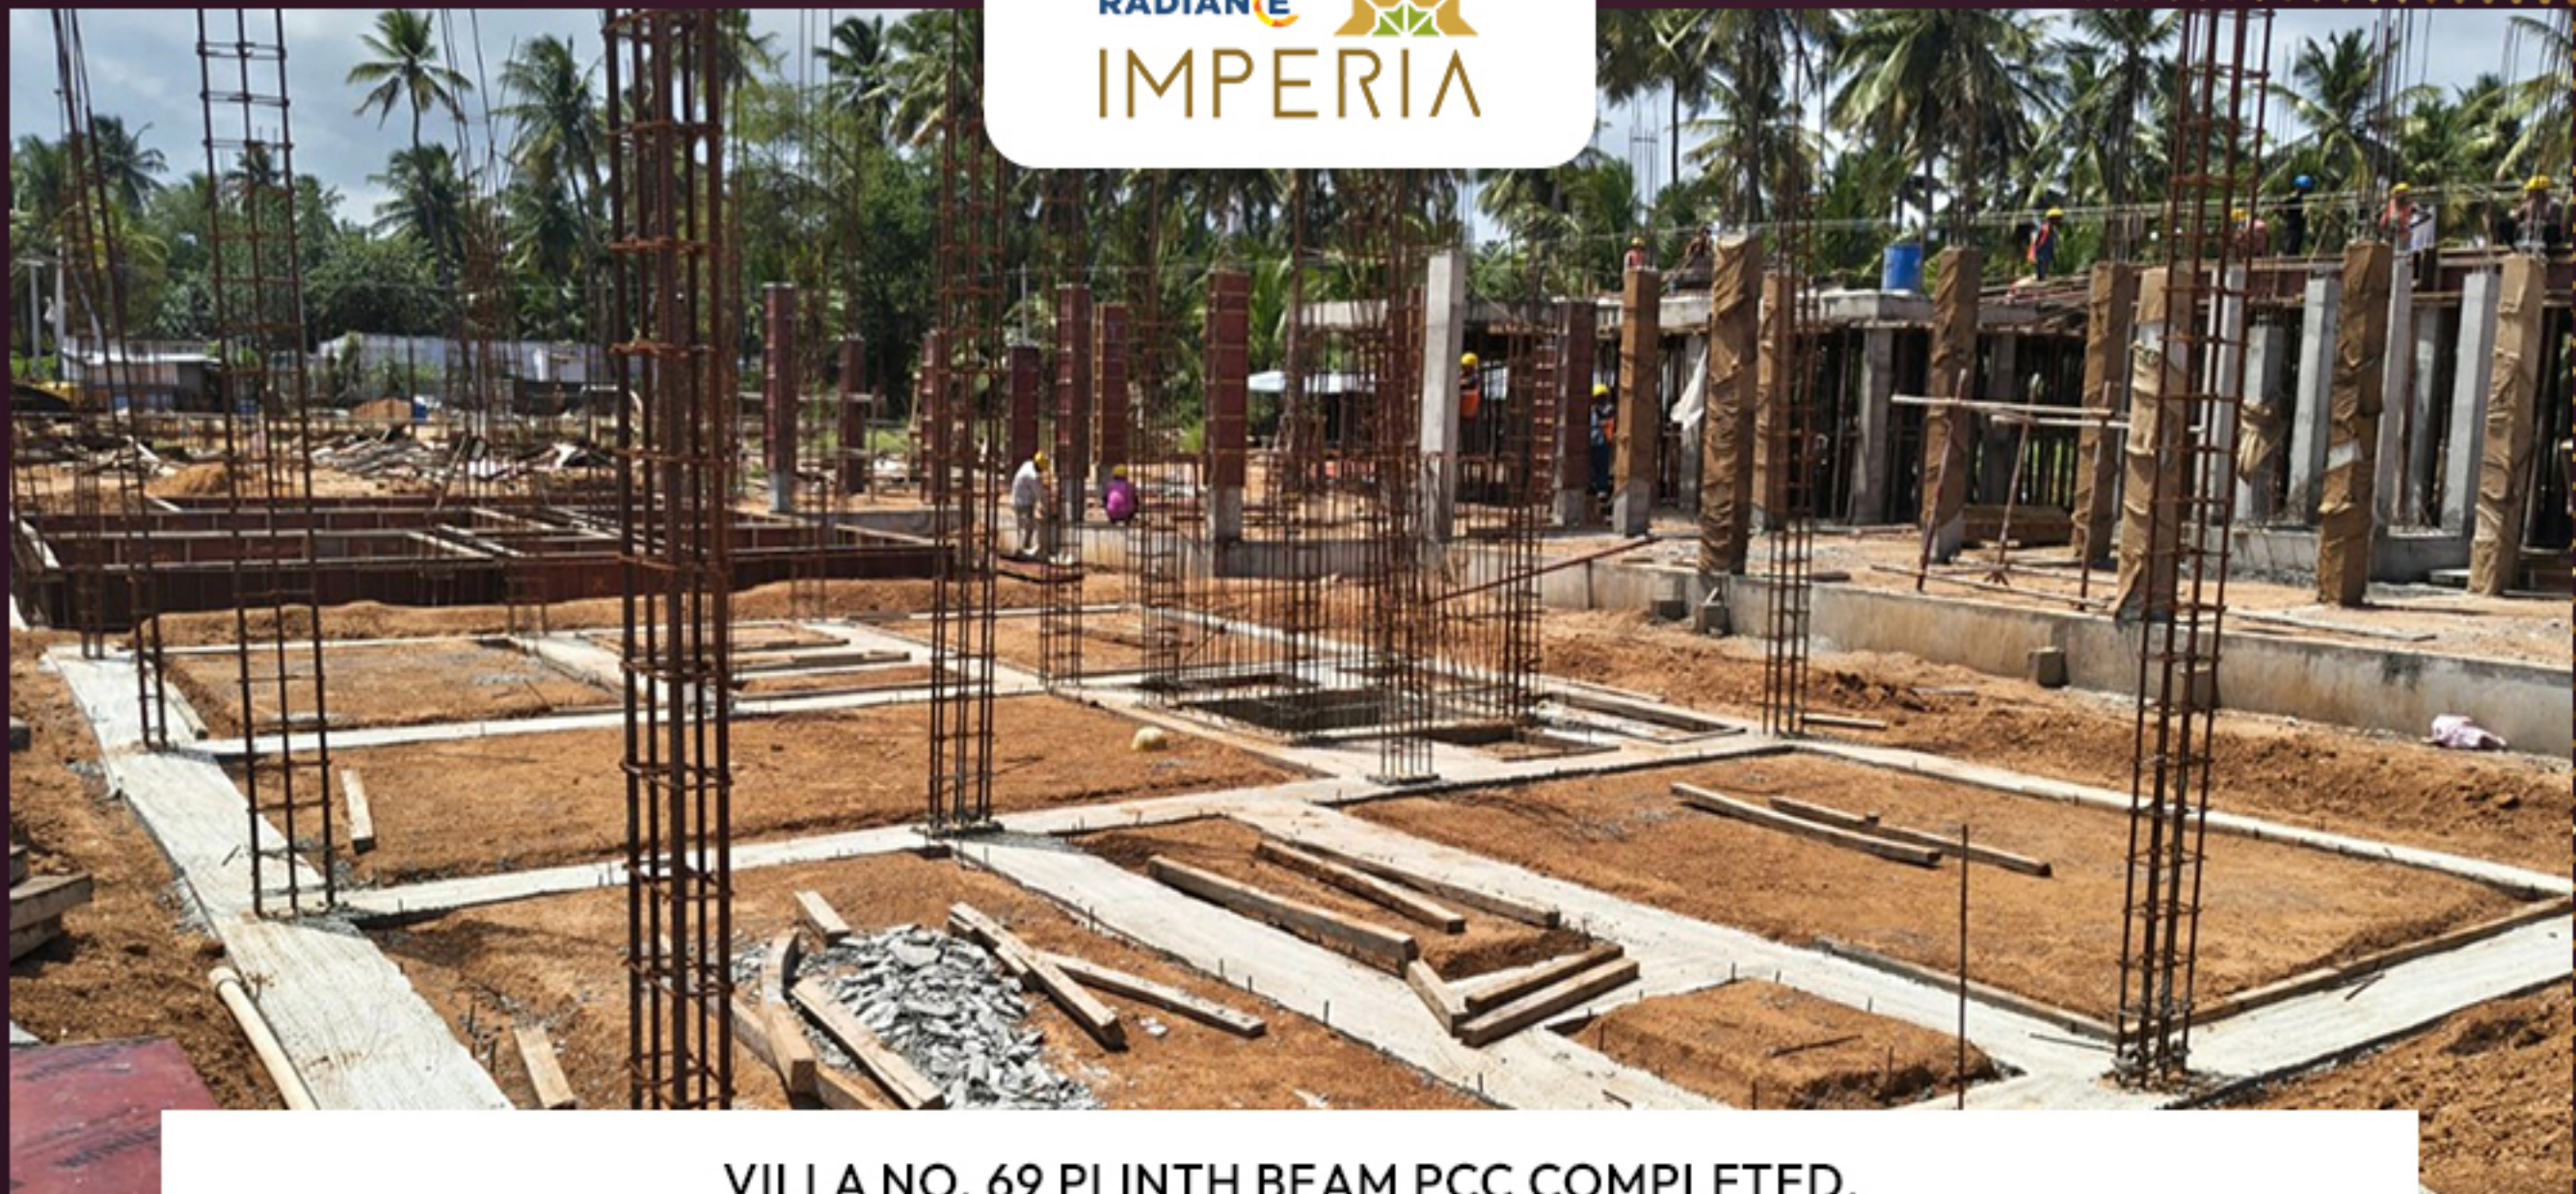
VILLA NO. 69 PLINTH BEAM PCC COMPLETED.

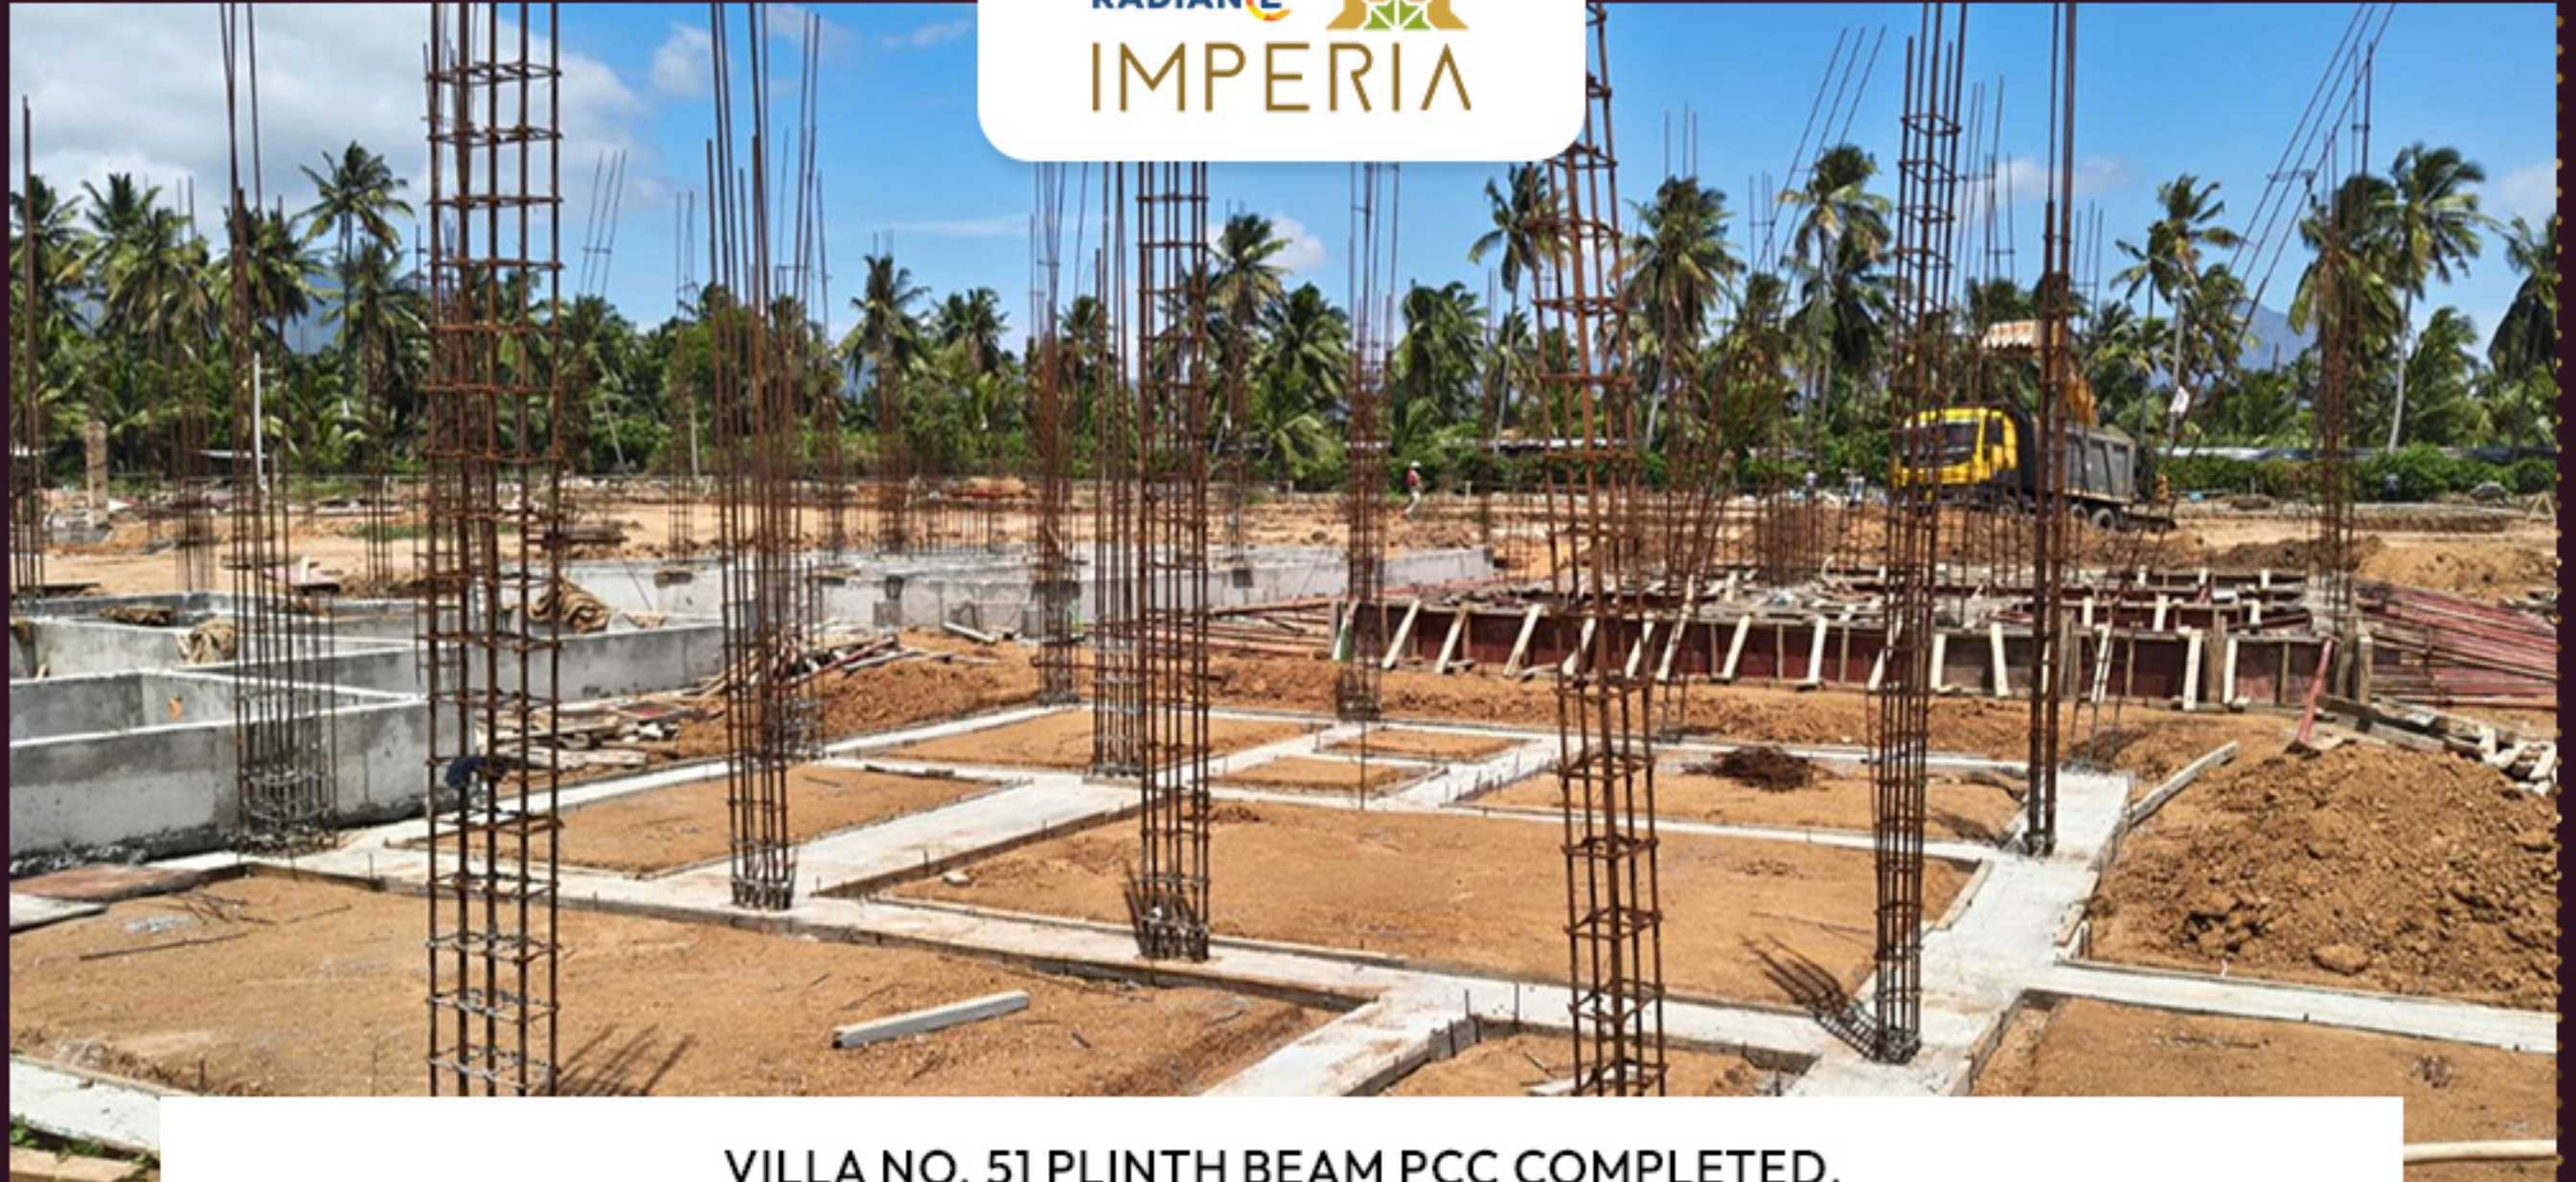
VILLA NO. 51 PLINTH BEAM PCC COMPLETED.

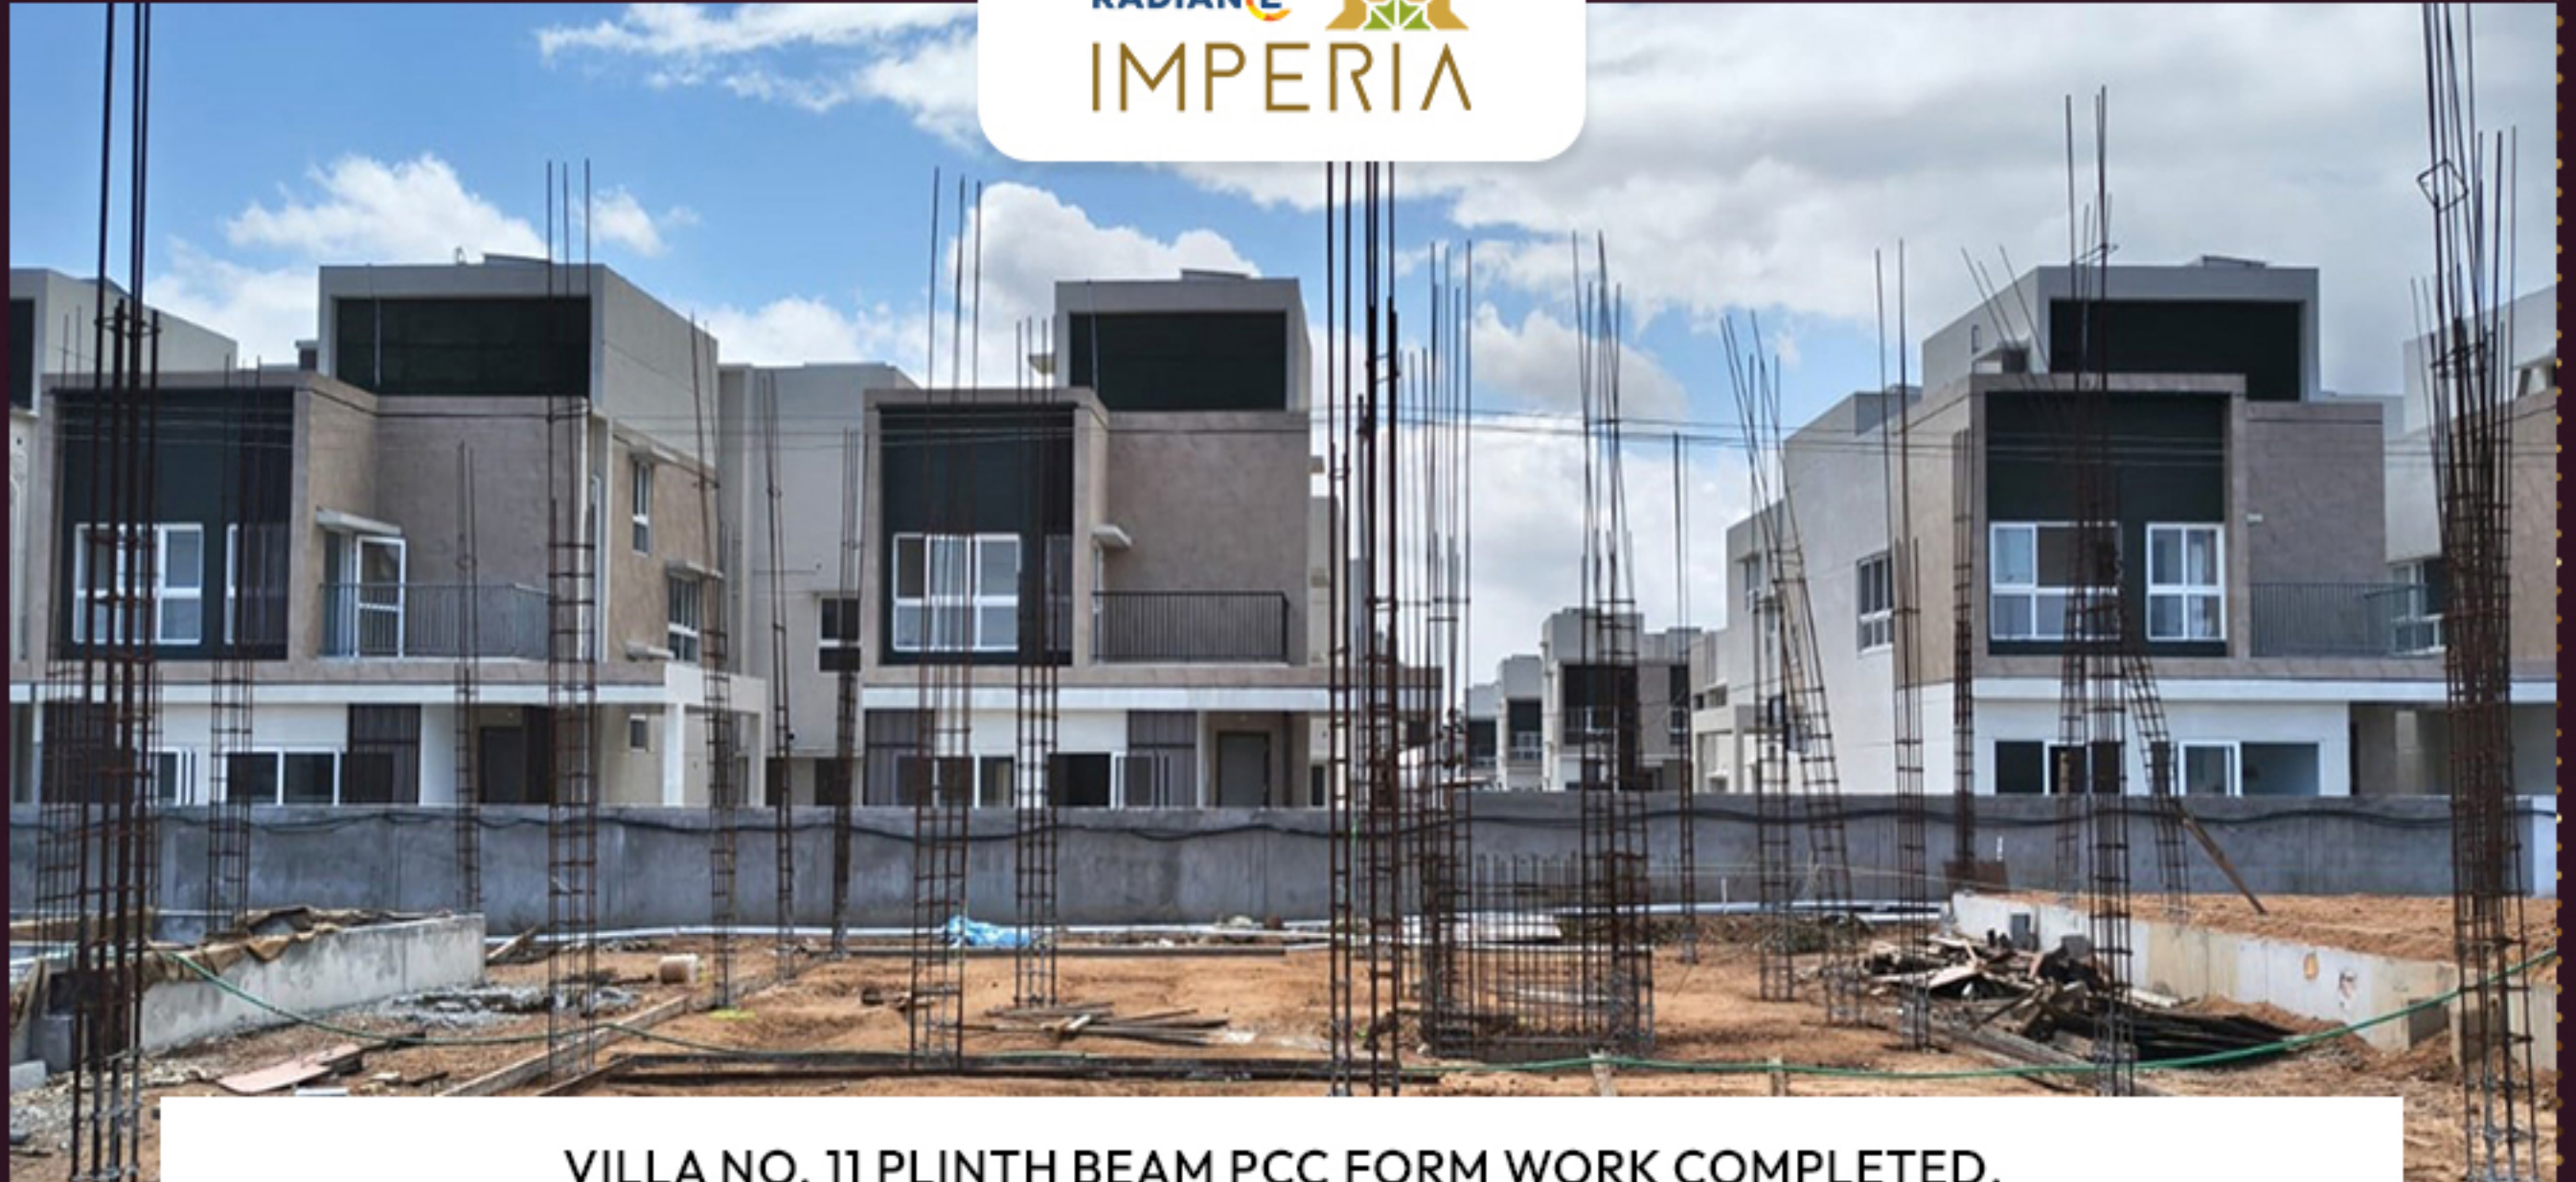
VILLA NO. 11 PLINTH BEAM PCC FORM WORK COMPLETED.
