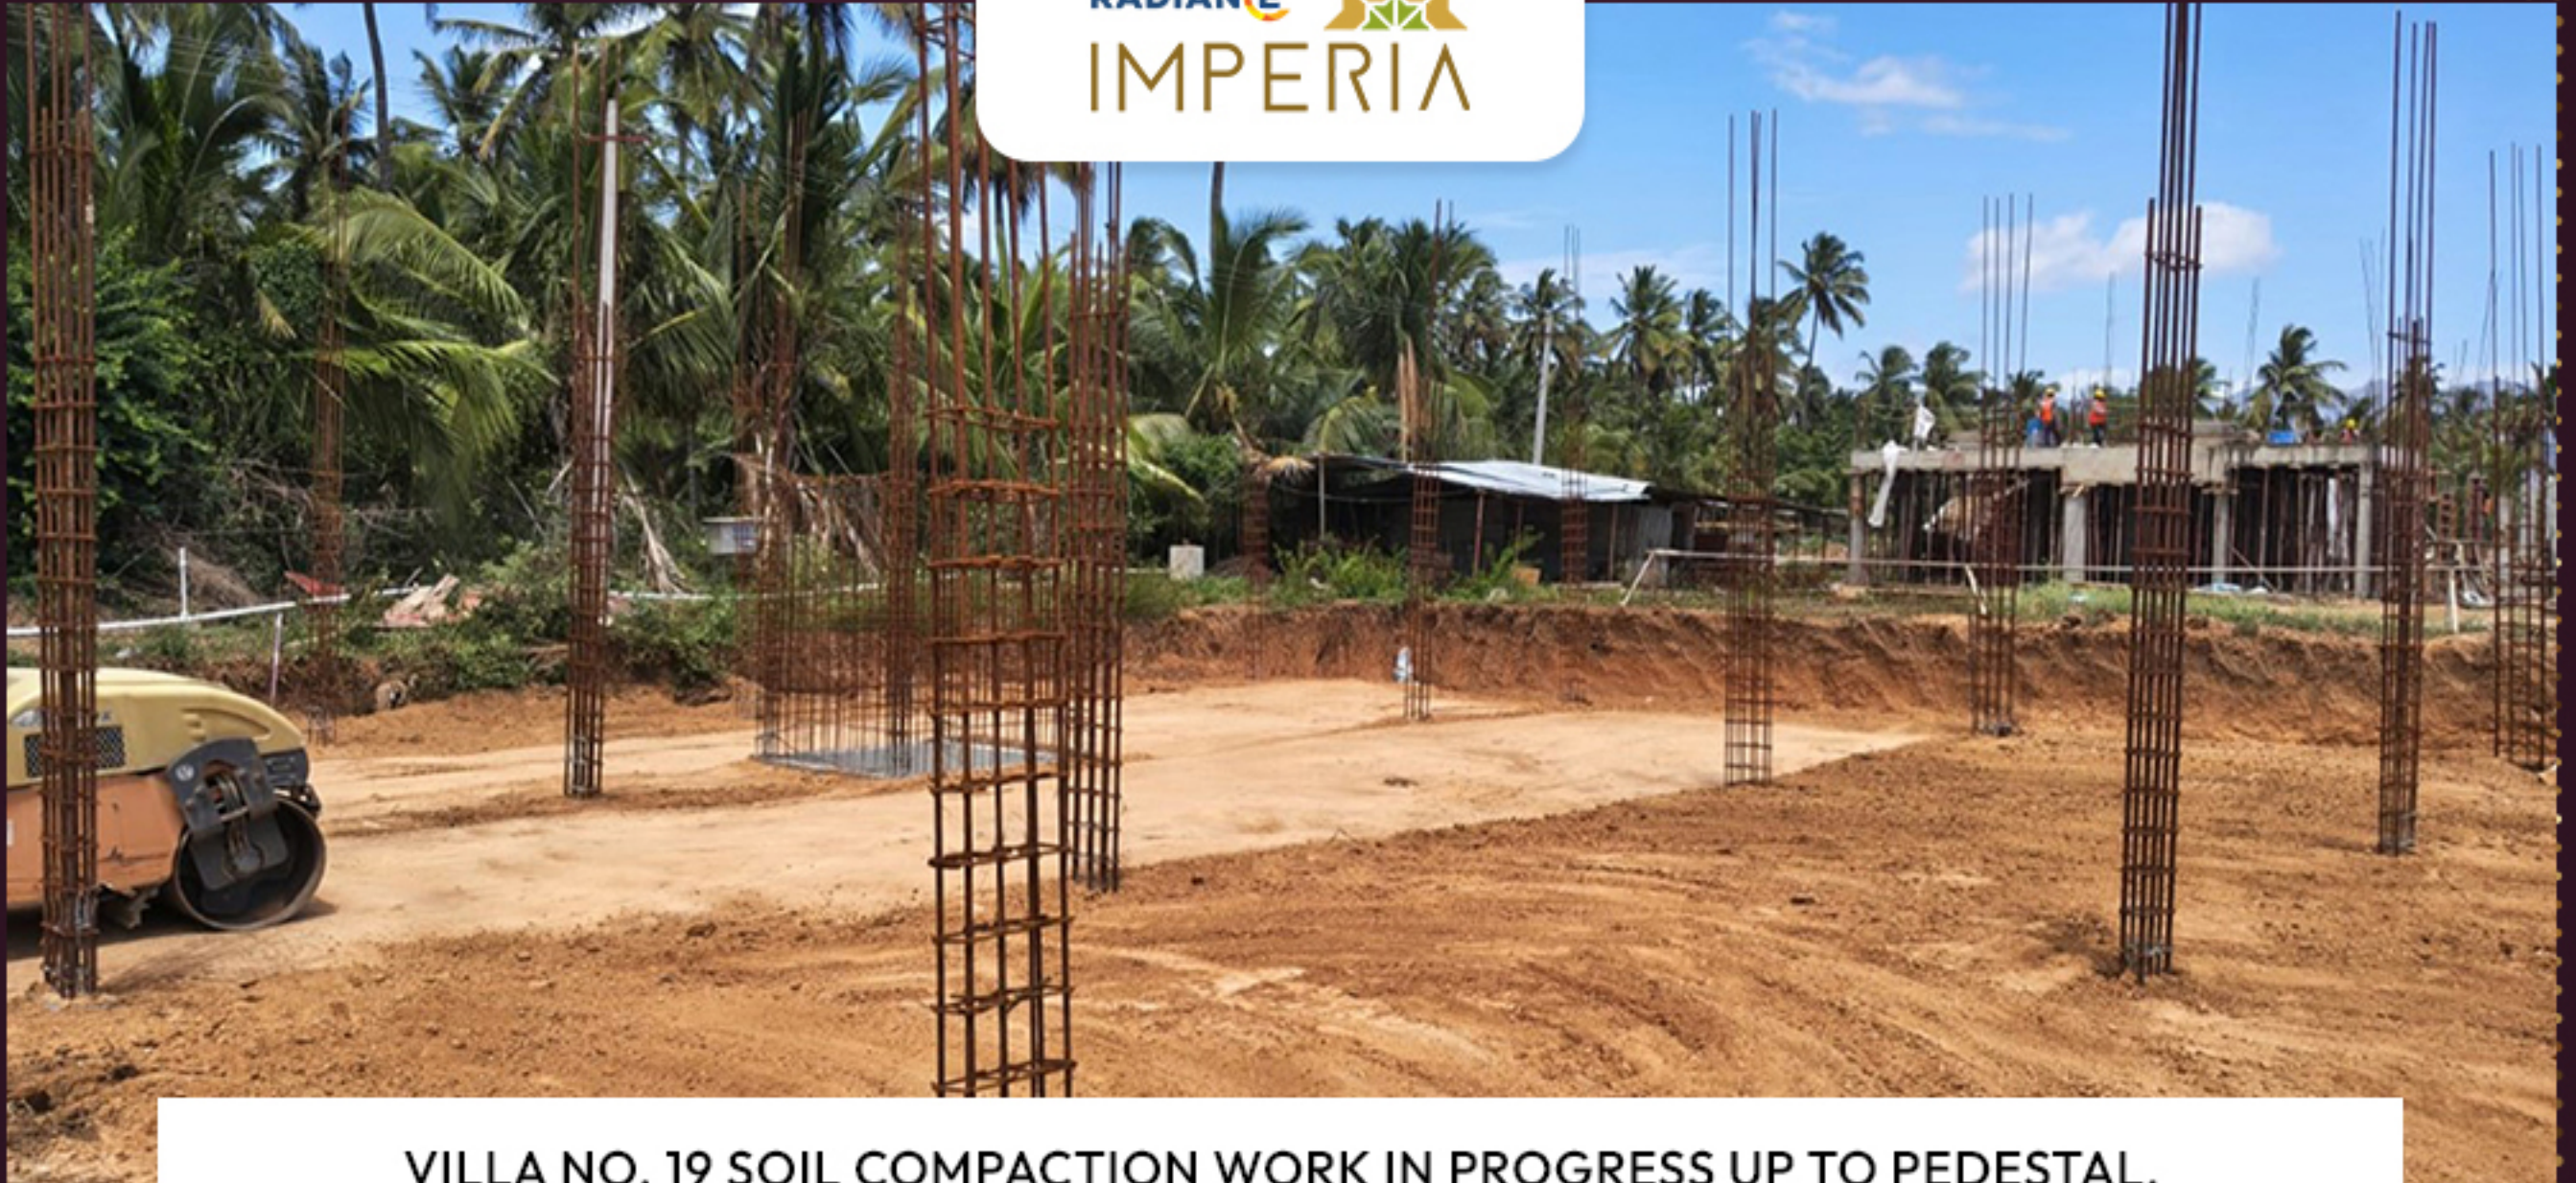
VILLA NO. 19 SOIL COMPACTION WORK IN PROGRESS UP TO PEDESTAL.

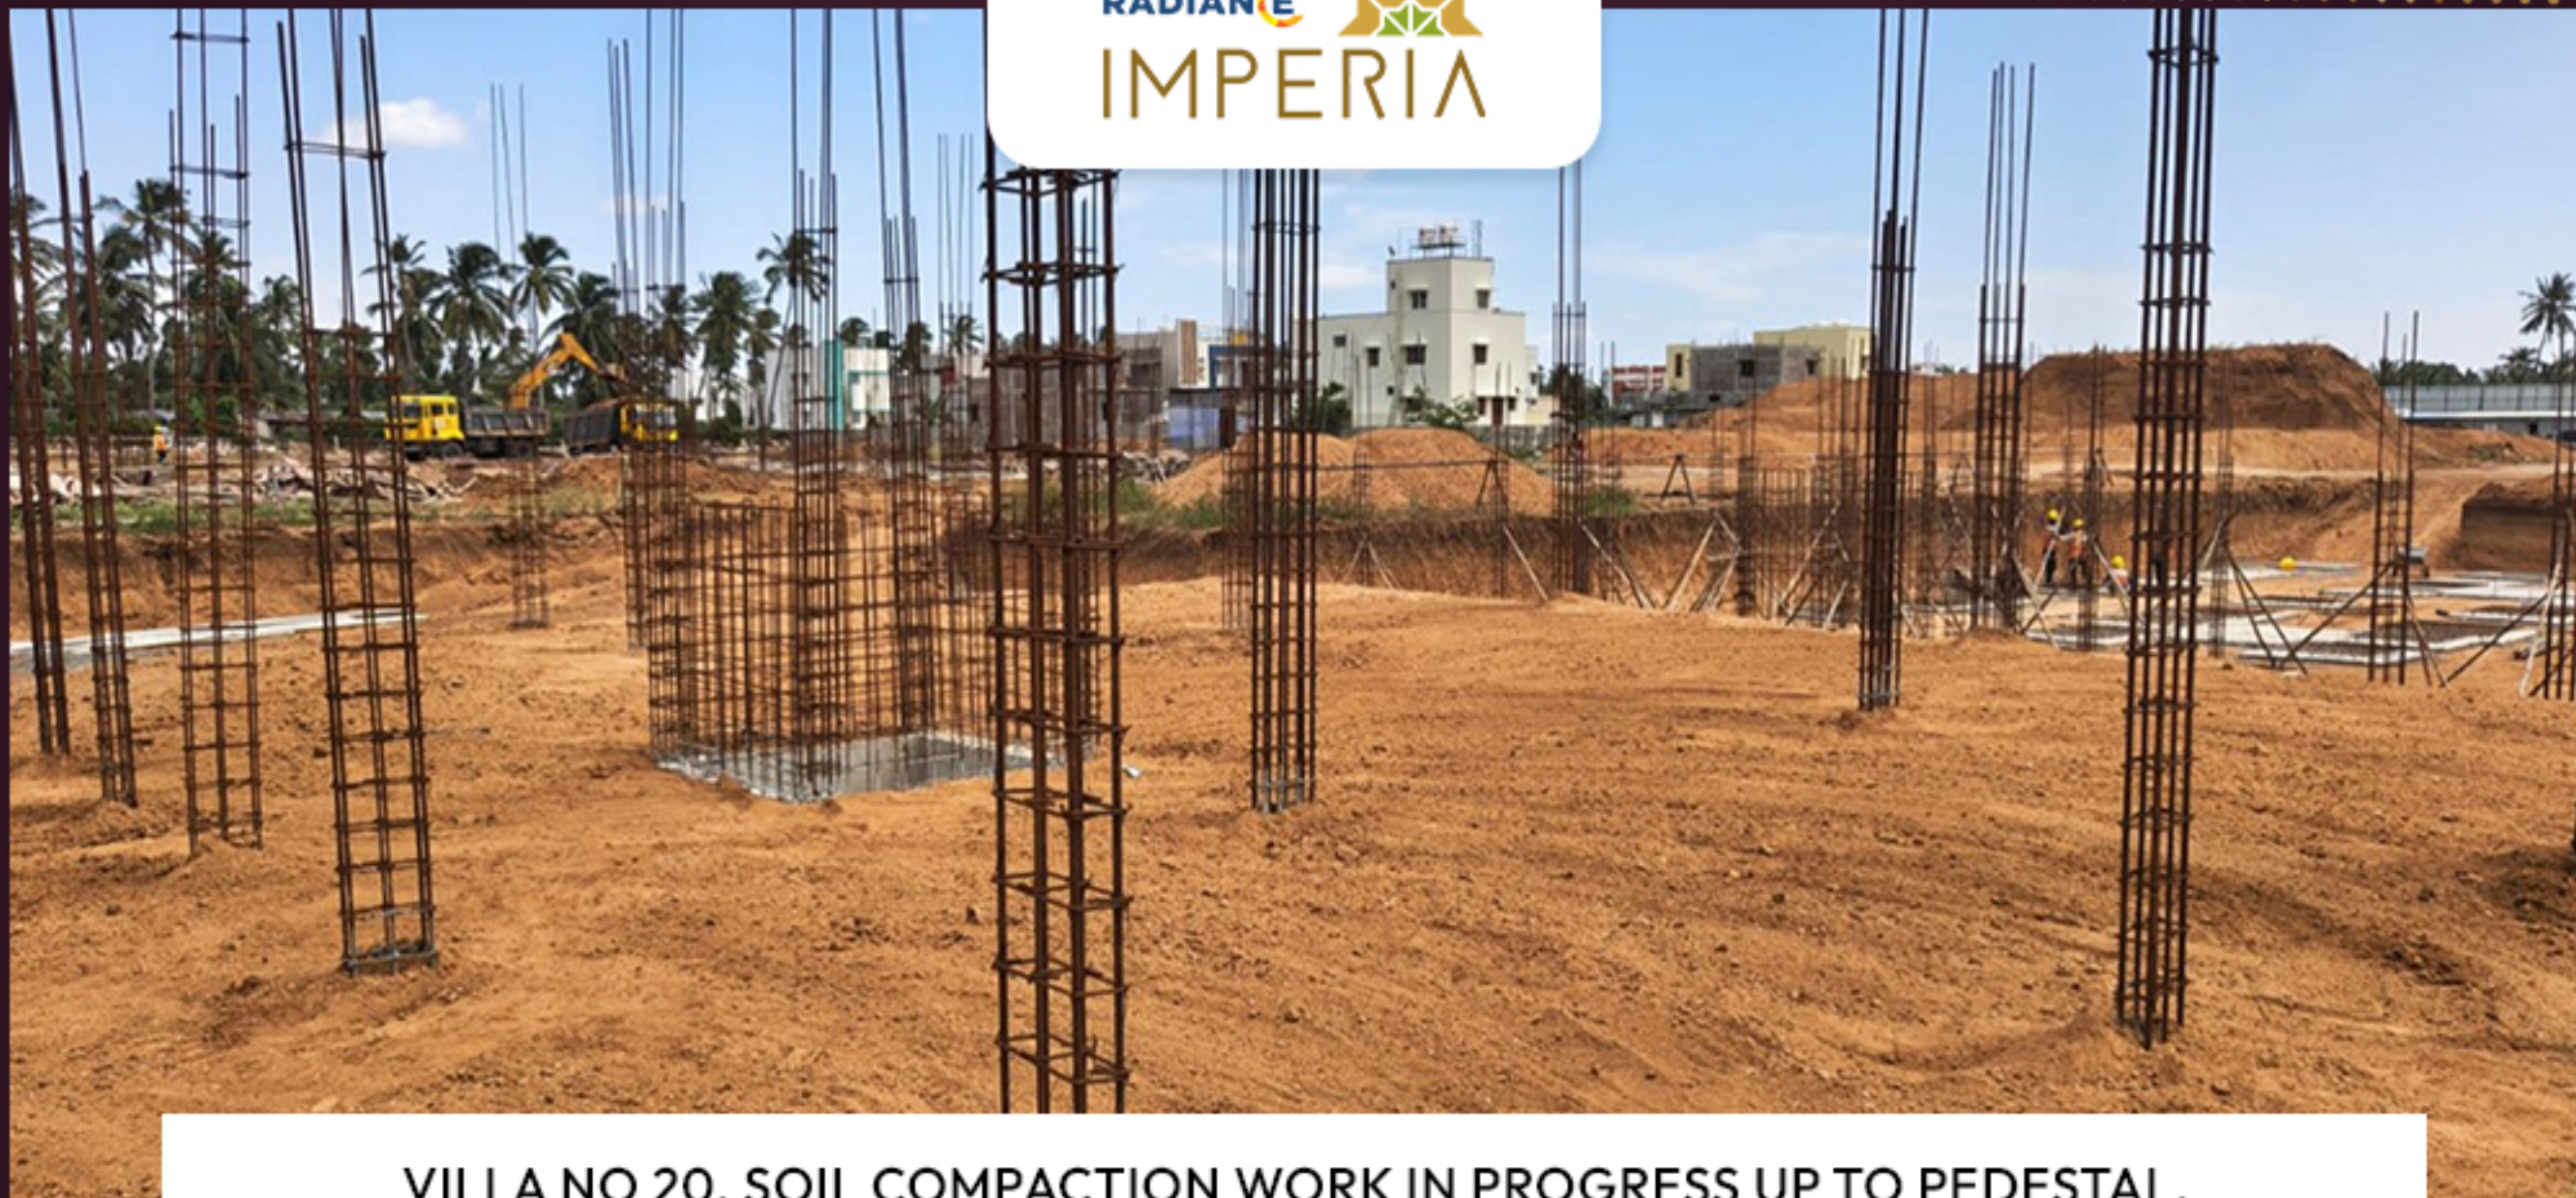
VILLA NO 20. SOIL COMPACTION WORK IN PROGRESS UP TO PEDESTAL.

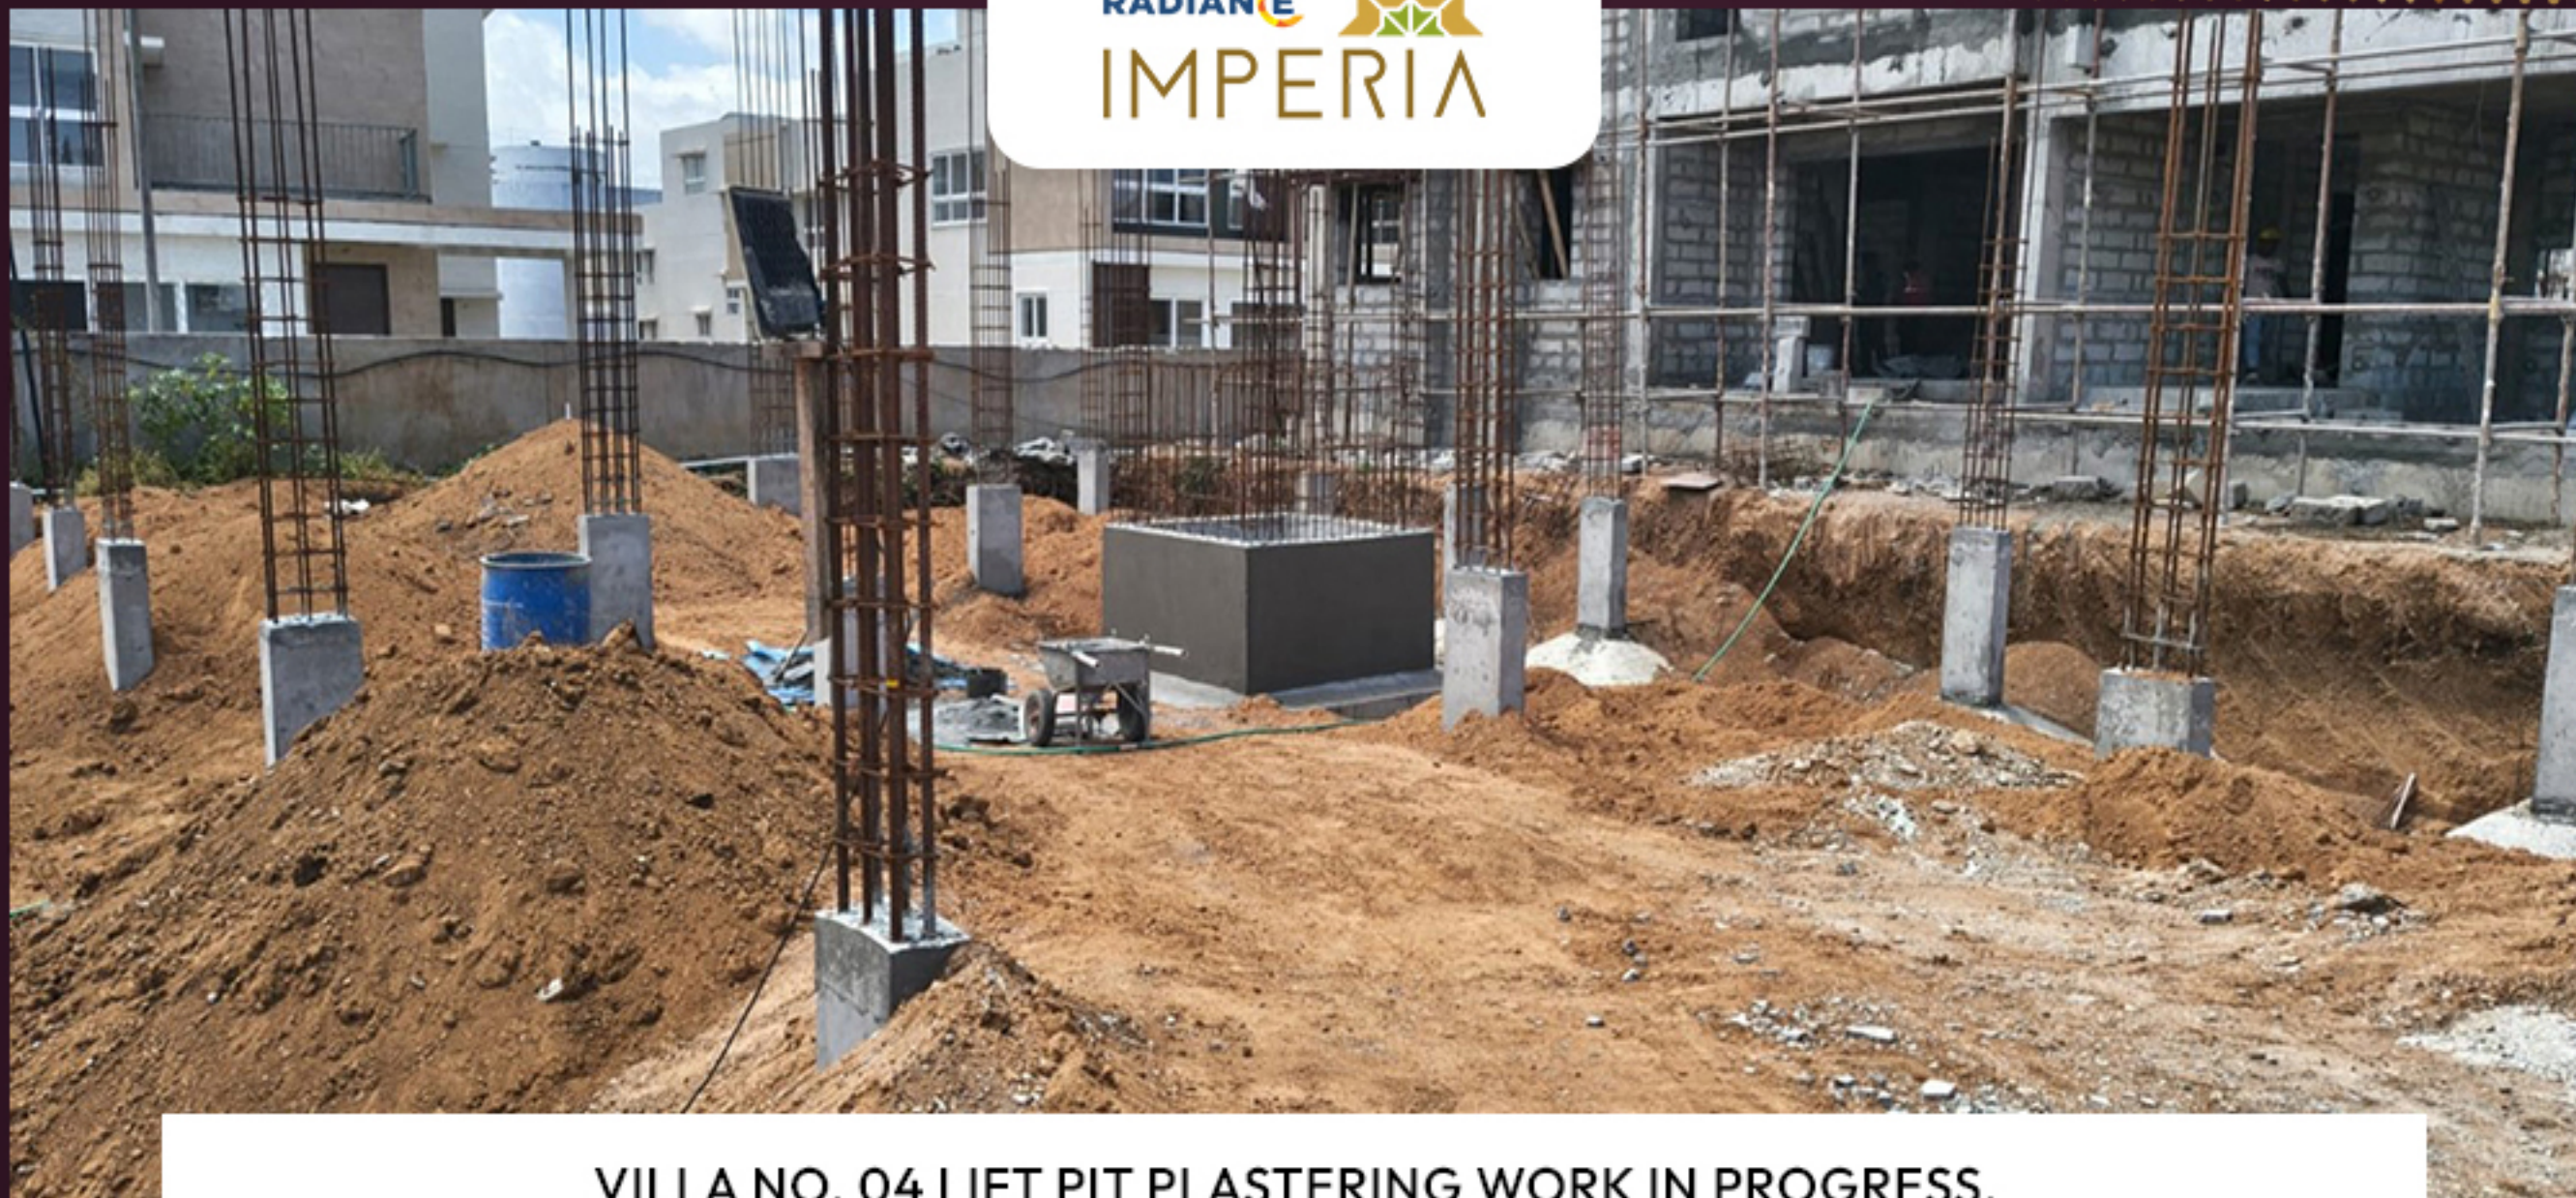
VILLA NO. 04 LIFT PIT PLASTERING WORK IN PROGRESS.

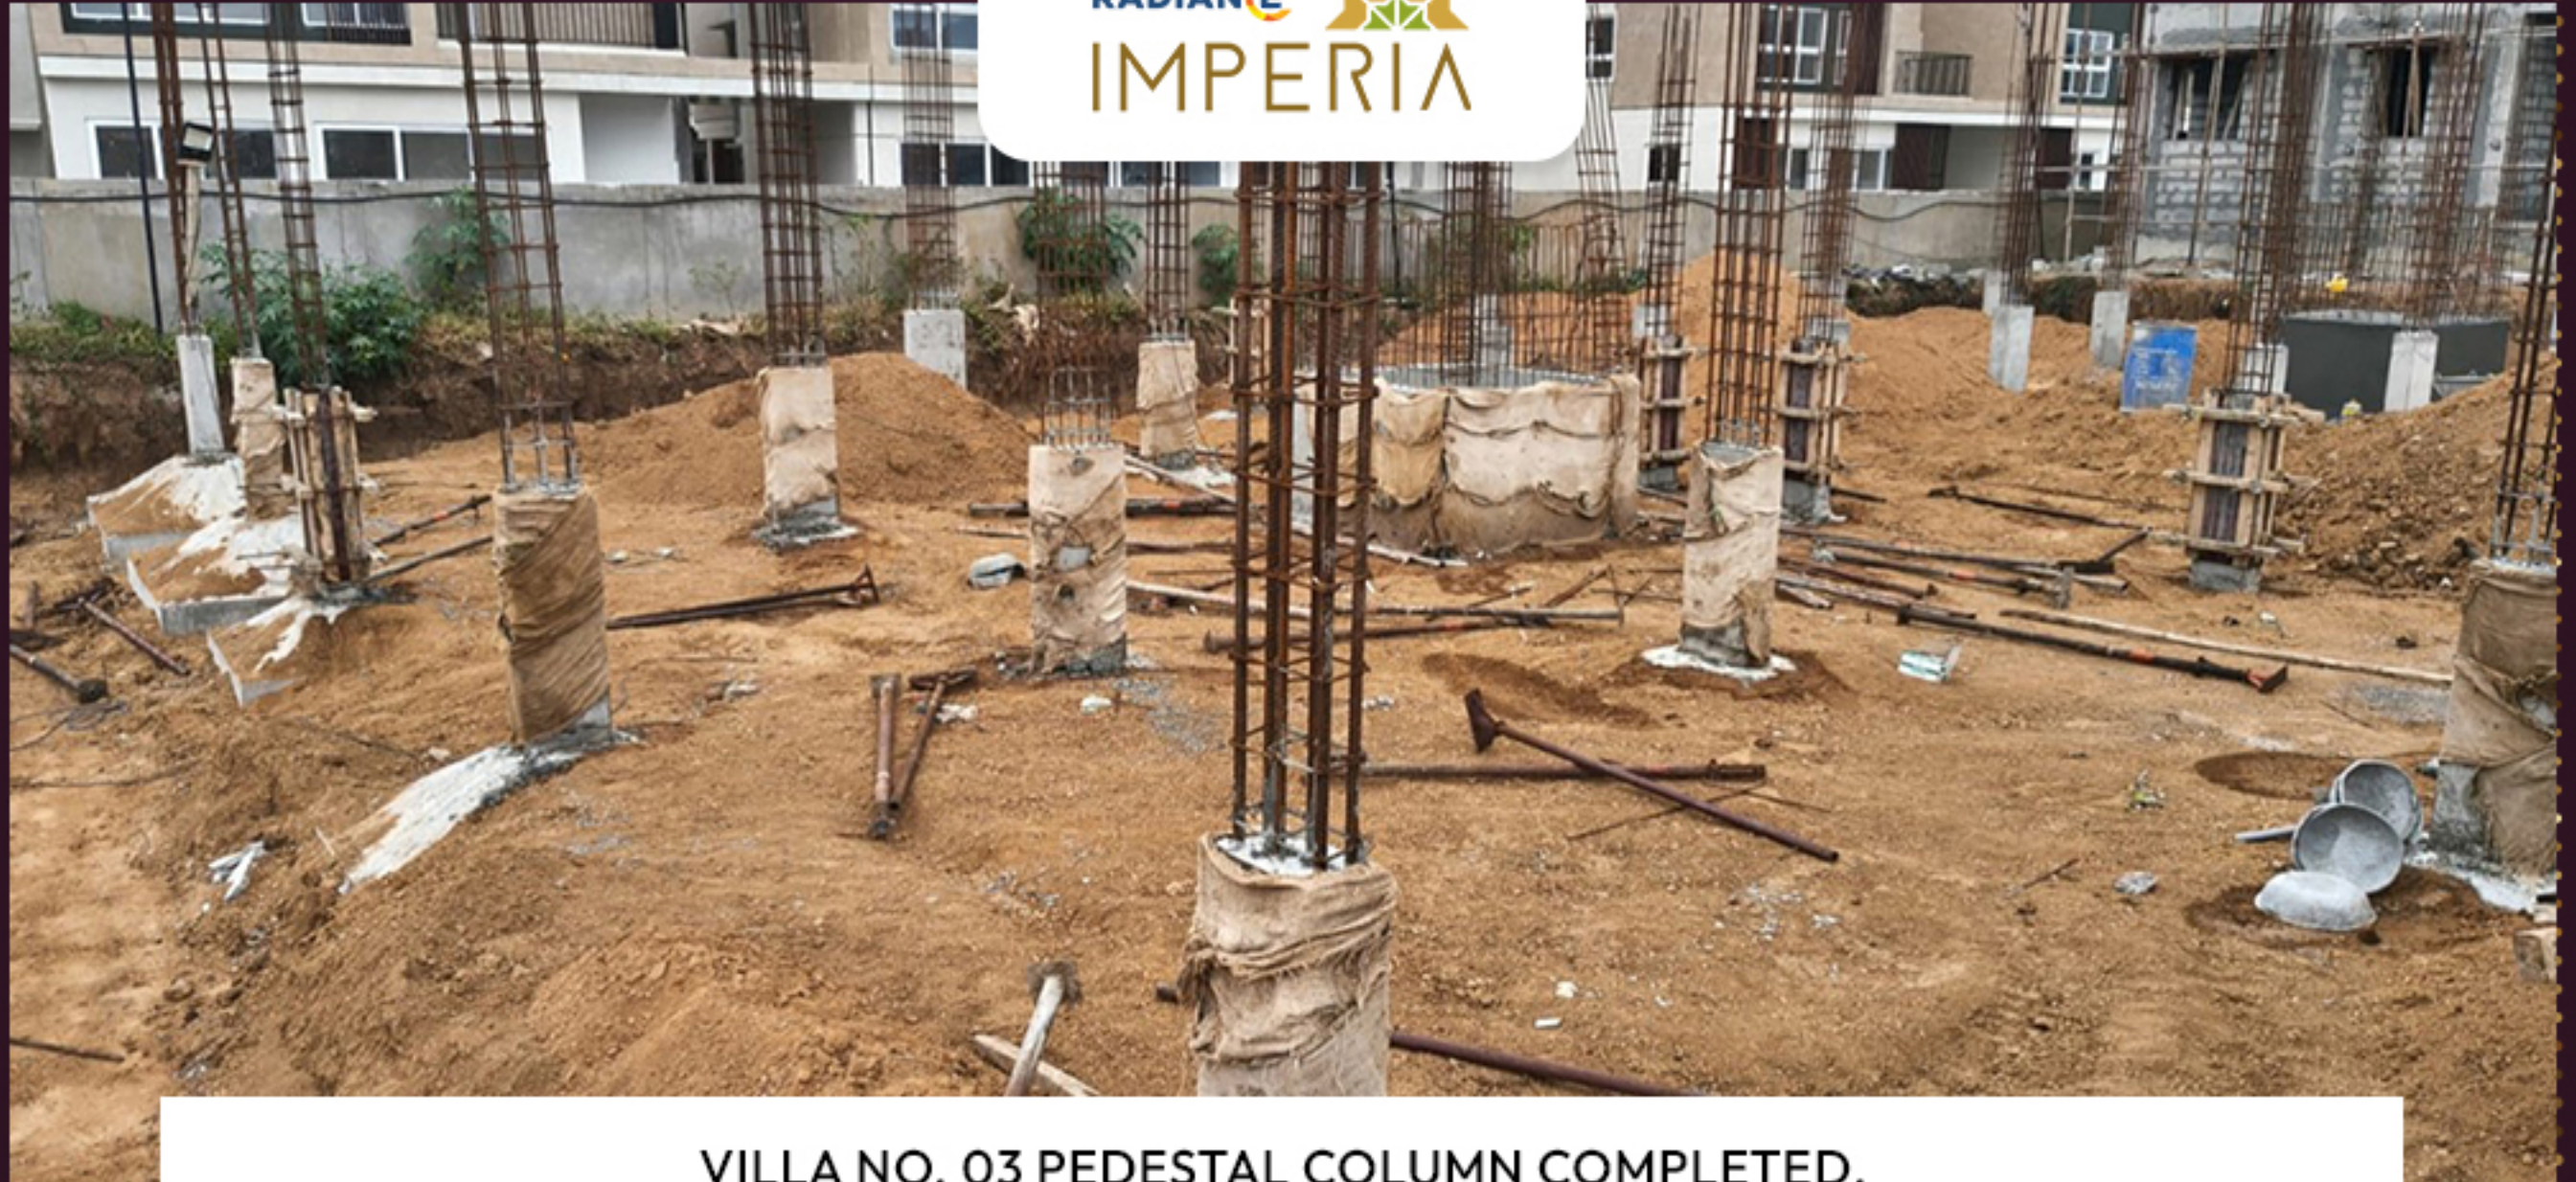
VILLA NO. 03 PEDESTAL COLUMN COMPLETED.

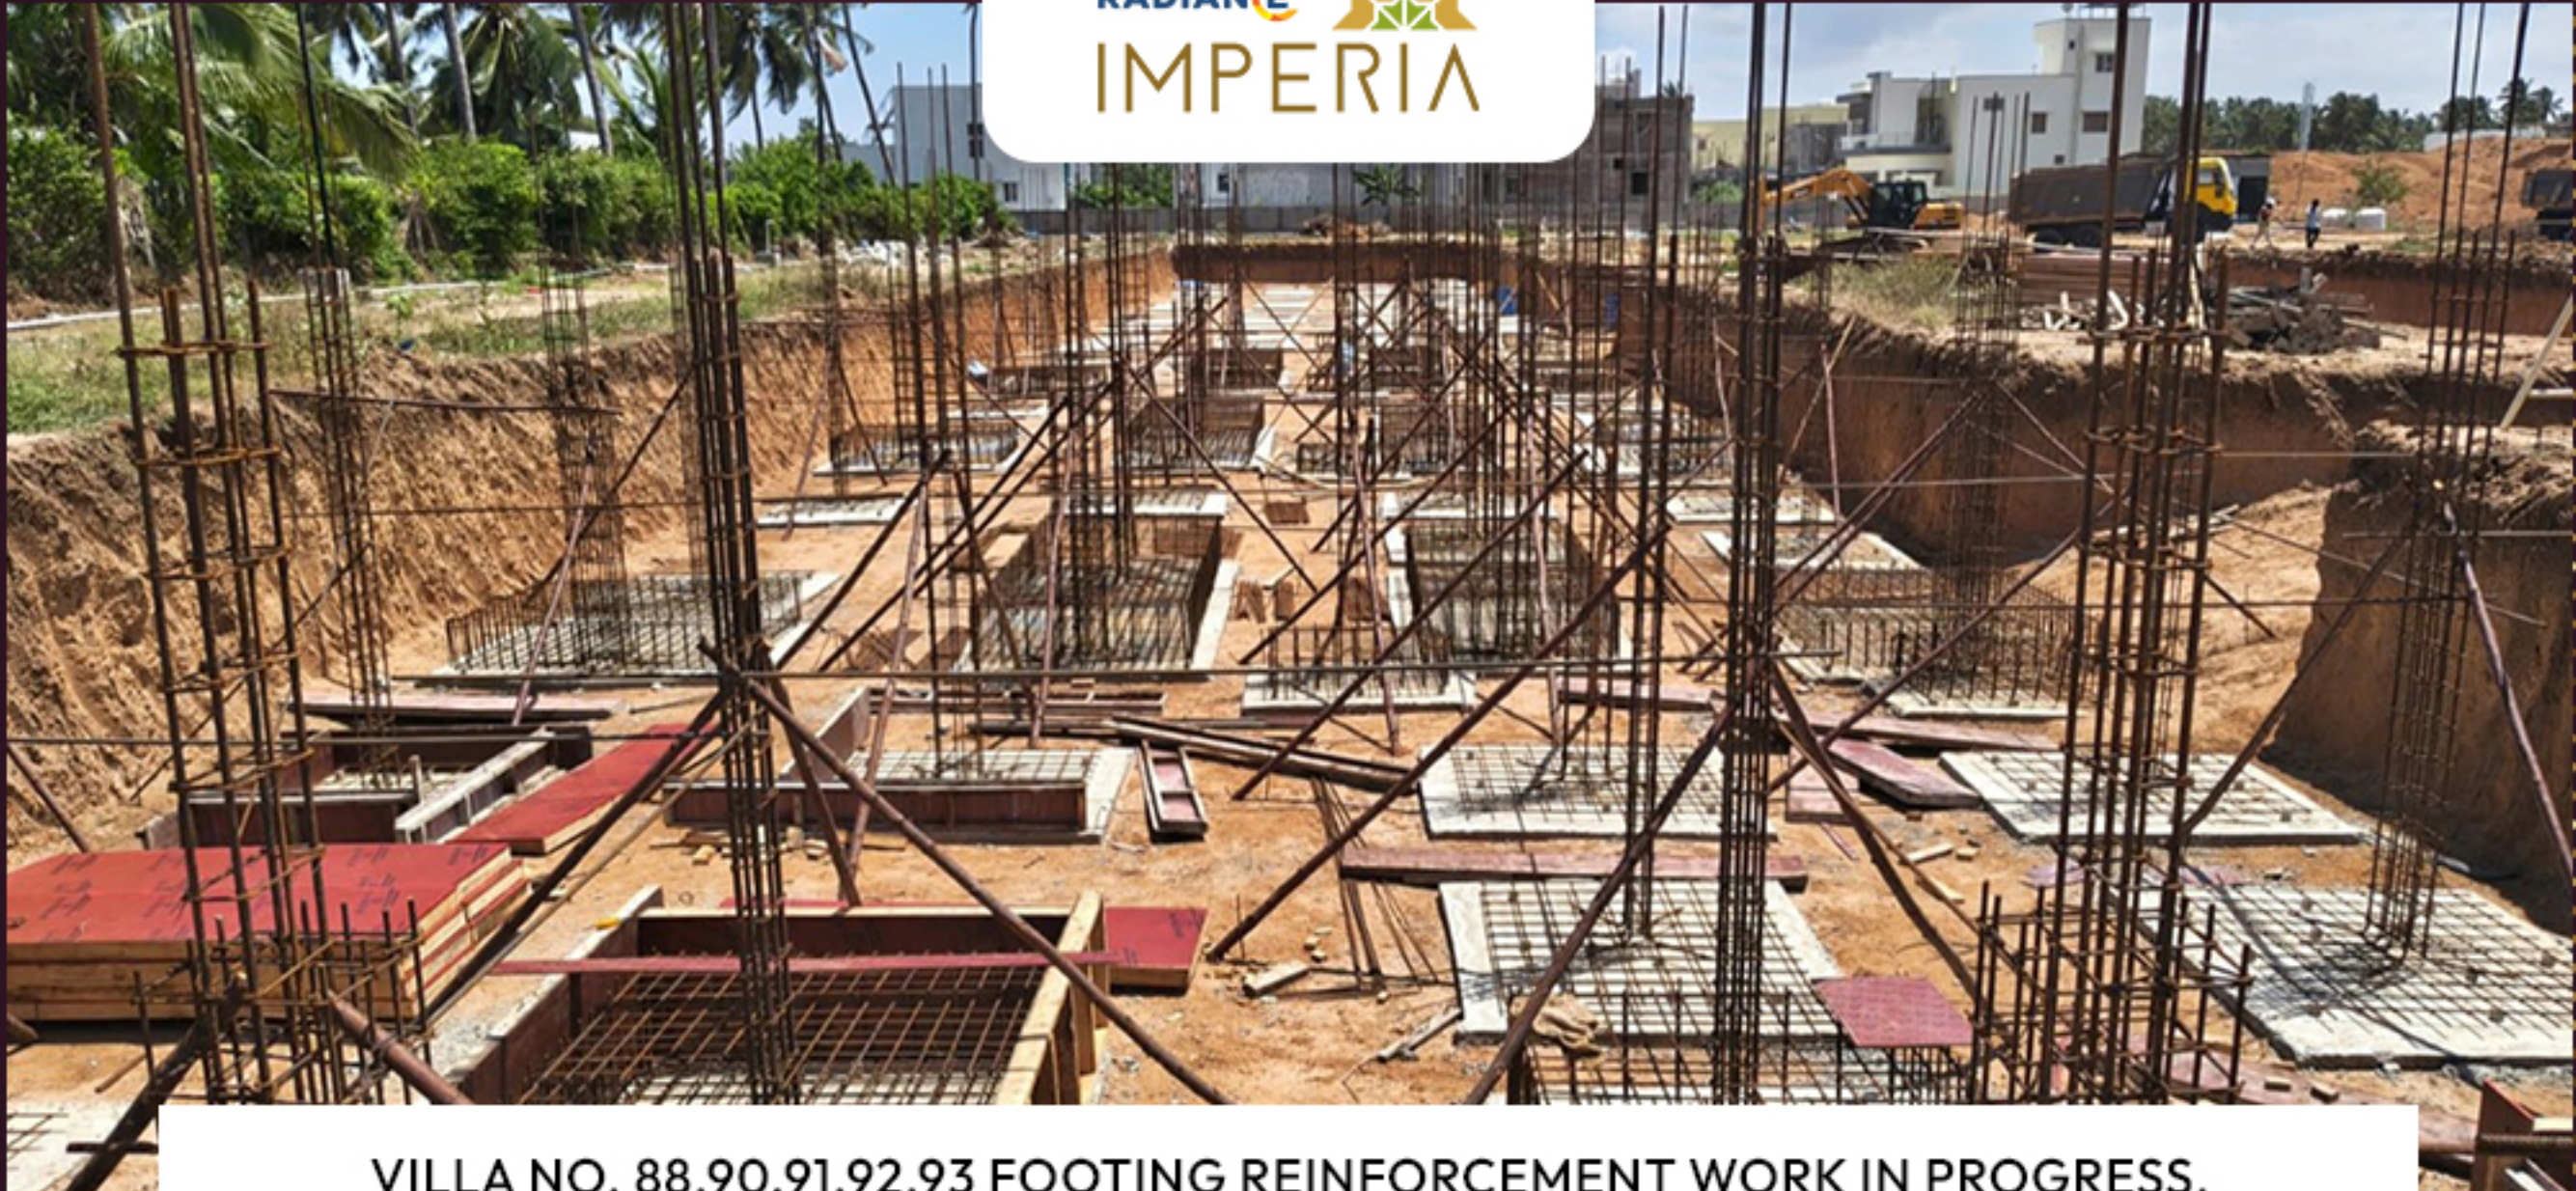
VILLA NO. 88,90,91,92,93 FOOTING REINFORCEMENT WORK IN PROGRESS.

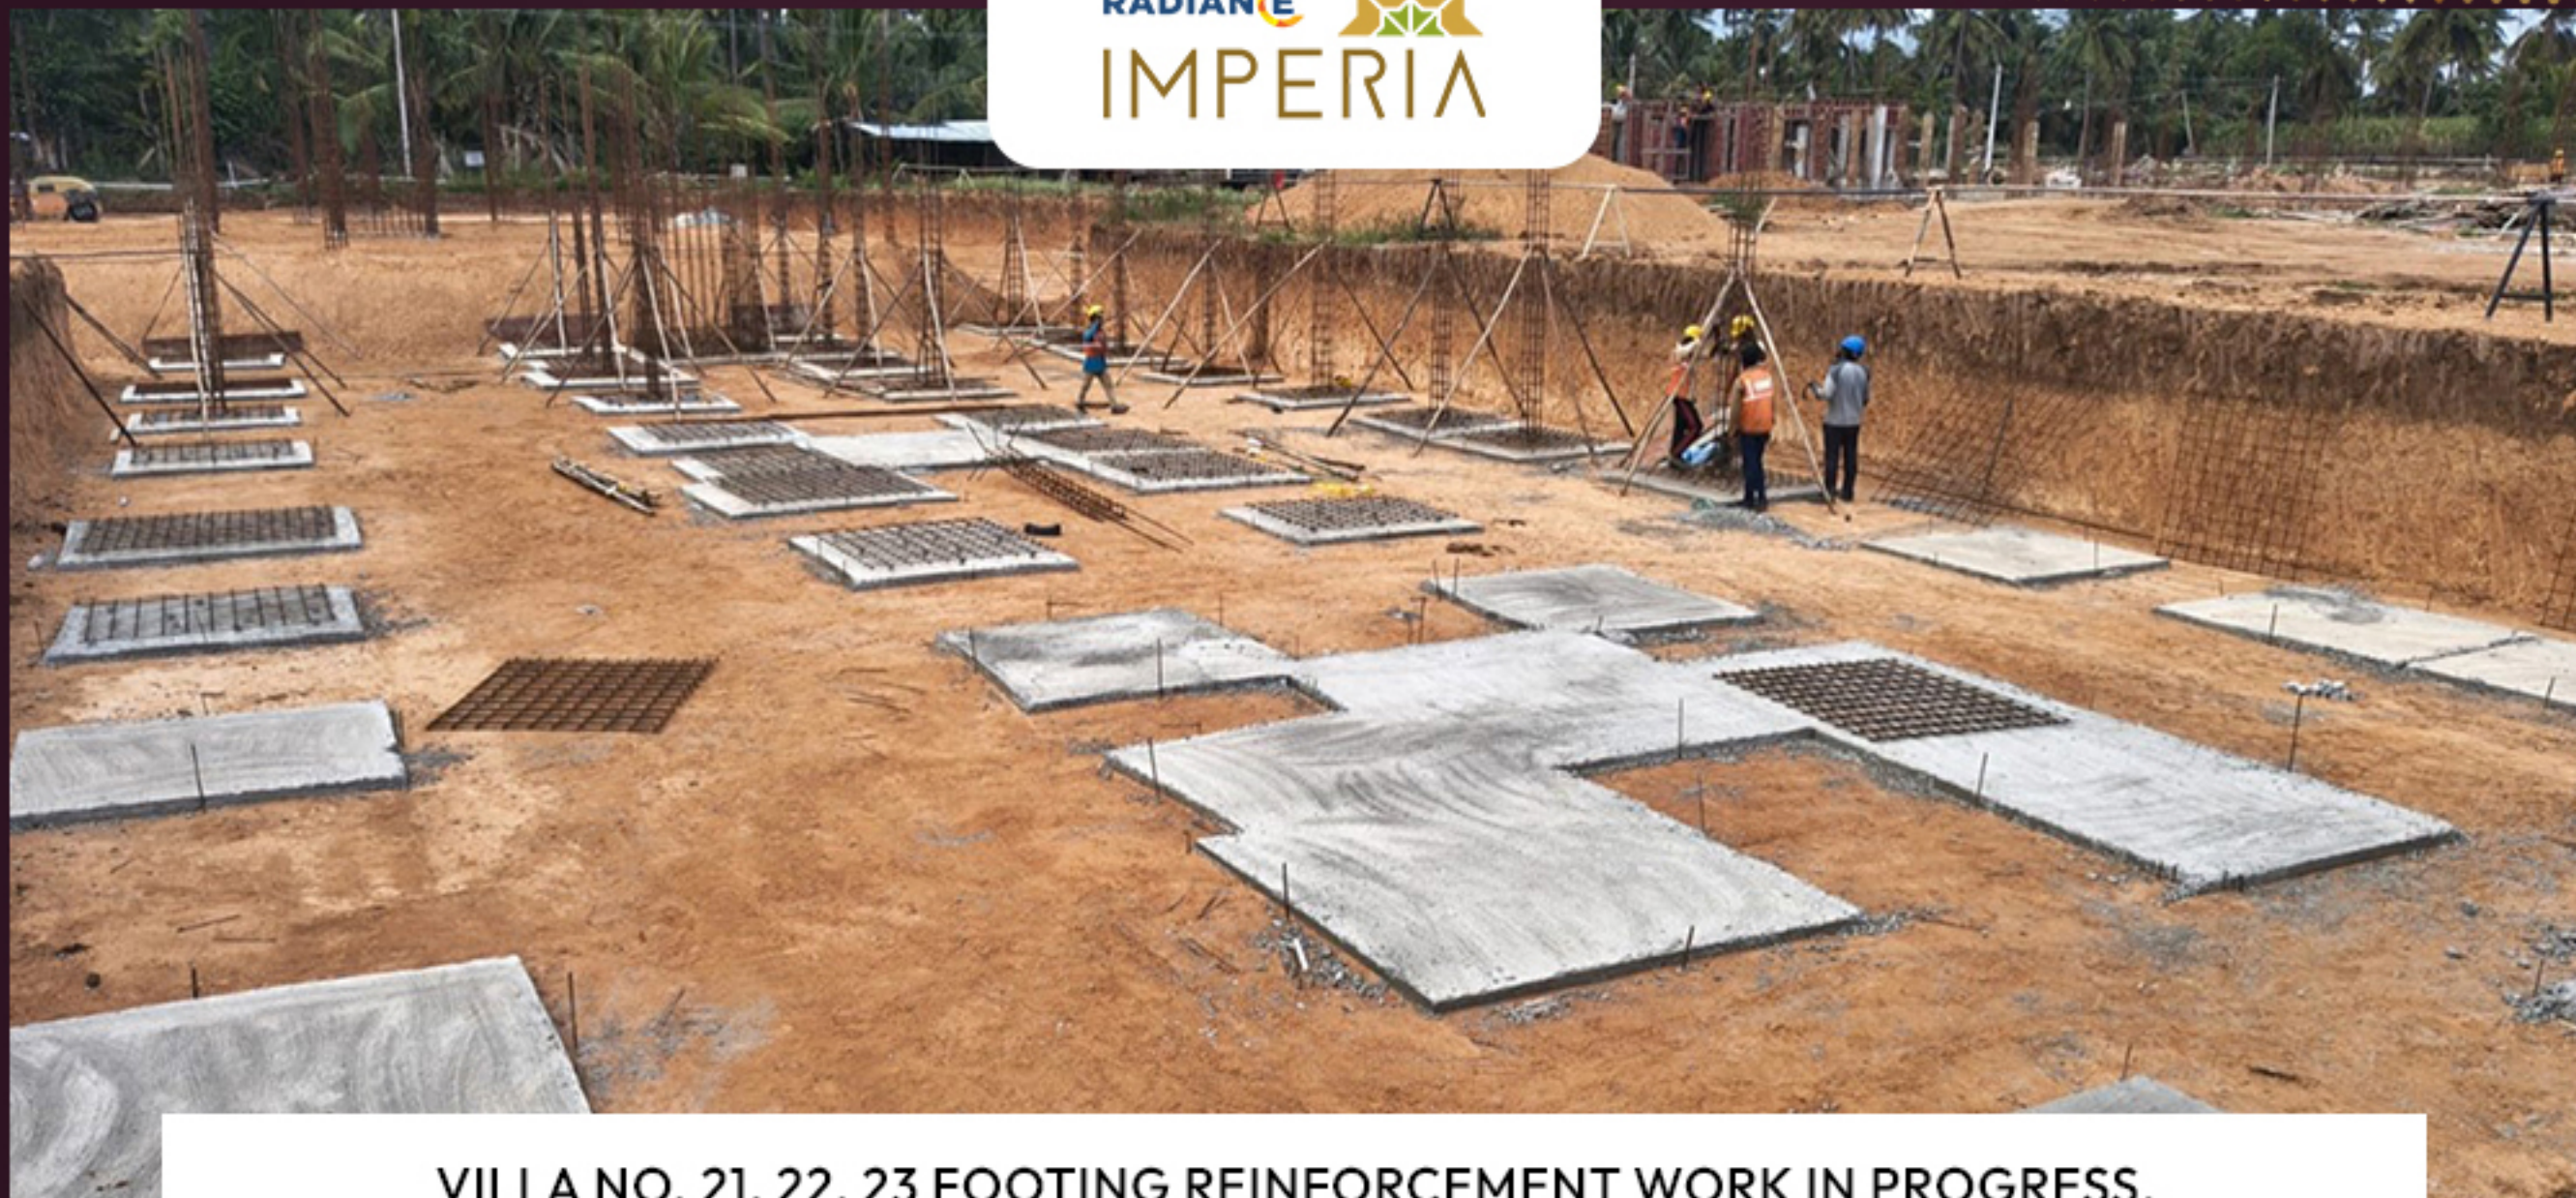
VILLA NO. 21, 22, 23 FOOTING REINFORCEMENT WORK IN PROGRESS.

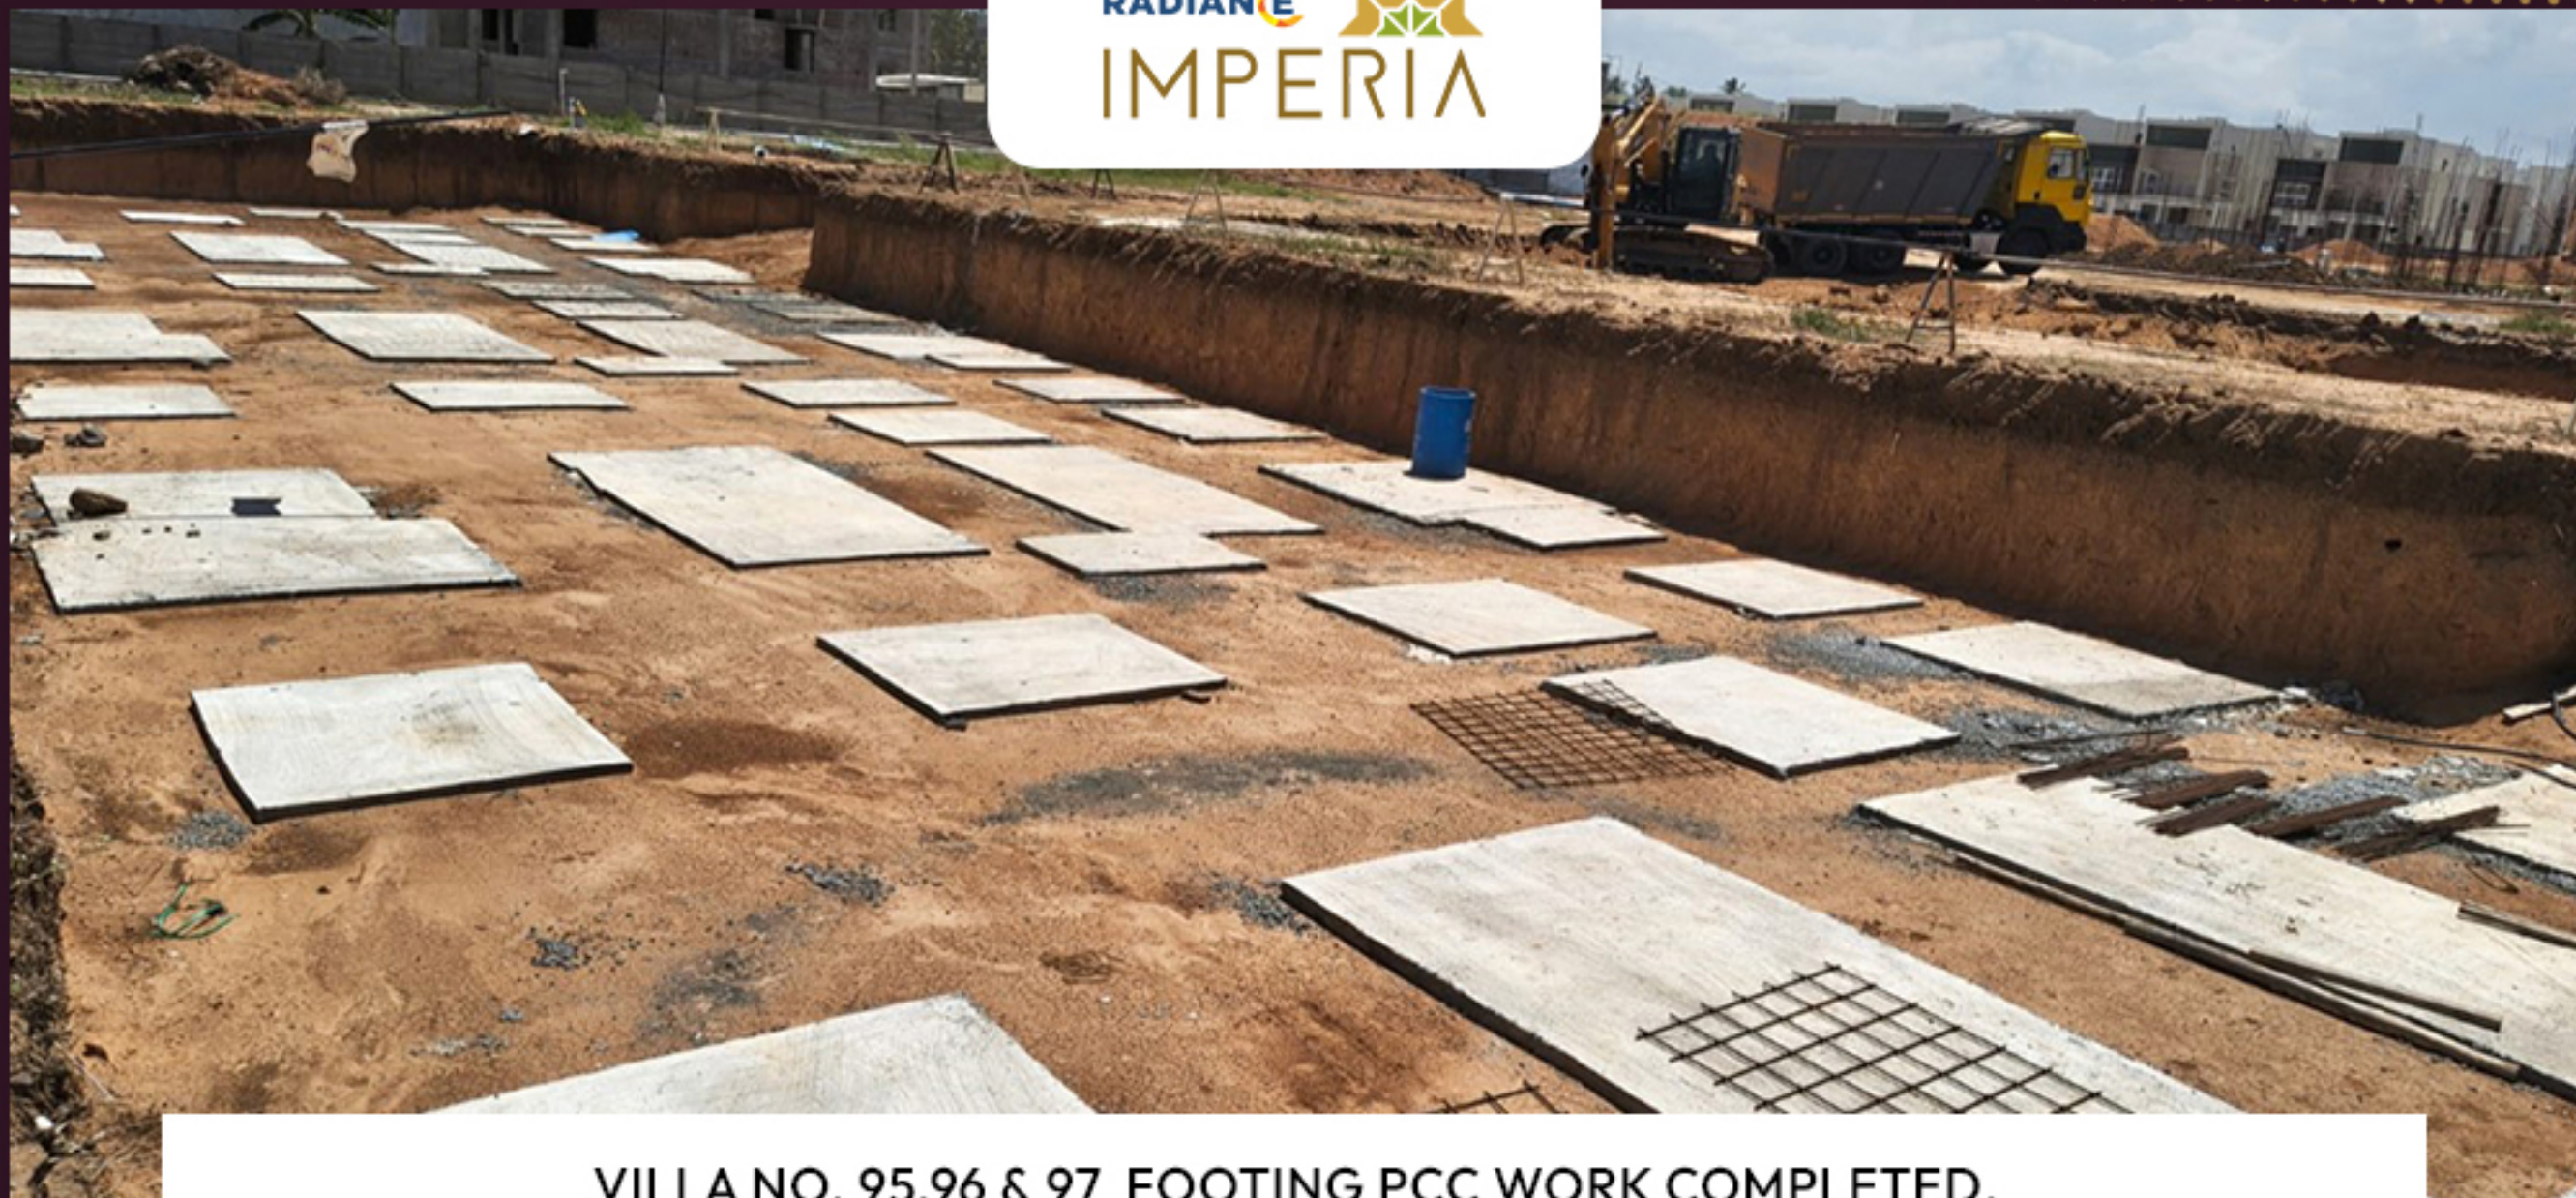
VILLA NO. 95,96 & 97 FOOTING PCC WORK COMPLETED.
