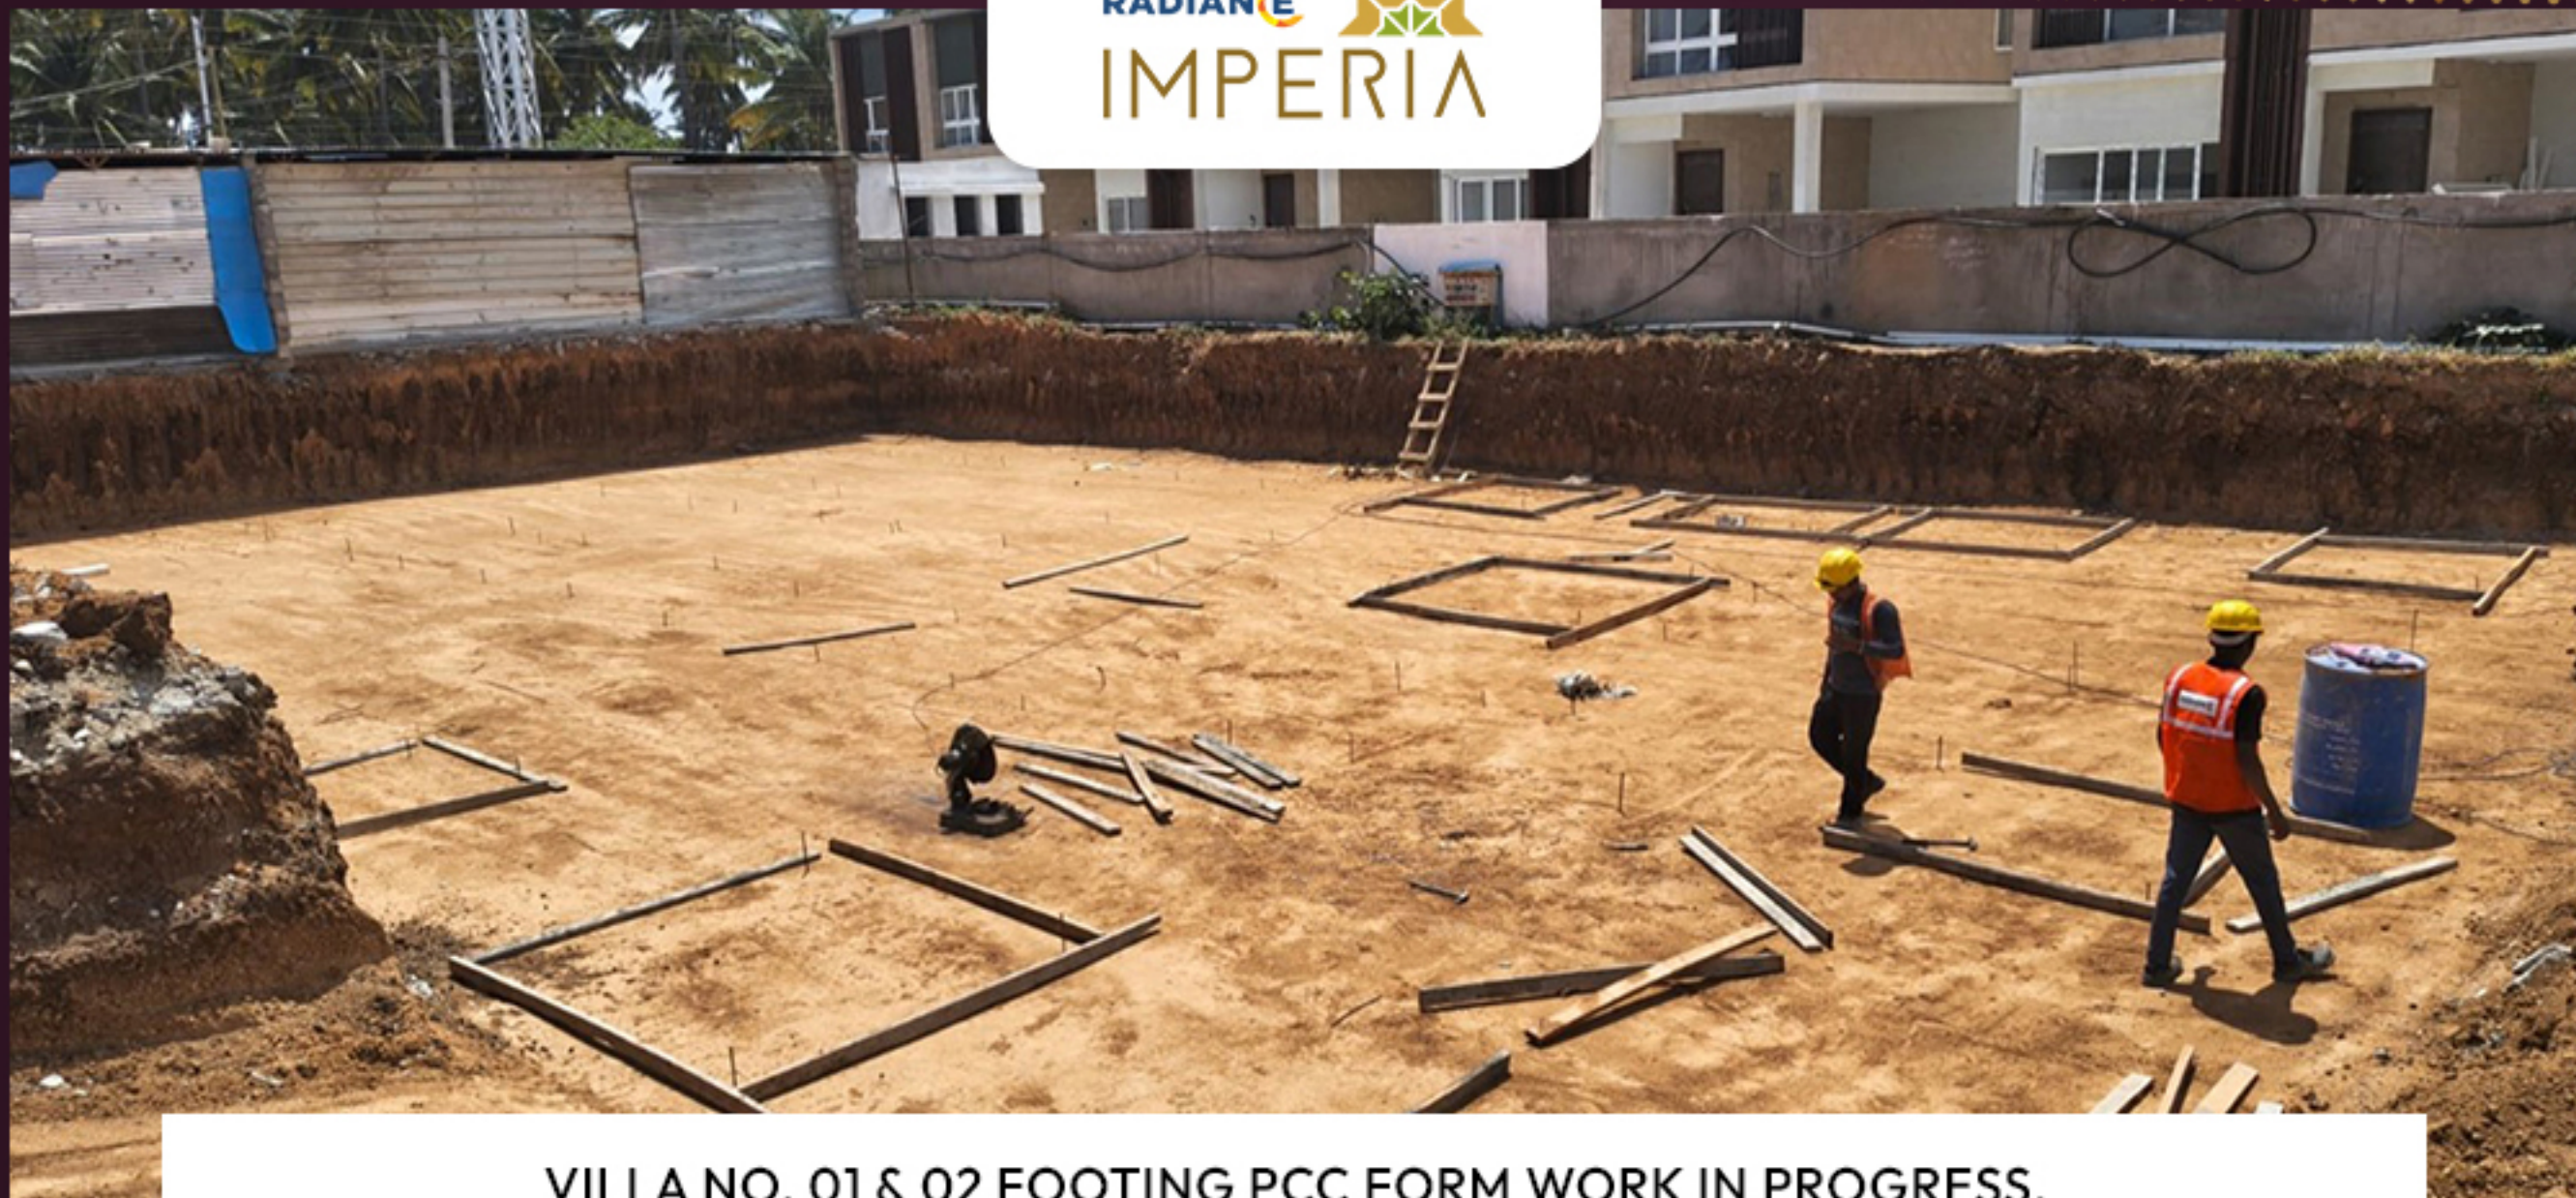
VILLA NO. 01 & 02 FOOTING PCC FORM WORK IN PROGRESS.

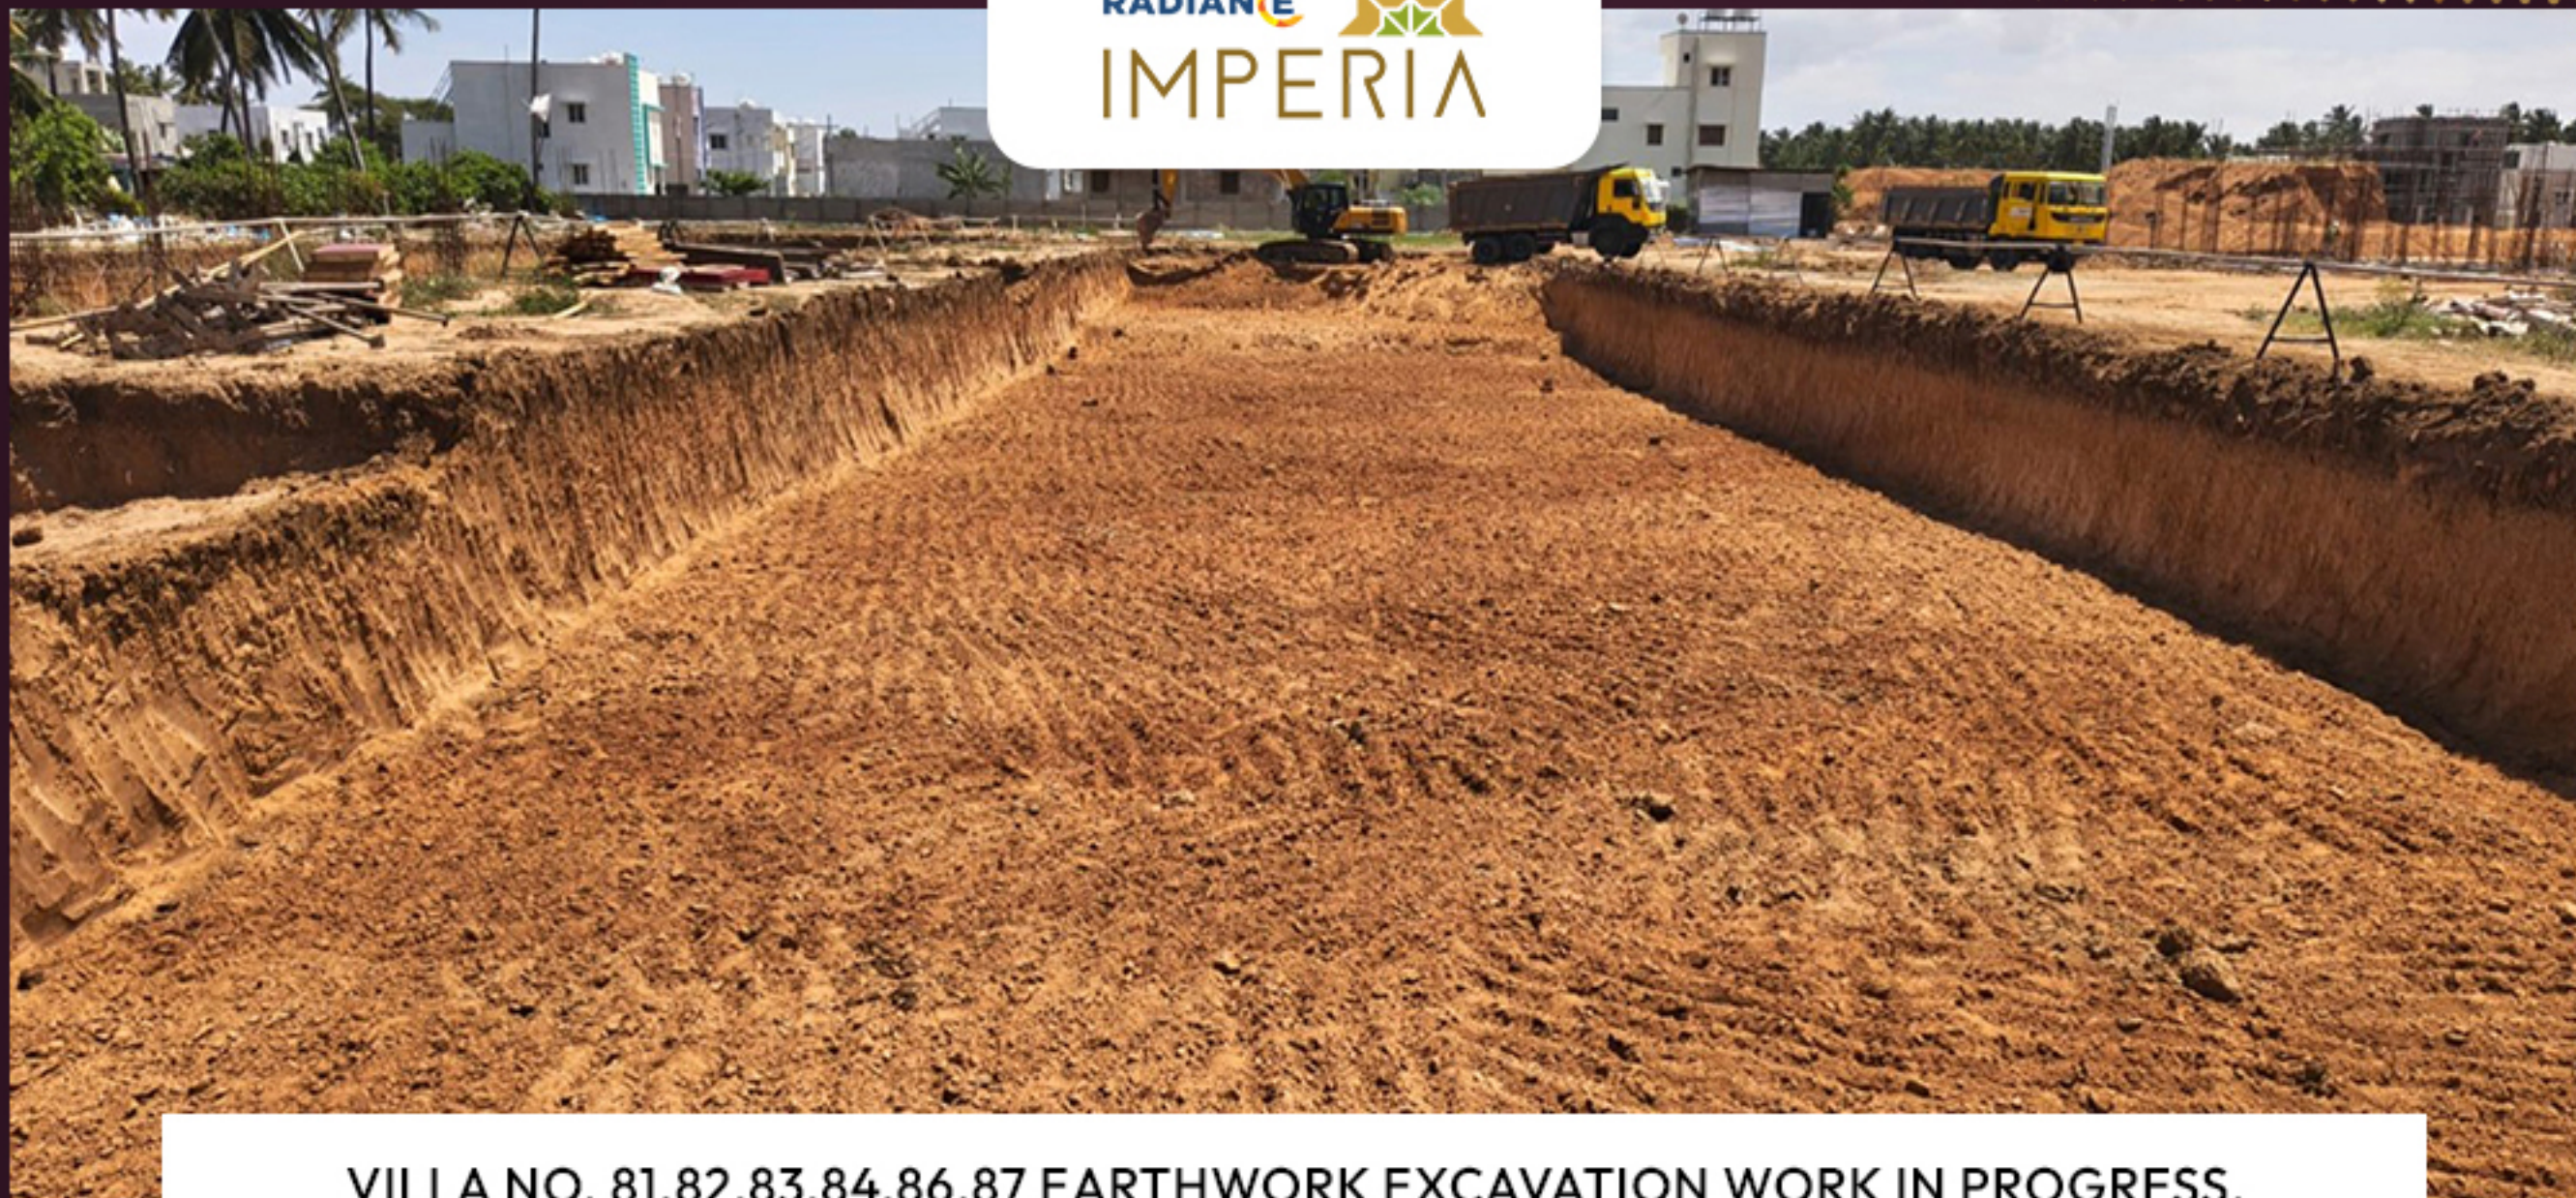
VILLA NO. 81,82,83,84,86,87 EARTHWORK EXCAVATION WORK IN PROGRESS.
