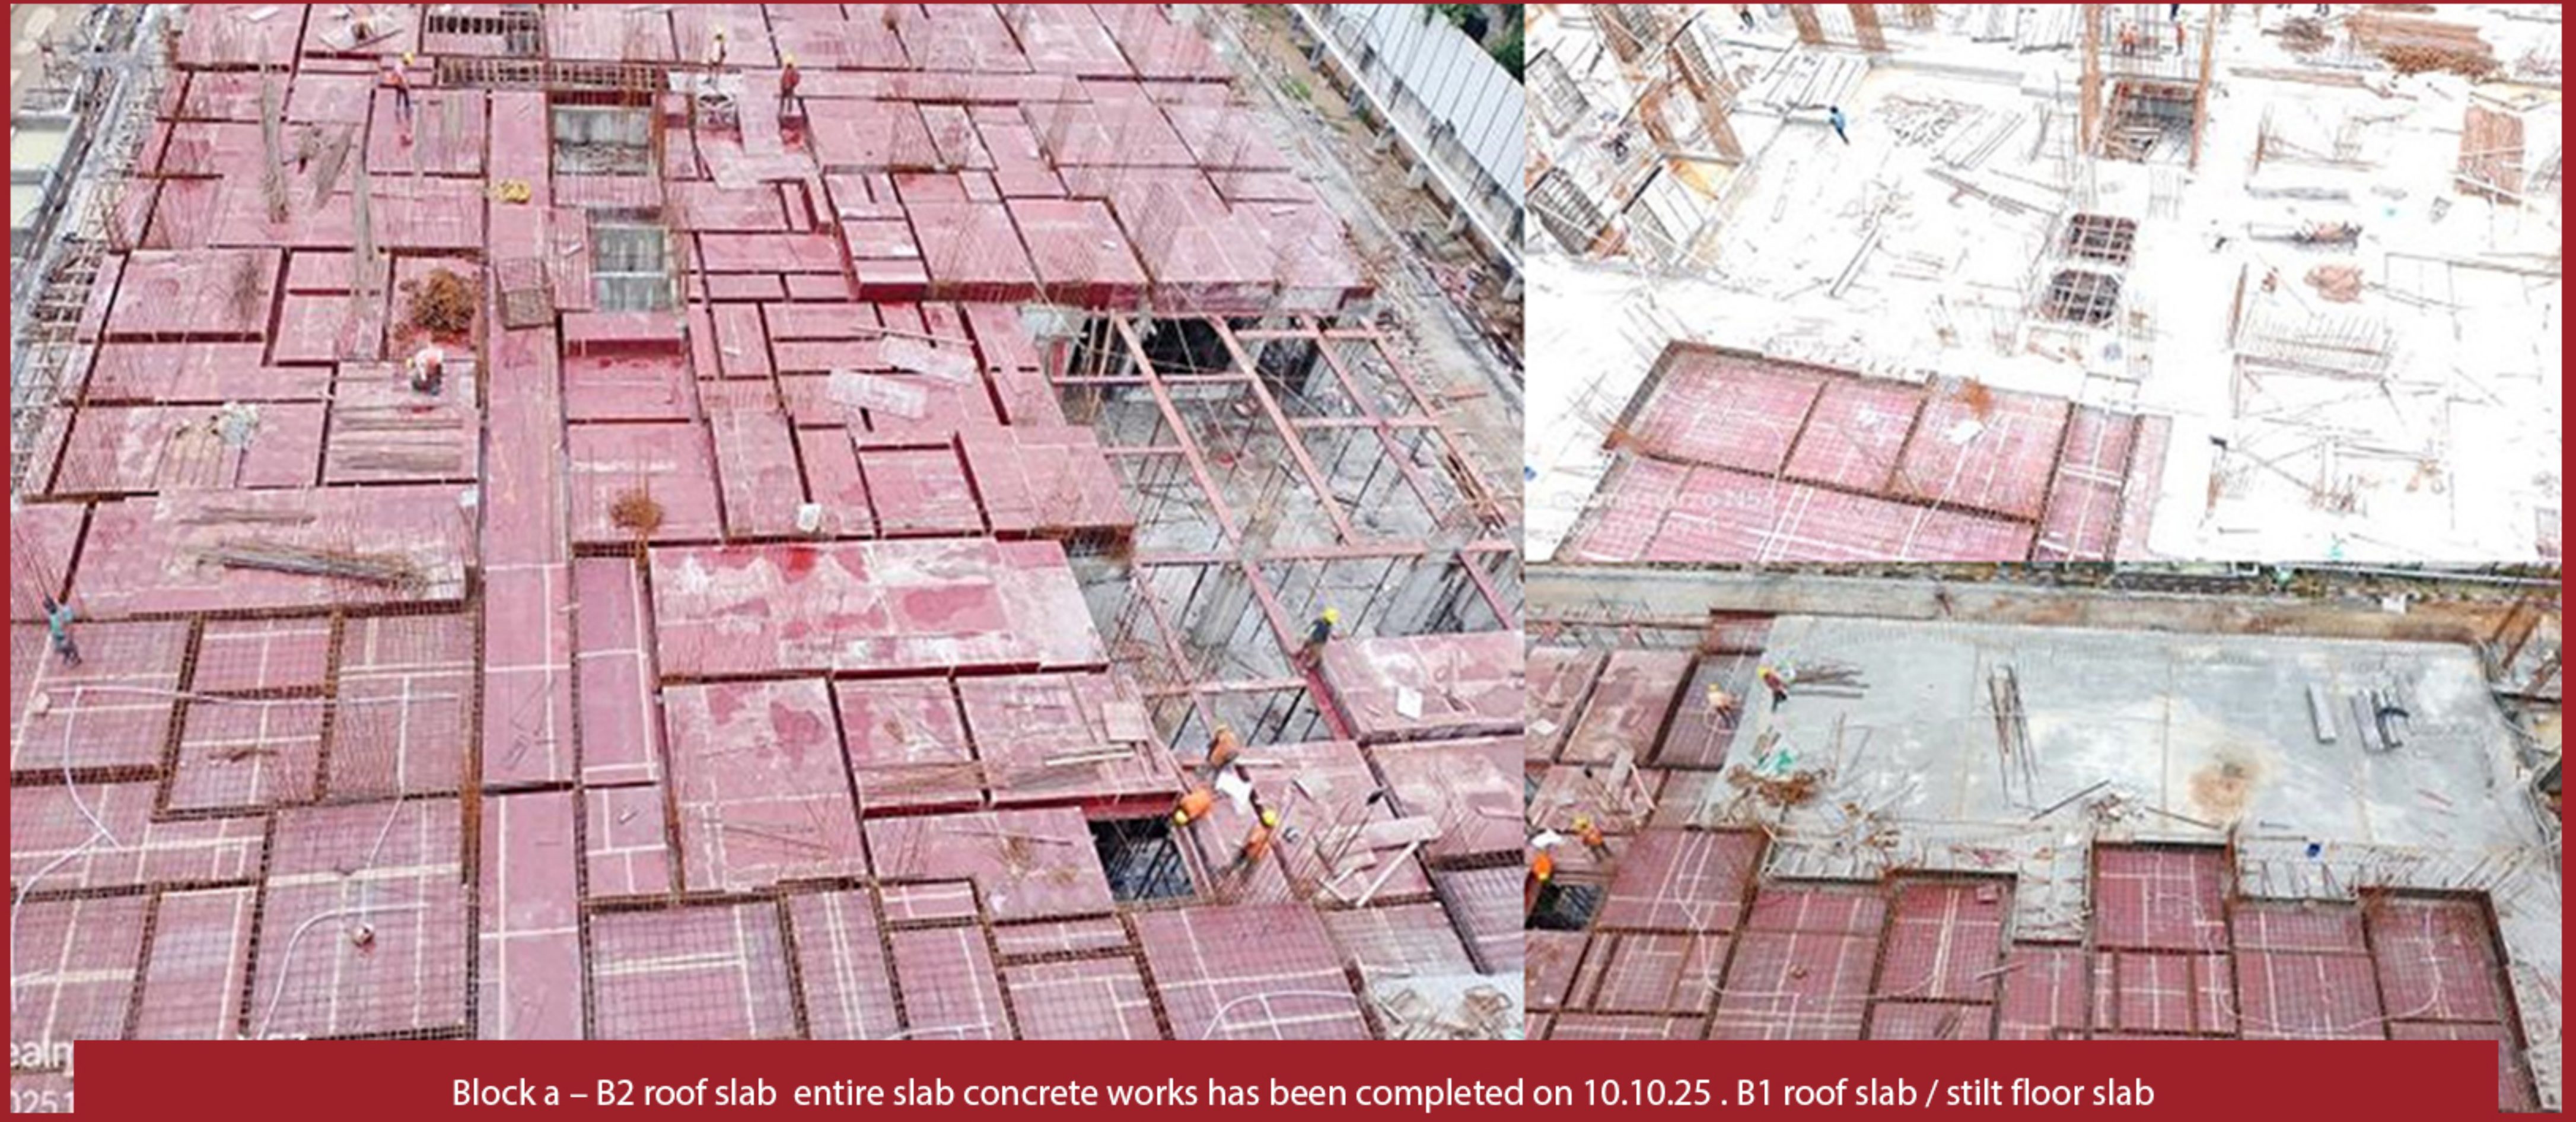
Block a – B2 roof slab entire slab concrete works has been completed on 10.10.25 . B1 roof slab / stilt floor slab concrete works has been completed on 15.11.25 stilt roof level/1st floor slab level column completed and slab concrete at east side podium landscape sunken area & units wip.

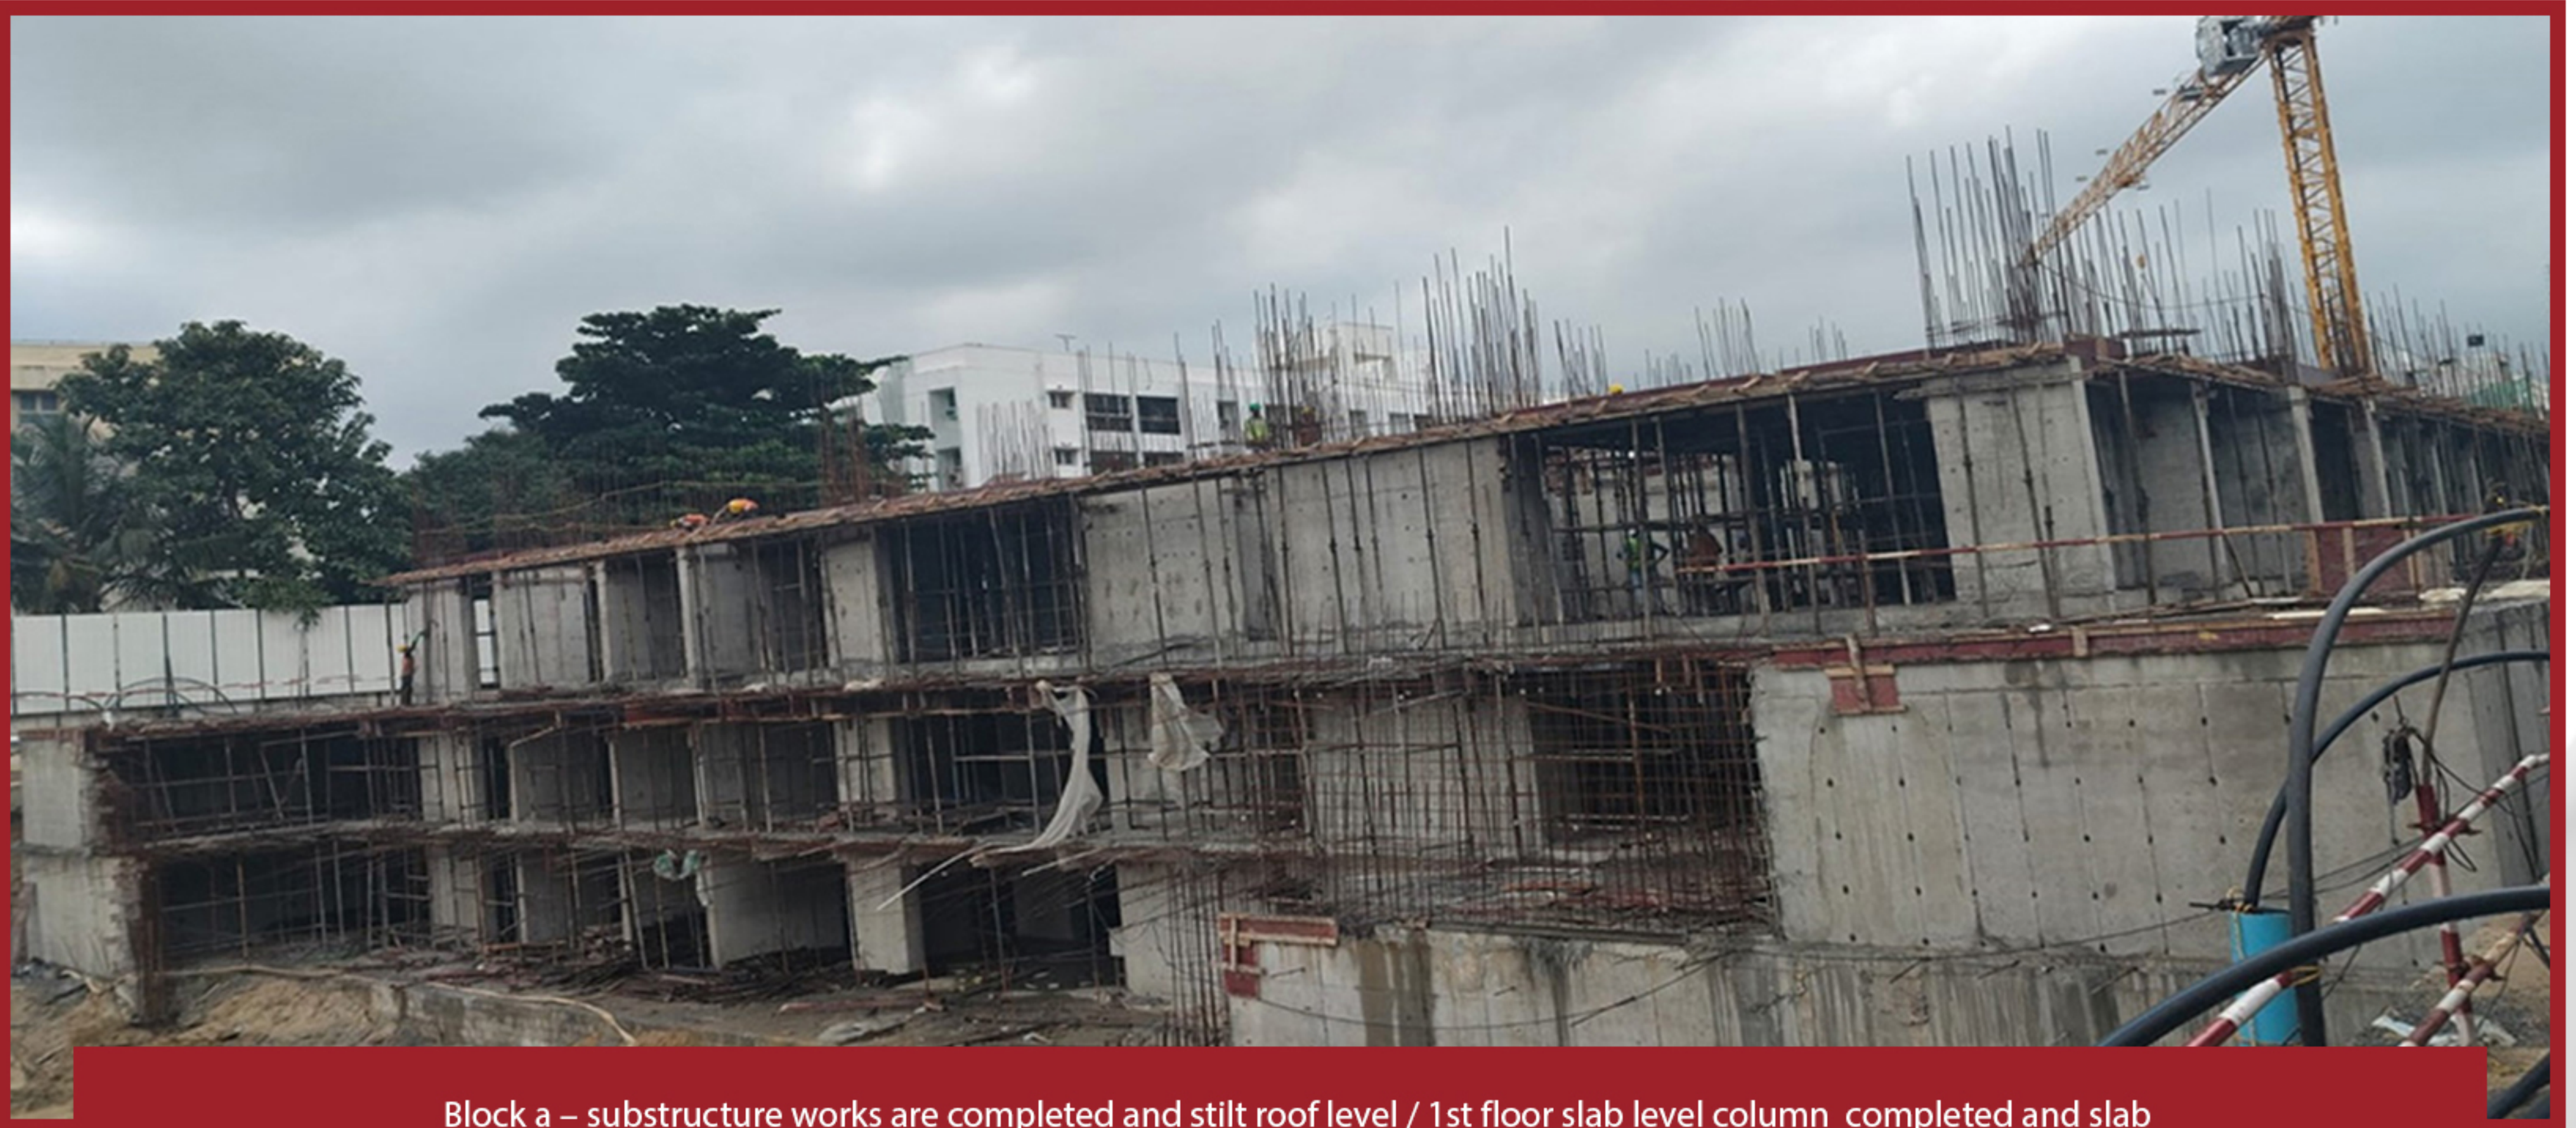
Block a – substructure works are completed and stilt roof level / 1st floor slab level column completed and slab shuttering, reinforcement and slab concrete works in progress.

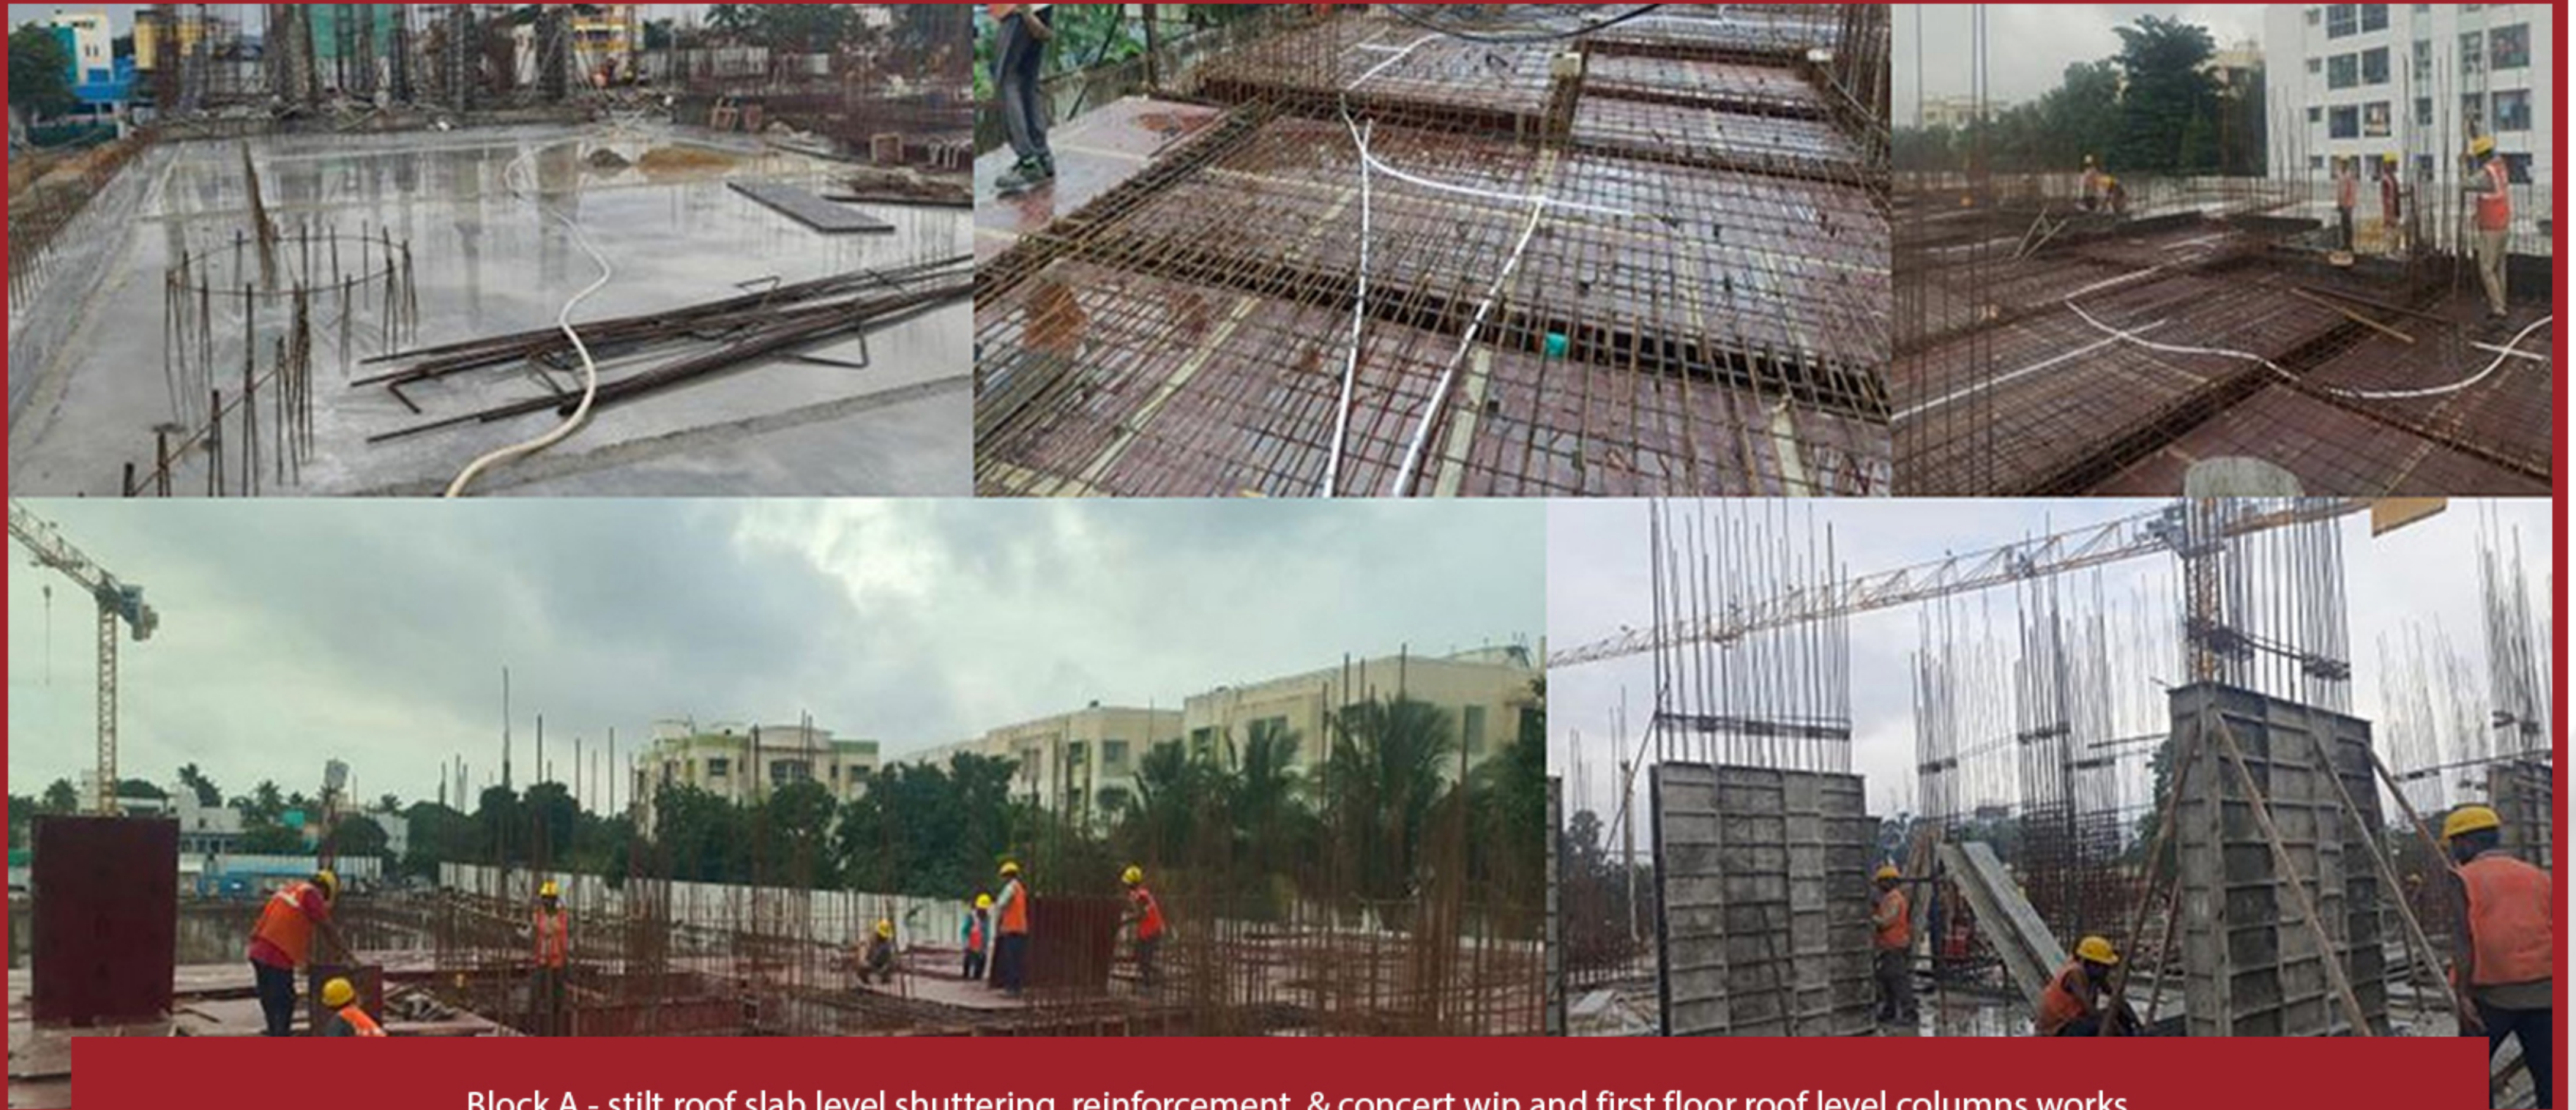
Block A - stilt roof slab level shuttering, reinforcement & concrete work and first floor roof level columns works commenced.

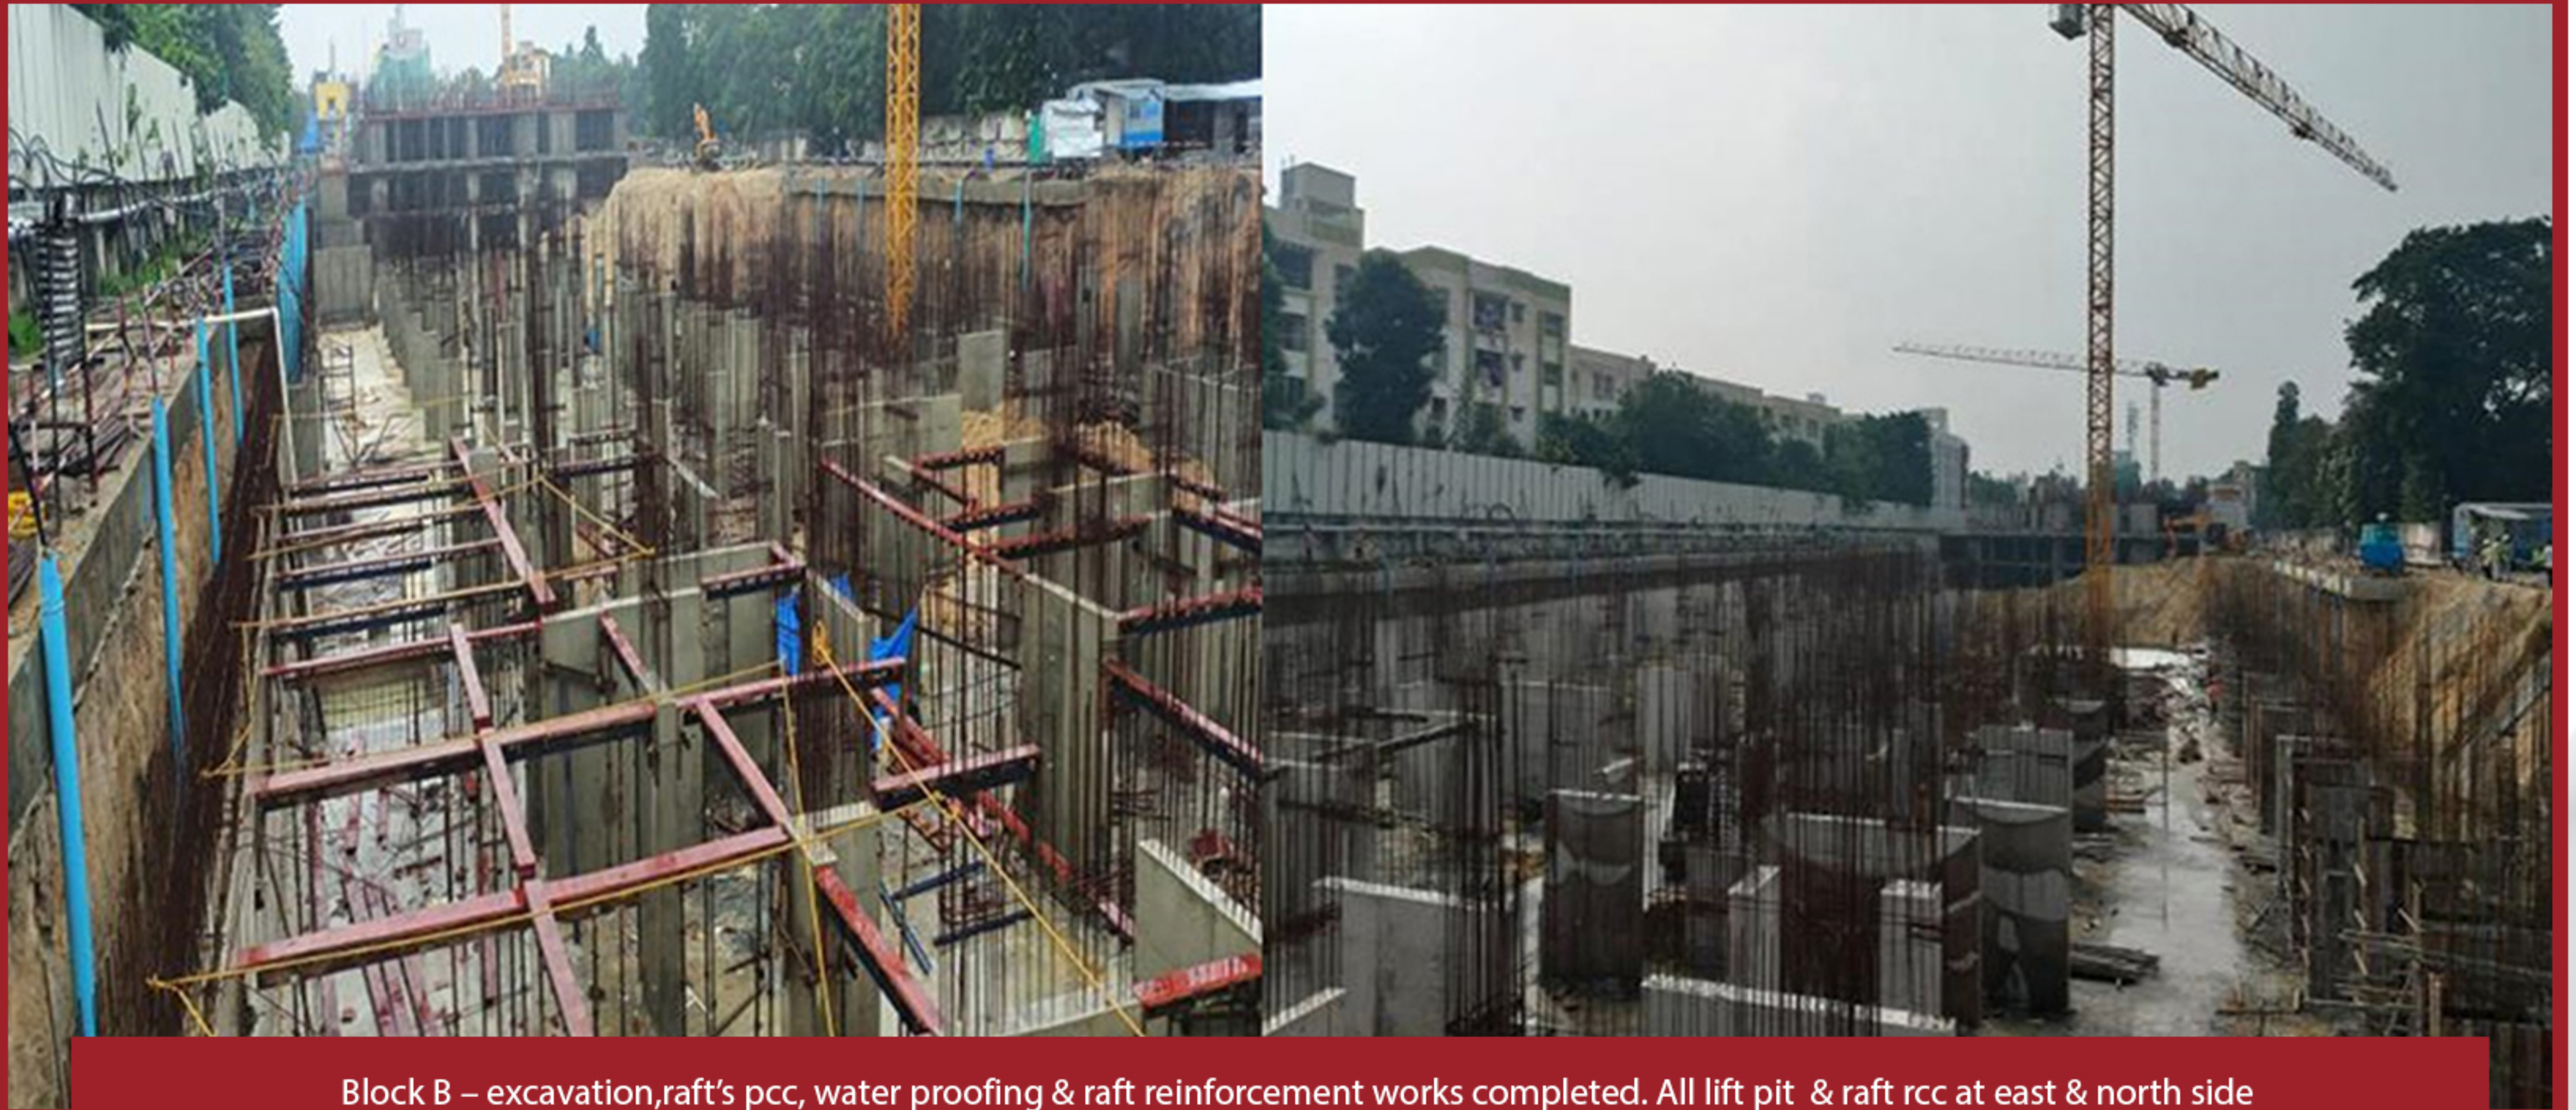
Block B – excavation,raft's pcc, water proofing & raft reinforcement works completed. All lift pit & raft rcc at east & north side completed. Till B1 level retaining wall water proofing, raft above soil filling and pcc wip. Tower crane erected in lift pit and east side slab shuttering works has been commenced.

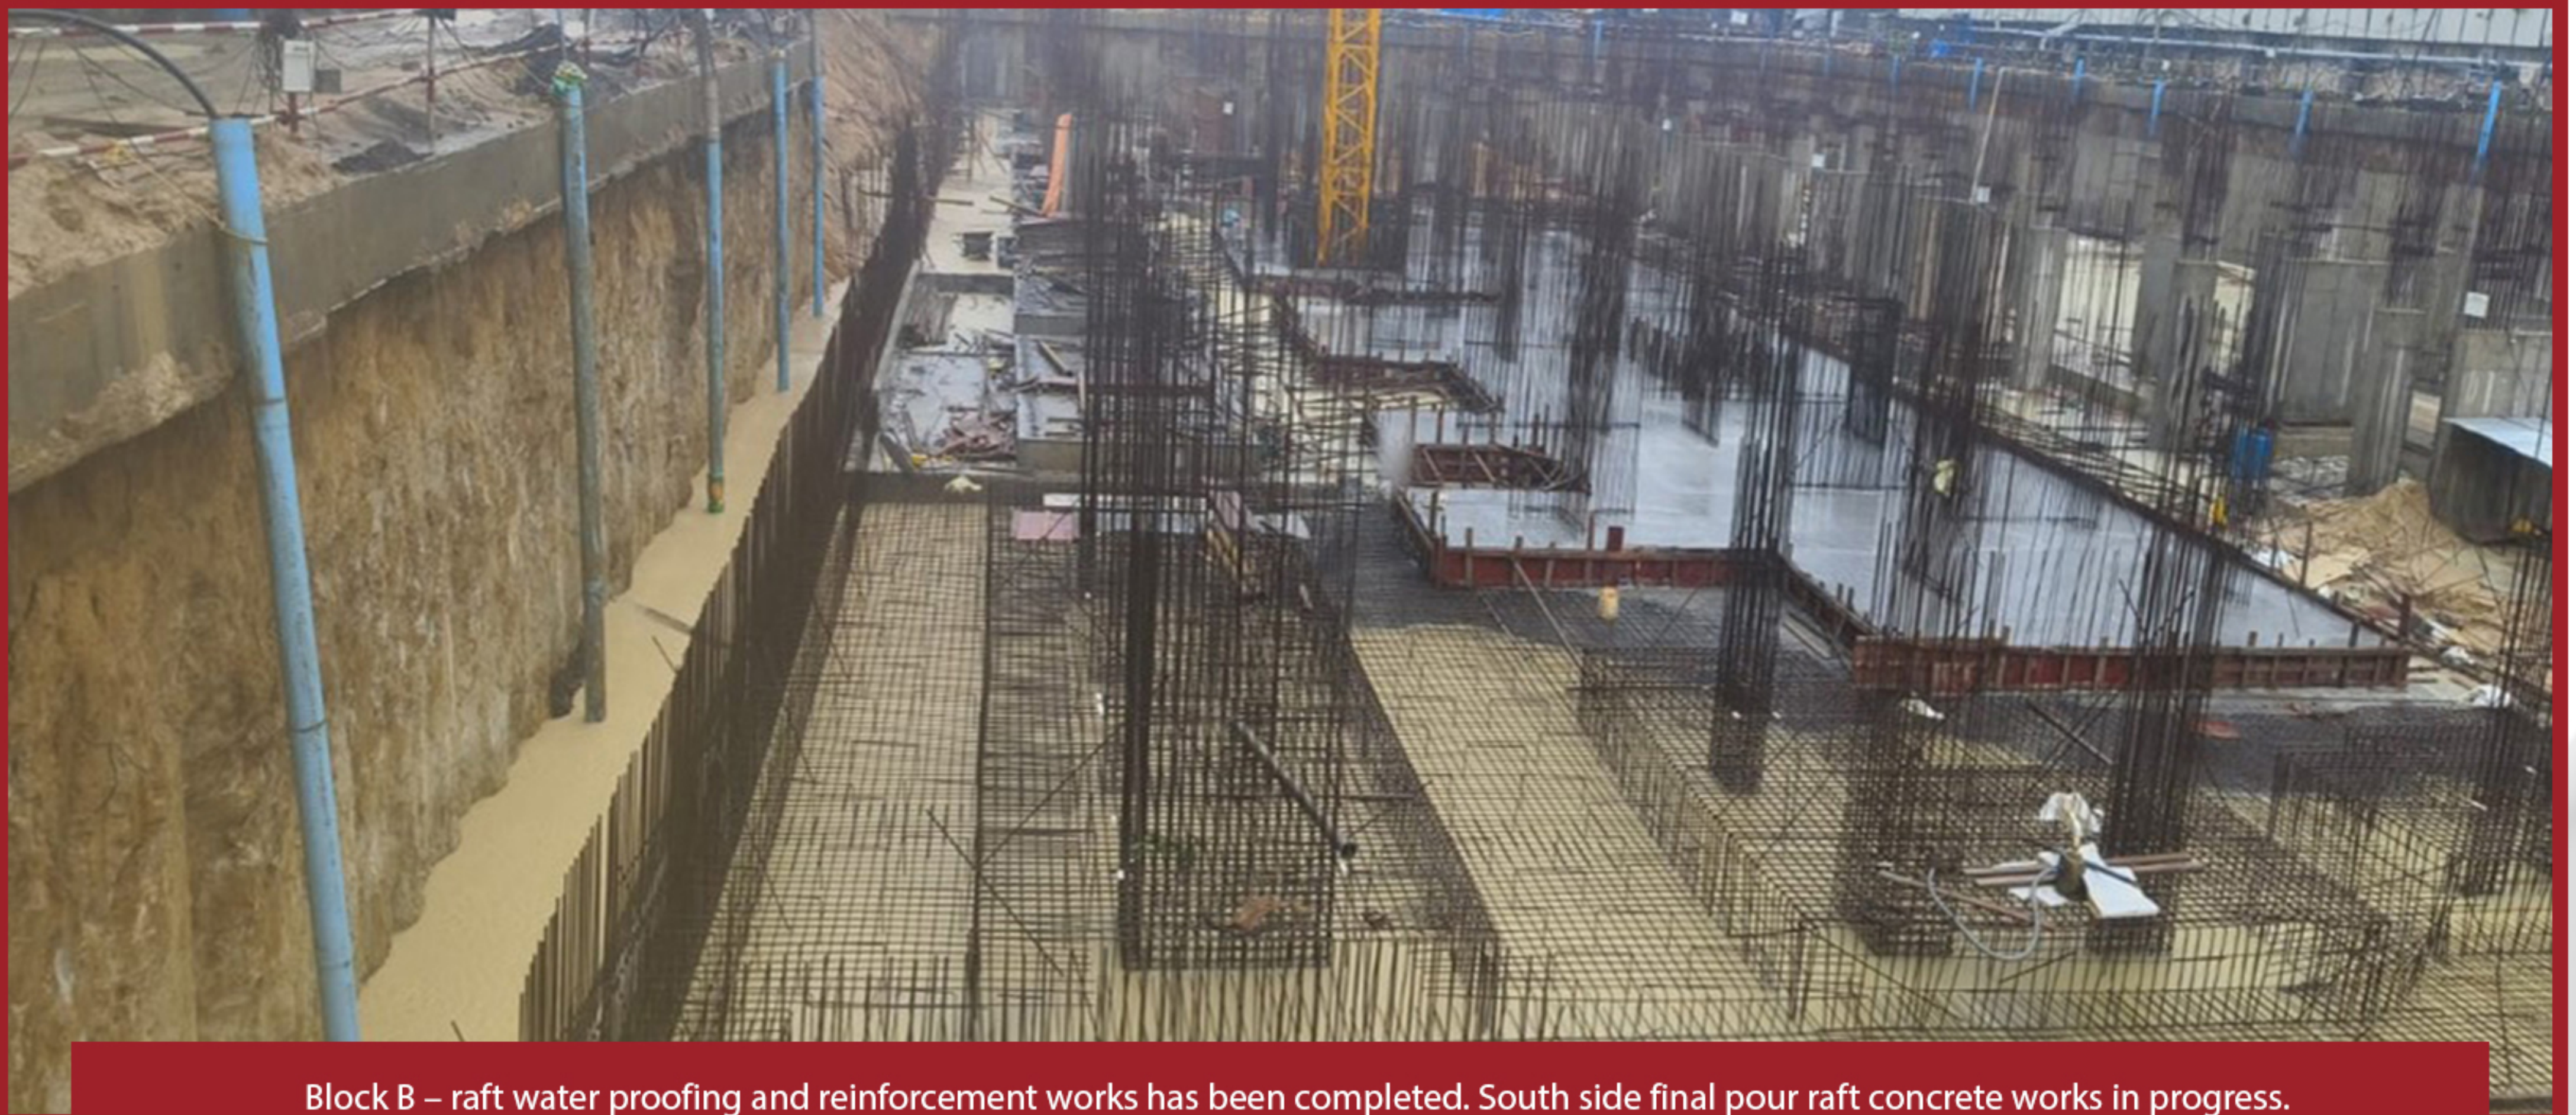
Block B – raft water proofing and reinforcement works has been completed. South side final pour raft concrete works in progress.  
North and east side columns & retaining wall completed.

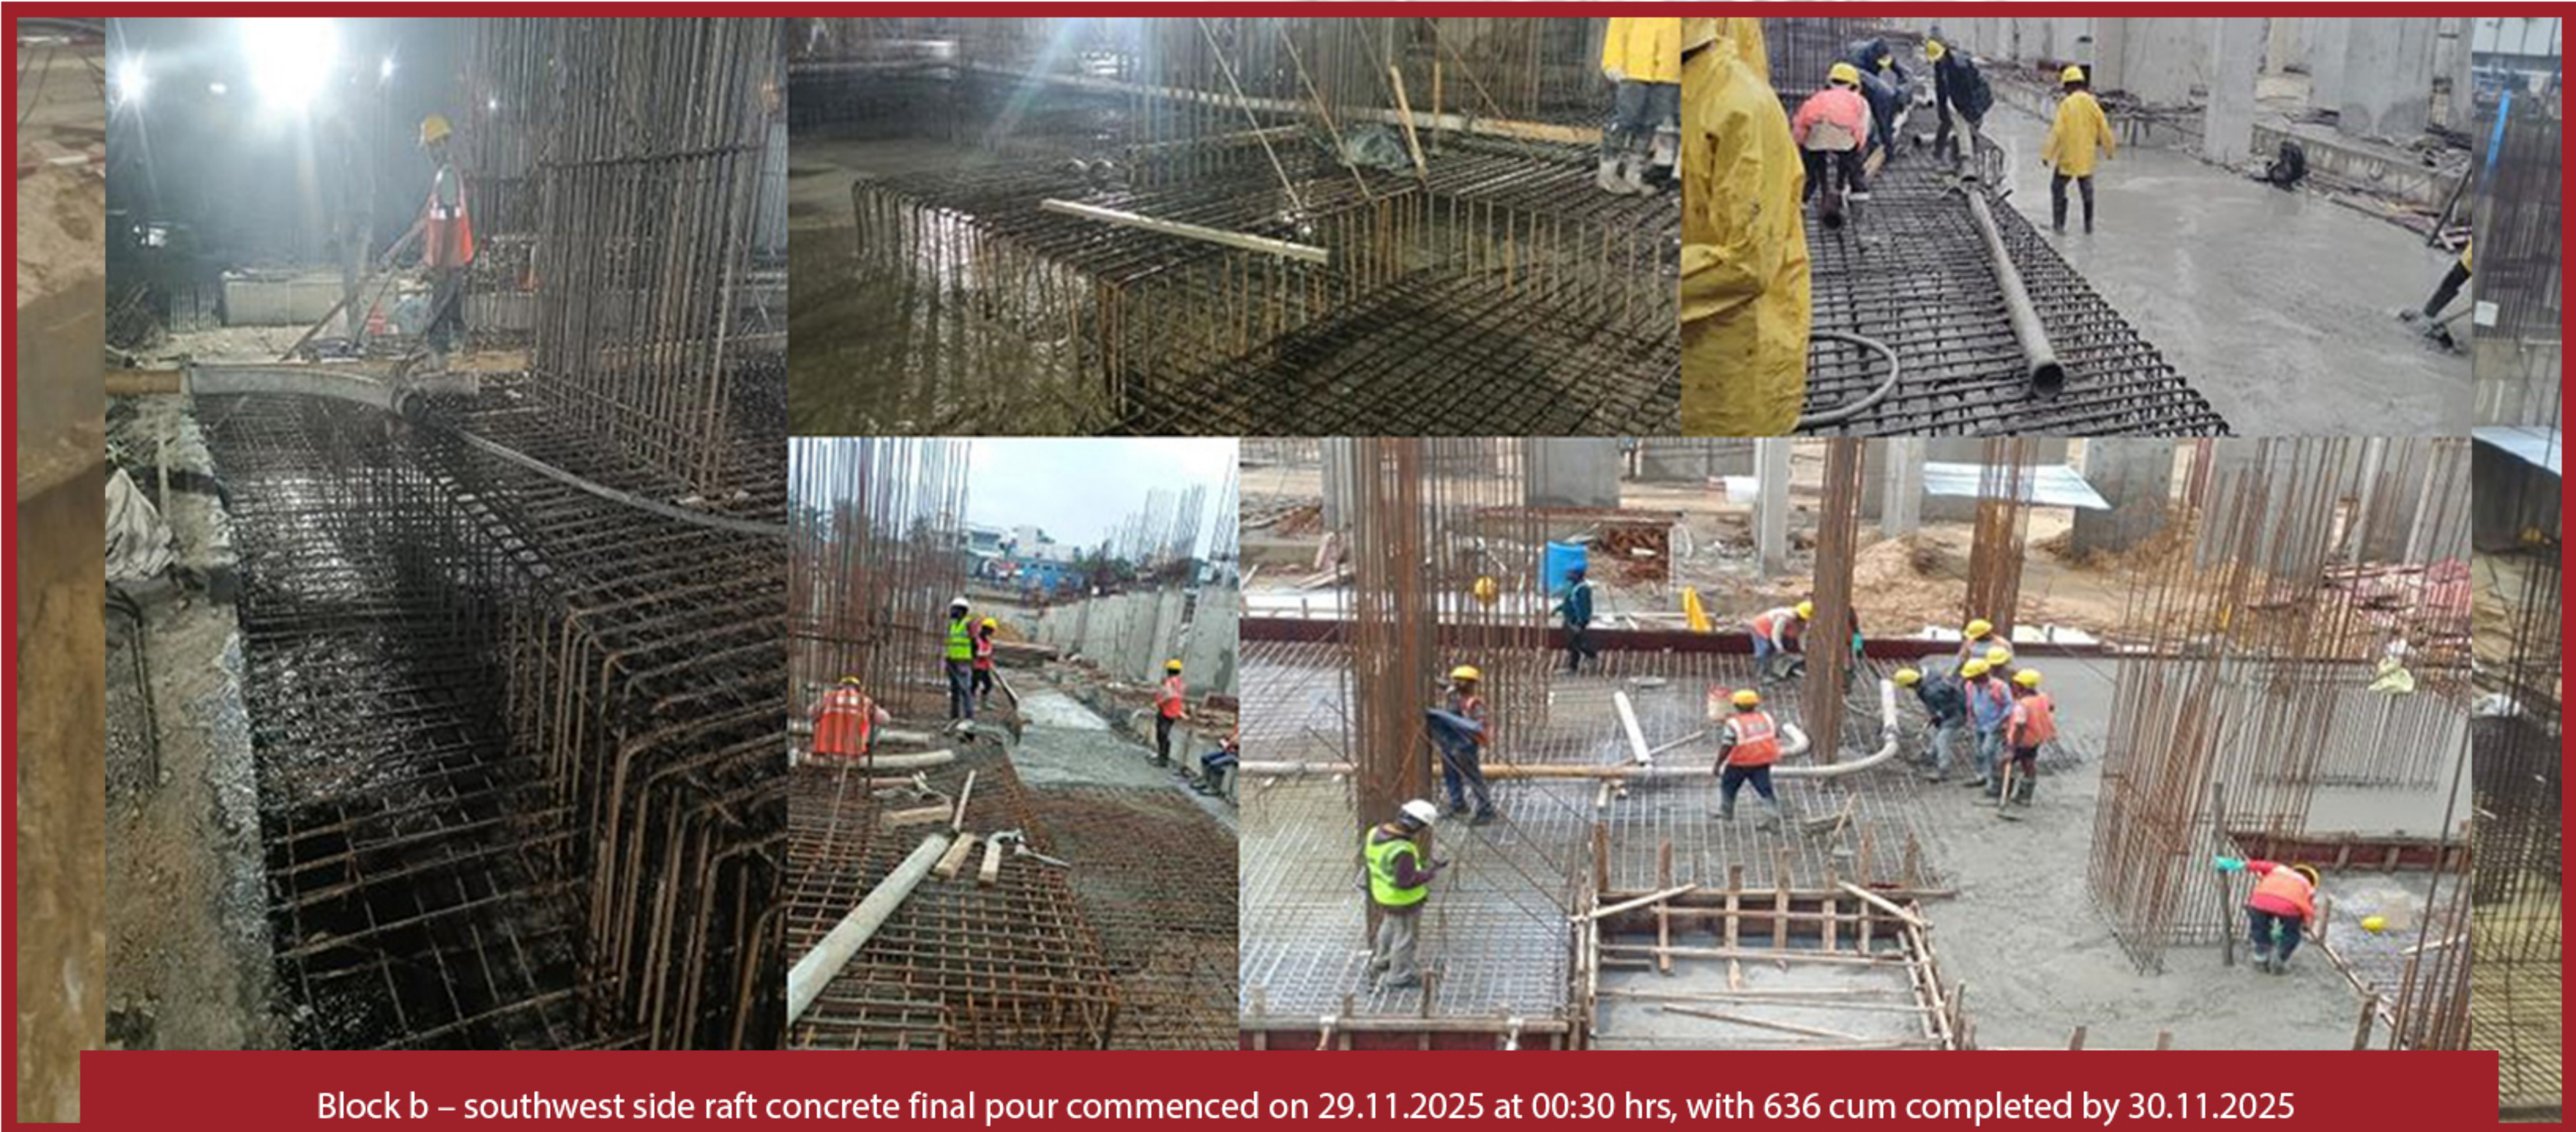
Block b – southwest side raft concrete final pour commenced on 29.11.2025 at 00:30 hrs, with 636 cum completed by 30.11.2025 at 21:40 hrs (at ~14 cum/hr pouring rate). Due to rain, further concreting was halted; resumption is planned for 01.12.2025 under favorable weather conditions.

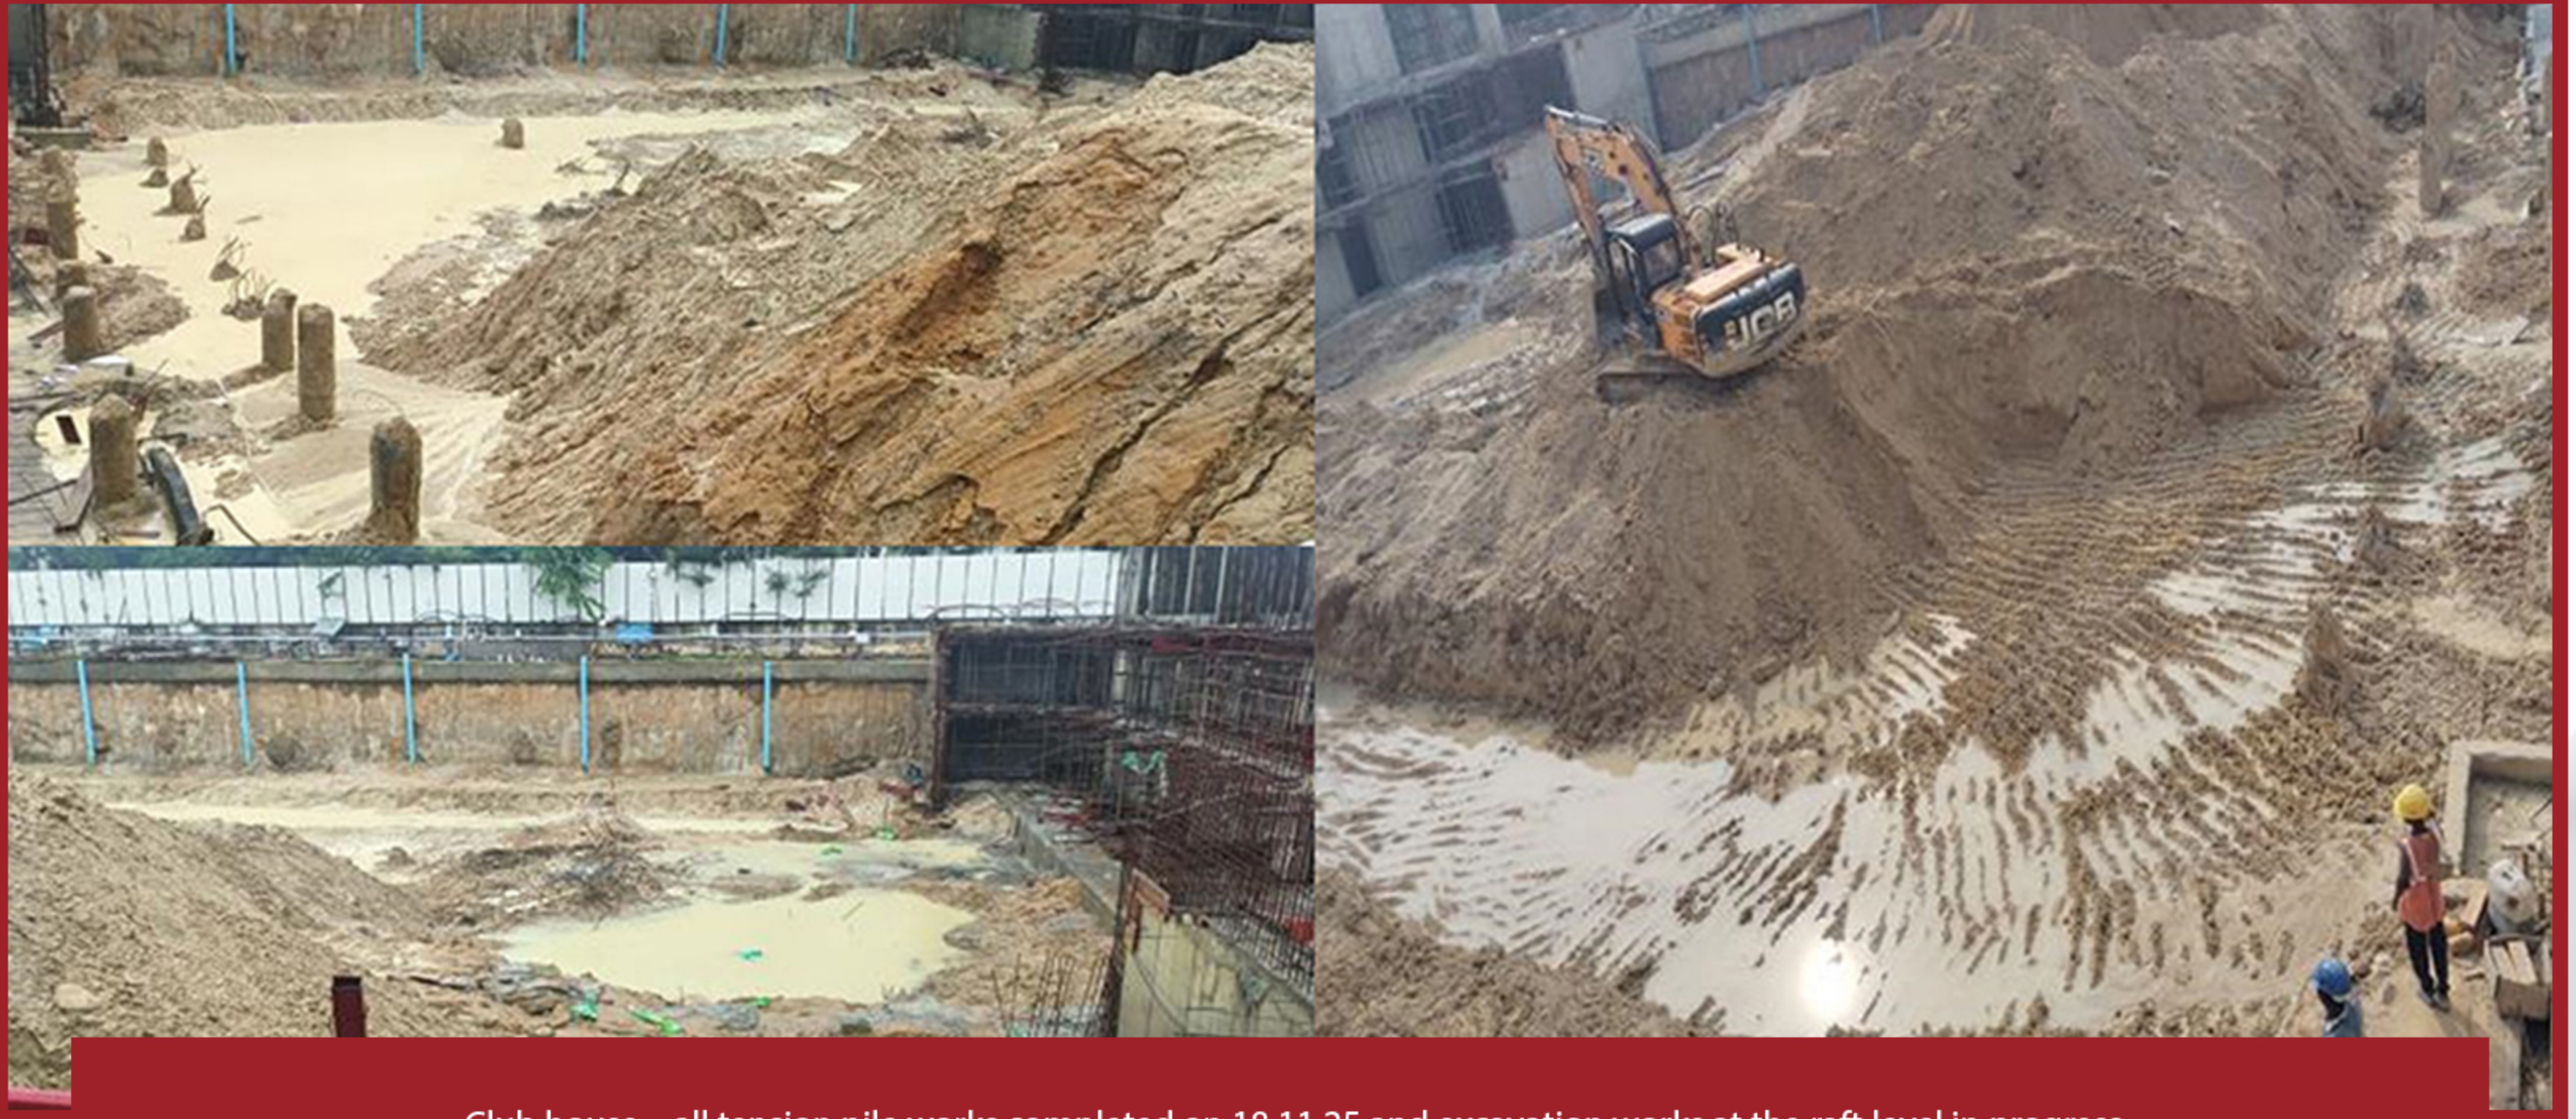
Club house – all tension pile works completed on 18.11.25 and excavation works at the raft level in progress.
