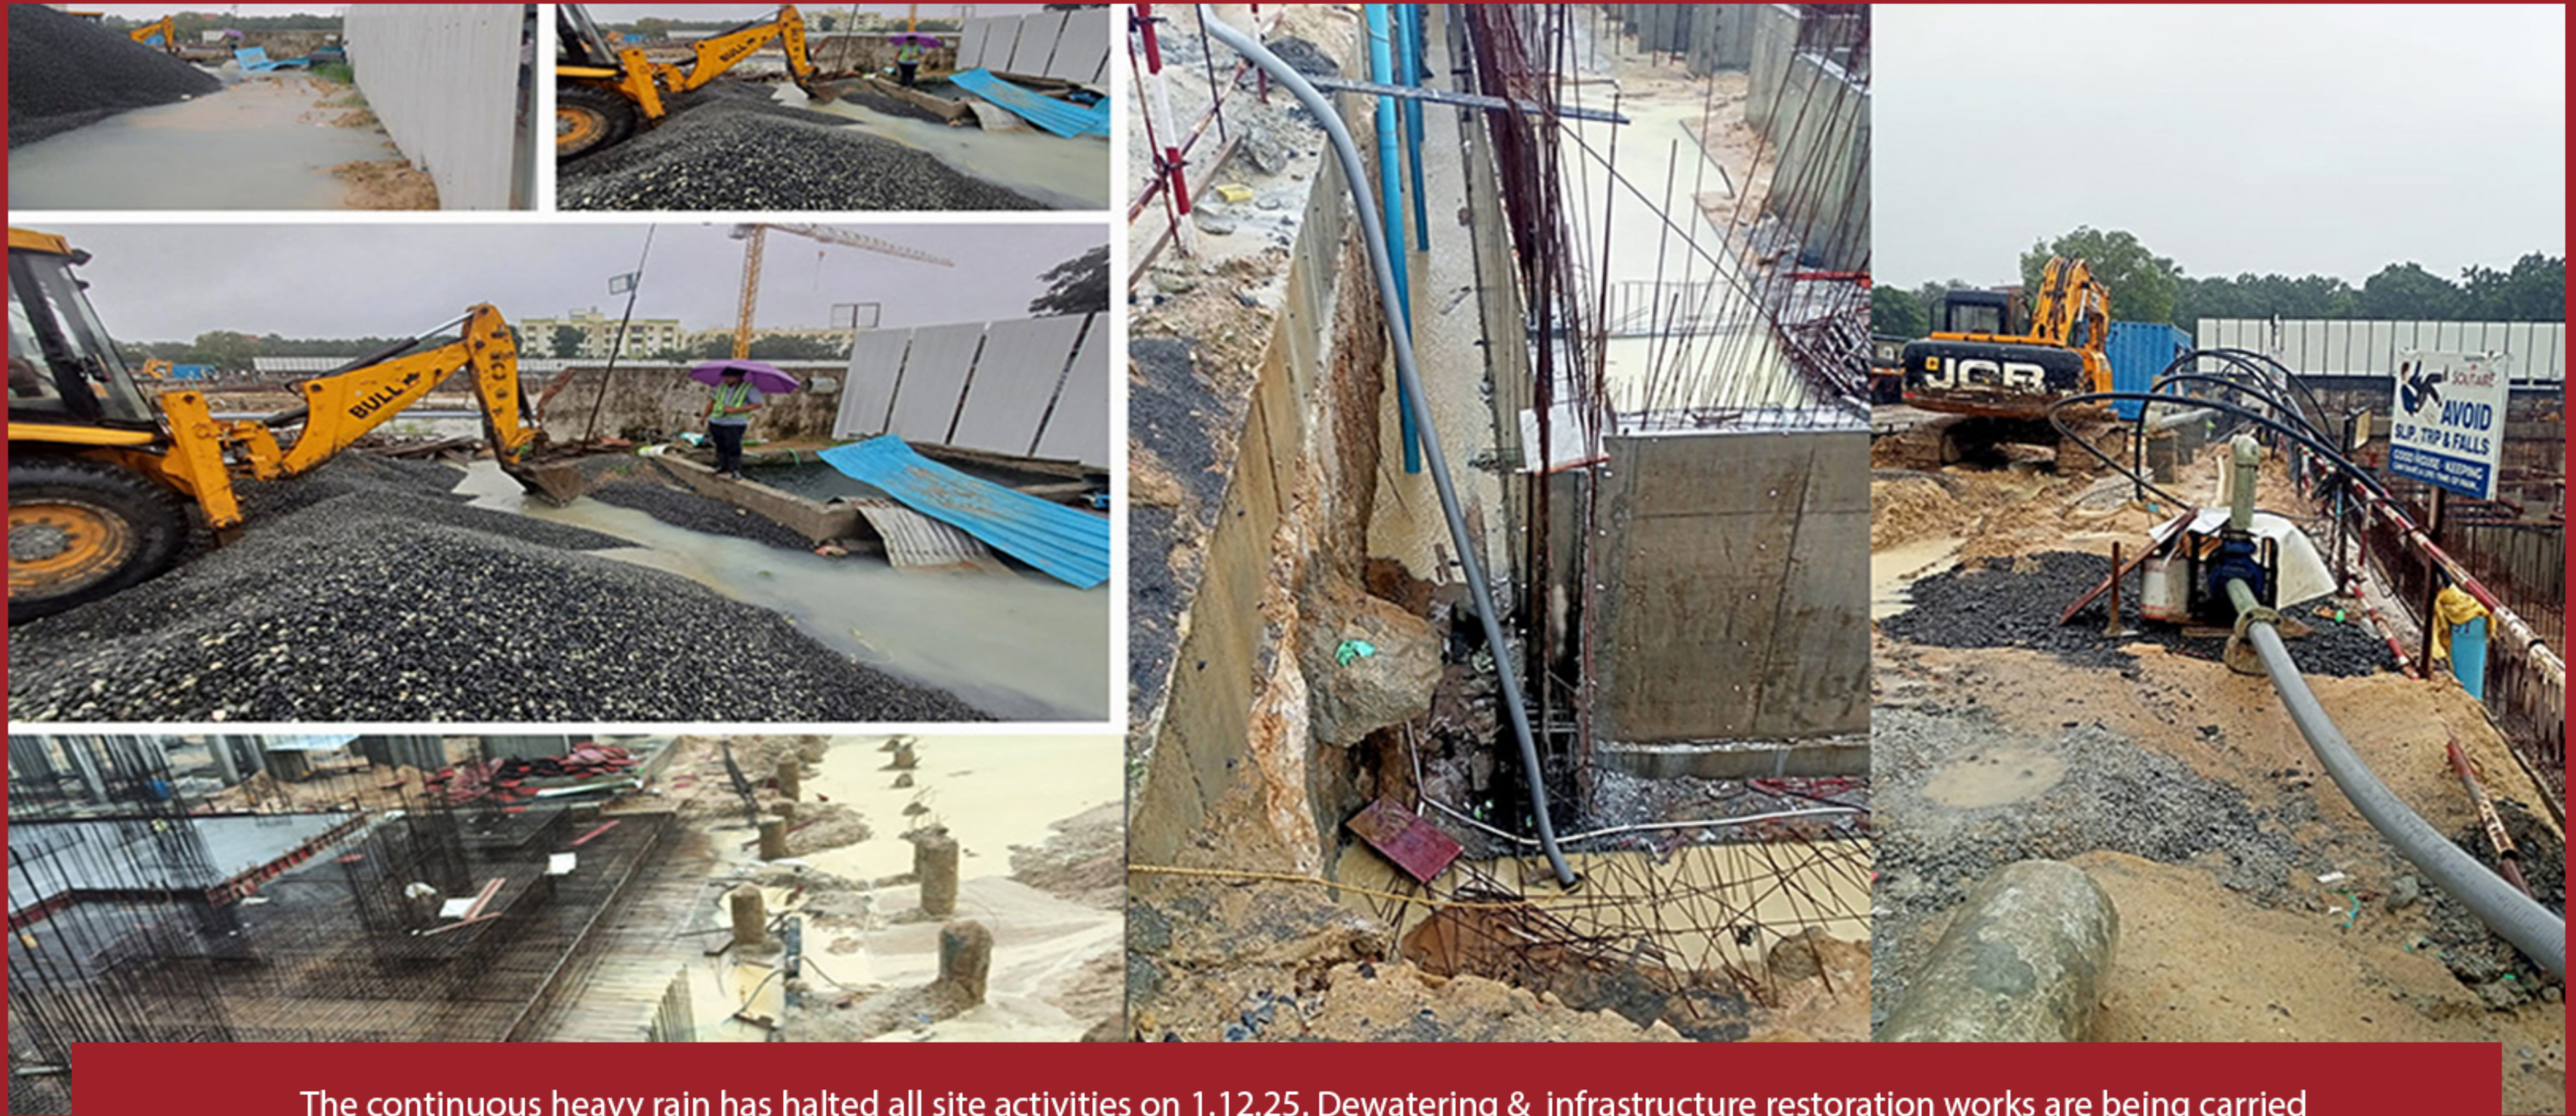
The continuous heavy rain has halted all site activities on 1.12.25. Dewatering & infrastructure restoration works are being carried out as safety precautions due to deep depression warnings. Over the past two days, work has been disrupted during rainy periods due to cyclone's (ditwah) effect.
